B.Dolgoshein

CALICE meeting, DESY, October 12, 2005

SiPM's production, tests and long term behavior

MEPhI&PULSAR

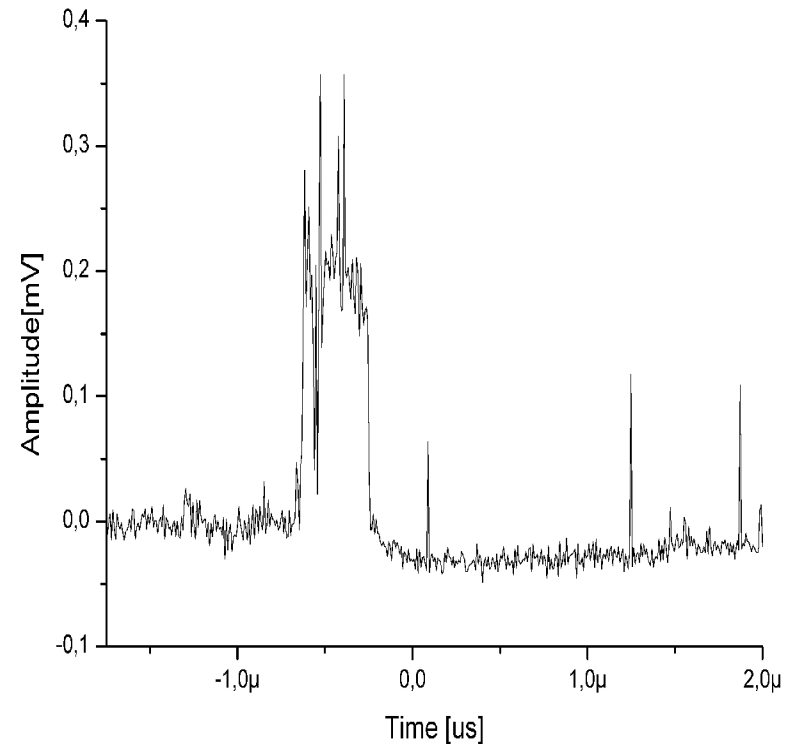
Example of long discharge signal

- Most probable reason is:
Something happens with a quenching polysilicon resistor (its value is reduced from a few MOhm down to ≤ 100 kOhm for some pixel(s))
 - ➔ quenching current rises up to $\geq 10\mu\text{A}$
 - ➔ quenching time rises up to ≥ 100 ns

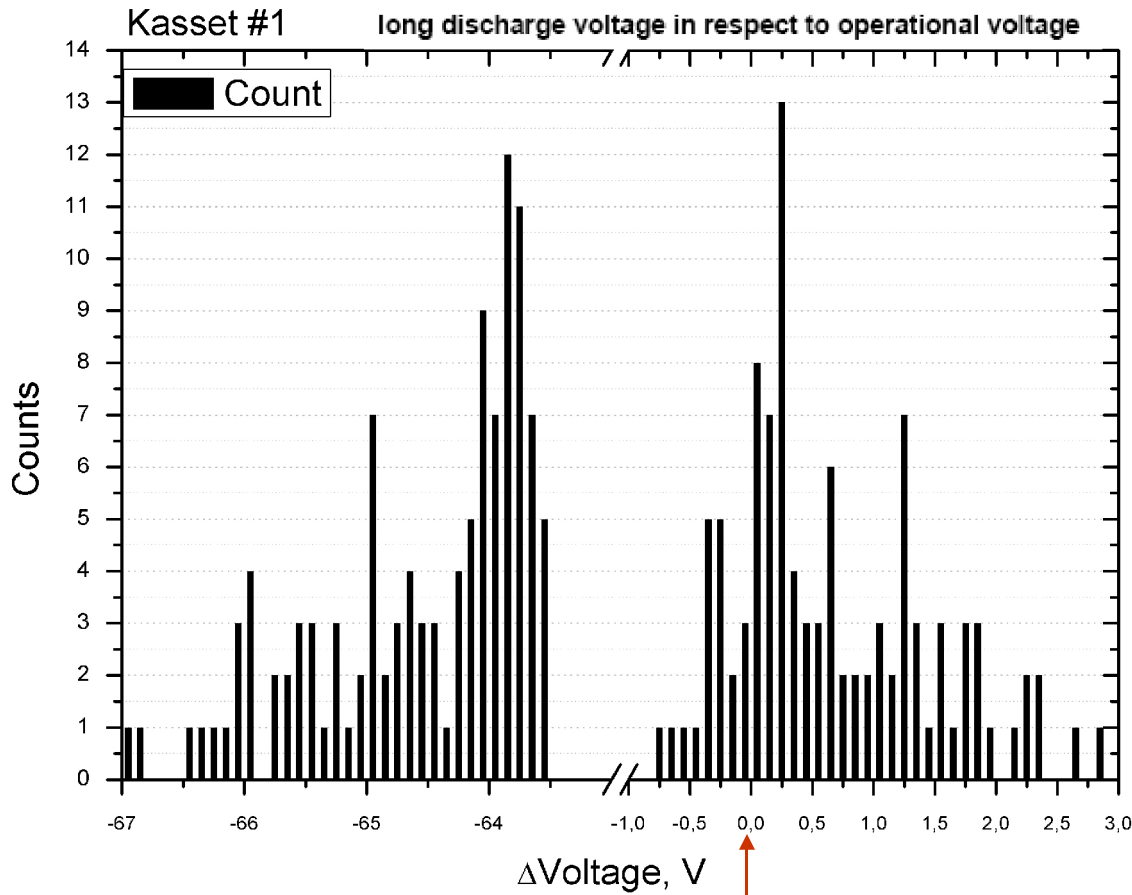
LD behavior observations: module 1

All LD are observed within 2-2.5 V over the ITEP voltage

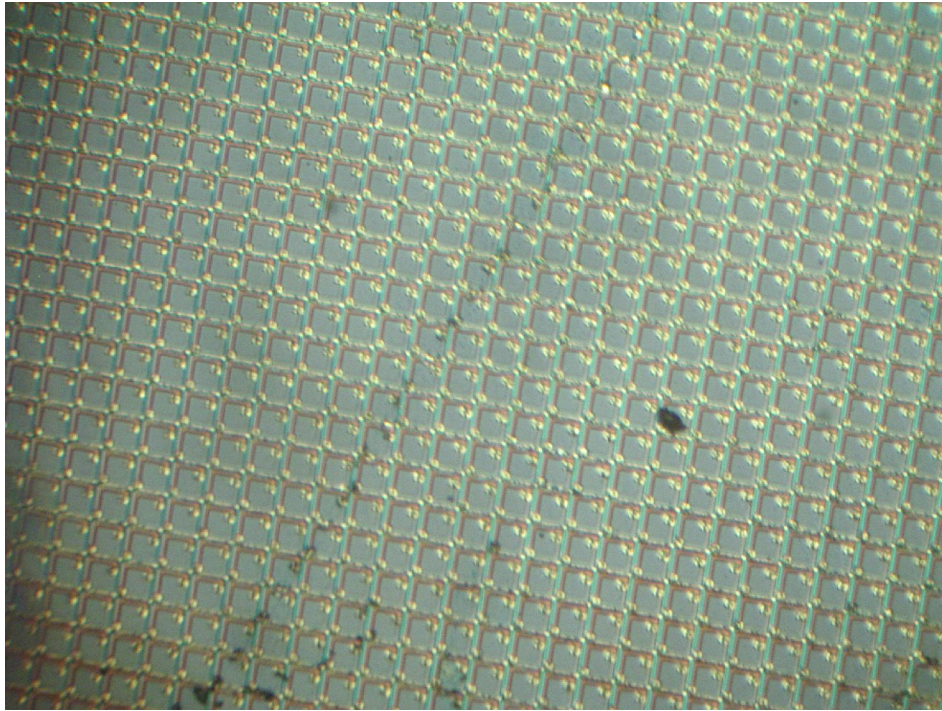
SiPM 2591

Died SiPM (no signal and big current)

Big scratch

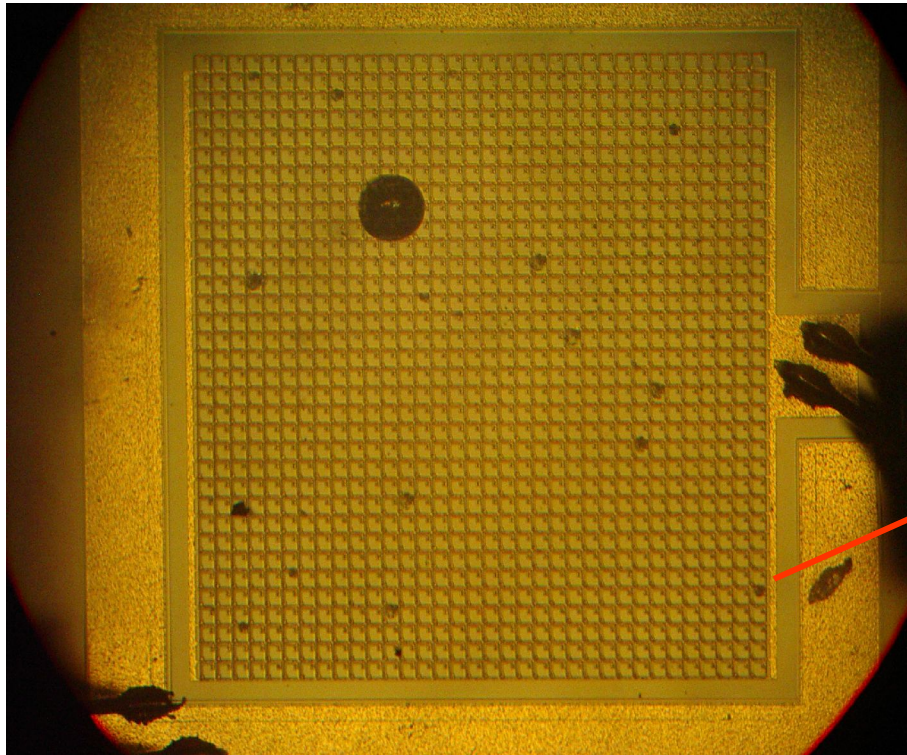
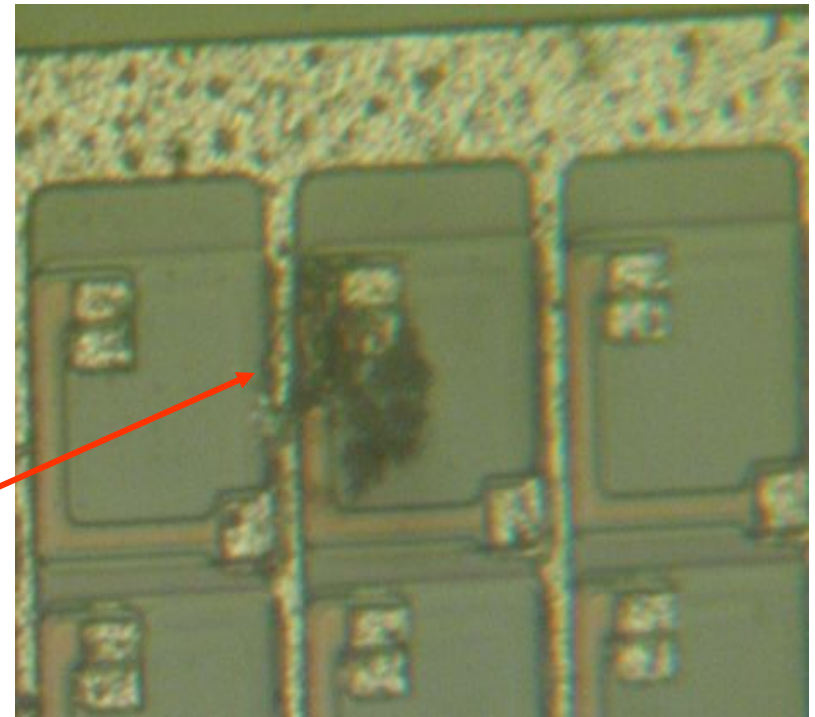
Died SiPM (no signal and big current)

Discharge between resistor and Al bus.
Damage of resistor and short circuit

Another example of damages due to resistor-Al bus discharge

Al (short circuit?)

Such damages can appear as a result of

- big overvoltages for reverse bias
- High voltages for direct bias

➡ Now SiPM's modification with additional SiO_2 layer for Al-polySi resistor isolation is under study.

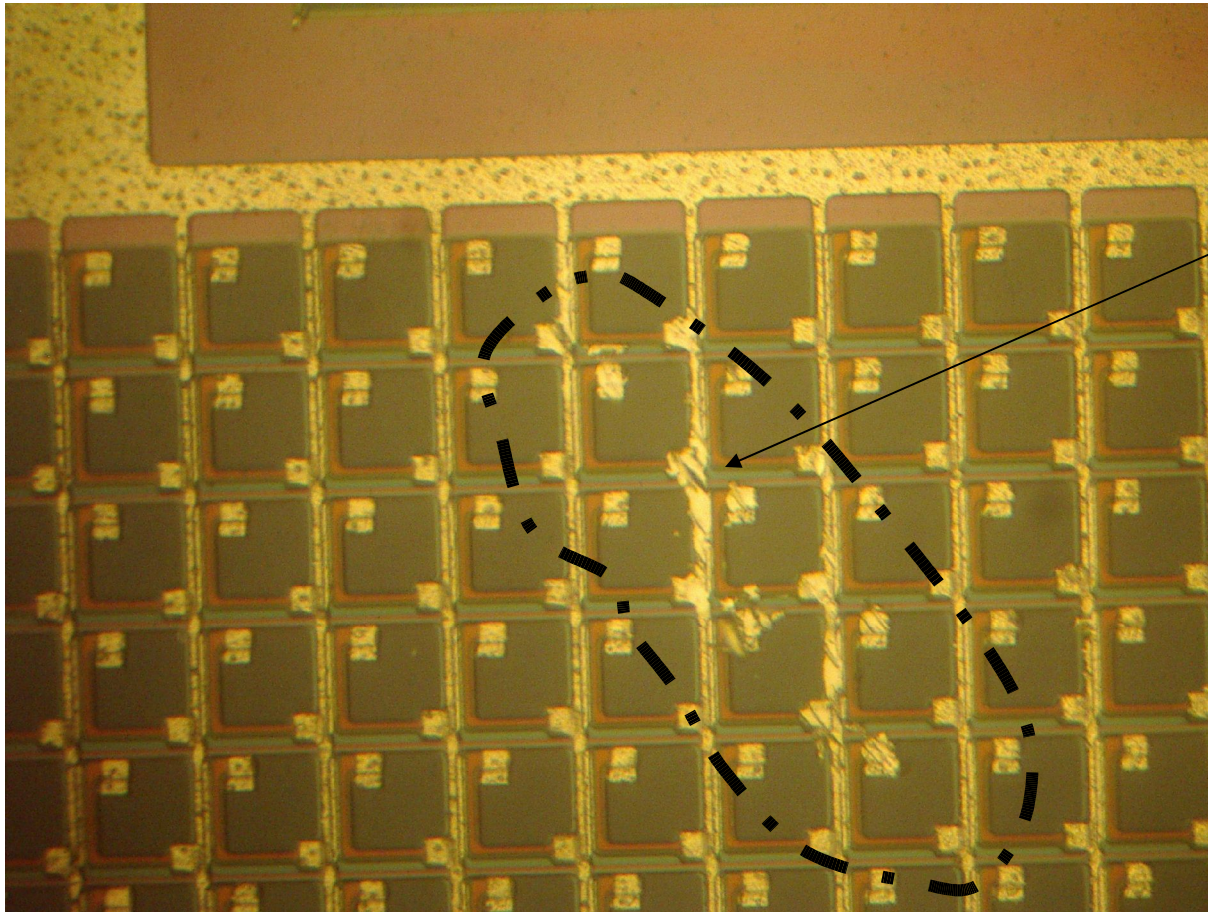
SiPM 2593

LD area

Al short
circuit due to
scratch

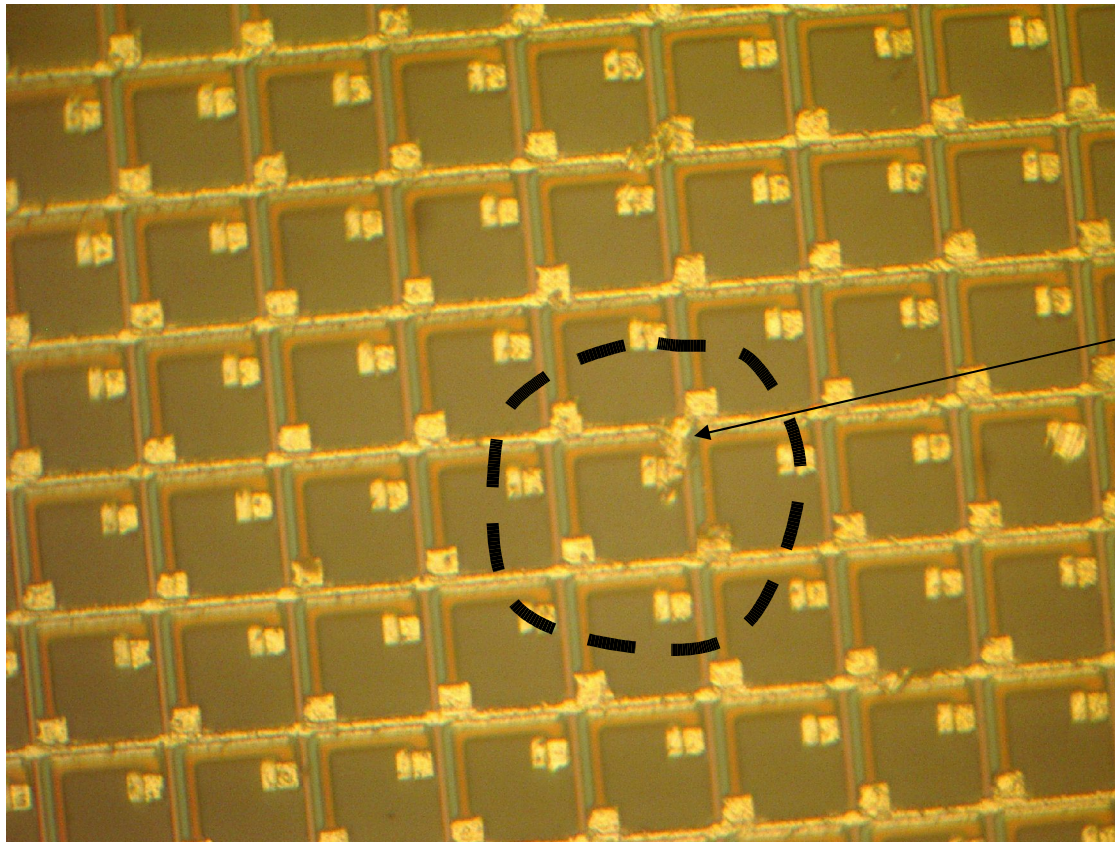
SiPM 2634

Pixel with LD

Al short circuit due to point like defect
