# Status of the TPC readout electronics

Status 9.2.2017

Leif Jönsson  
(representing the Lund group)  
Lund University

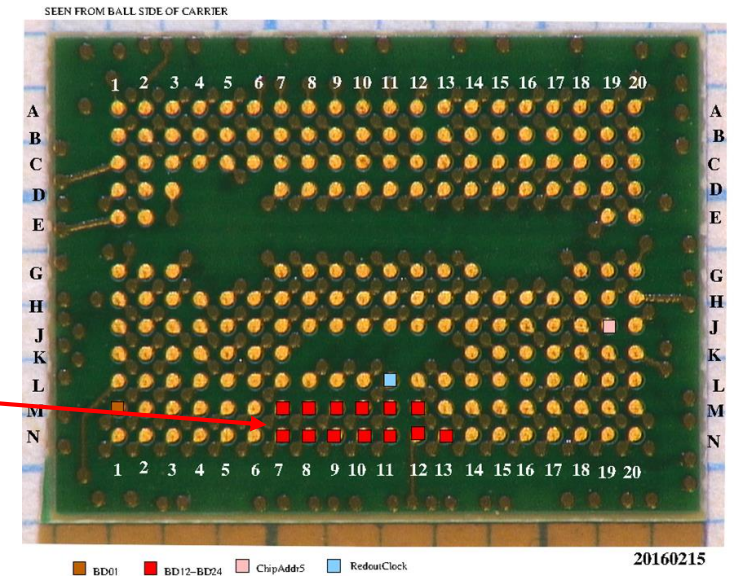
- After bonding of the die tests were performed and all connections were confirmed.
- After application of the epoxy glob and the tin balls the connections were tested again and everything was ok.
- After soldering onto an adaptor board, for characterization, some connections were lost.

- 1st attempt: an Al-filter from the previous user had not been removed
- 2nd attempt: no bonding wires could be identified

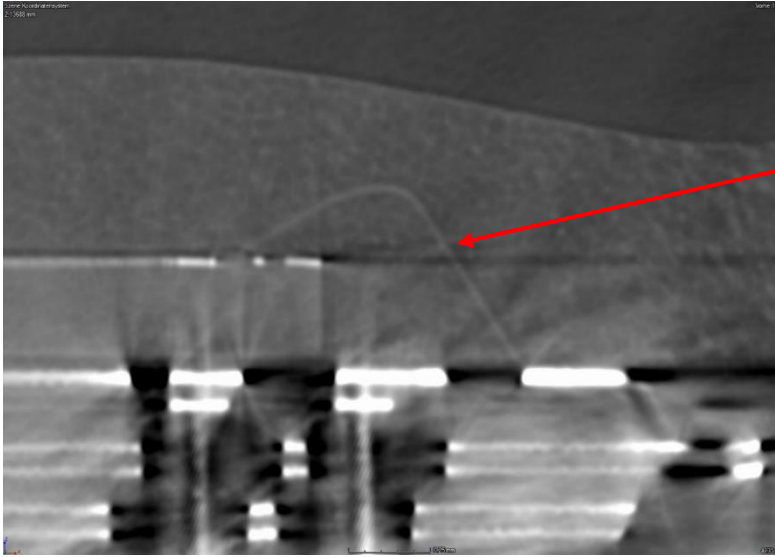
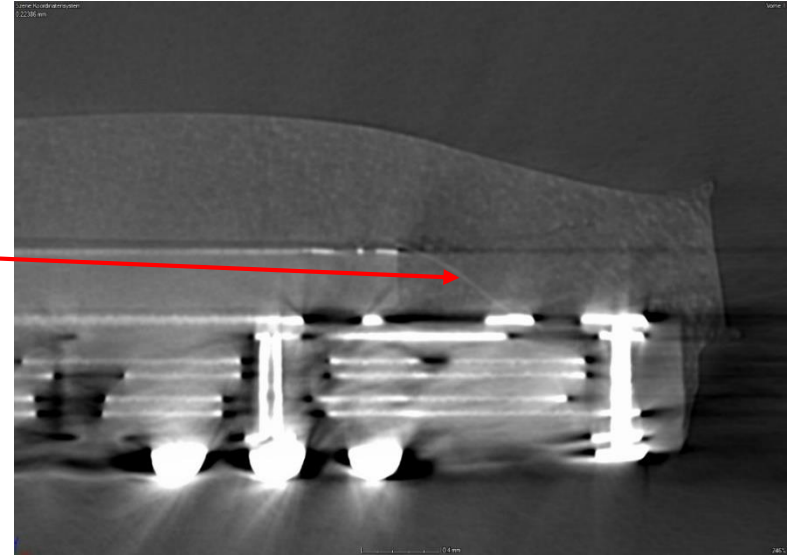
Normal bonding loop

Bond wire without a significant loop

- There is nothing indicating an error in the design of the carrier board.
- The lost connections are due to the different expansions of the PCB and the epoxy material in the soldering process, which causes breaks in those wires where the wire loop is not sufficiently high.
- Another disadvantage of this method is that the surface of the epoxy layer is not flat enough to provide efficient cooling.

Possible way out: we have found a 3-D printing system which produces capsules with sufficiently thin walls to fit our carrier board.

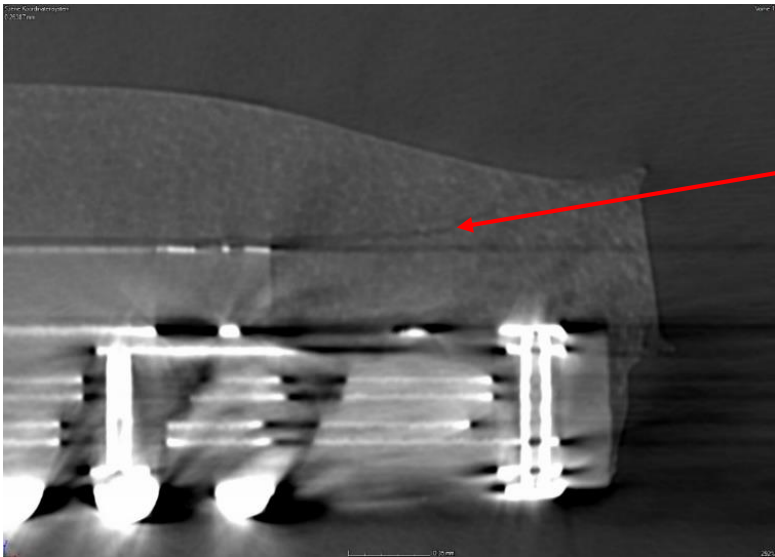
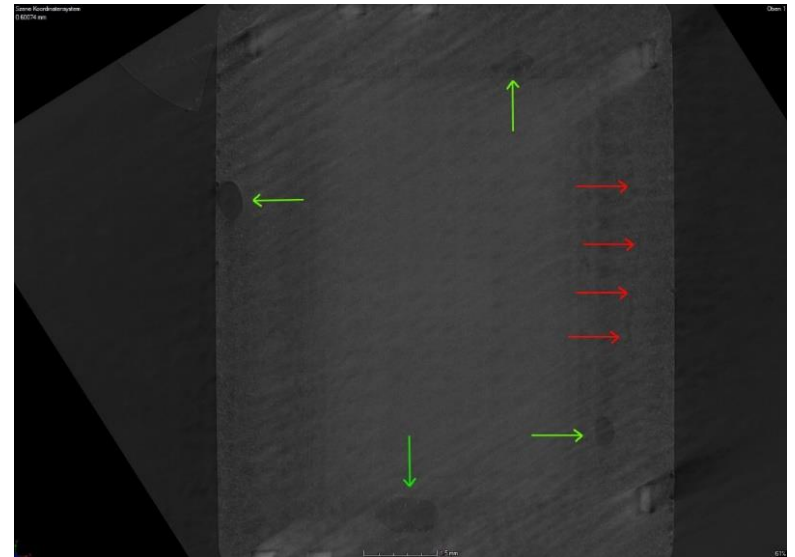
Cracks in the epoxy (red arrows) and air bubbles (green arrows).

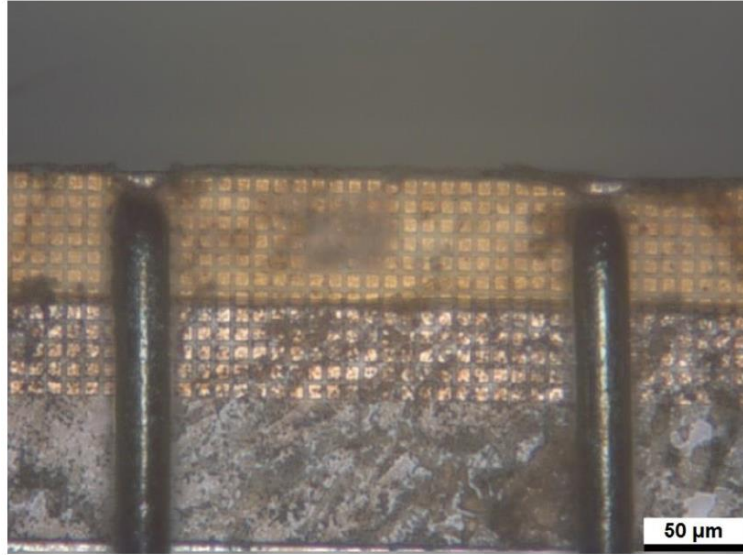
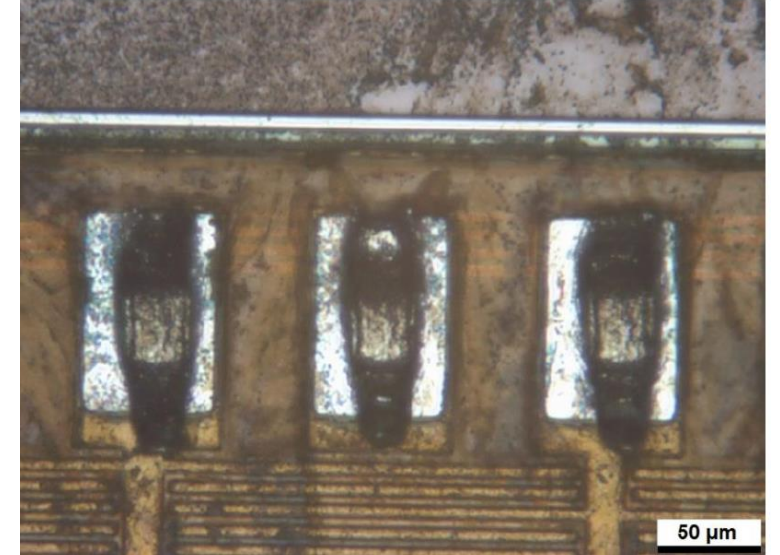
The bond wires have been torn off at the edge of the chip. You may also notice that there is notches at the edge of the die.

Some bond wires are broken already at the soldering point.
