Cleanroom Assembly of the IFMIF SRF LINAc

Linear Collider Workshop 2024

IFMIF/EVEDA Project

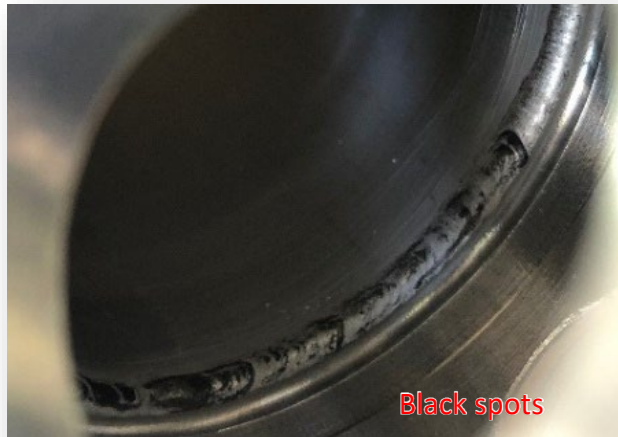
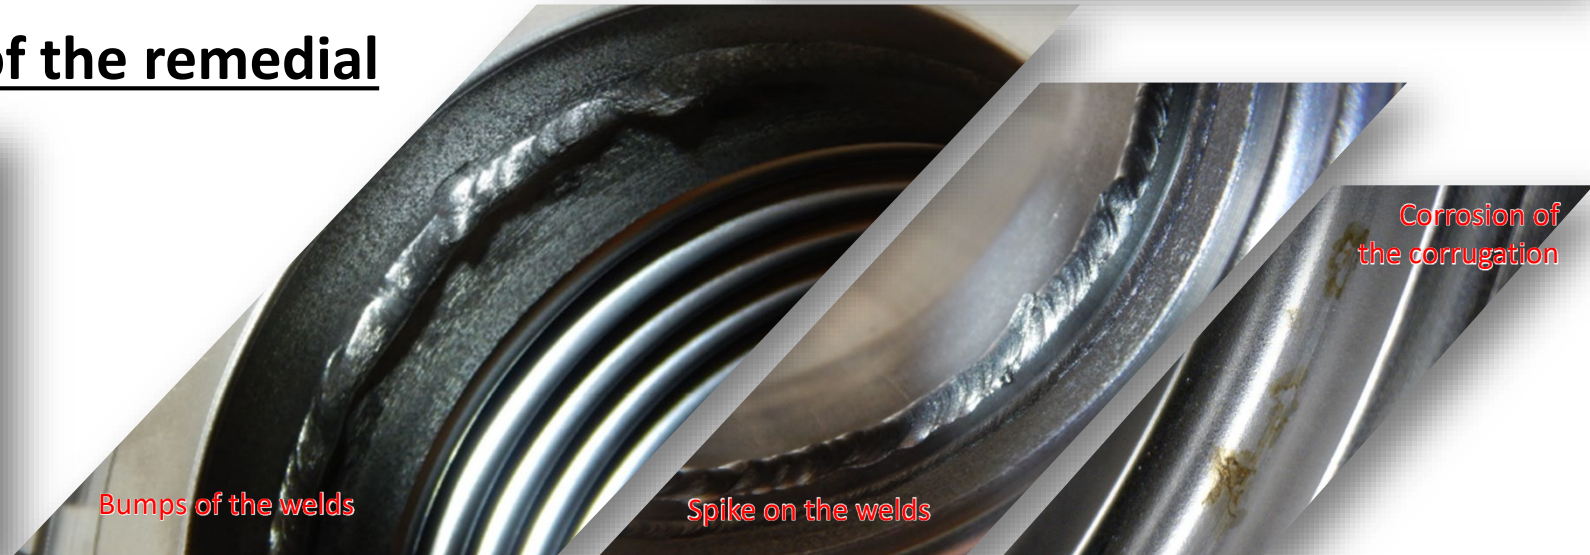
- **2019, March** : quality issue on the solenoid discovered during their HPR preparation in cleanroom at CEA.
 - Rust spots, weld quality issues inside the beam tube, particulate material trapped in the bellows, external surface finished.
 - Remedial actions: light grinding/polishing of the welds, pickling and passivation.
 - Black spots appeared on the newly passivated welds.
 - The process was repeated locally on the weld before a final passivation.

Spike on the welds

Corrosion of the corrugation

- **2019 September: completion of the remedial action.**

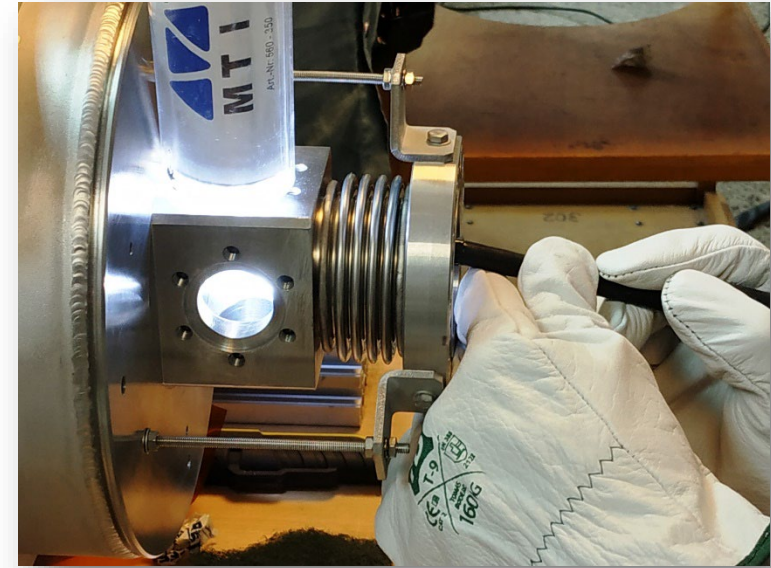
- **2019, October**: a leak is detected on solenoid V06.
 - Located on the bellows on the BPM side.
 - A first attempt of repaired failed.
 - The bellows was changed by a new one.
 - After completion of the repair, a new leak was detected on a threaded hole of the BPM.
 - A previous repairs was actually discovered on that thread.
 - The hole was recharged with welding material but a gas volume was trapped.

- **Early 2020**
 - V06 was finally leak tight.

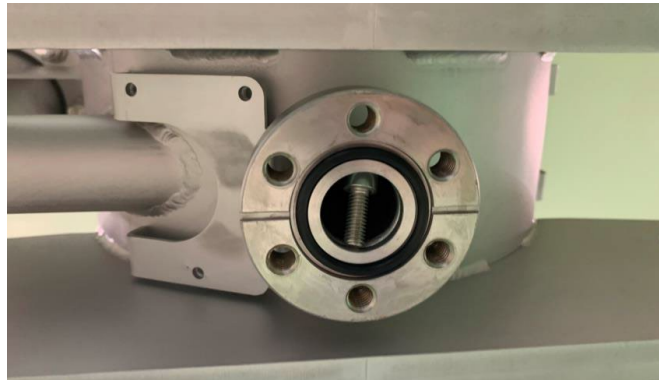
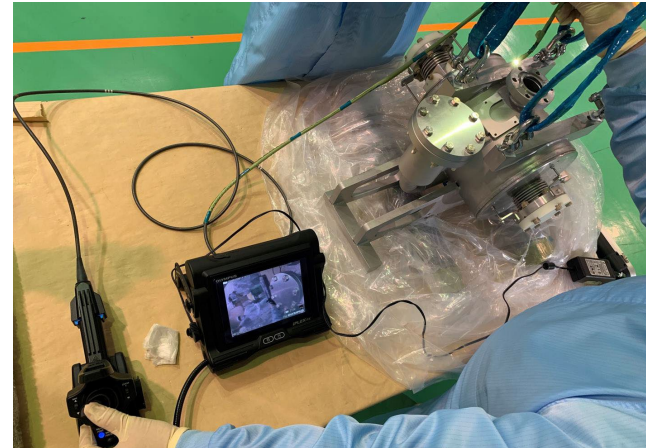
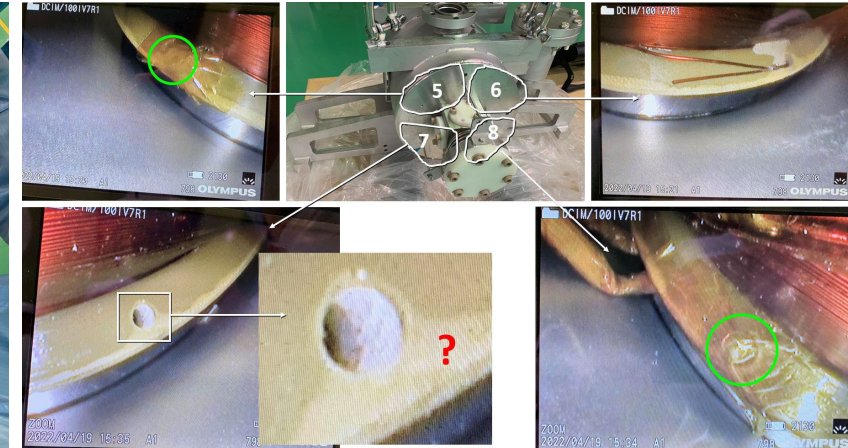
- **2022, June:** -rattling noise detected in 2 solenoids (V06 + V07) during the ultrasonic cleaning prior to HPR at MHI.
 - one BPM pick-up does not fit on solenoid V06 in cleanroom.
 - The two solenoid helium vessels were checked with an endoscope. One loose screw was found in the first one but nothing in the second.

- The screw found in V06 is used to keep the coil in place during the assembly and can be removed.
- A CT scan of all the solenoids was decided.
- The BPM port on V06 was deformed. Same face that had one of its thread repaired. To be solved at QST during the cleanroom assembly.

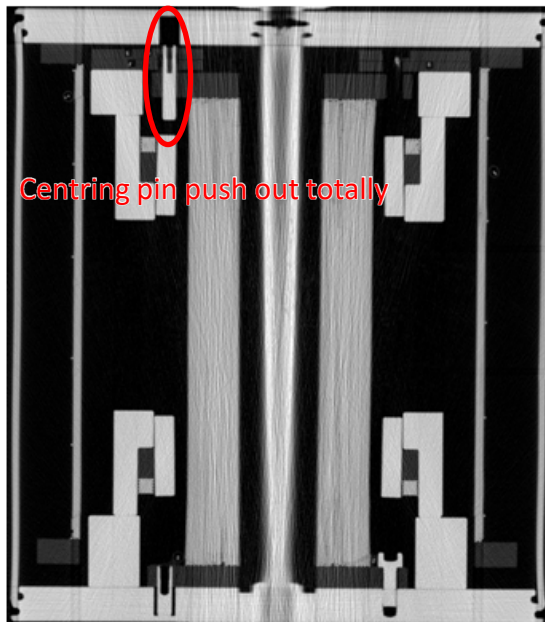
- New issues were detected by analysing the centring pins and screws used for the assembly of the coils (solenoids & steerers).
- Some pins were pushed out during the final assembly.

Centring pin push out totally

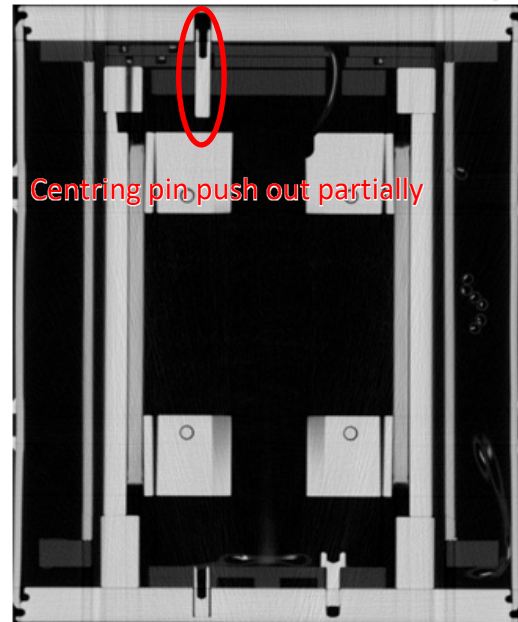
Centring pin push out partially

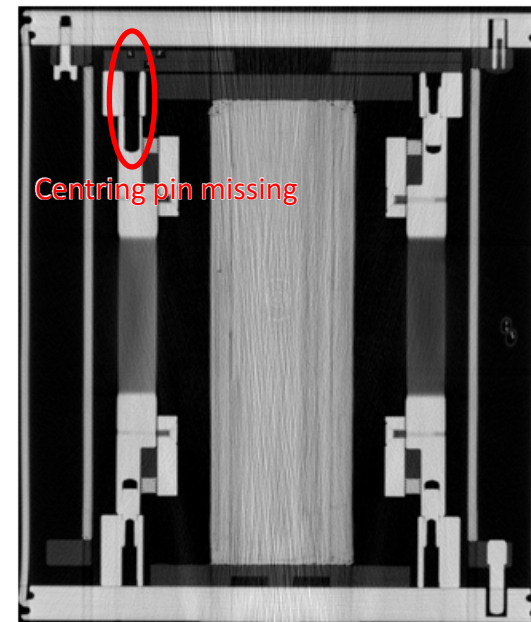
Centring pin missing

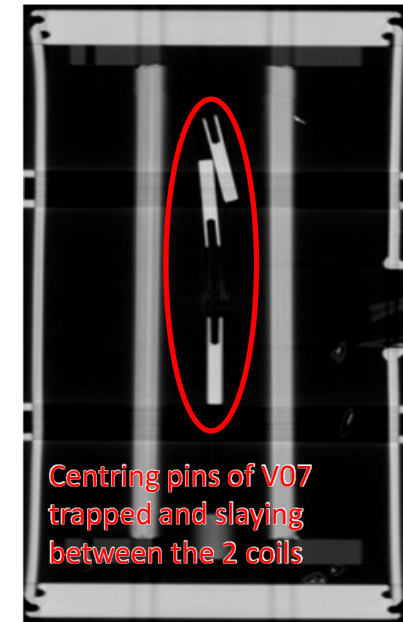
Centring pins of V07 trapped and slaying between the 2 coils

- The solenoids were sorted by degree of severity.
- Beam simulations were done to determine the best arrangement on the beam line in case of a failure of one or more solenoid.
- Solenoids 1 and 8 are critical for the operation of the LINAC.
- Solenoids 4 and 7 can be turn off (Sol4 for a better beam physics)
- Solenoid 2 will be the third dedicated position for a degraded mode

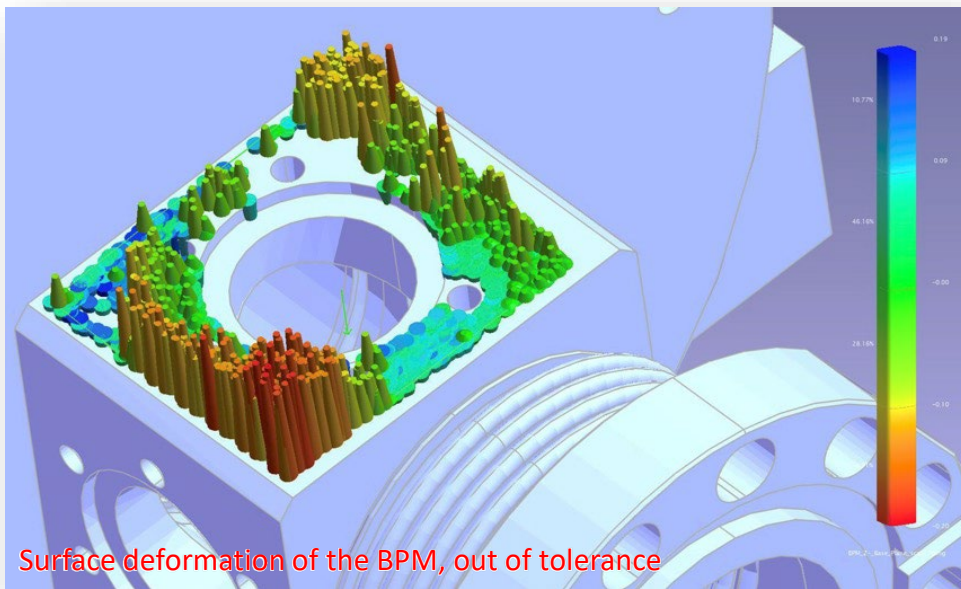
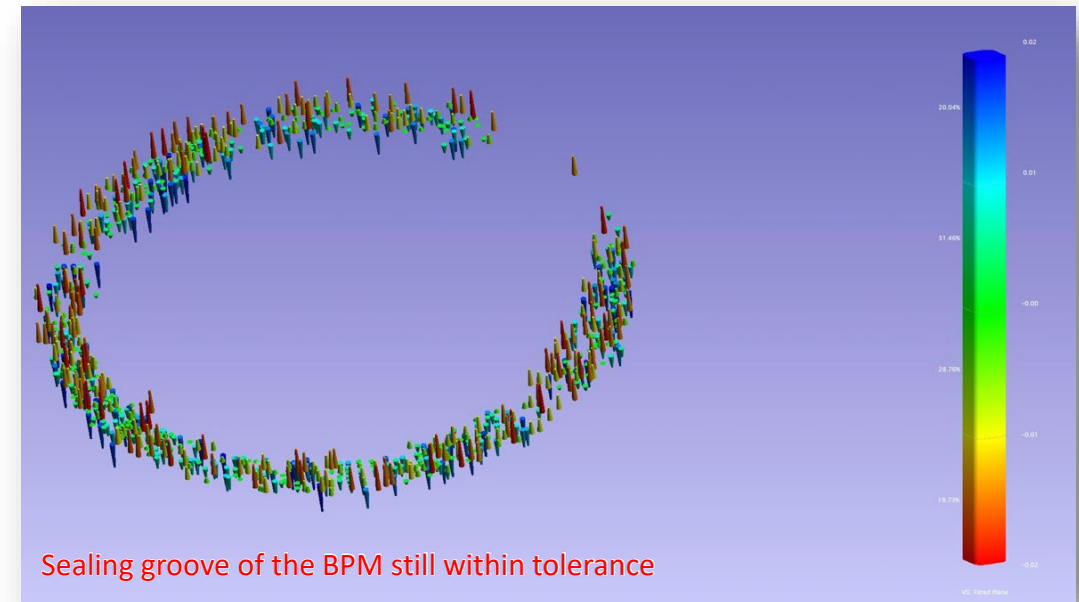
- **October 2022:** BPM pick-up issue on V06
 - The pick-up head was machined to removed $0.2\ \mu\text{m}$ on the diameter.
 - The pick-up finally fitted but was tilted and leaking.
 - The face of the BPM was deformed probably as a consequence of the repair.
 - The sealing groove was still within tolerance, but a scratch was found.

- After different attempts of preserving the HPR, a more invasive rework of the sealing surface was done. An aluminium gasket was also chosen in place of the Helicoflex to preserve the flatness of the pick-up.
- A new HPR was needed at MHI.
- During the incoming inspection at MHI, a new leak appeared on the bellows on the non-BPM side

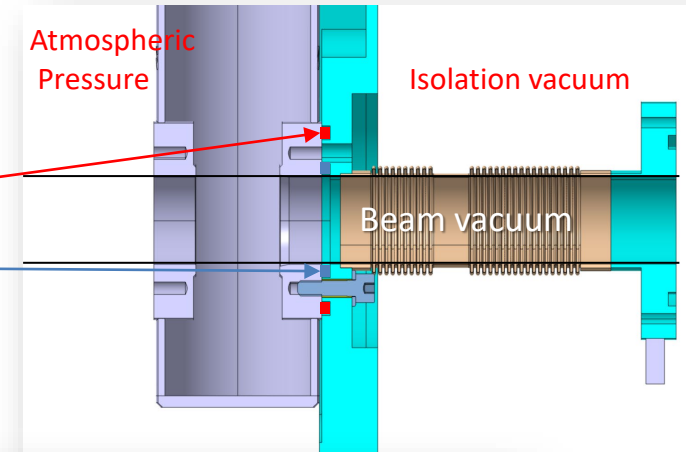
- **October 2022:** the 2 cold warm transitions of the beam lines had NC on their sealing surfaces (Helicoflex gaskets)
 - Cold Warm Transition: allows transport of the beam to/from the SRF Linac.
 - Transition from 300 K to 4 K and from Atmospheric pressure to Vacuum.

Miling machine traces

Polishing with grit 60

Gasket imprint CWT side

Gasket imprint valve side

Machining on the valve side

- After two repair attempts it was not possible to get the two gaskets leak tight at the same time.
- New gaskets were ordered:
 - Helicoflex gaskets with tin plating.
 - Aluminium hexagonal gaskets.
- For the third attempt both new gaskets were leak tight.
- The Al hexagonal gaskets were chosen at the end (easier assembly and cleaner than Helicoflex for the inner gasket) solved in **September 2023**

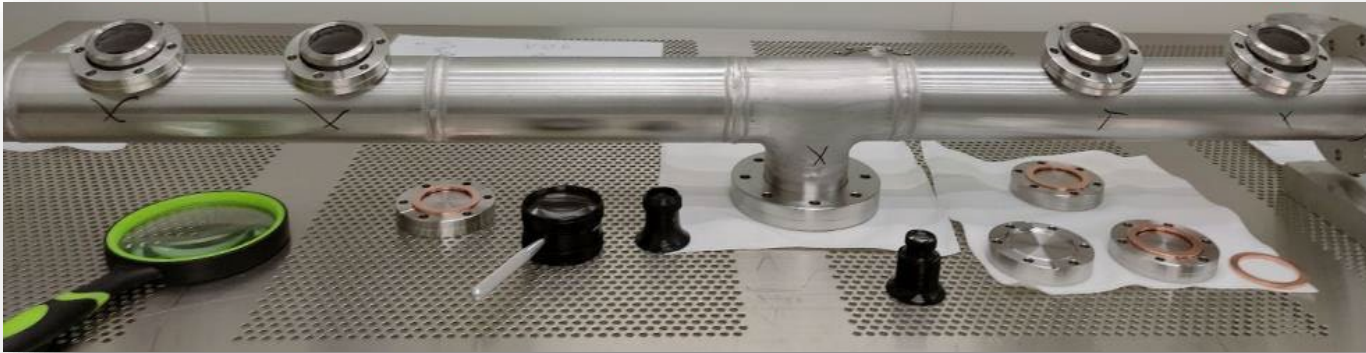
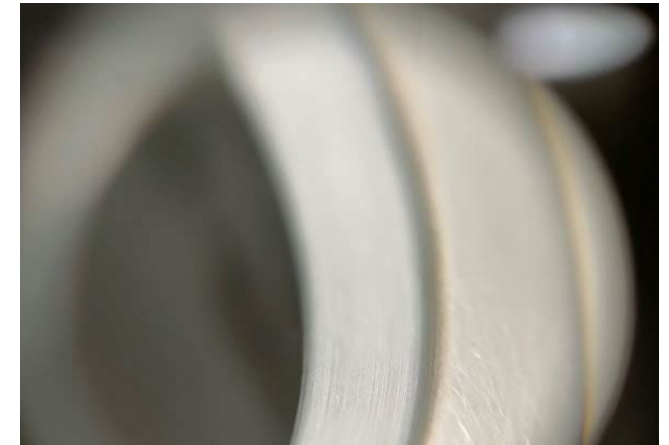
- **October 2022:** multiple leaks on the pumping manifold
 - 4 of 7 CF flanges had dulled knives. Improper protection during passivation was suspected.

- A new manifold was manufactured (easier than repairing) - **October 2023**

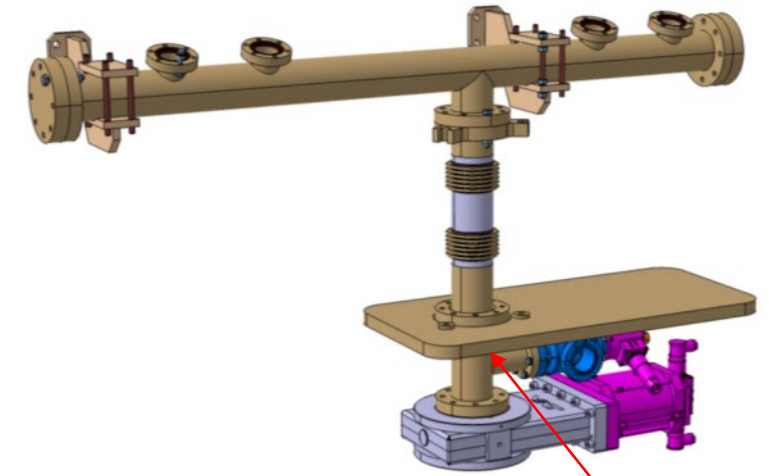
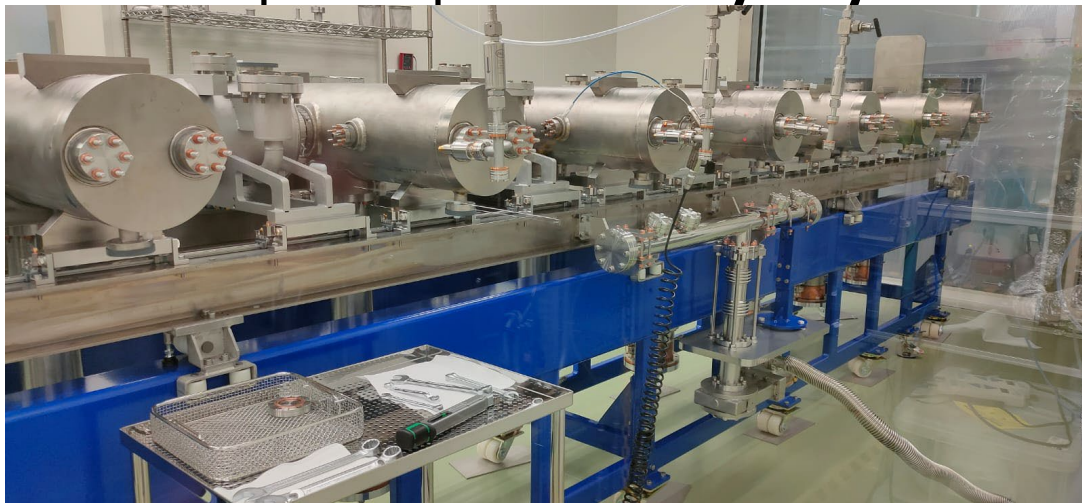
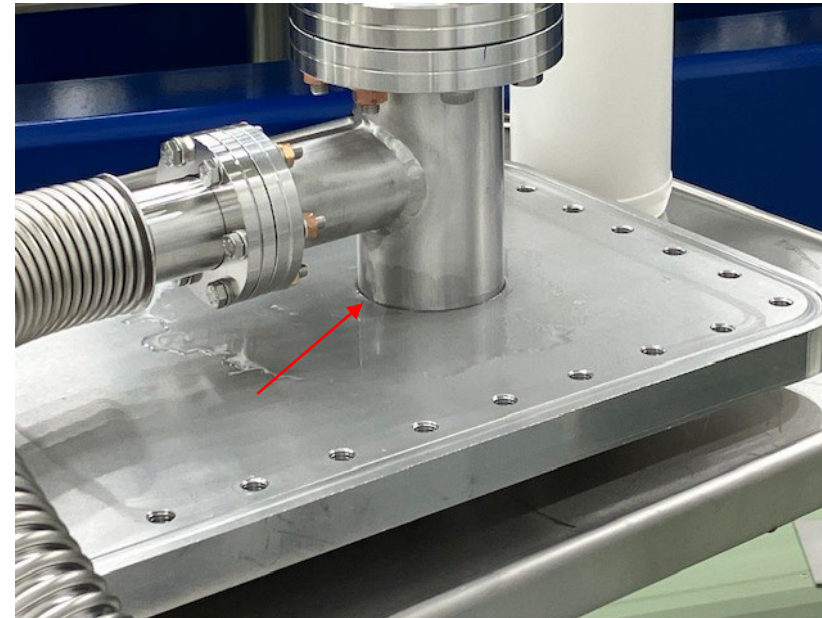
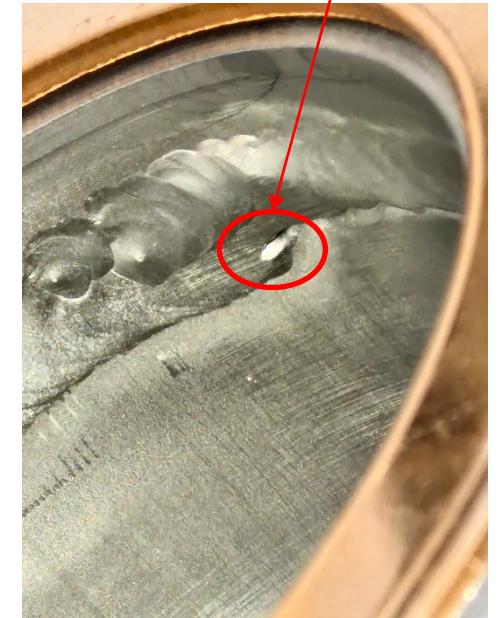
- **June 2024:** leak on the main pumping flange
 - A big leak was detected on the preassembly of the pumping line.
 - After investigation, a crack on a weld is suspected (bubble test).
 - A weak point of the weld cracked after assembly the main gate valve.
 - Repair expected **early July 2024**
