Magnetic center with respect to the mechanical center

Problems with magnet & alignment plate

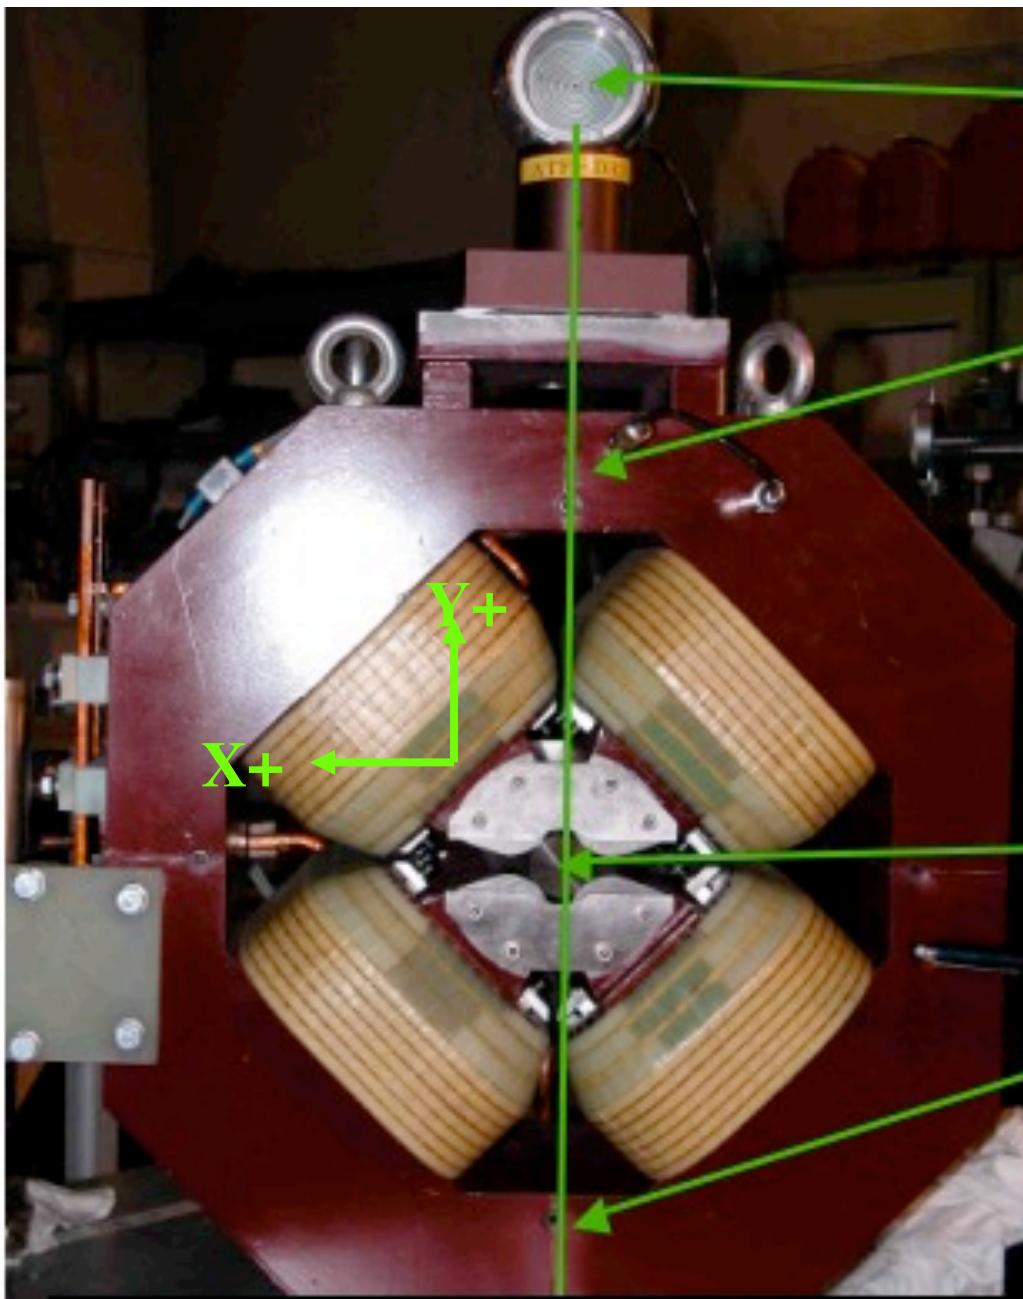
- Large offset was found, especially in the horizontal direction.
 - Needs to be taken care of when aligning the magnets in the beam line, using the field measurement results.

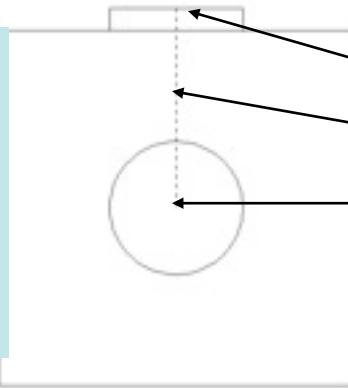
Correct case

Alignment base center

Split line between the cores

bore center

Must be aligned.

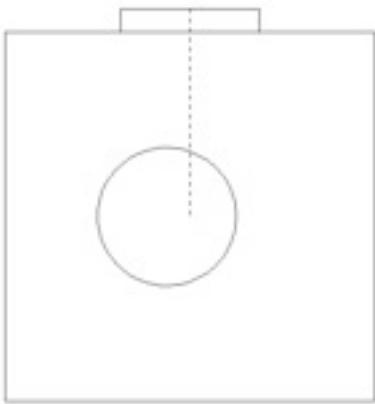
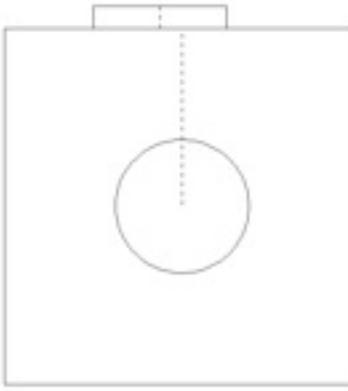
(1) Magnet bore is not aligned.
How could this happen??
EDM process???

(2) Alignment base is
not aligned.

(3) (1)&(2) mixed.
