# Optical Inspection Update and Material Studies at JLab

Jefferson Lab ILC08, November 16-20, 2008, UIC

## A13 Bulk EP + 600CX10hr Full Inspection Equator EBW typical

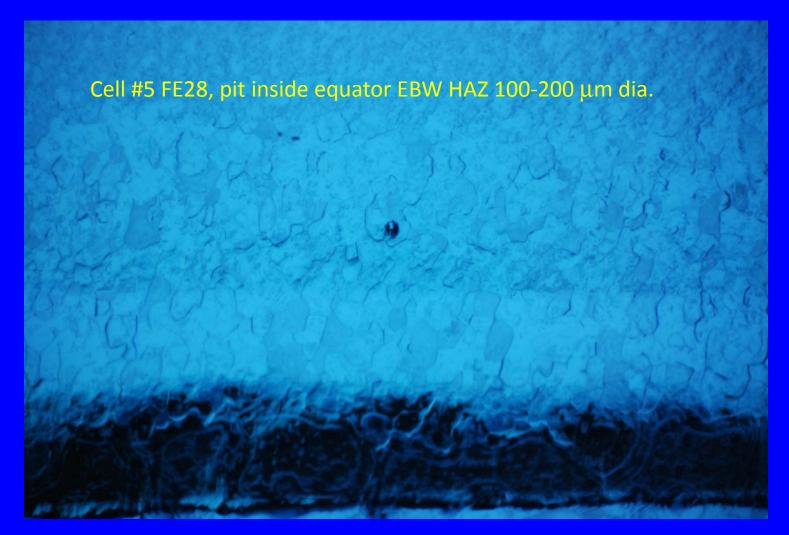
## A13 Bulk EP + 600CX10hr Full Inspection

many pits of various sizes (50-200 µm dia.) inside & outside equator EBW HAZ

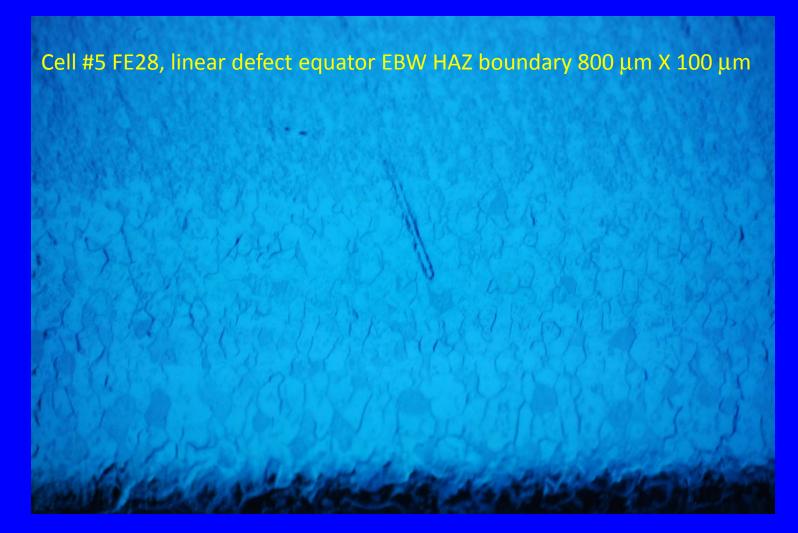
## A13 Bulk EP + 600CX10hr Full Inspection

First observation of linear defect (most likely dislocation etching pit)

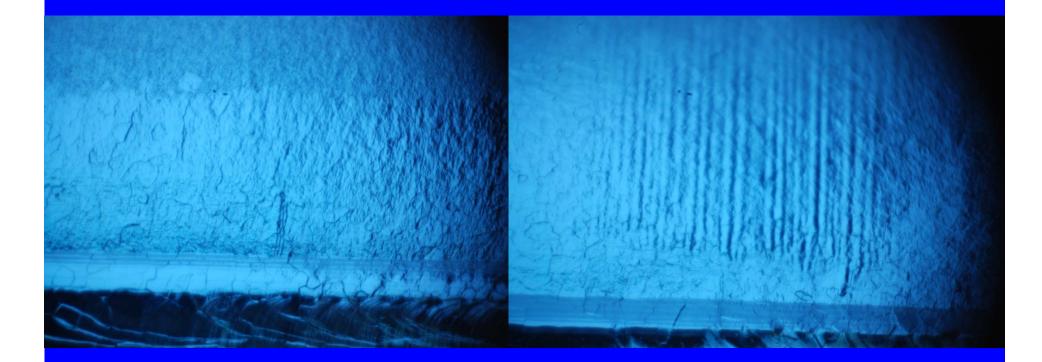
Linear defects (most likely slip lines and slip bands associated with plastic deformation)

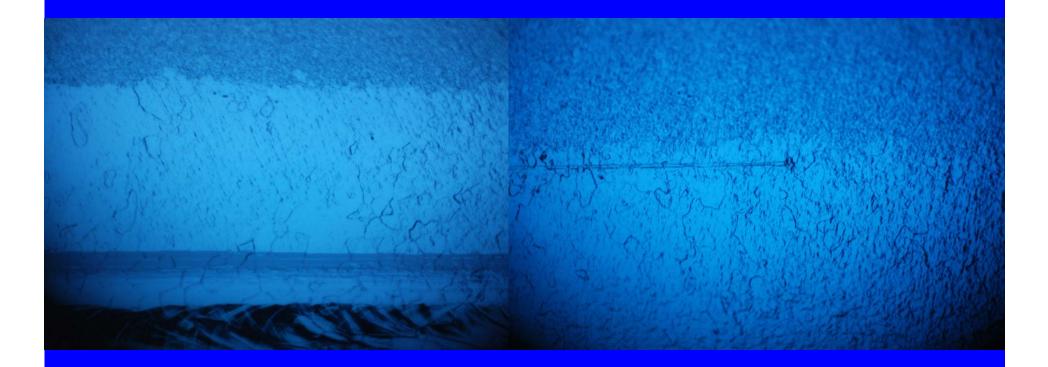
#### Textured surface in equator EBW HAZ (most likely dislocation etching pits)
