Optical Inspection at JLab

Rong-Li Geng, Curtis Crawford

Jefferson Lab

ILC Cavity Group Meeting, September 16, 2008

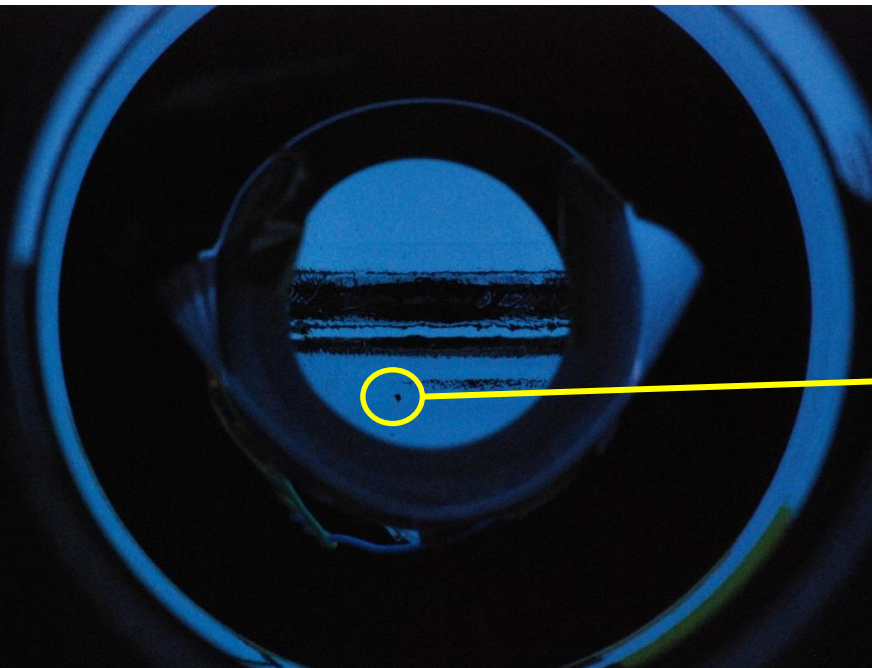
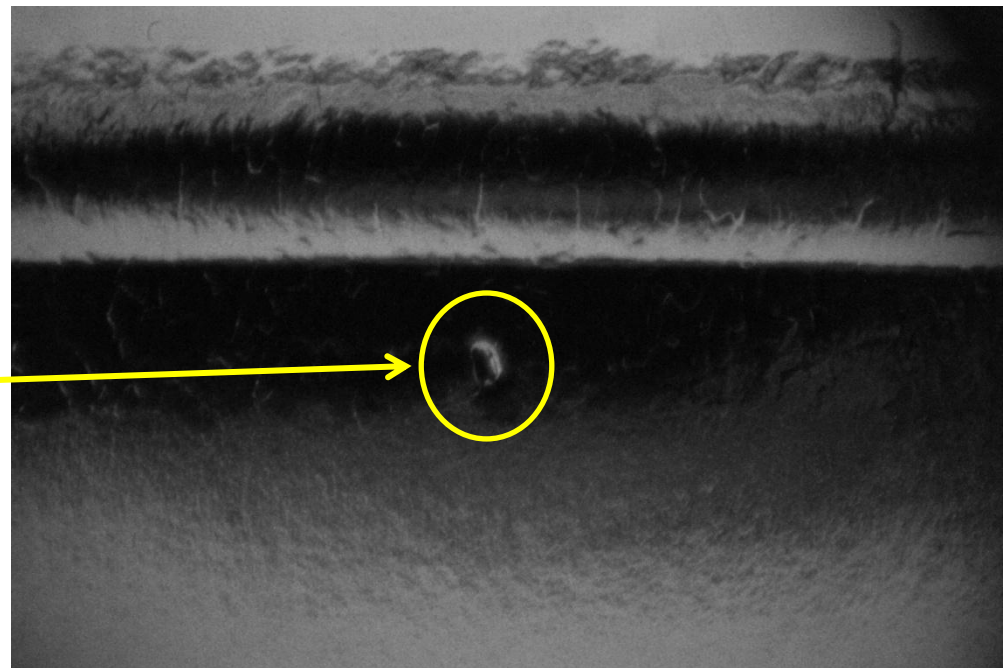
1st Example of Finding Defect in Equator Region

- A15 hard quench limit 17-19 MV/m
- Pass-band measurements pointed to cell #3/7
- T-mapping found hot spots correlated to quench
- Optical inspection found defect near hot spot

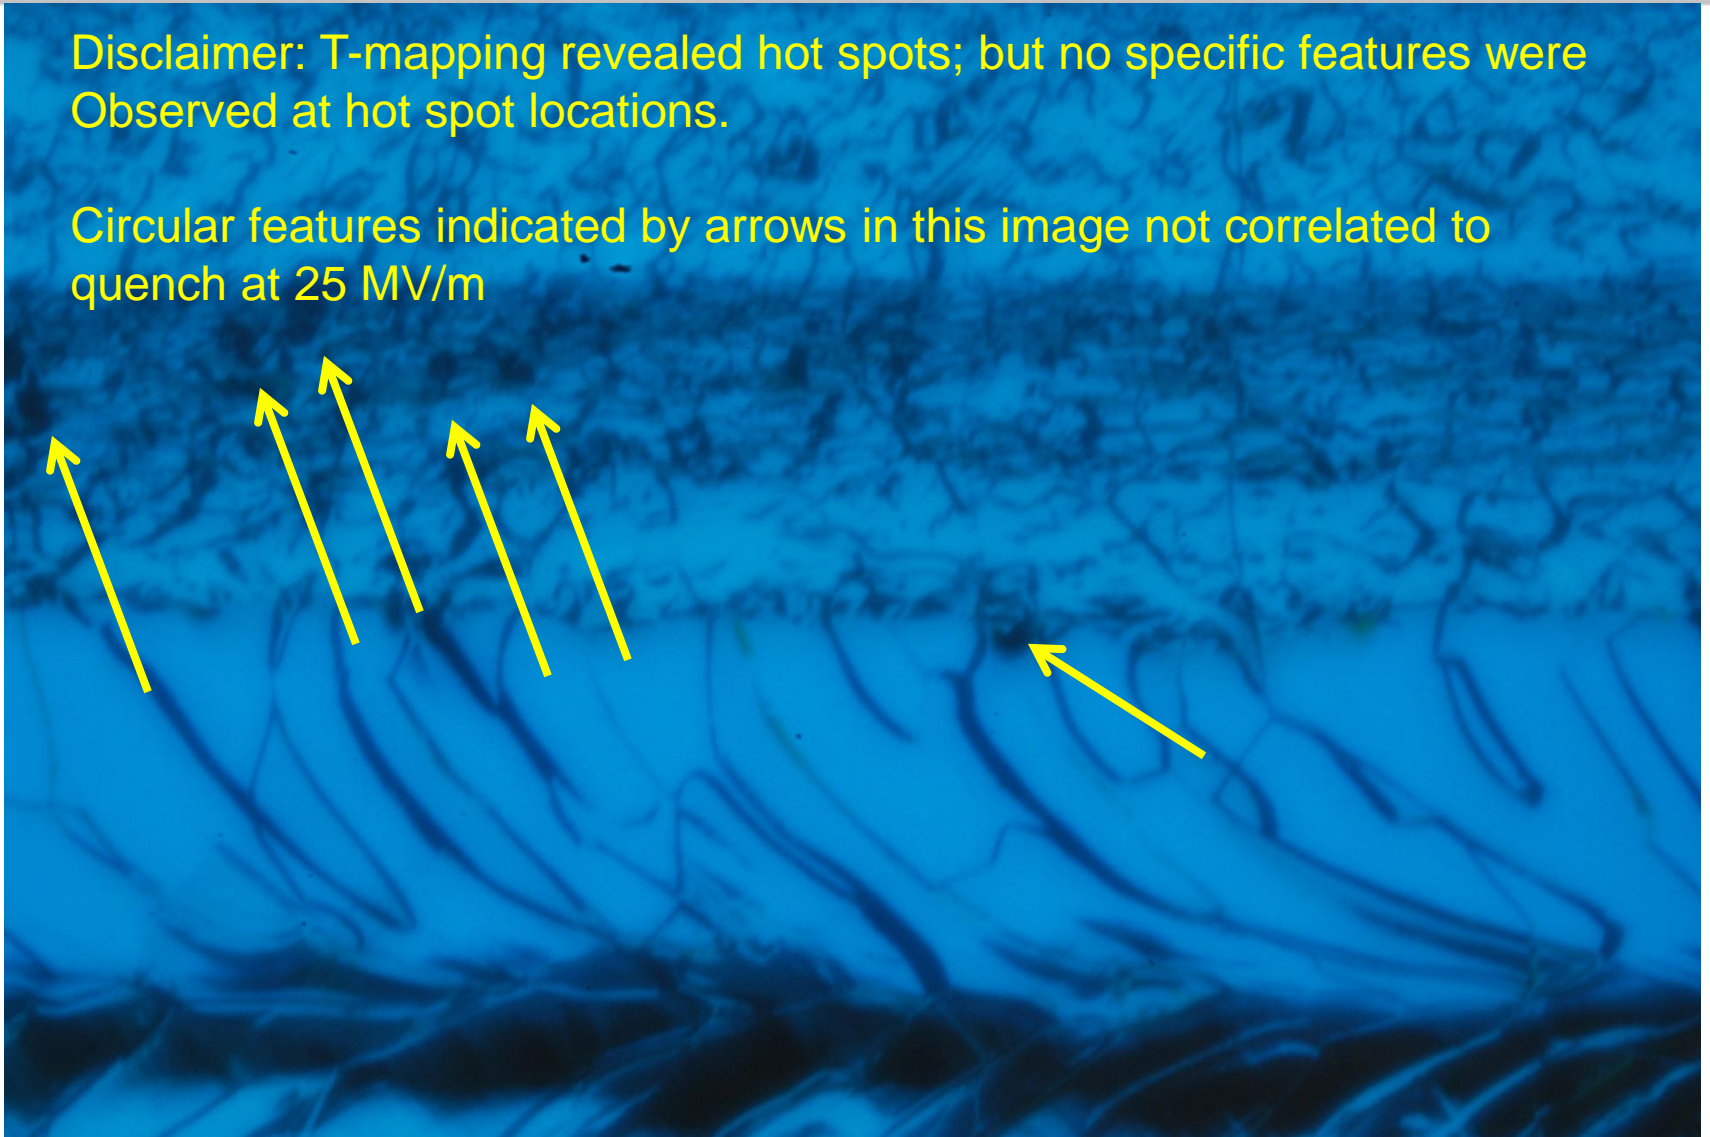
JL001 (25 MV/m) Equator (BCP only + 1250C)

Disclaimer: T-mapping revealed hot spots; but no specific features were observed at hot spot locations.

Circular features indicated by arrows in this image not correlated to quench at 25 MV/m

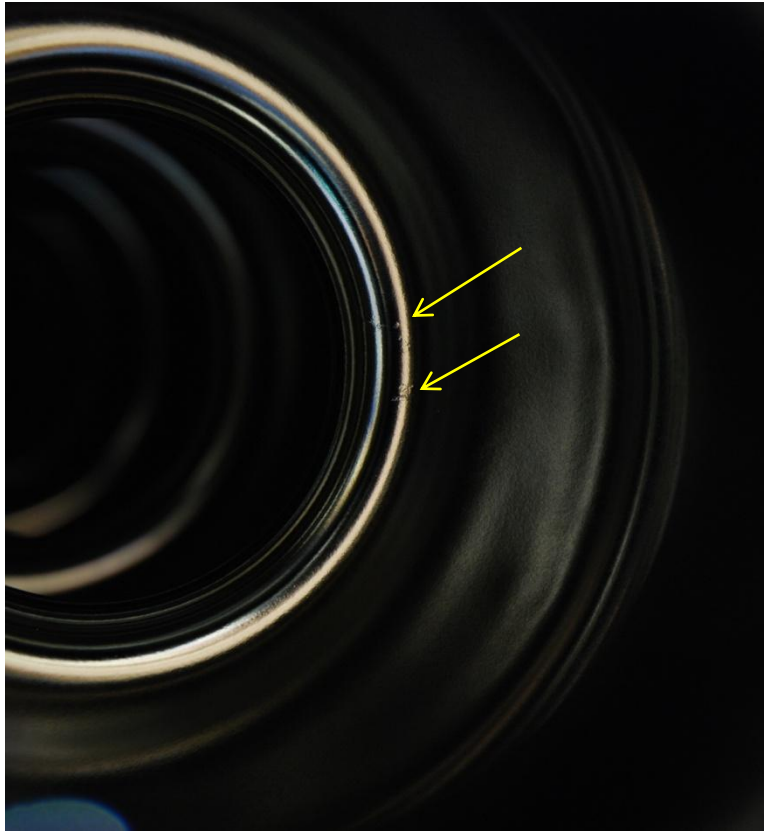
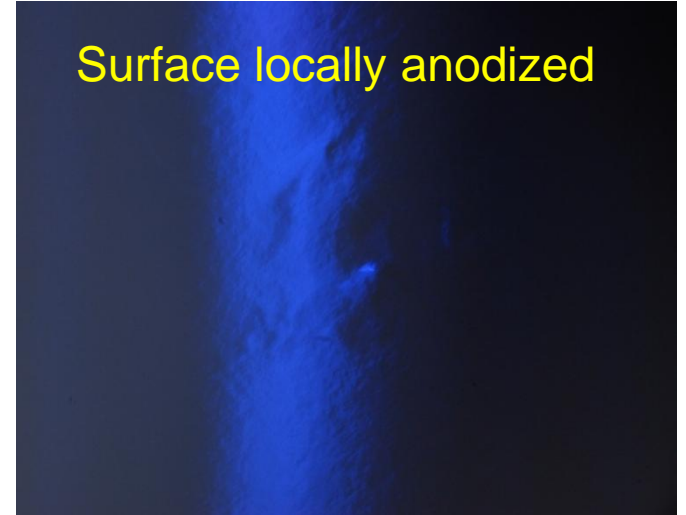
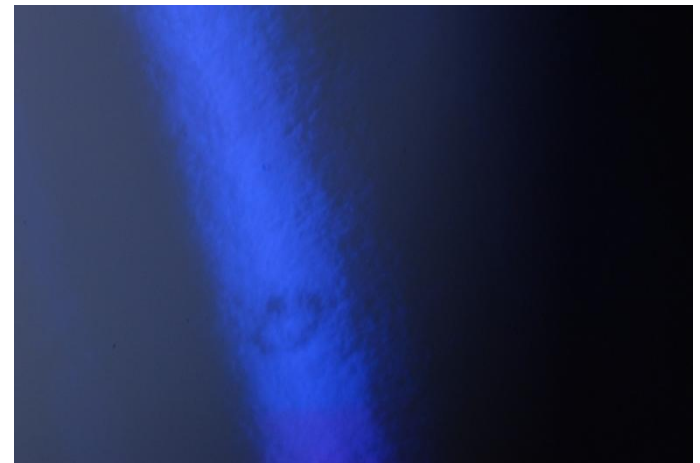
ICHIRO5 Surface Damage in Iris Region

As received (digital camera image)

After EP + RF test w/ FE limit

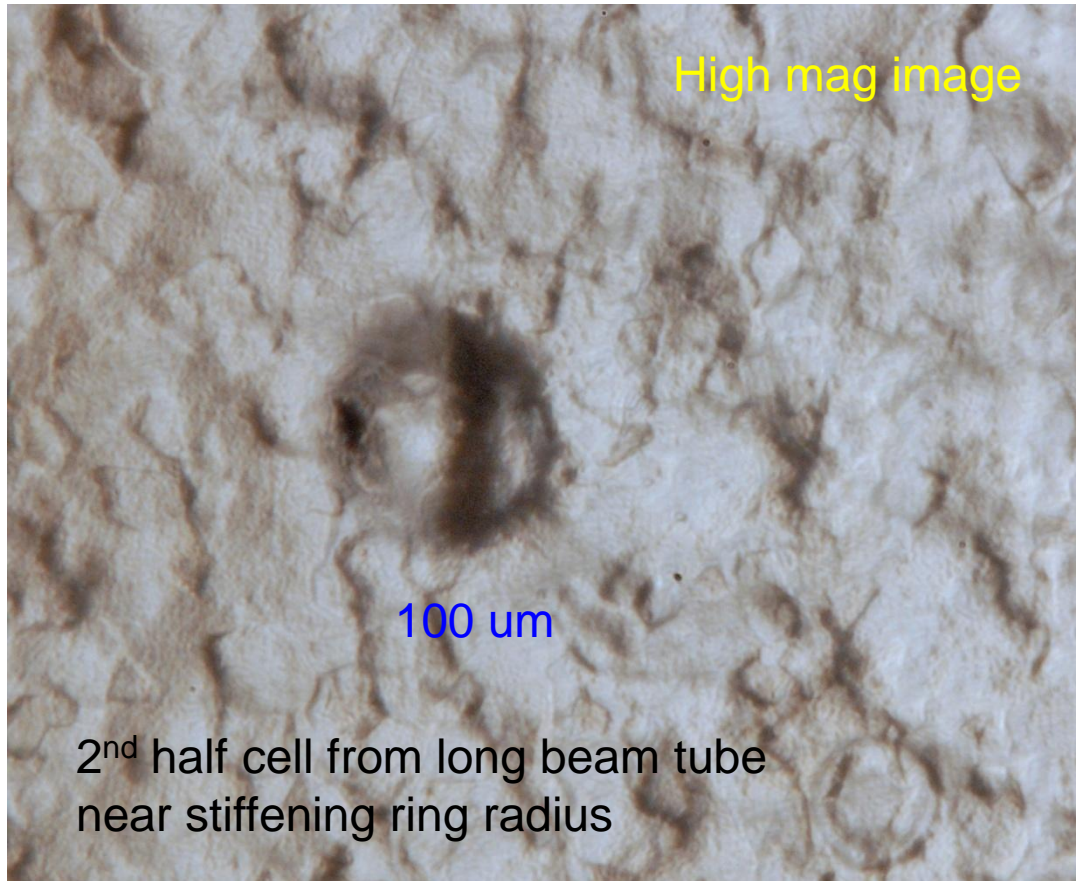
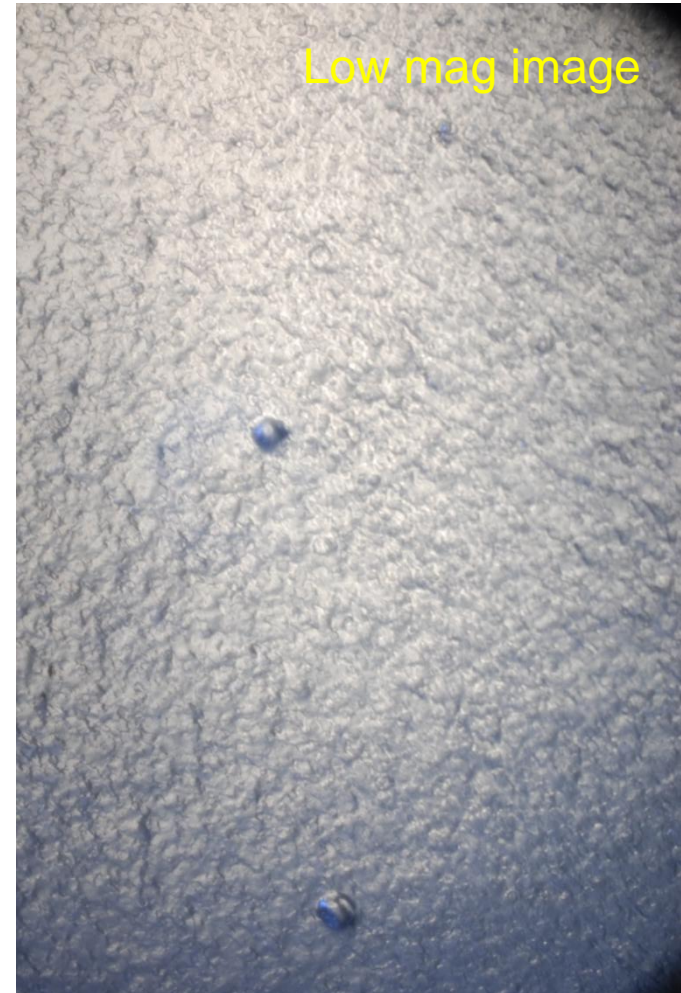
AES4 High E Field Region

Cavity FE limited even after repeated EP
pass-band measurements suggest field emitters in end cells

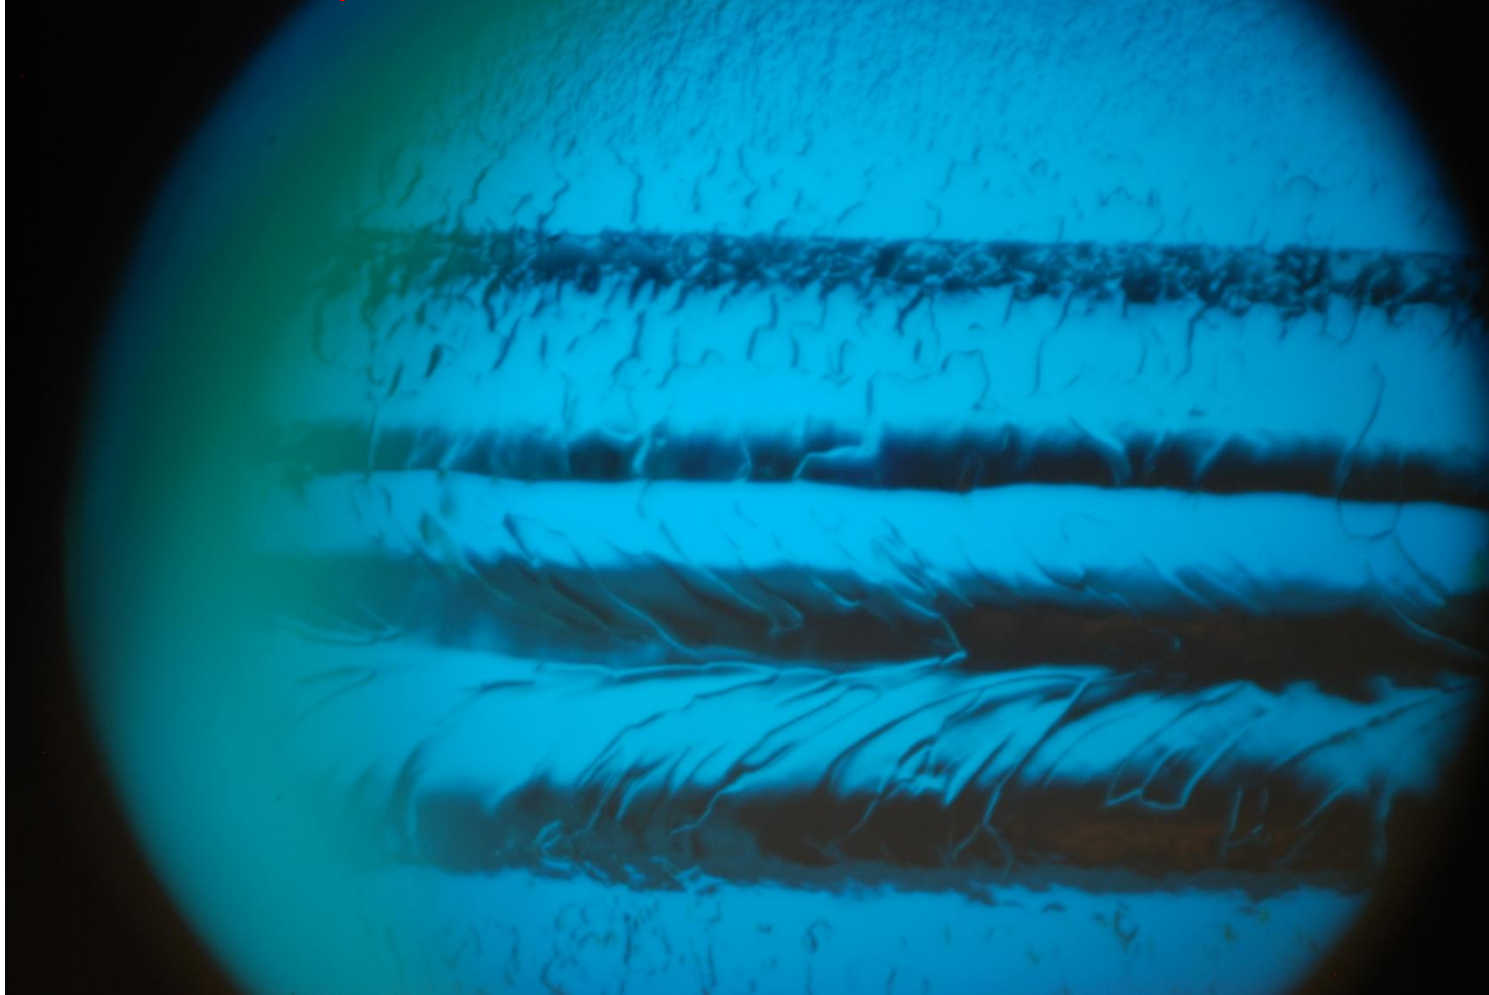
A8 – 32 MV/m Surface

Typical Appearance of Equator Weld, w/ exception of one observed irregularity,
Which corresponds to an observable dent from exterior surface

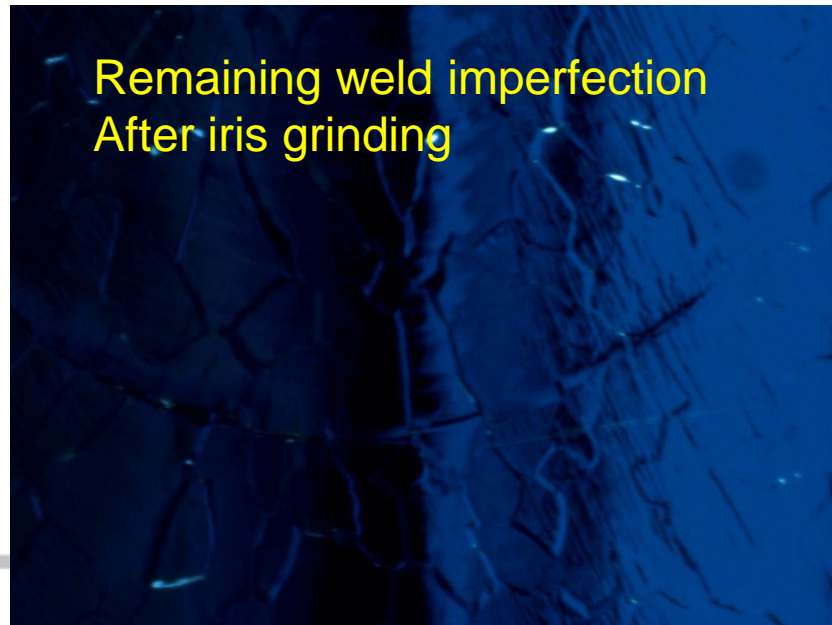
J1 9-cell cavity as-built RF surface

Damage caused by grinding

Damage caused by contact at iris

Remaining weld imperfection
After iris grinding

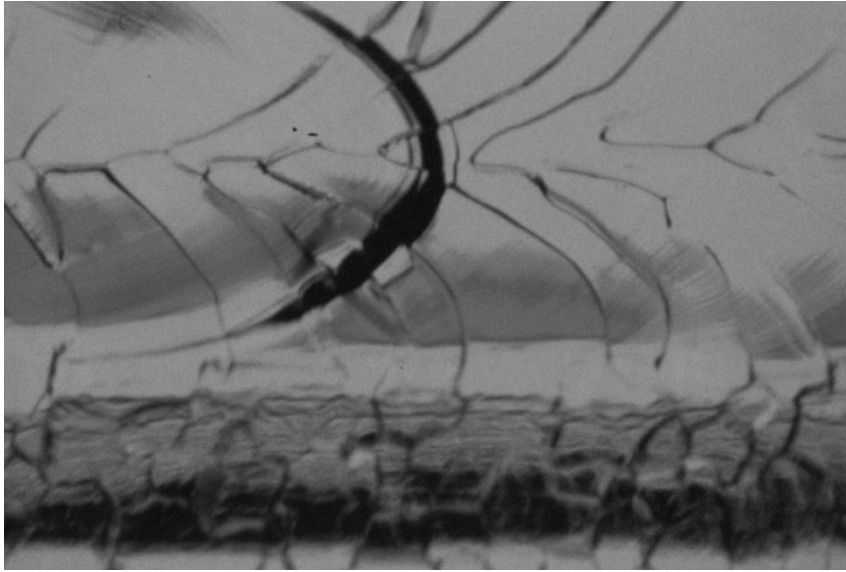
HG006 (1) – after 340 um BCP

Outstanding irregularity (step) near equator
EBW overlap of cell#7 from WG

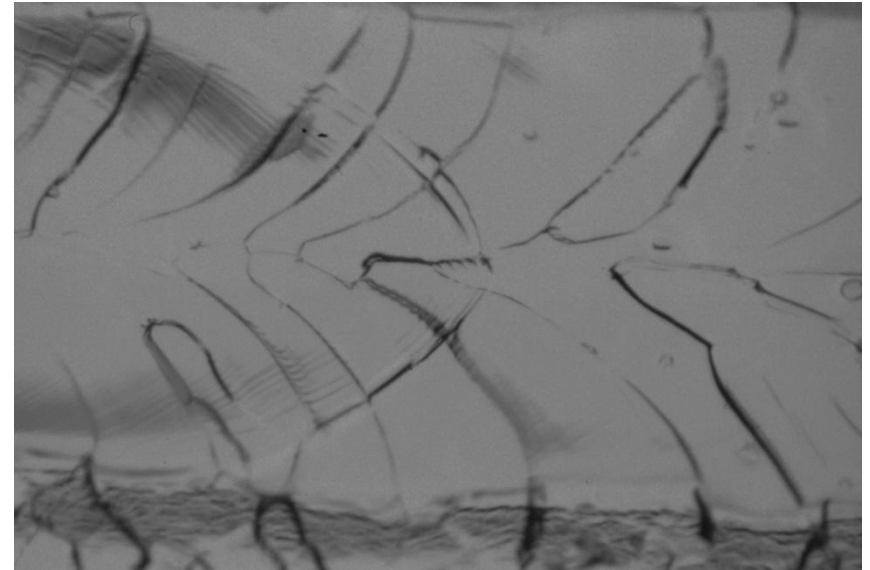
Two other cells less pronounced feature
Four other cells no recognizable feature

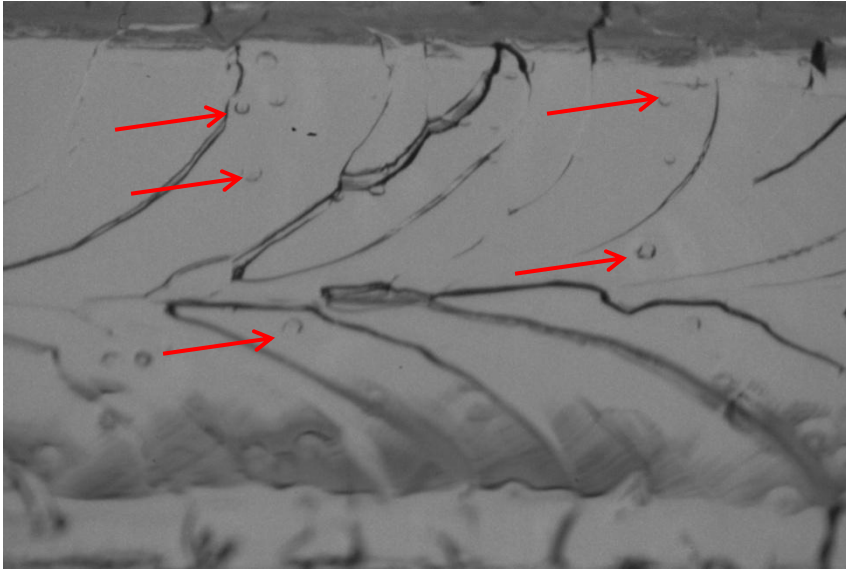
HG006 (2) – after 340 um BCP

Many “blisters” inside weld
somehow no “blister” in some area

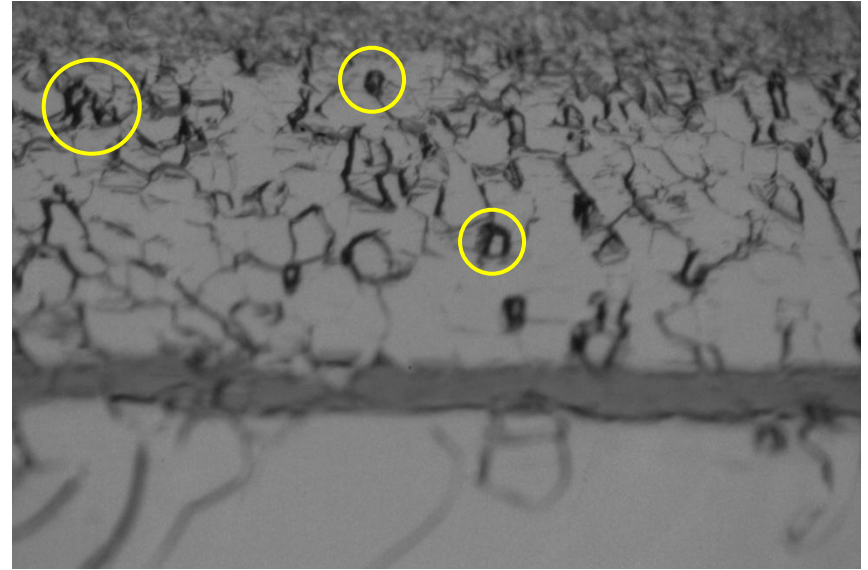
Many apparent “deep pits”
in heat affected zone

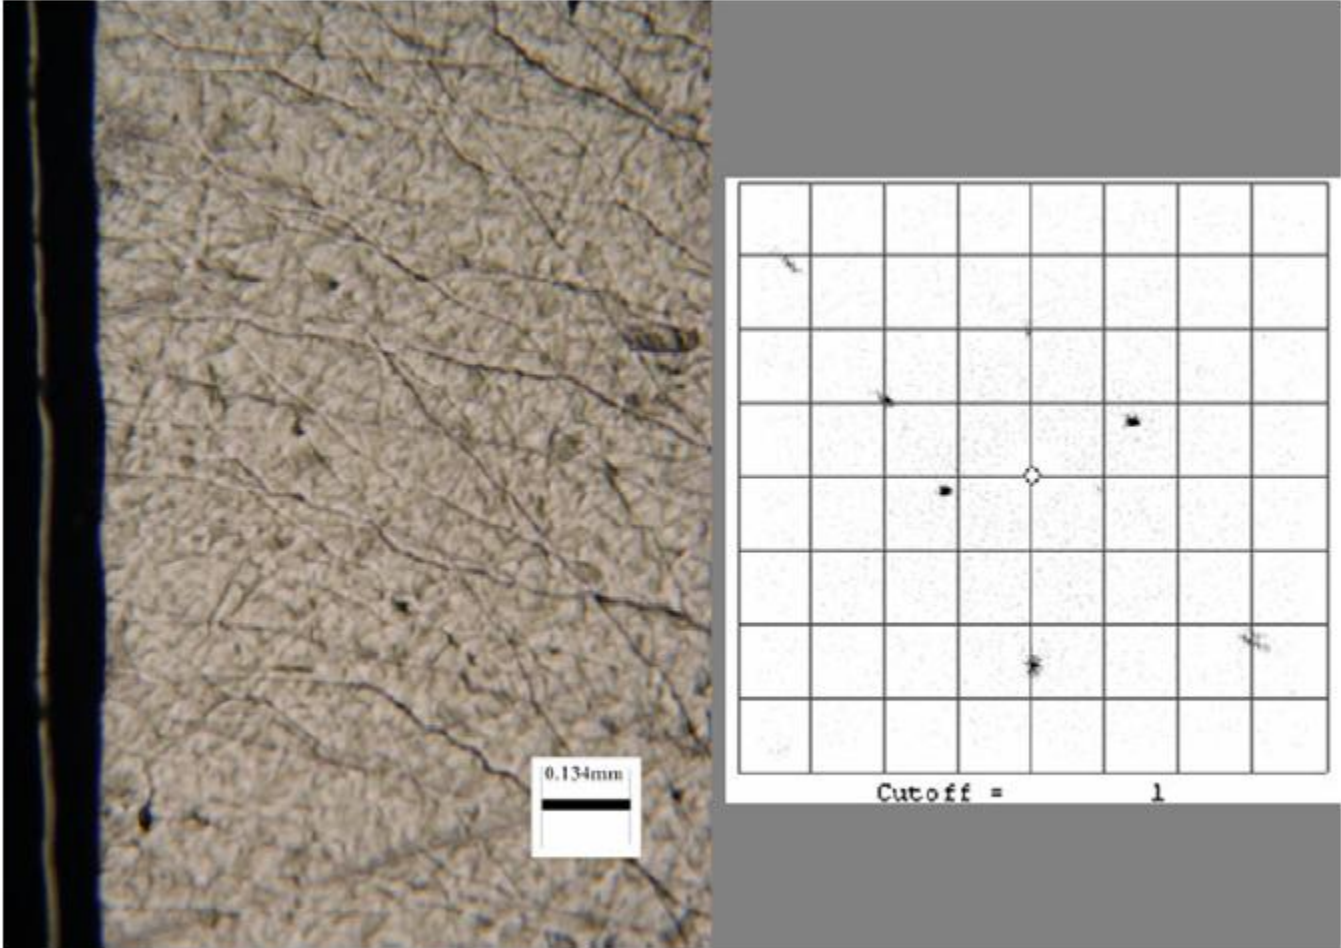
Point & Line Defects in HAZ of Large-Grain Niobium EBW Sample

- Inside surface of the stiffening ring EBW: AES4
- Origin of these defect not clear. It seems they are observable at random depth into the bulk. They are observable independent the manufacturer. Fine grain or large grain niobium (next slide for one example). It is possible they have to do with some intrinsic behaviors of electron beam weld of niobium.

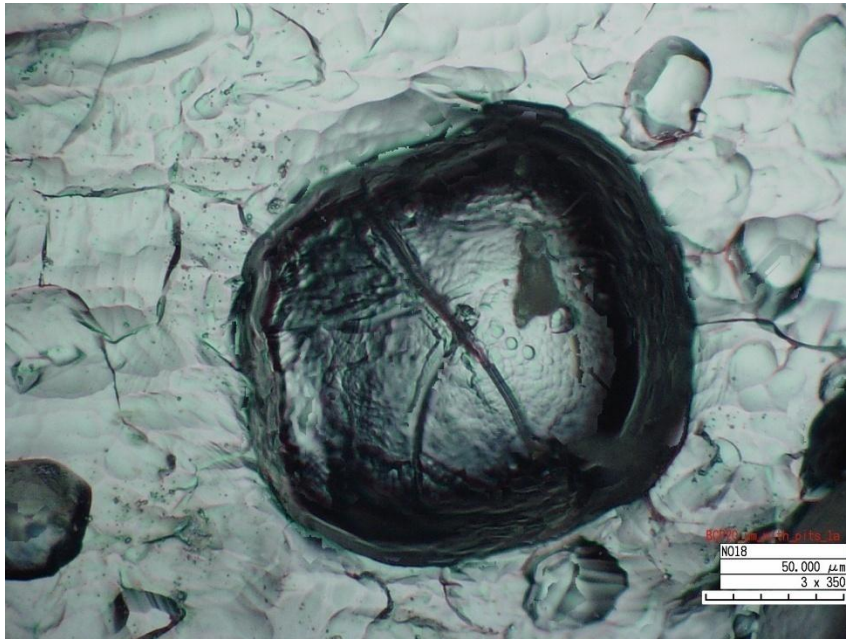
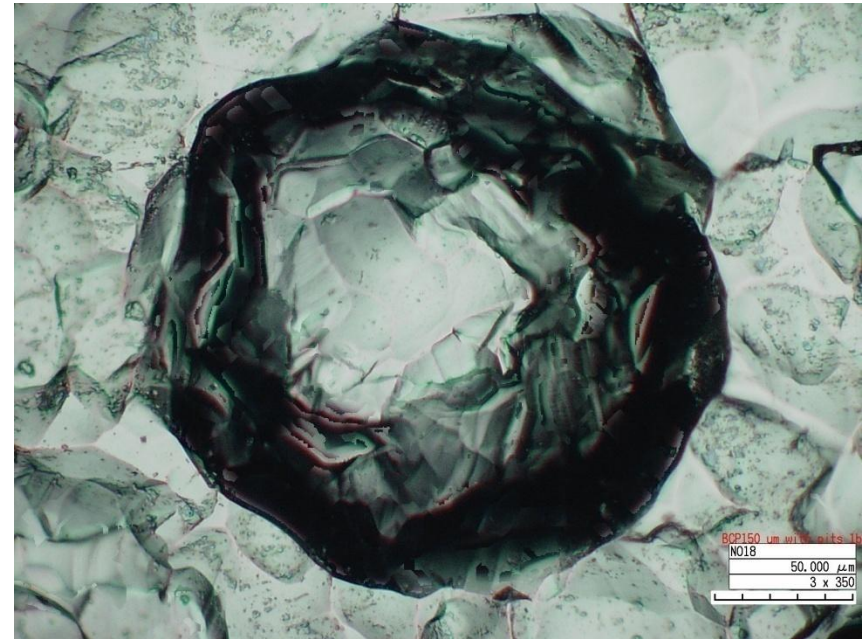
Inability of BCP to Remove Pit

Controlled mechanical defect ($\sim 100 \mu\text{m}$) for re-melting test

A pit becomes a bigger pit after more BCP

BCP 20 μm

BCP 150 μm

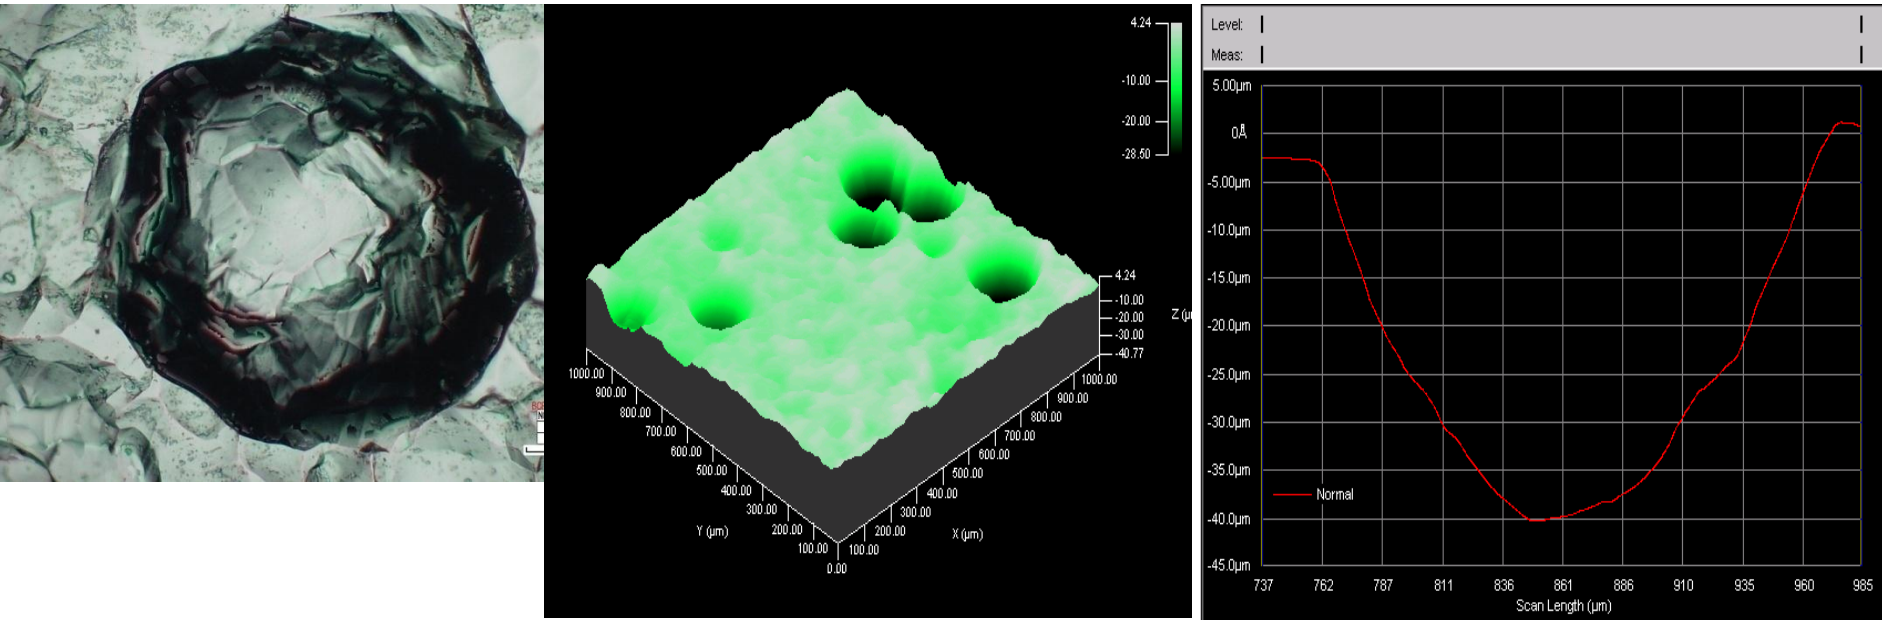
An example of depth profiling of controlled defect

Slope angle 26° - 47°
