Optical Inspection at DESY

ILC S0 telephone meeting

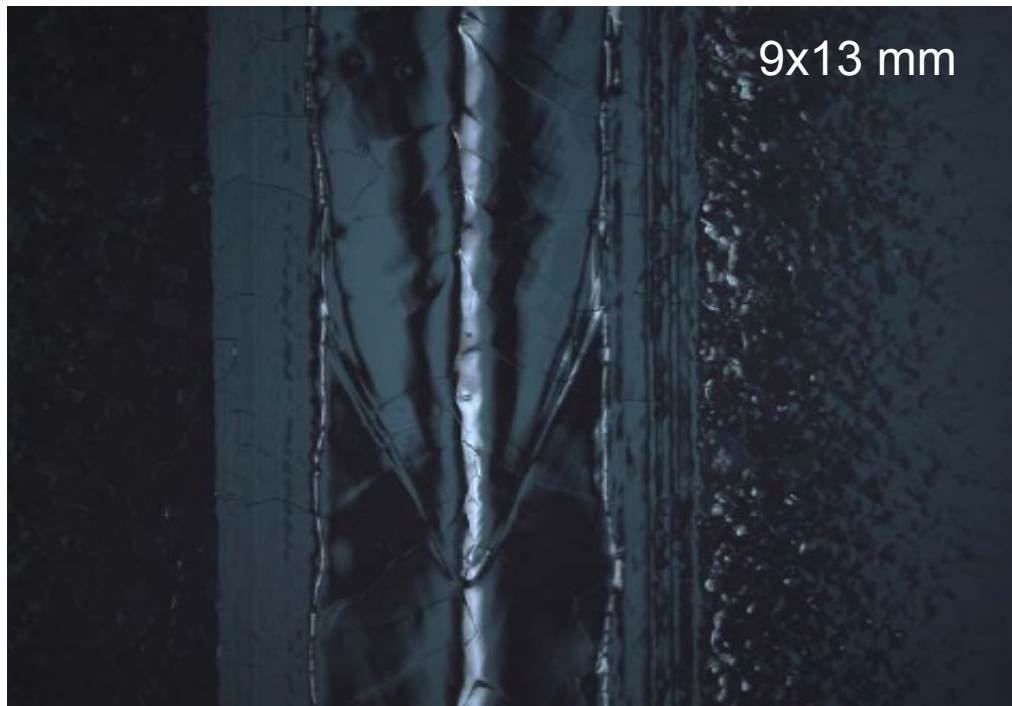
KEK: picture at 43 deg

Welding transition at equator in cell #2 of Z111

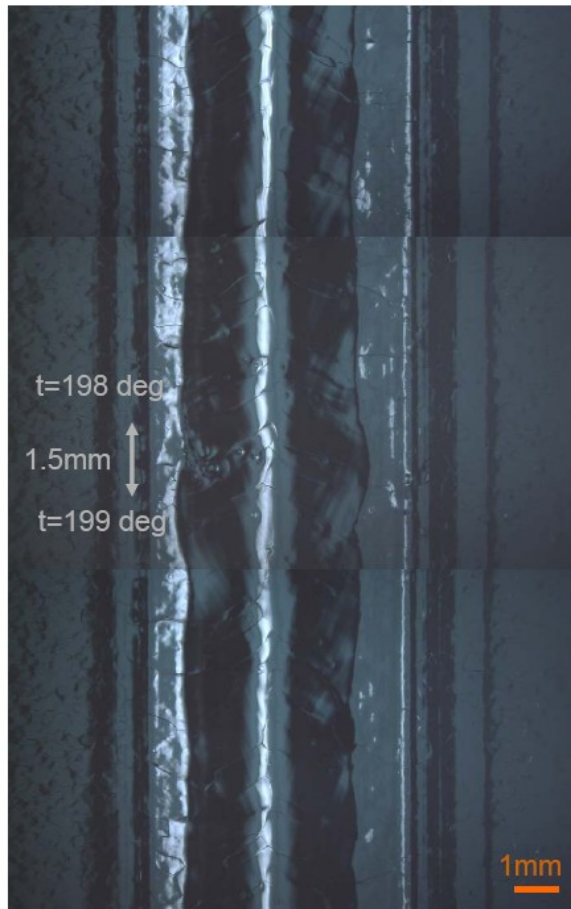
KEK

Z111: Quench-position found
by T-map in cell #6

#6 equator, $t=193 \sim 204$ deg

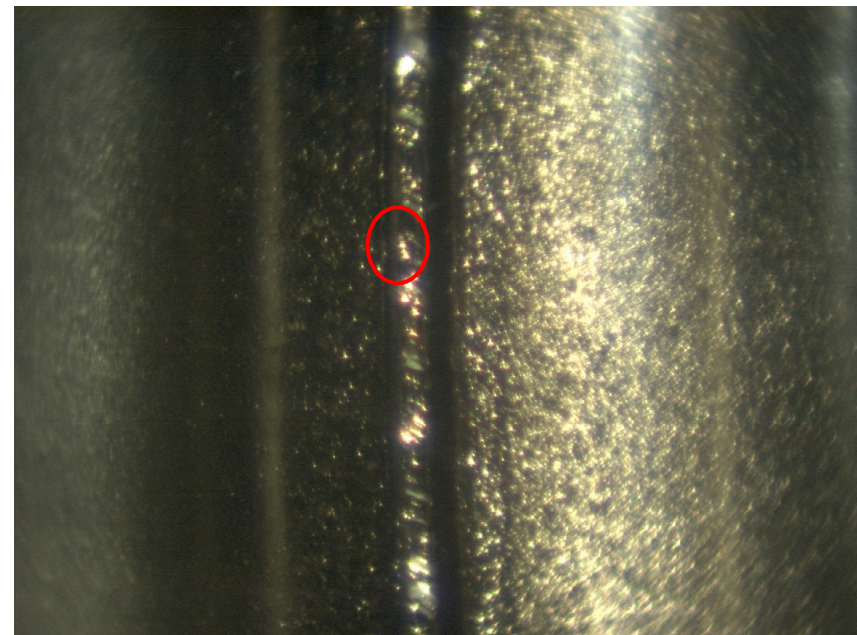
DESY
marking at
198 deg
