# **Results of Second Alignment and Longterm Variation of Tilt of Magnets**

**R. Sugahara**

**KEK**

**October 22, 2008**

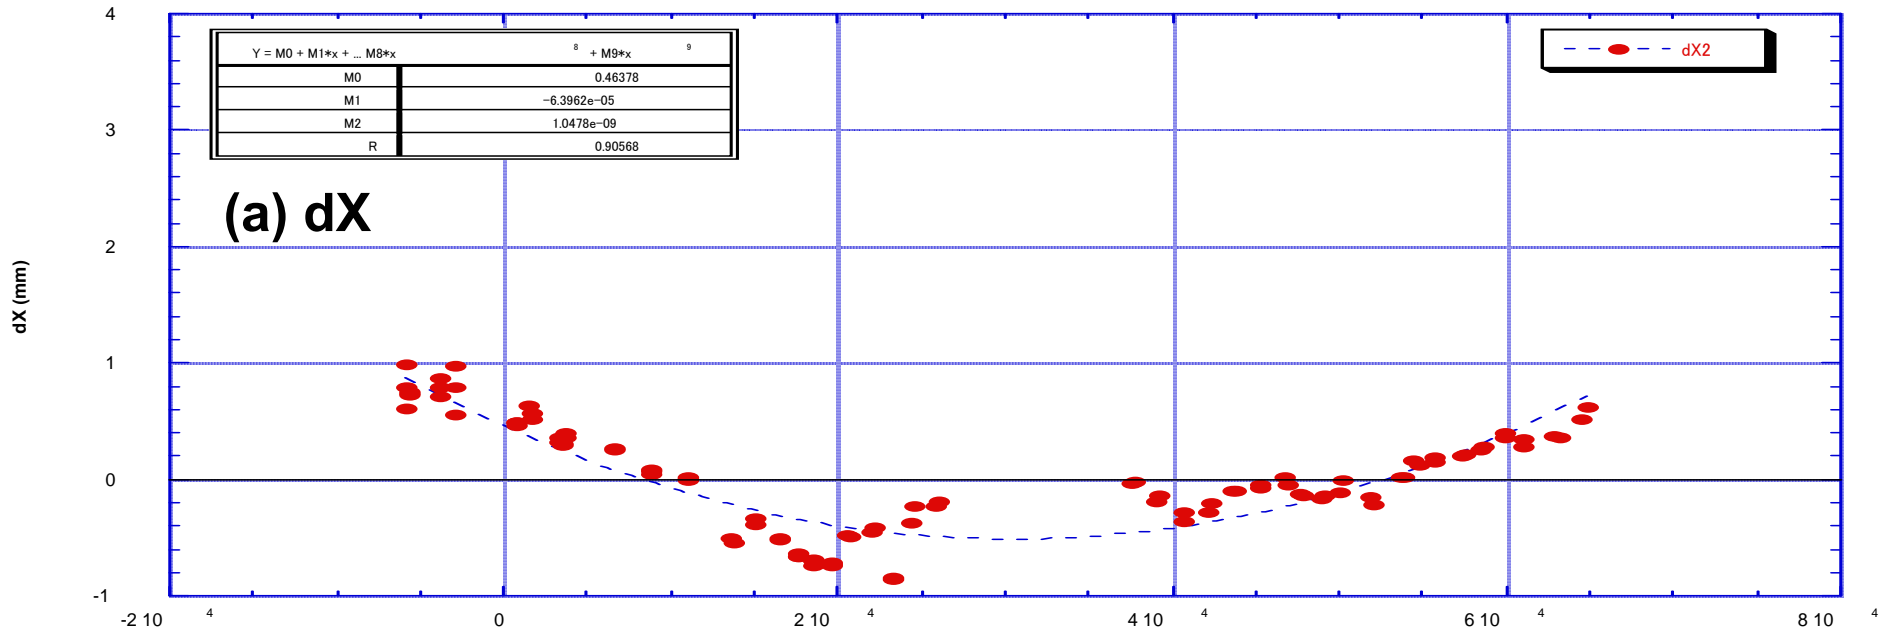
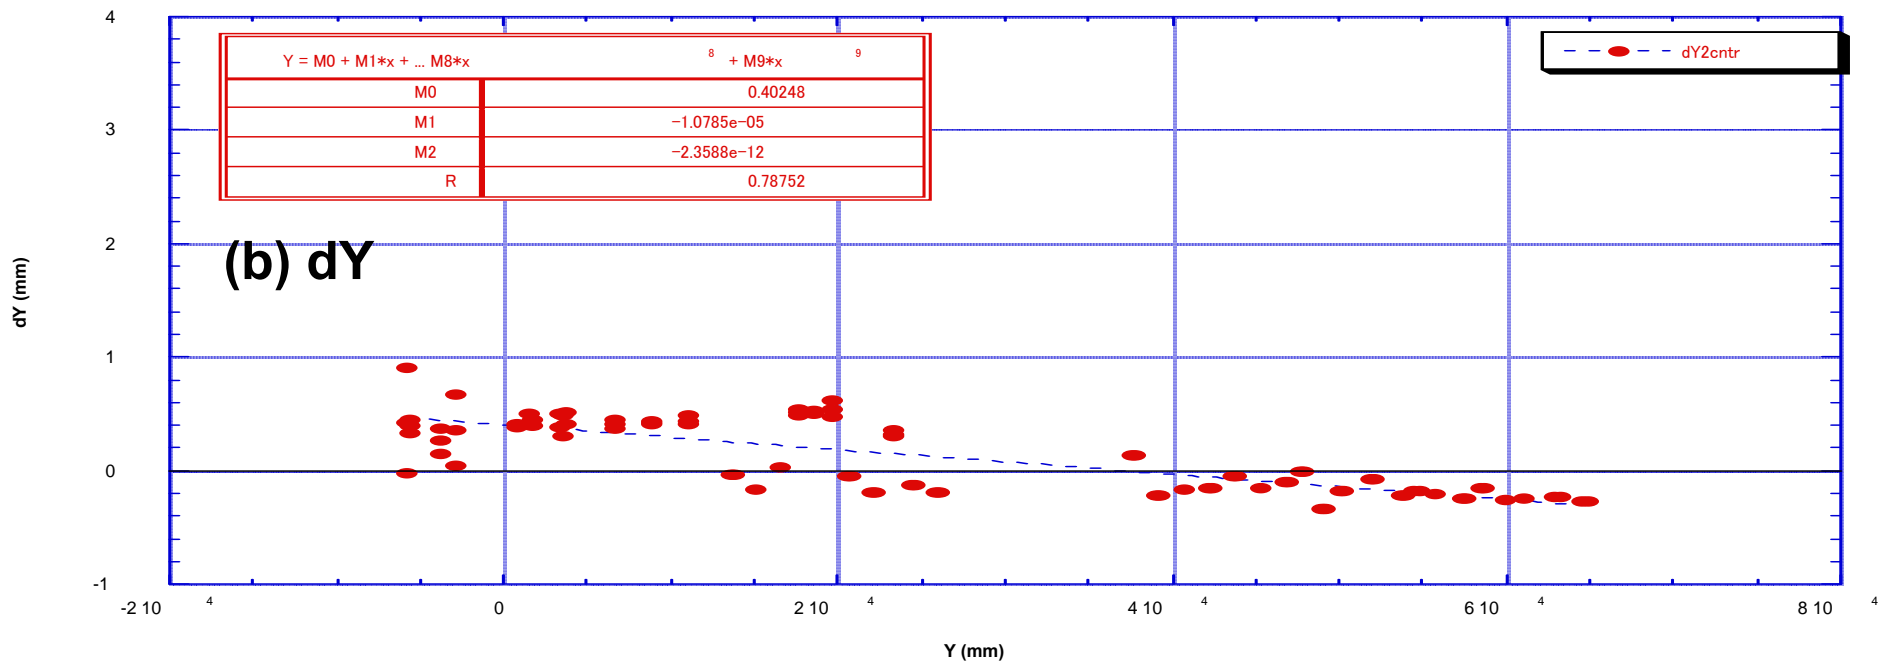
# Deviation from Smoothing Curves

About the variation of the smoothing curve, I am suspicious of the tracker's systematic error in angle measurement, because the tracker is not good in straight line measurement.

--> We will do the tracker calibration before the next ATF2 beamline survey, and let's see .....

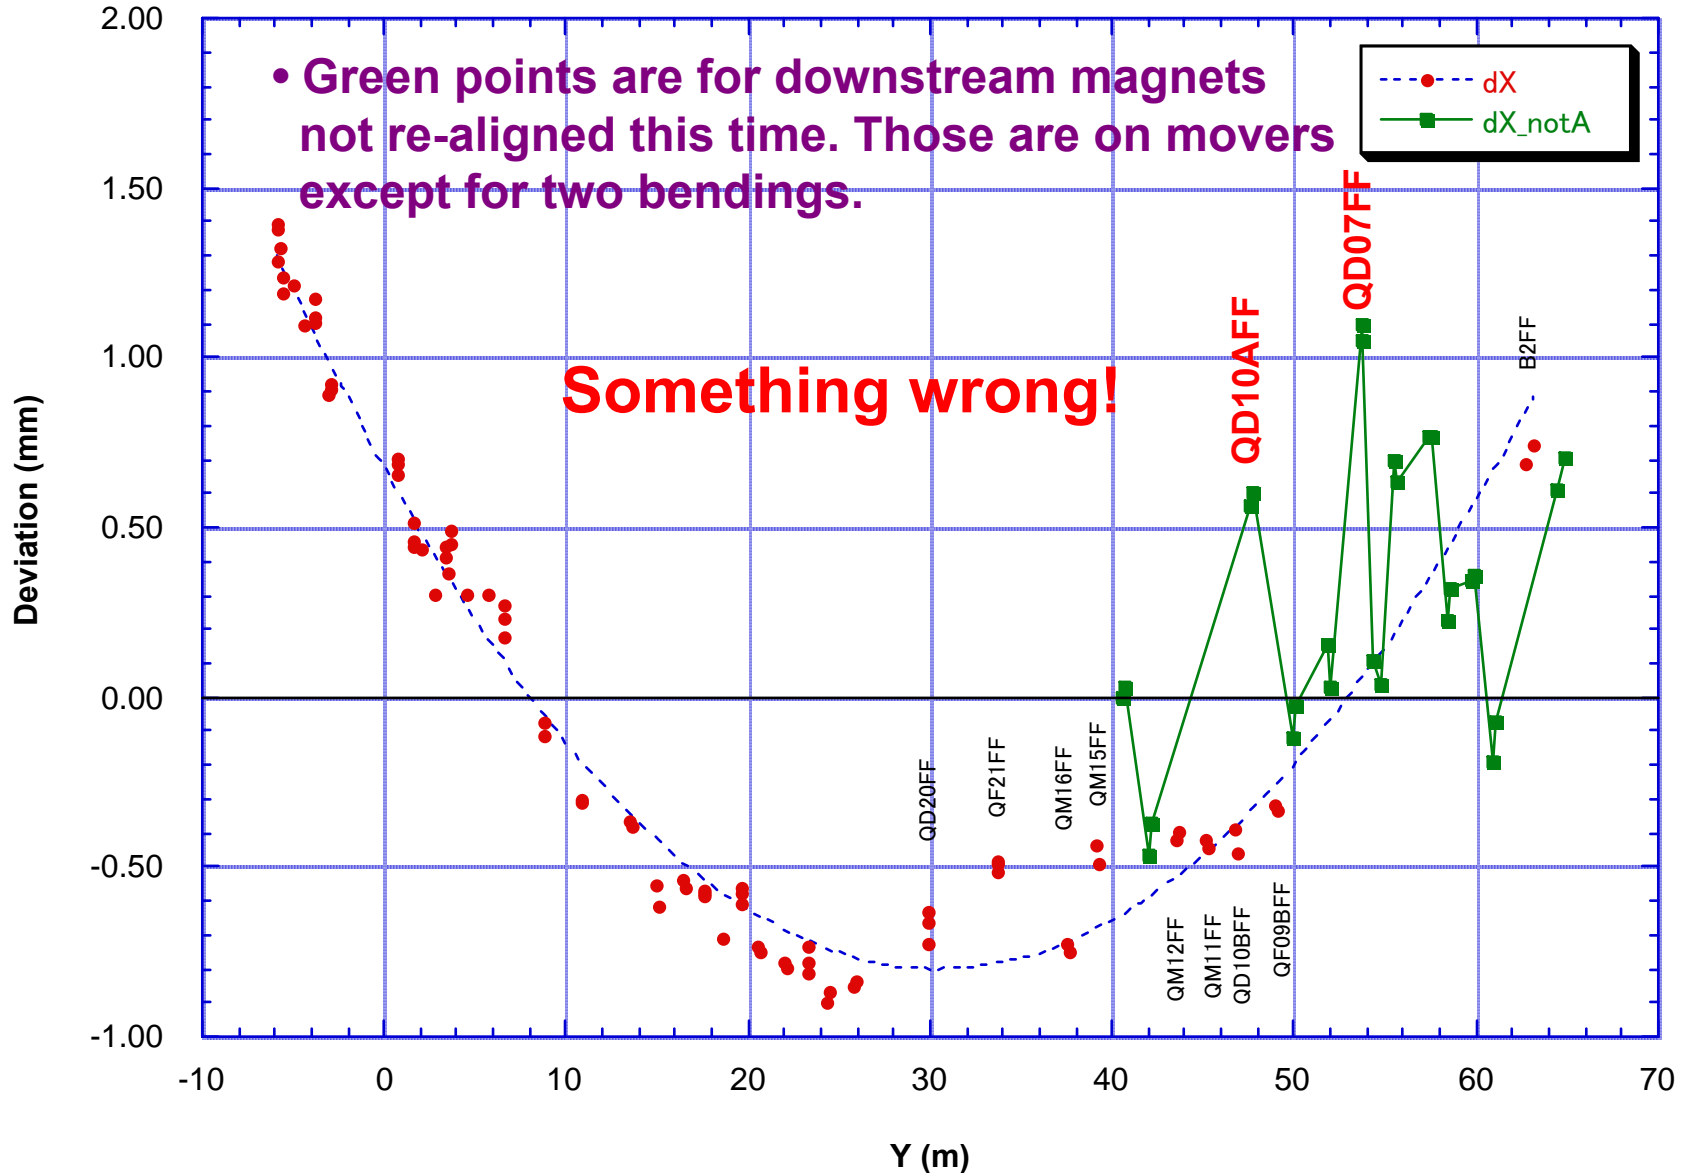
## dX

- It is obvious that some movers have moved after 1st alignment, because abnormal deviations are observed only in X direction

**All the movers' voltages will be checked and corrected if necessary, then X and Y positions will be surveyed again.**
