Update on S0 Work in the Americas Region

Mark Champion

04 November 2008

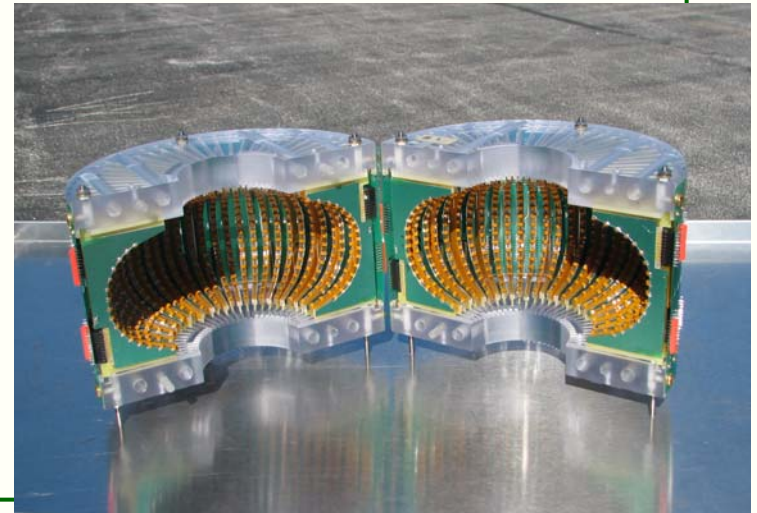
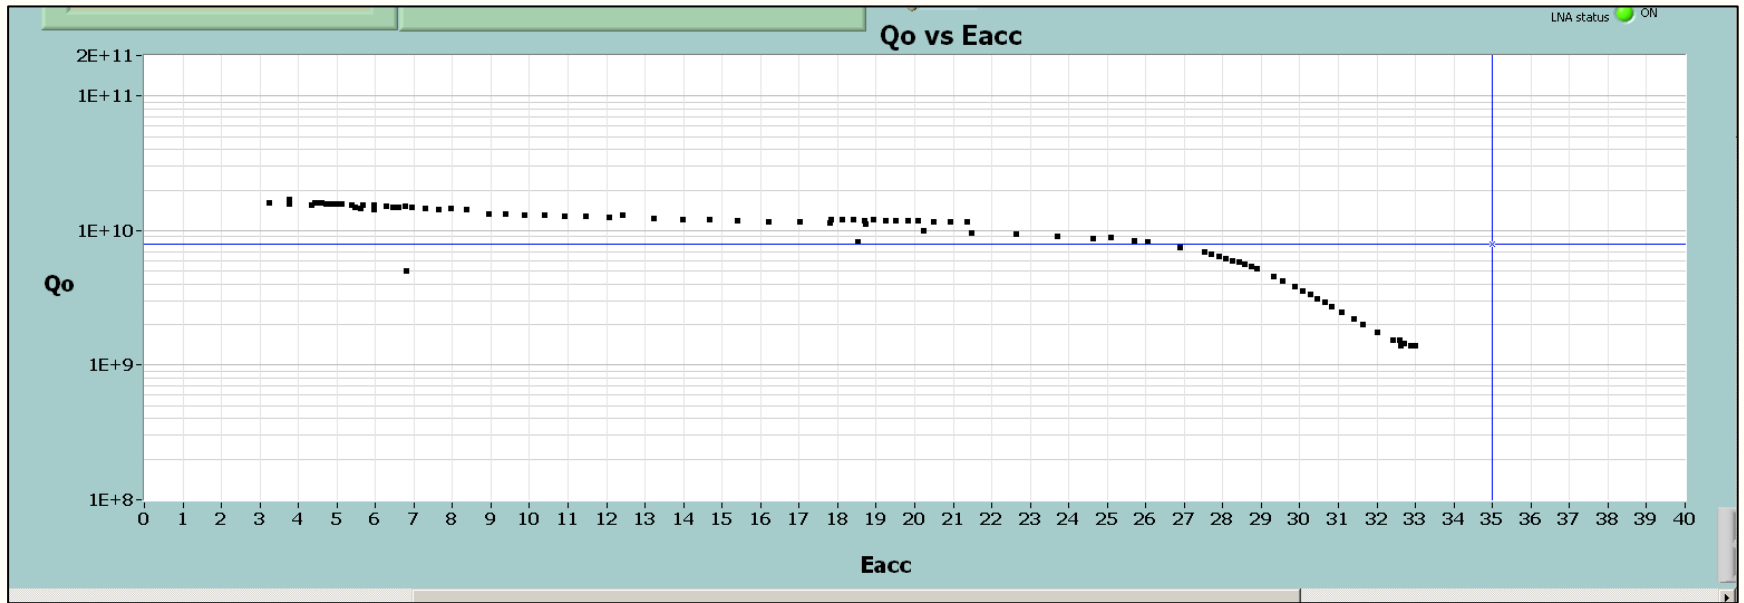
- 33 MV/m at $Q_o \sim 1.3e9$; field emission limited; no baking
- Next performed 120 C bake, but leak in cavity vacuum line caused contamination and greatly increased the field emission
- Cavity will undergo additional degreasing and high-pressure rinsing and then another test
- Meanwhile, a Niowave-Roark single-cell cavity (NR2) has been electro-polished and is being prepared for testing at Fermilab

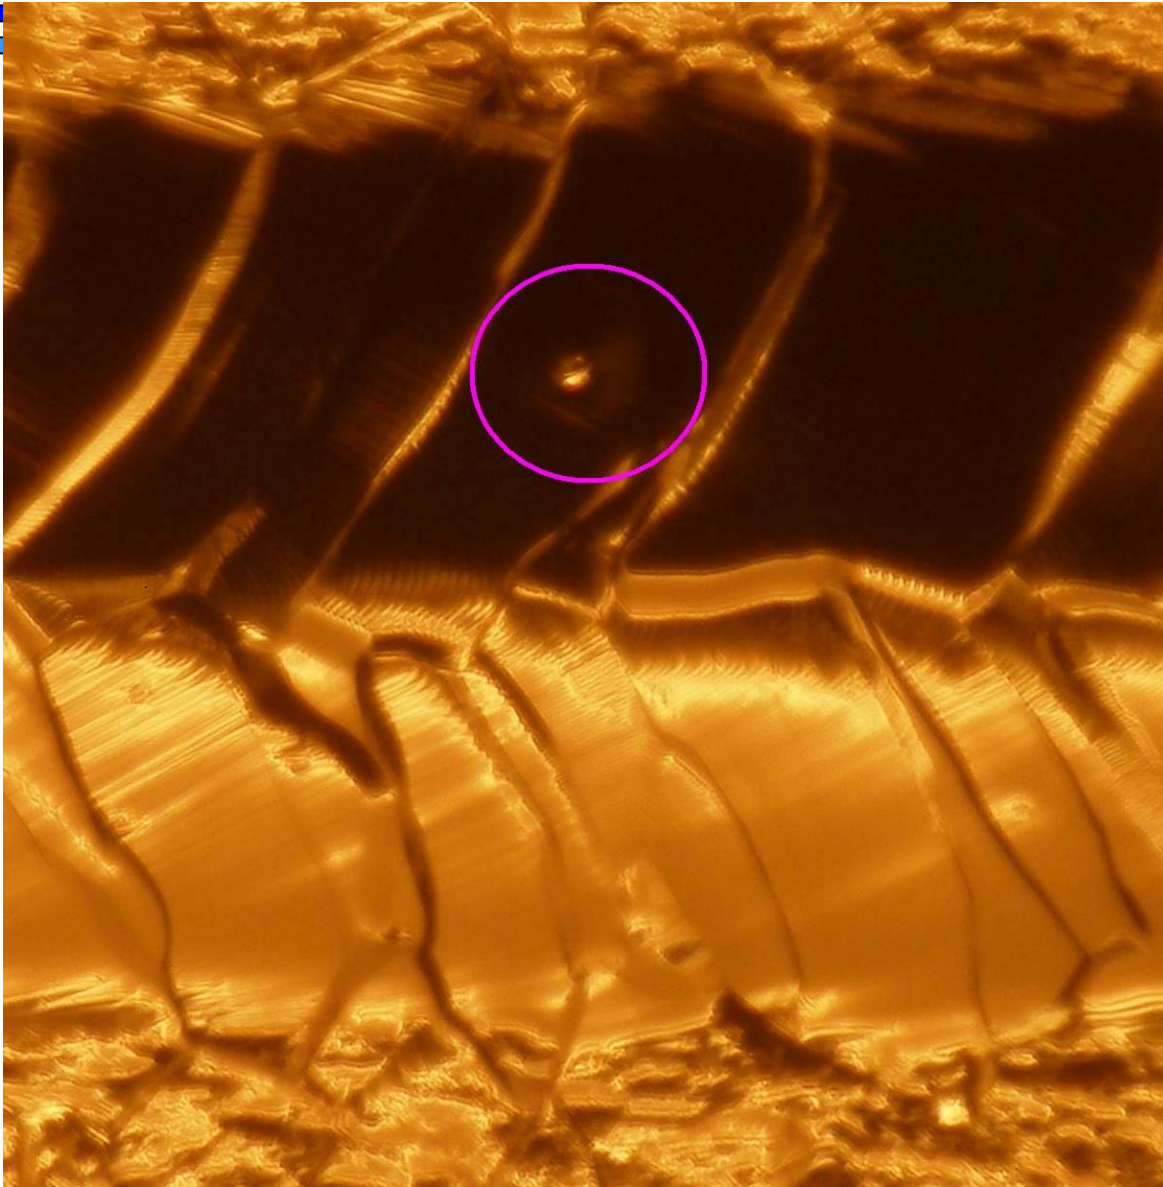
Cavity #5: Pit on Equator Weld Discovered with 2nd Sound Detection and Questar Optical Inspection

Pit size = 100 μm

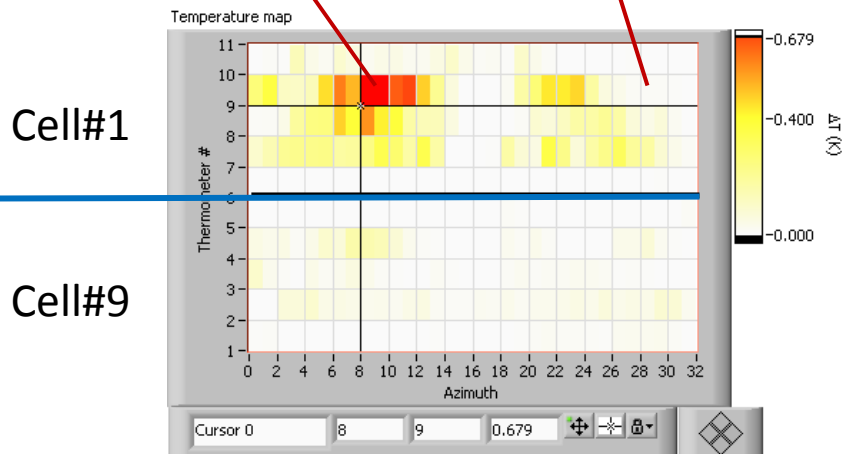
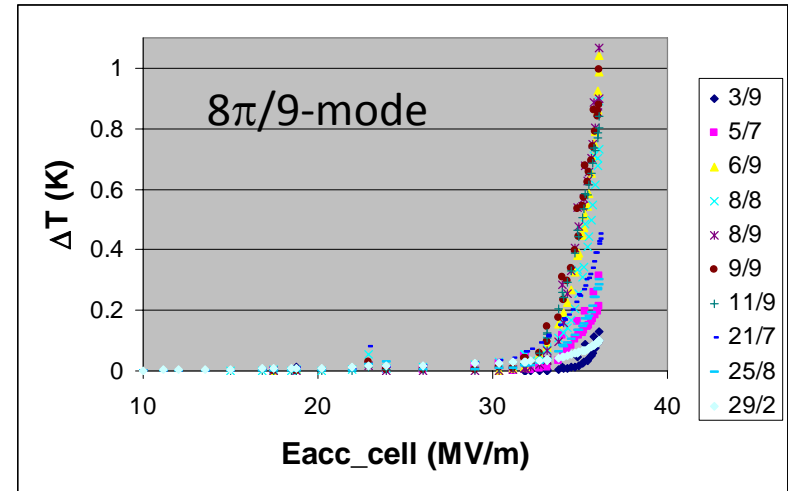
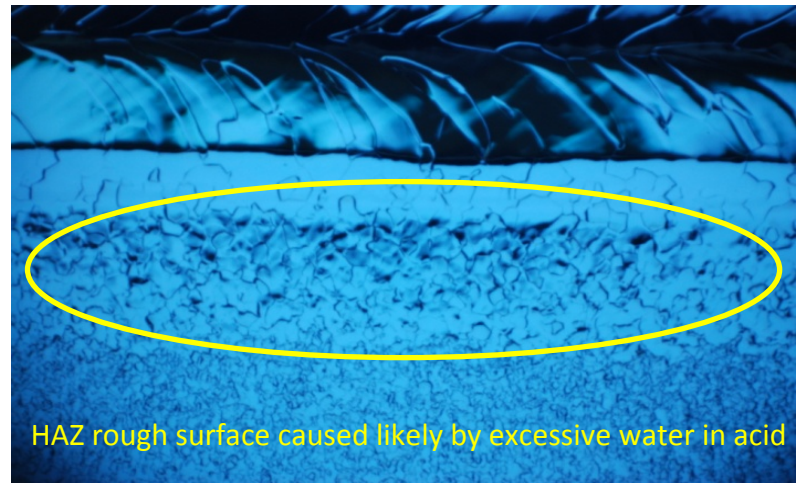
- Thermometers on cell #1 & #9. Mode-mixing (π & $8\pi/9$) observed when $E_{acc} > 9$ MV/m for π -mode excitation. Some evidence of electronic activity at tip of transmitted power antenna.
- With $8\pi/9$ -mode excitation, Quench limit reached at 36 MV/m. Hot spots in cell#1.
- Apparent enhanced roughness in hot region as well as pits close to hot spots.
- $\Delta T(E_{acc})QE^n$, $n=2.5-3$ for $E_{acc}=10-30$ MV/m in hot AND cold region; $n=25-40$ for $E_{acc}>30$ MV/m.
- HAZ of all cells inspected (7 of 9) show enhanced roughness – presumably caused by less-optimal bulk EP due to water addition into EP acid after one use.

HAZ rough surface caused likely by excessive water in acid

A major bug (causing H2O addition into sump) in EP machine discovered/removed J2 second light EP Wednesday – stay tuned

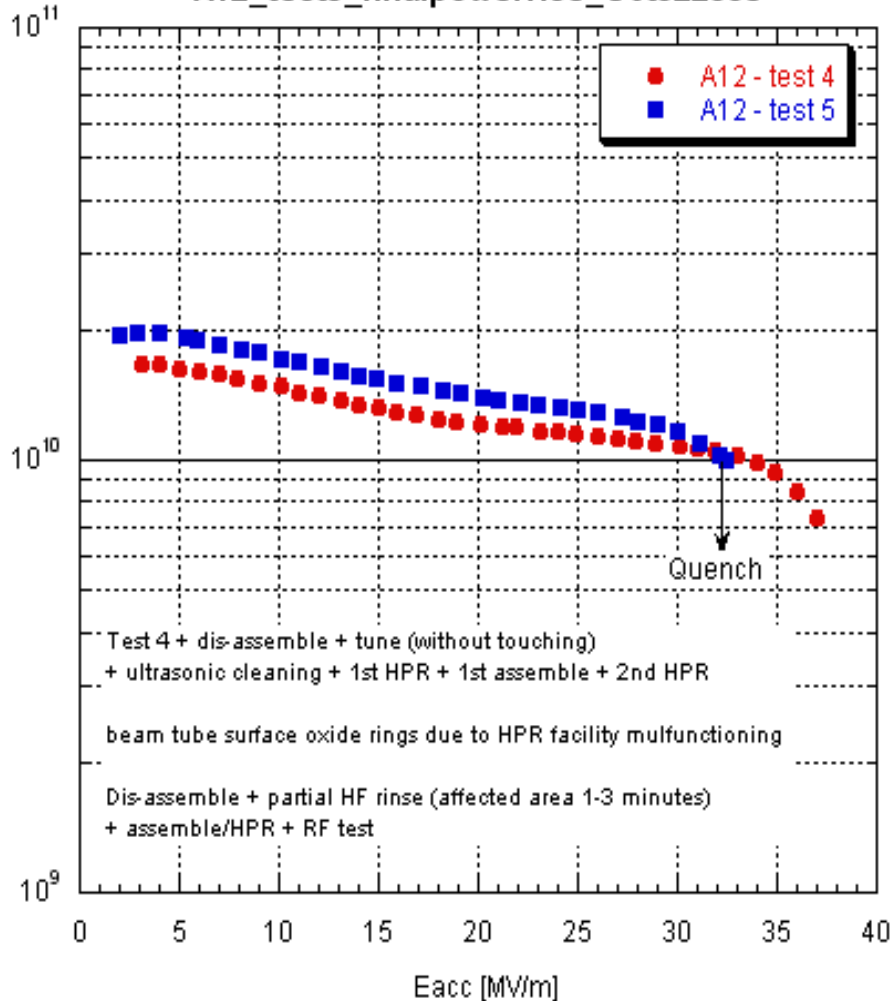
A12_test4_finalpowerrise_July212008
 A12_test5_finalpowerrise_Oct022008

- A12 exceeded 35 MV/m after first light EP.
- Plan was tuning for final frequency and field flatness and ship to FNAL.
- Oxide rings formed inside beam tube during final HPR due to stoppage of wand movement.
- Removal of oxide rings necessary – localized HF rinse successful.
- A12 reached quench limit at 32.5 MV/m after localized HF rinse.

- T-mapping is next
- Another light EP will follow
