Optical Inspection at DESY

S. Aderhold (DESY)
TILC09

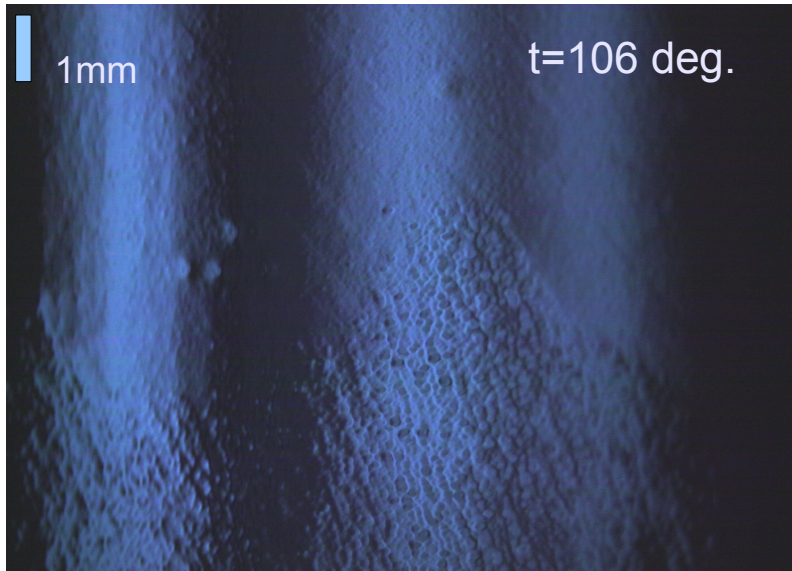
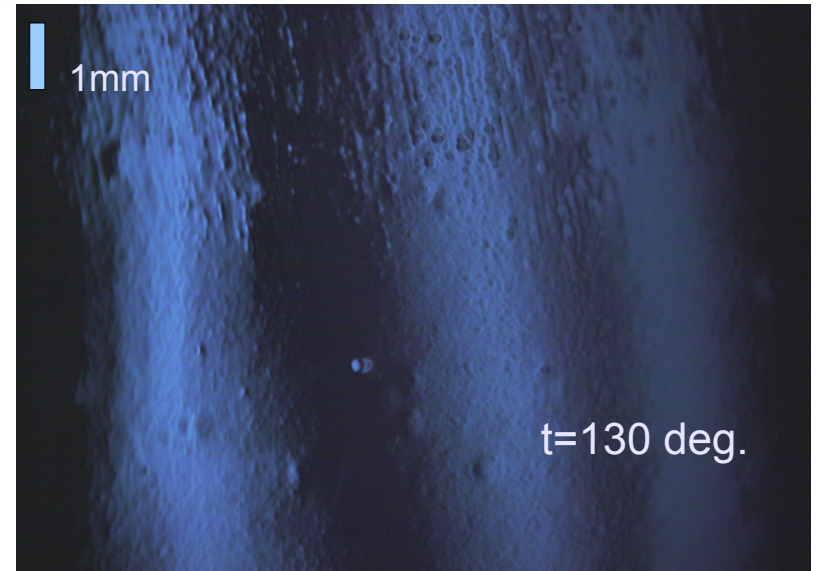
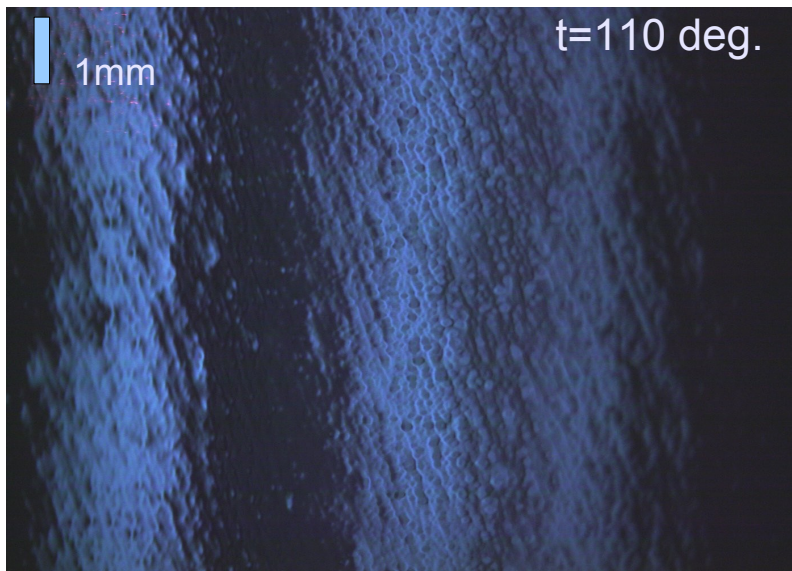
Cell 2, resistor 98 (next to equator)

- Cell 2
- Limited at 15 MV/m
- Hotspot in π -mode and $1/9$ - π -mode
- Lower spot: hotspot in $4/9$ -, $3/9$ - and $2/9$ - π -mode

hotspot in modes: $4\pi/9$, $3\pi/9$ and $2\pi/9$

leftover from grinding

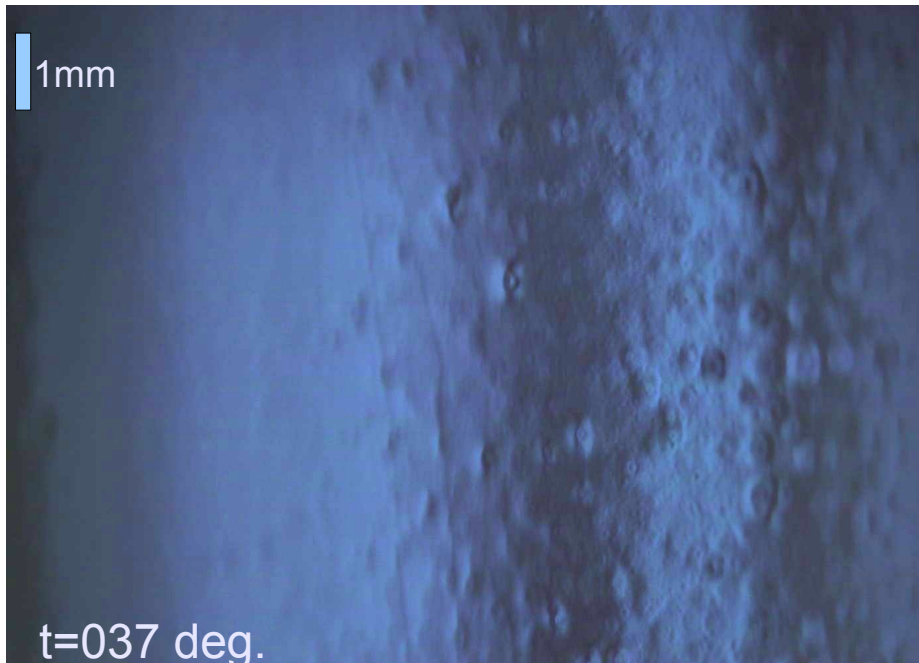
Next to equator of cell 1

- Pits at several areas all over inner and outer surface

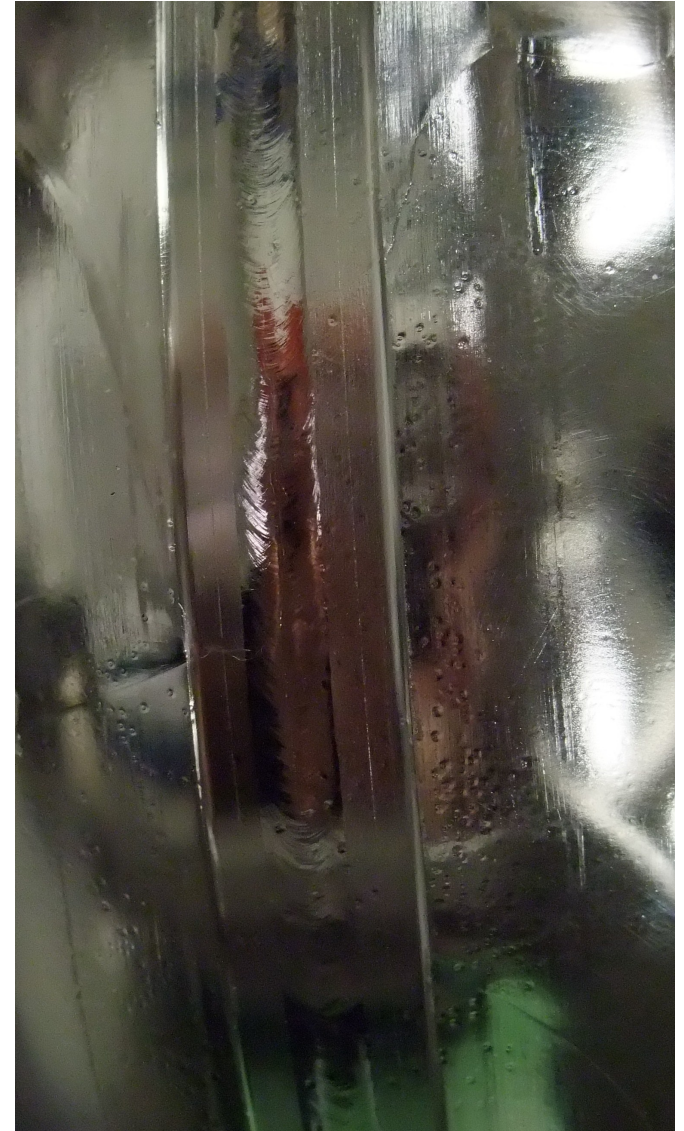
Pits on outer surface of Z142

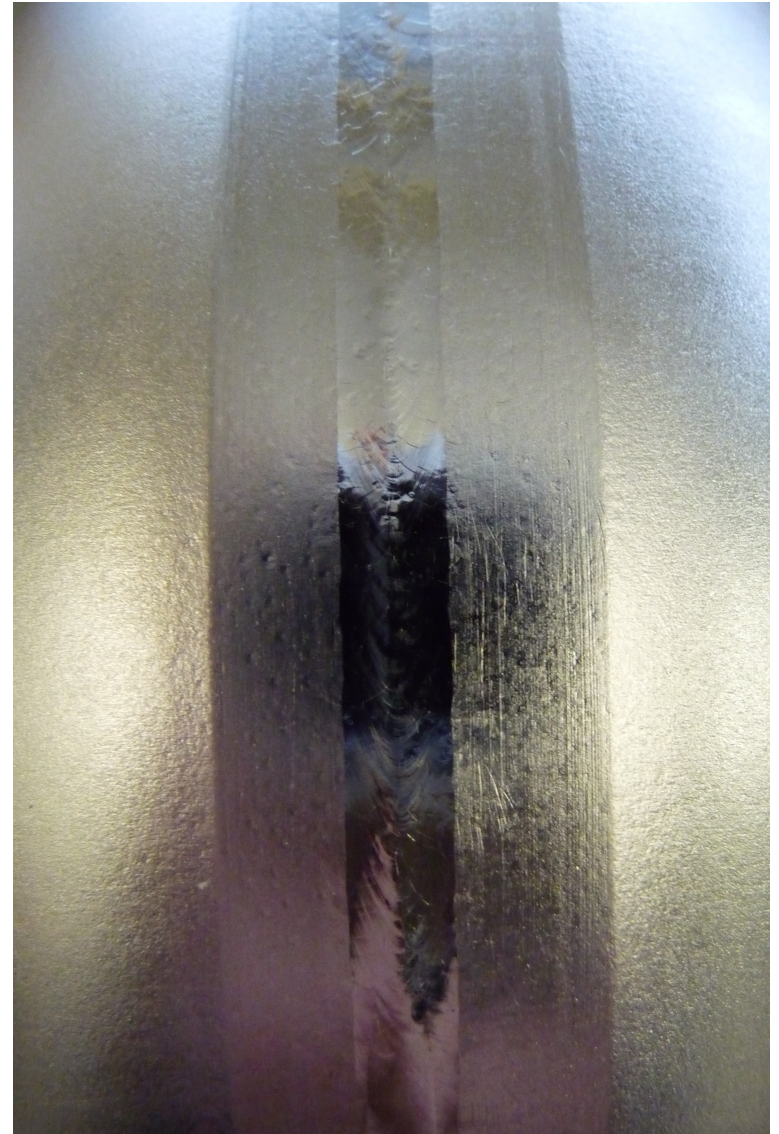
- Pits on machined part next to equator weld
- Cells 2-9
- 250-320 deg.
- On outer surface only BCP is done

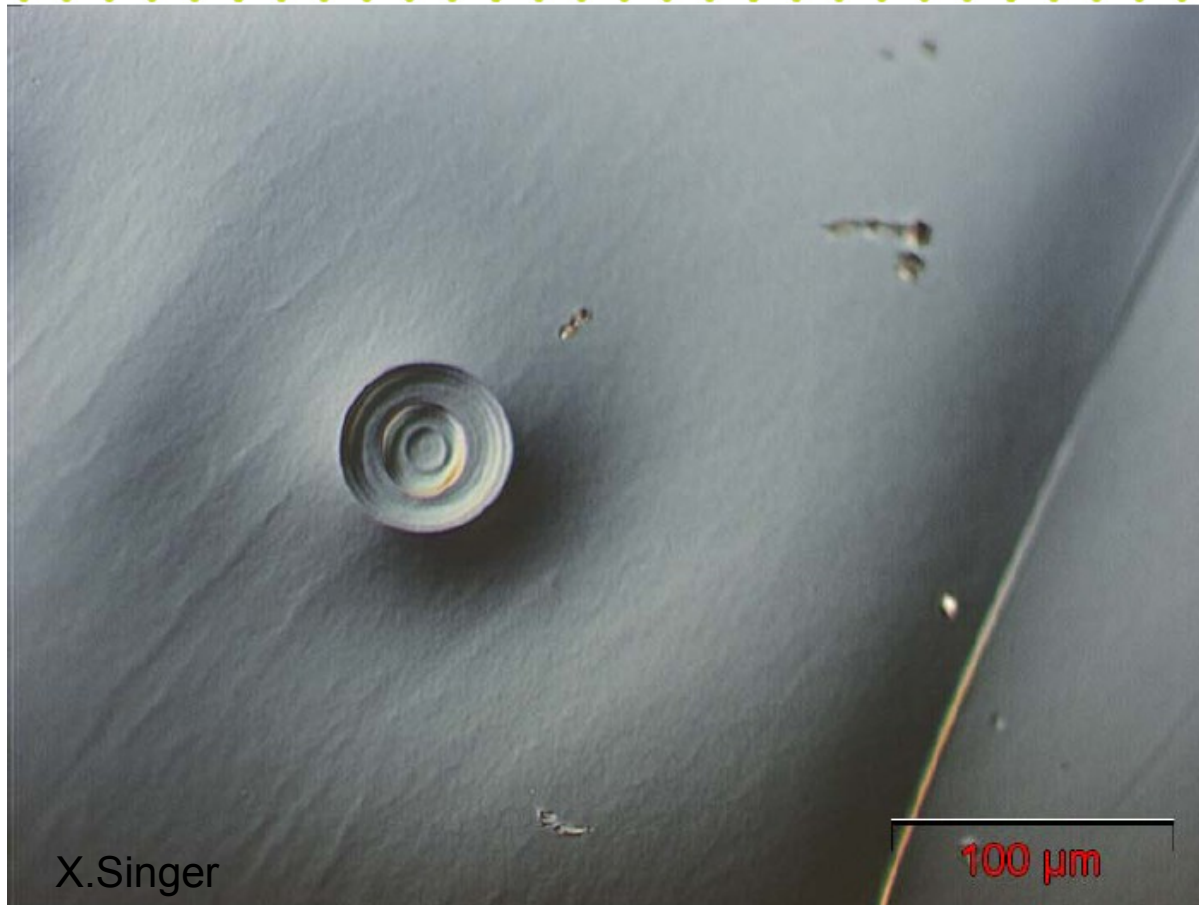
- Sample cut from Z111
- Pits only in one half of each cell → asymmetric process

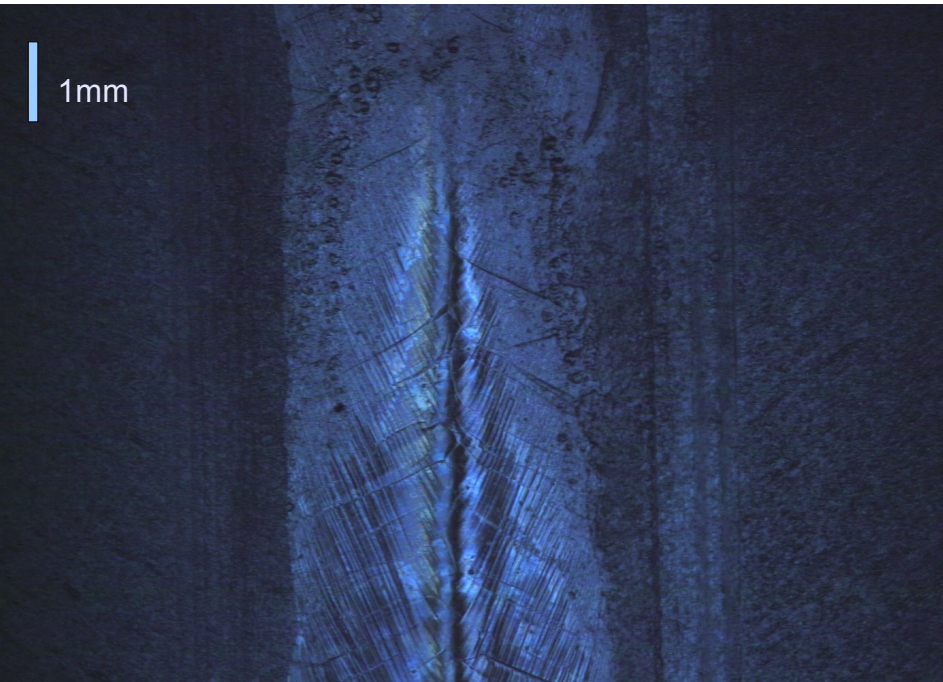
Before treatment

Equator #7 at 44 deg.

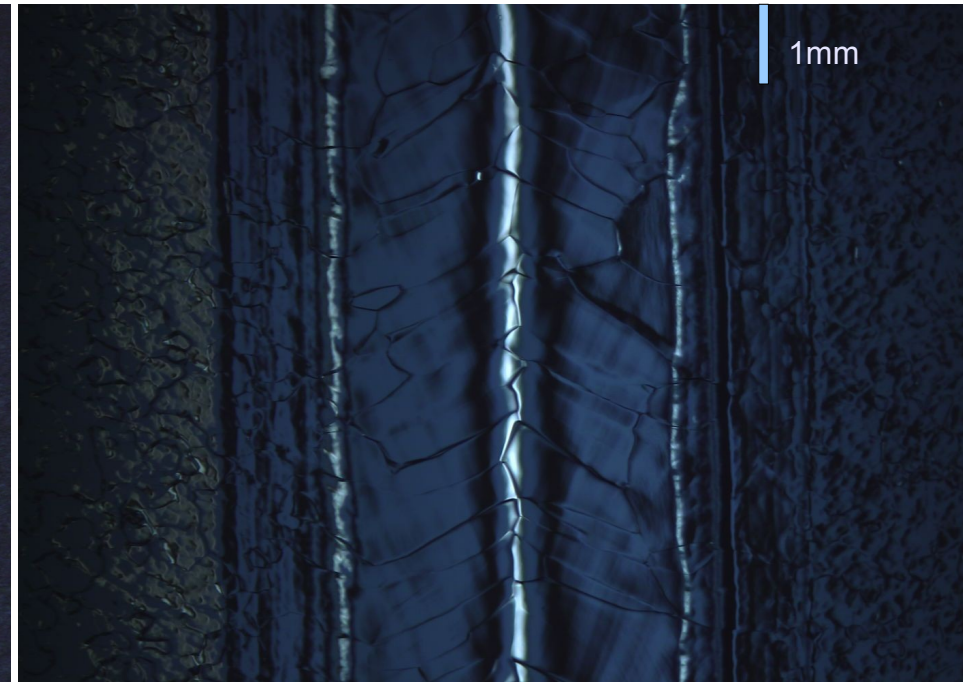
After 108 μm main EP

- Pits at weld interface removed by main EP

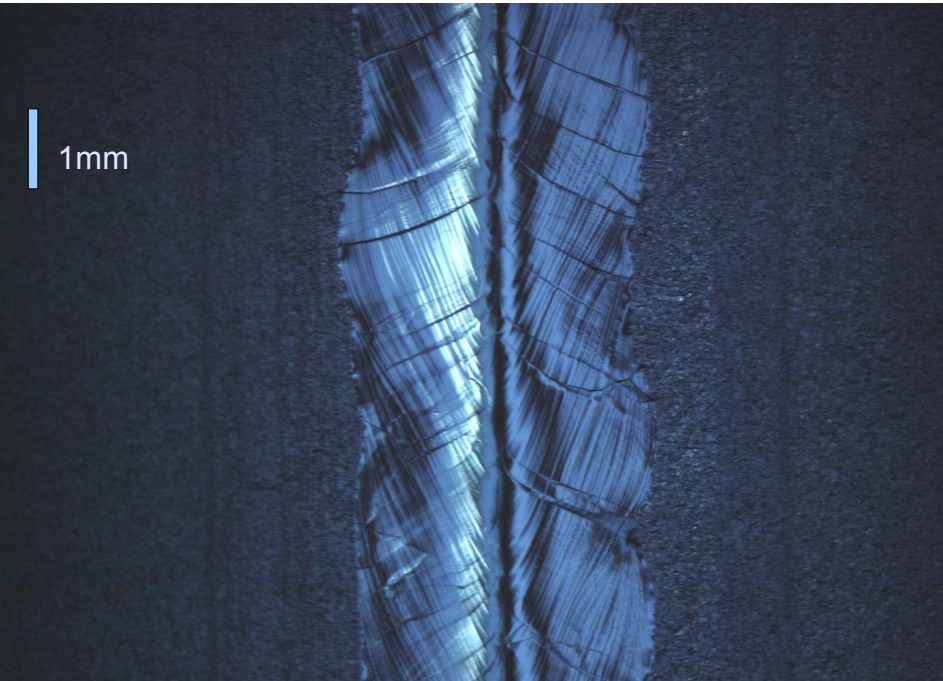
Before treatment

Equator #1 at 23 deg.

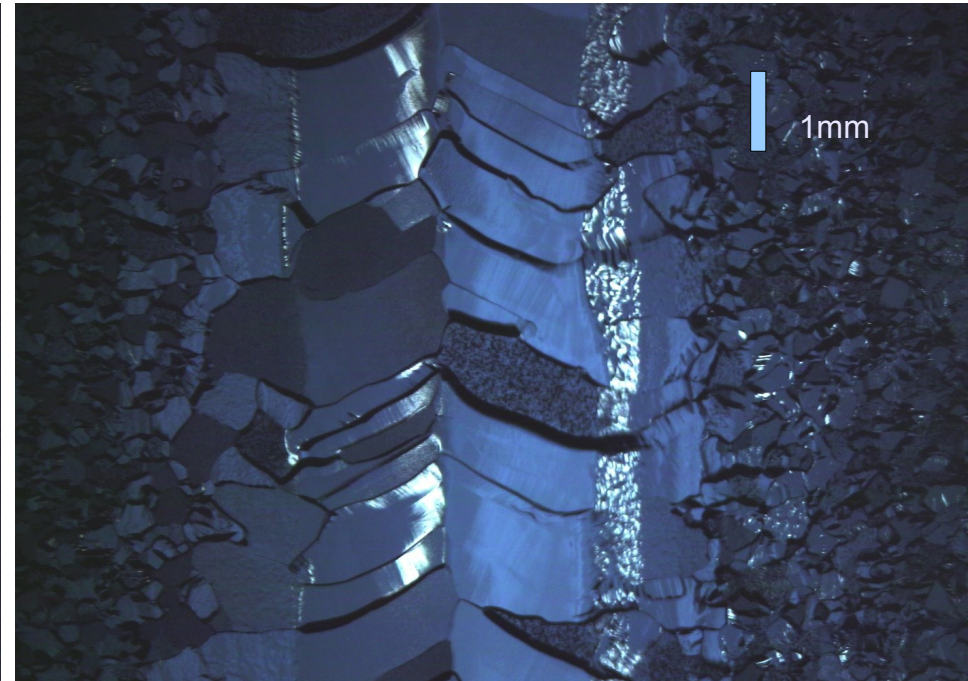
After 108 μm main EP

Equator #1 at 20 deg.

- Equator #1 shows large steps and rough grains after main EP
- All other equators normal

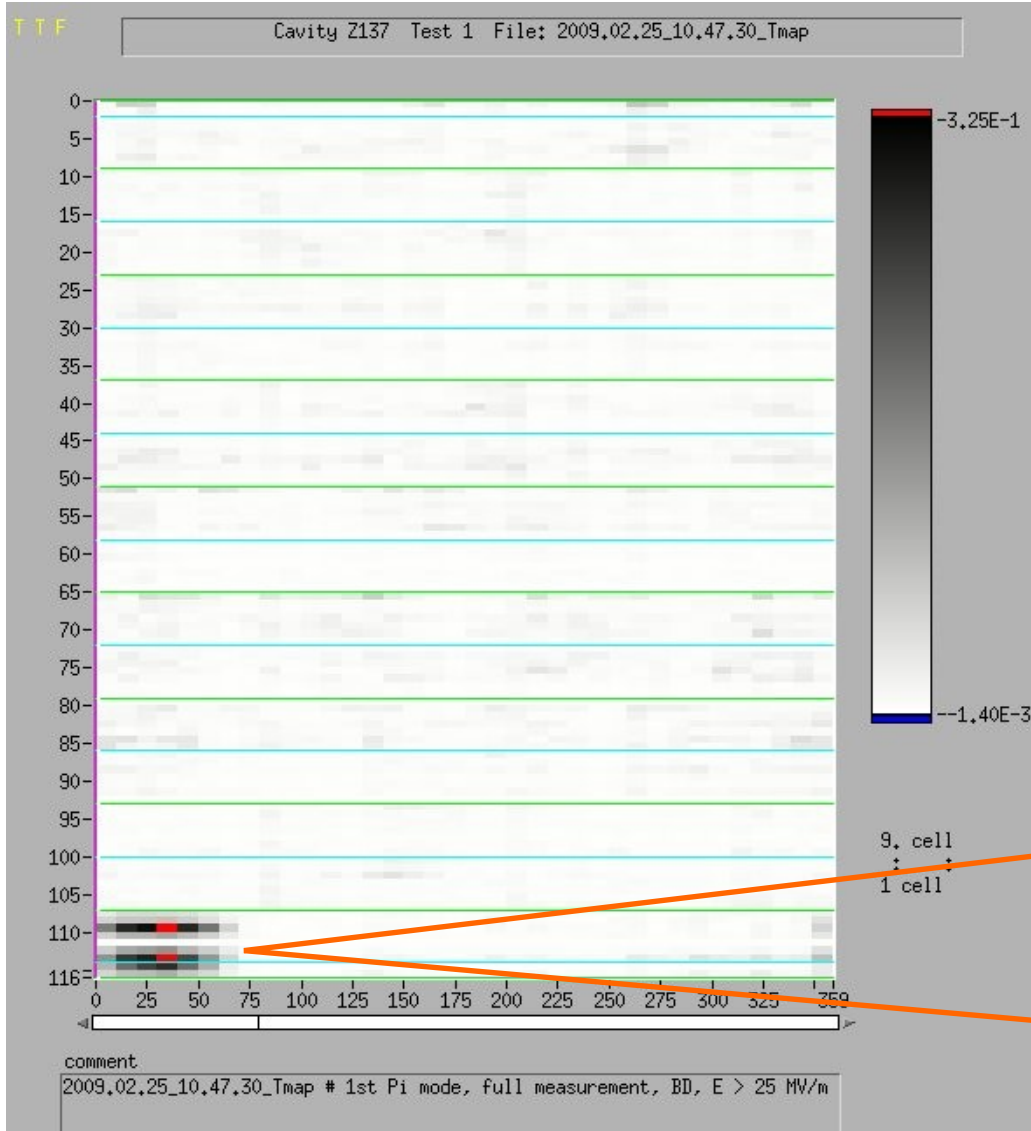
T-map of Z137

π -mode, BD at 25.2 MV/m
