Status of GEM module

Status of TPC

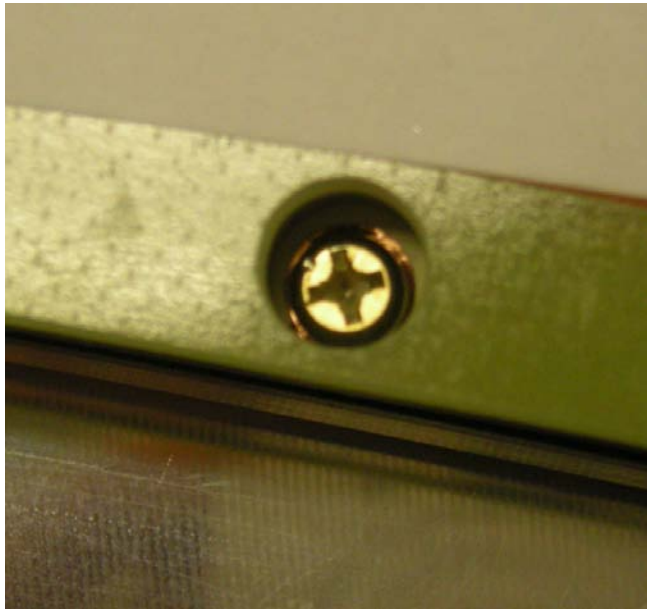
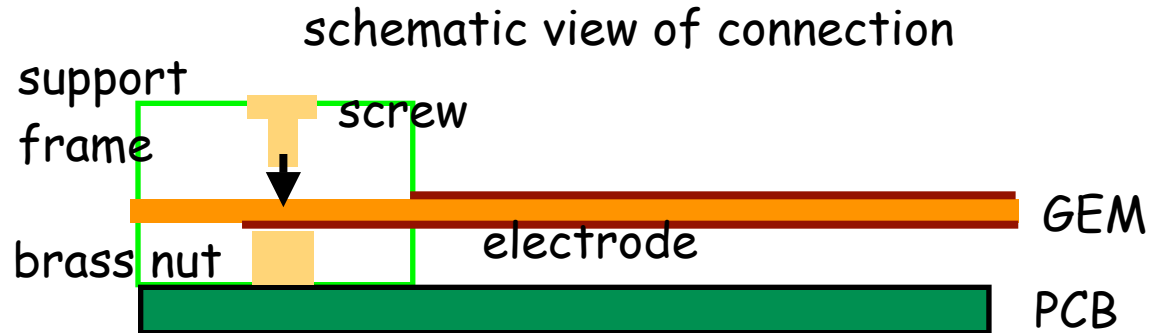
HV problem: half of the central module was dead

Reason: The lower electrode of bottom GEM has no connection to HV line

unmounted GEM module show the same problem once we establish HV connection (just unscrew-screw)
HV connection was OK until we tighten screw of mounting bracket. -> the same problem again
Our module may touch somewhere(dummy module?) in TPC????? and GEM might be displaced a little.

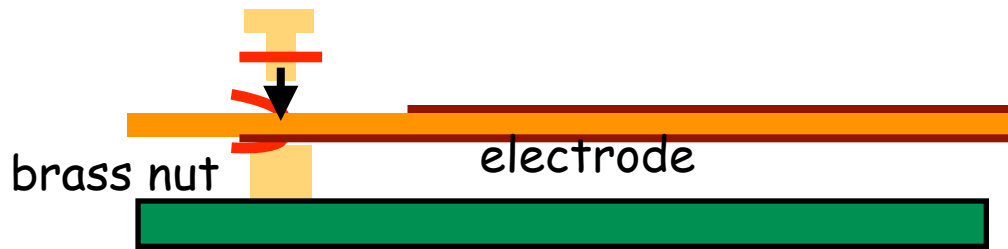
Connection looks OK now.

What we did. Tighten the connection inserting Cu washer and piece.

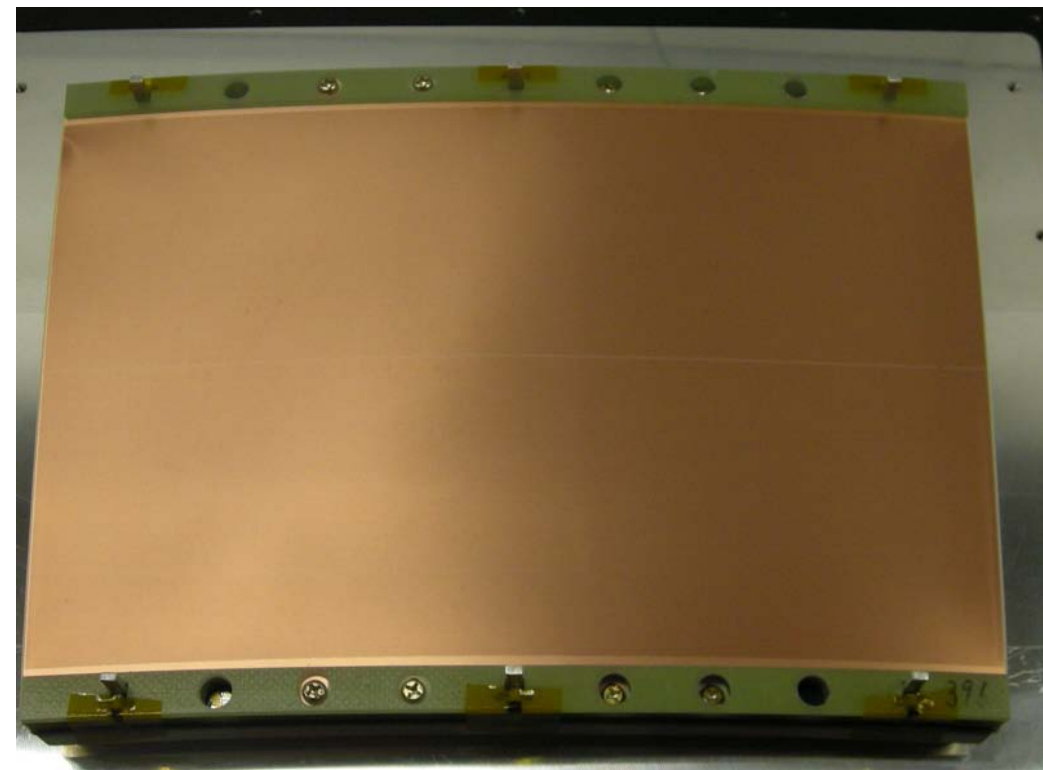
before

Distortion : due to insulator facing drift volume

GEM support frame are facing to drift volume

-> charge up -> E field distortion -> $E \times B$ near frame

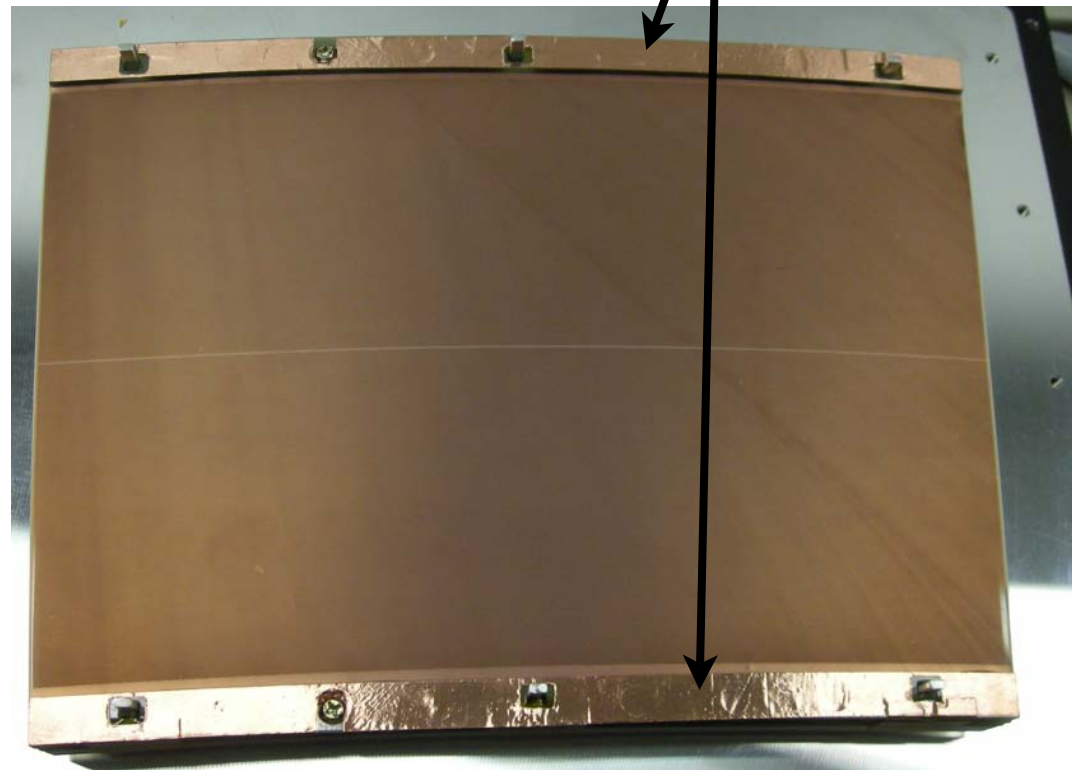
after

(2mm gap will provide distortion also)

Cu tape

We put Cu tape on frame surface and connect the GEM potential.

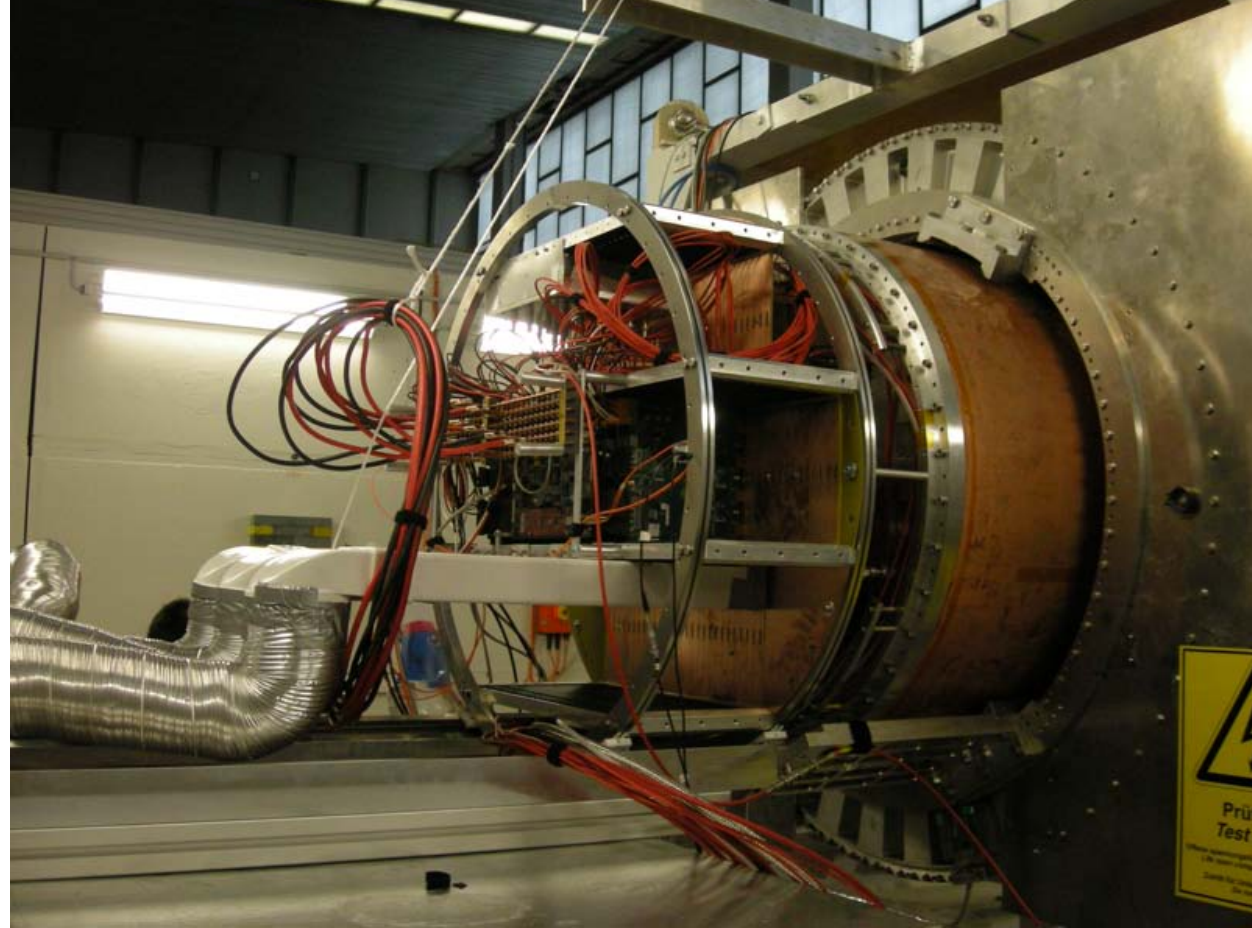
Today's TPC

HV connection
FEC cabling are done
