Replica-method and local grinding repair

K. Watanabe (KEK)

LCWS 2010 in Beijing.

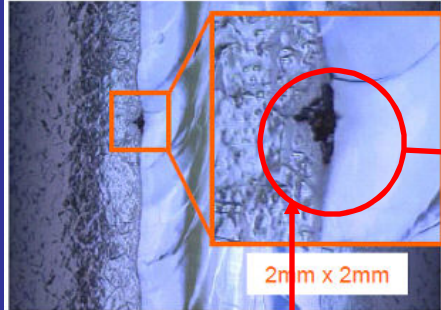
After V.T.

2-cell equator, $t=172$ deg. Pit

(Removed material = 125 μm)

The cavity was quench at 16 MV/m on the 2-cell equator. The defect was made after EP-2 process.

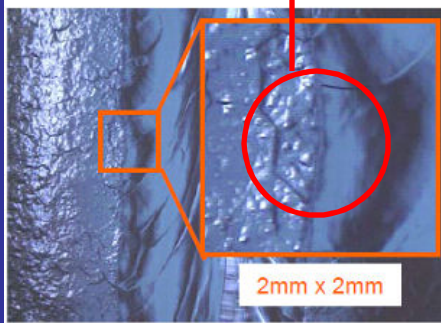
Before V.T.

(Removed material = 105 μm)

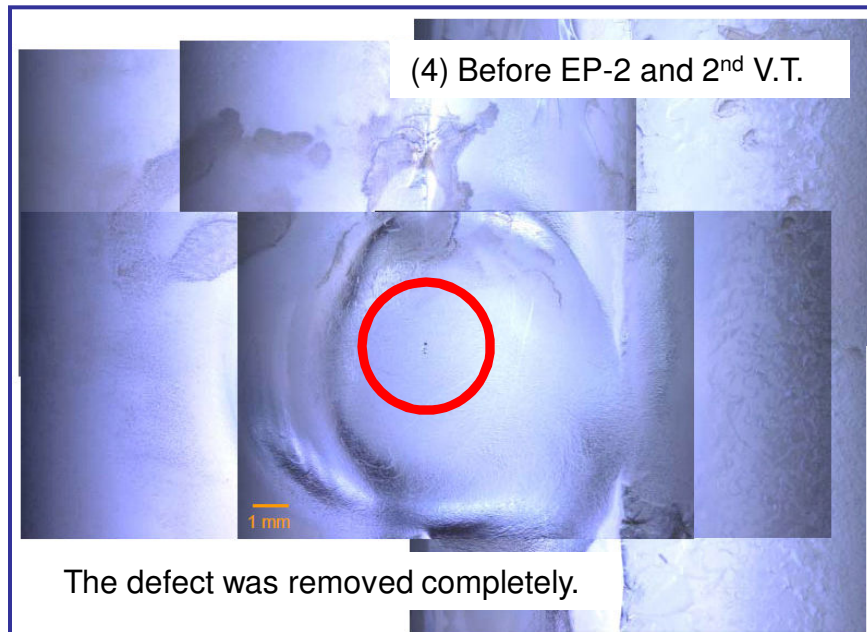
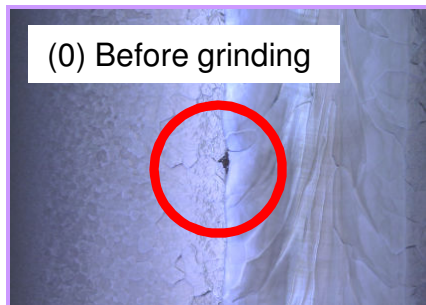
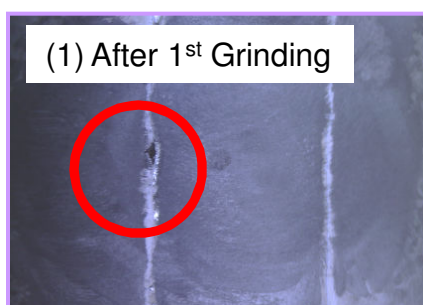
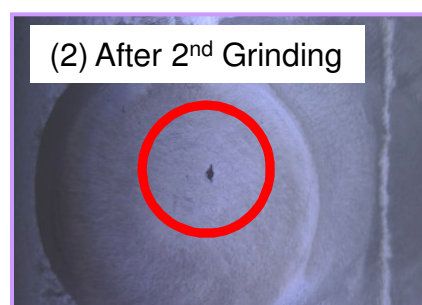
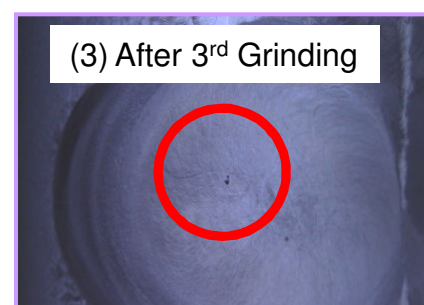
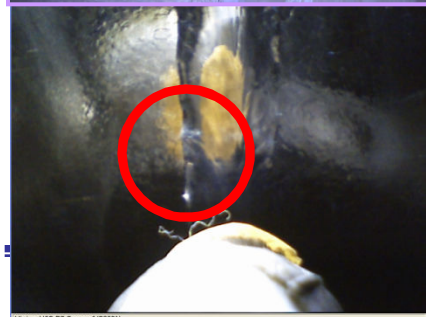
4. MHI-08 : Grinding of the defect : 2-cell equator $t = 172^\circ$

In this case, the defect type was pit at the boundary between EBW seam and HAZ.

History of the Grinding, (0) before Grinding.

- (1) 1st Grinding #400, 58 min
- (2) 2nd Grinding #400, 76min (Total 134min)
- (3) 3rd Grinding #400, 70min (Total 204min)
- (4) 4th Polishing #1000, 60min (Total : 264min) and EP (20 +30 μ m)

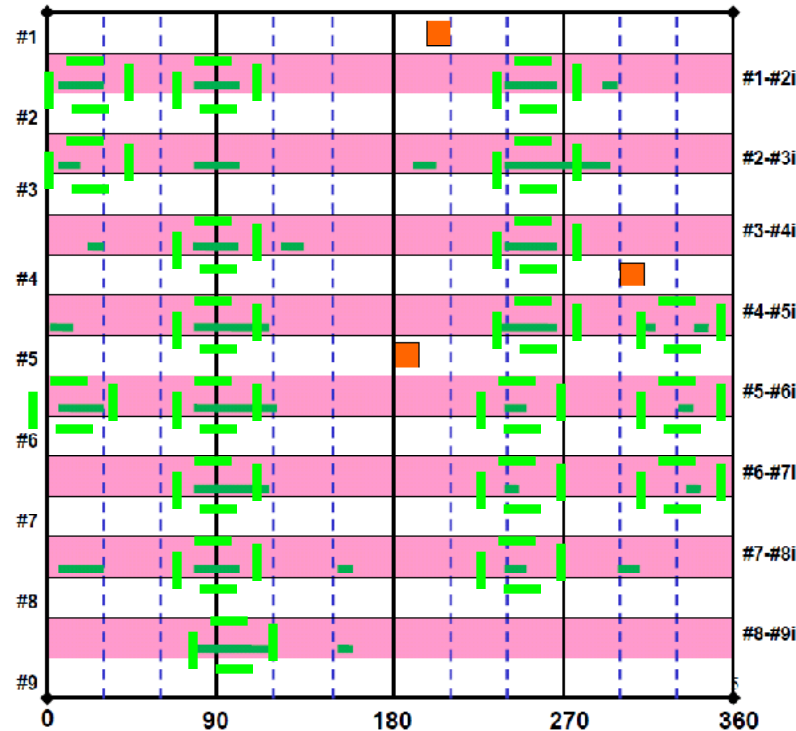
Equator: three places (1-cell $t=200$, 4-cell $t=306$, 5-cell $t=187$)

Iris: 20 places (see the map of the iris part.)

The Quench location was “4-cell equator, near $t=306$ degree” at 20 MV/m measured by FNAL and JLAB.

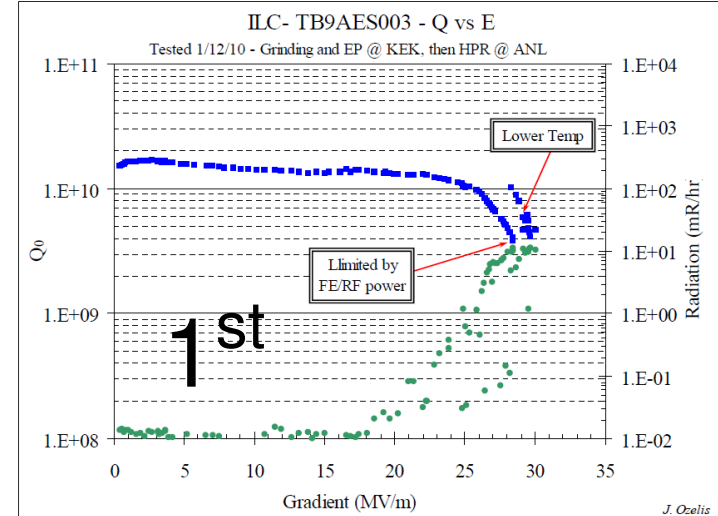
The gradient was very improvement. The gradient was raised to 30 MV/m in first test, to 34 MV/m in second test at FNAL. The limitation of cavity performance was field emission. The location of local grinding were no quench at high field.

Figure 1.) Q_0 vs E run at 2.05K. The highest gradients reached were after some degree of CW processing of the field emitter coupled with a decrease in the He bath temperature (to 1.97K)

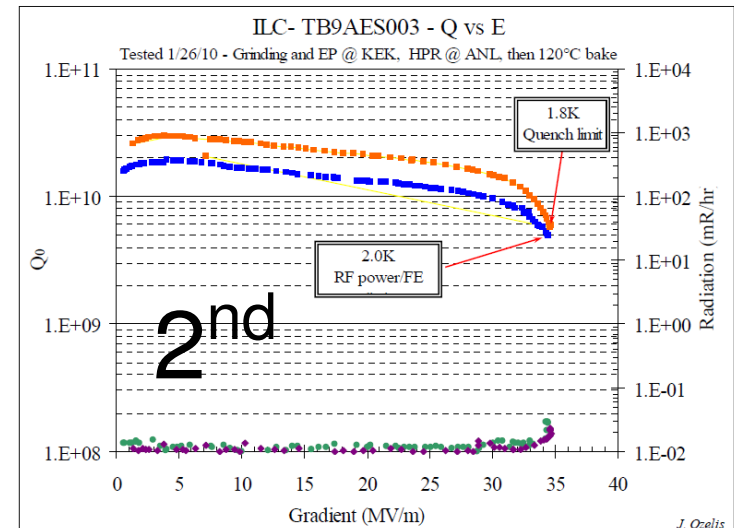
Figure 1.) Q_0 vs E runs at 2.00K and 1.80K.

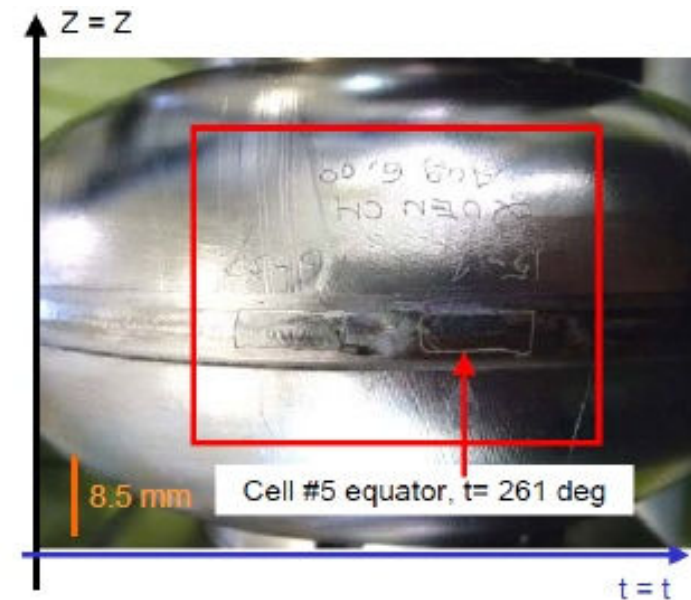
Limiting defect is weld repair – geometric flaw!

After the baseline test with quench limit at ~ 20 MV/m, the cavity was light EP treated - and the quench limit was raised to 30 MV/m. T-mapping found the quench location at the equator EBW of the cell#5. This cavity was then sent to KEK for local grinding.

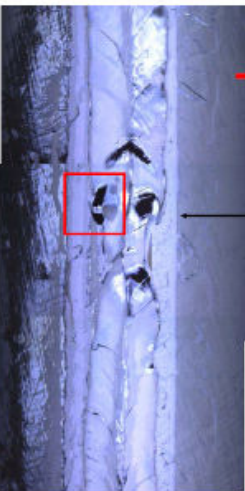
Cell #6 equator, t=060 deg.

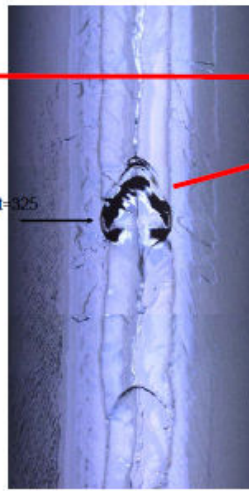
Cell #6 equator, t=325 deg.

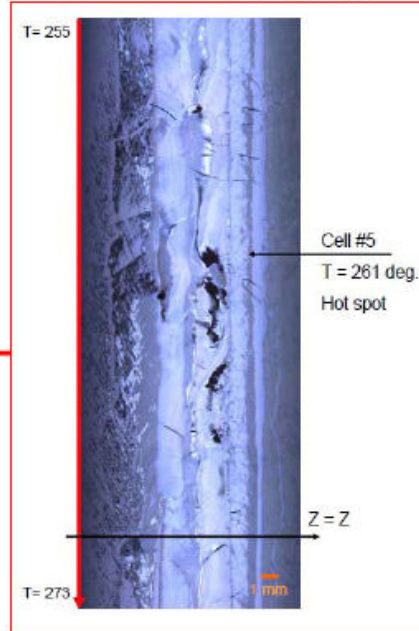
Hot spot at 30 MV/m

The welding seam was flaw in hot spot and other locations. Take a replica at 5-cell using by special tool. The Local Grinding made at 5-cell defect.

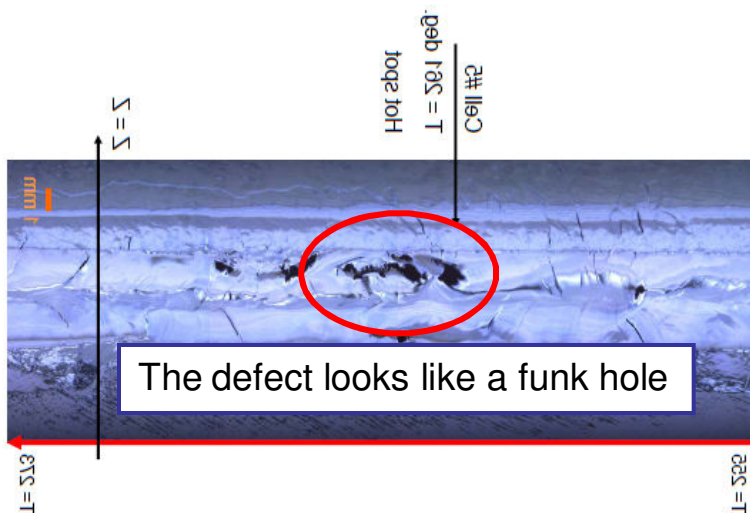
The Shape analysis is very easy by the replica before and after repair.

Depth = ~ 300 μm .
