Iris defect in TB9RI026

Dmitri A. Sergatskov
(das@fnal.gov)

Monday Morning Meeting
2010.03.01

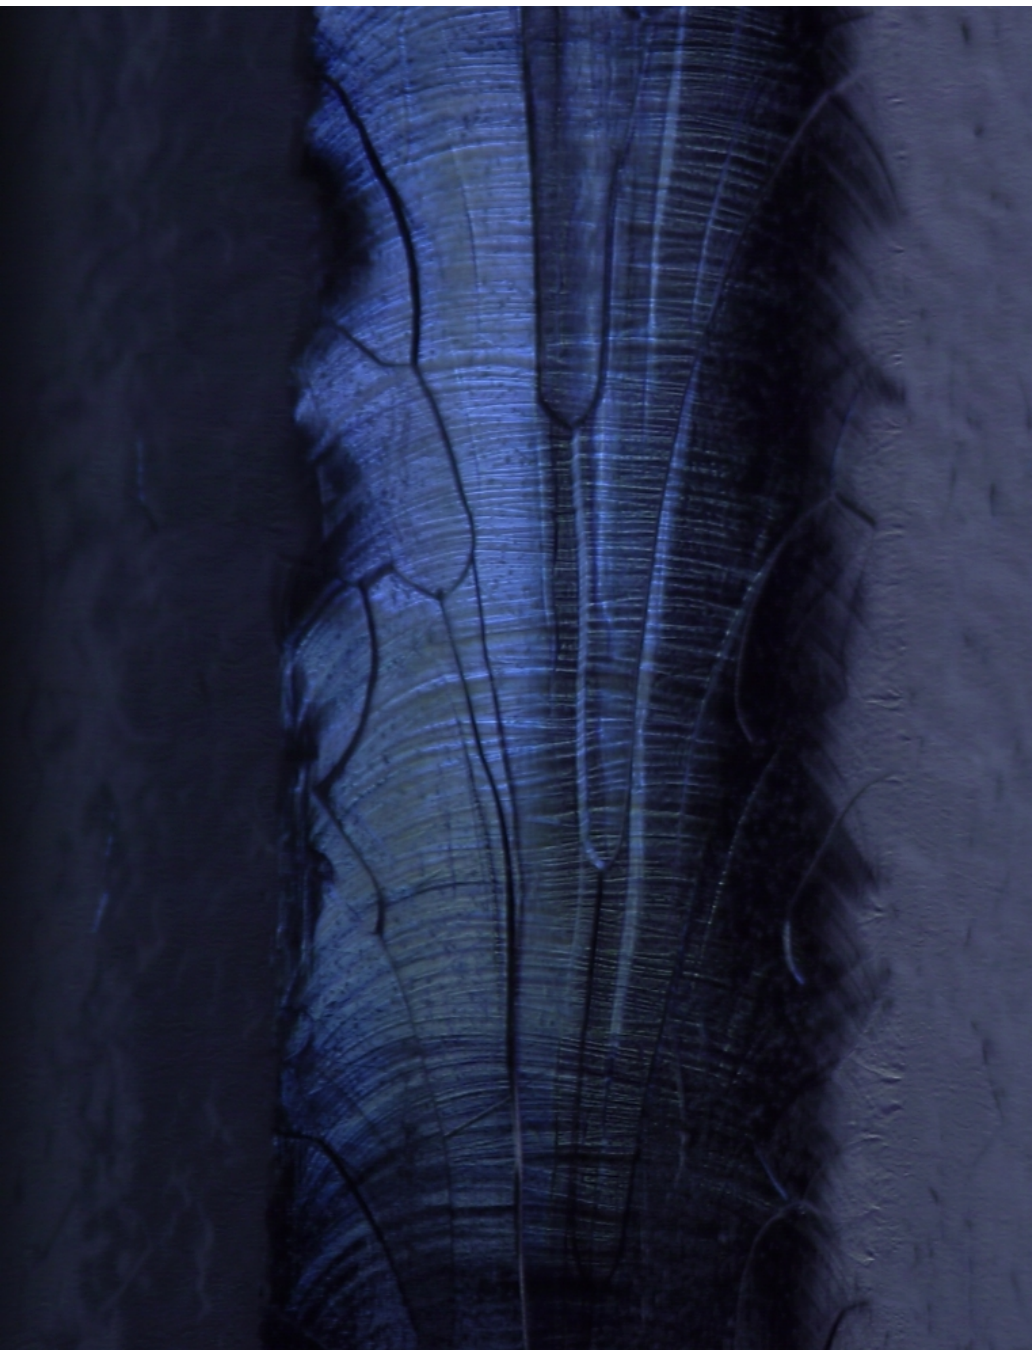
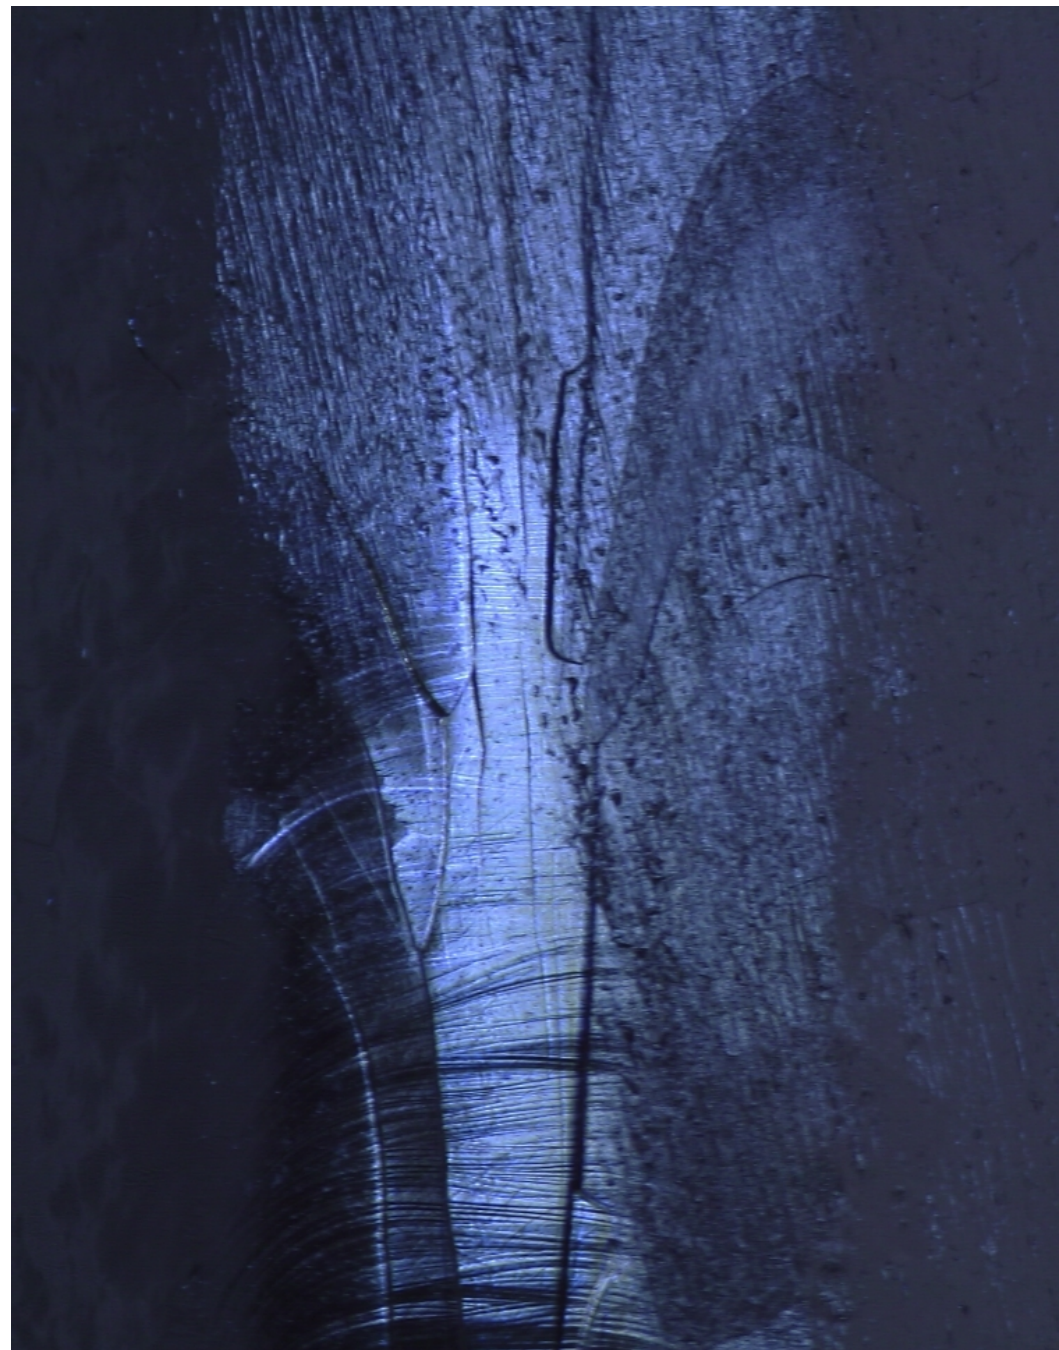
Pristine (left) and partially machined (right) iris weld

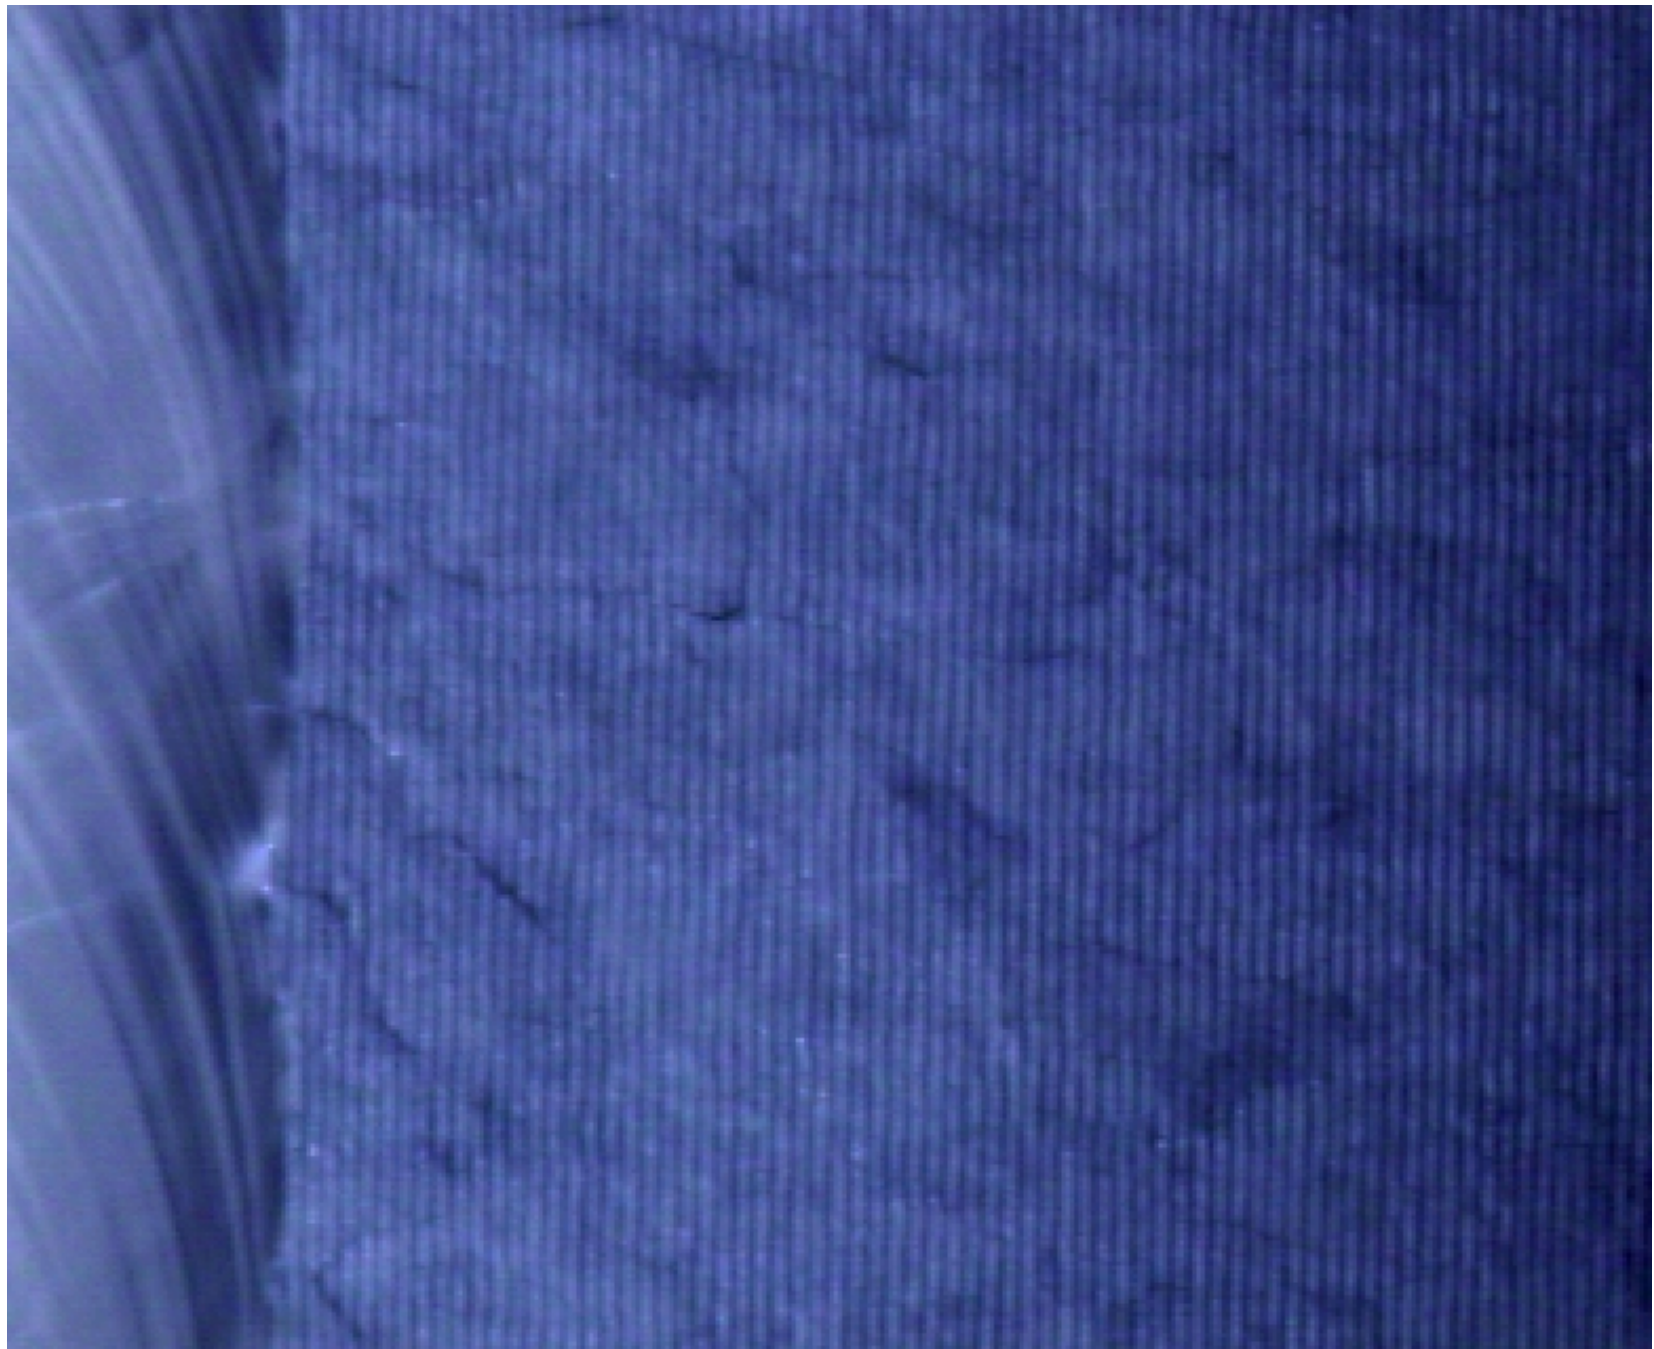
Traces of cutting tool on equator weld prep. ~30 micrometers (~0.001") period

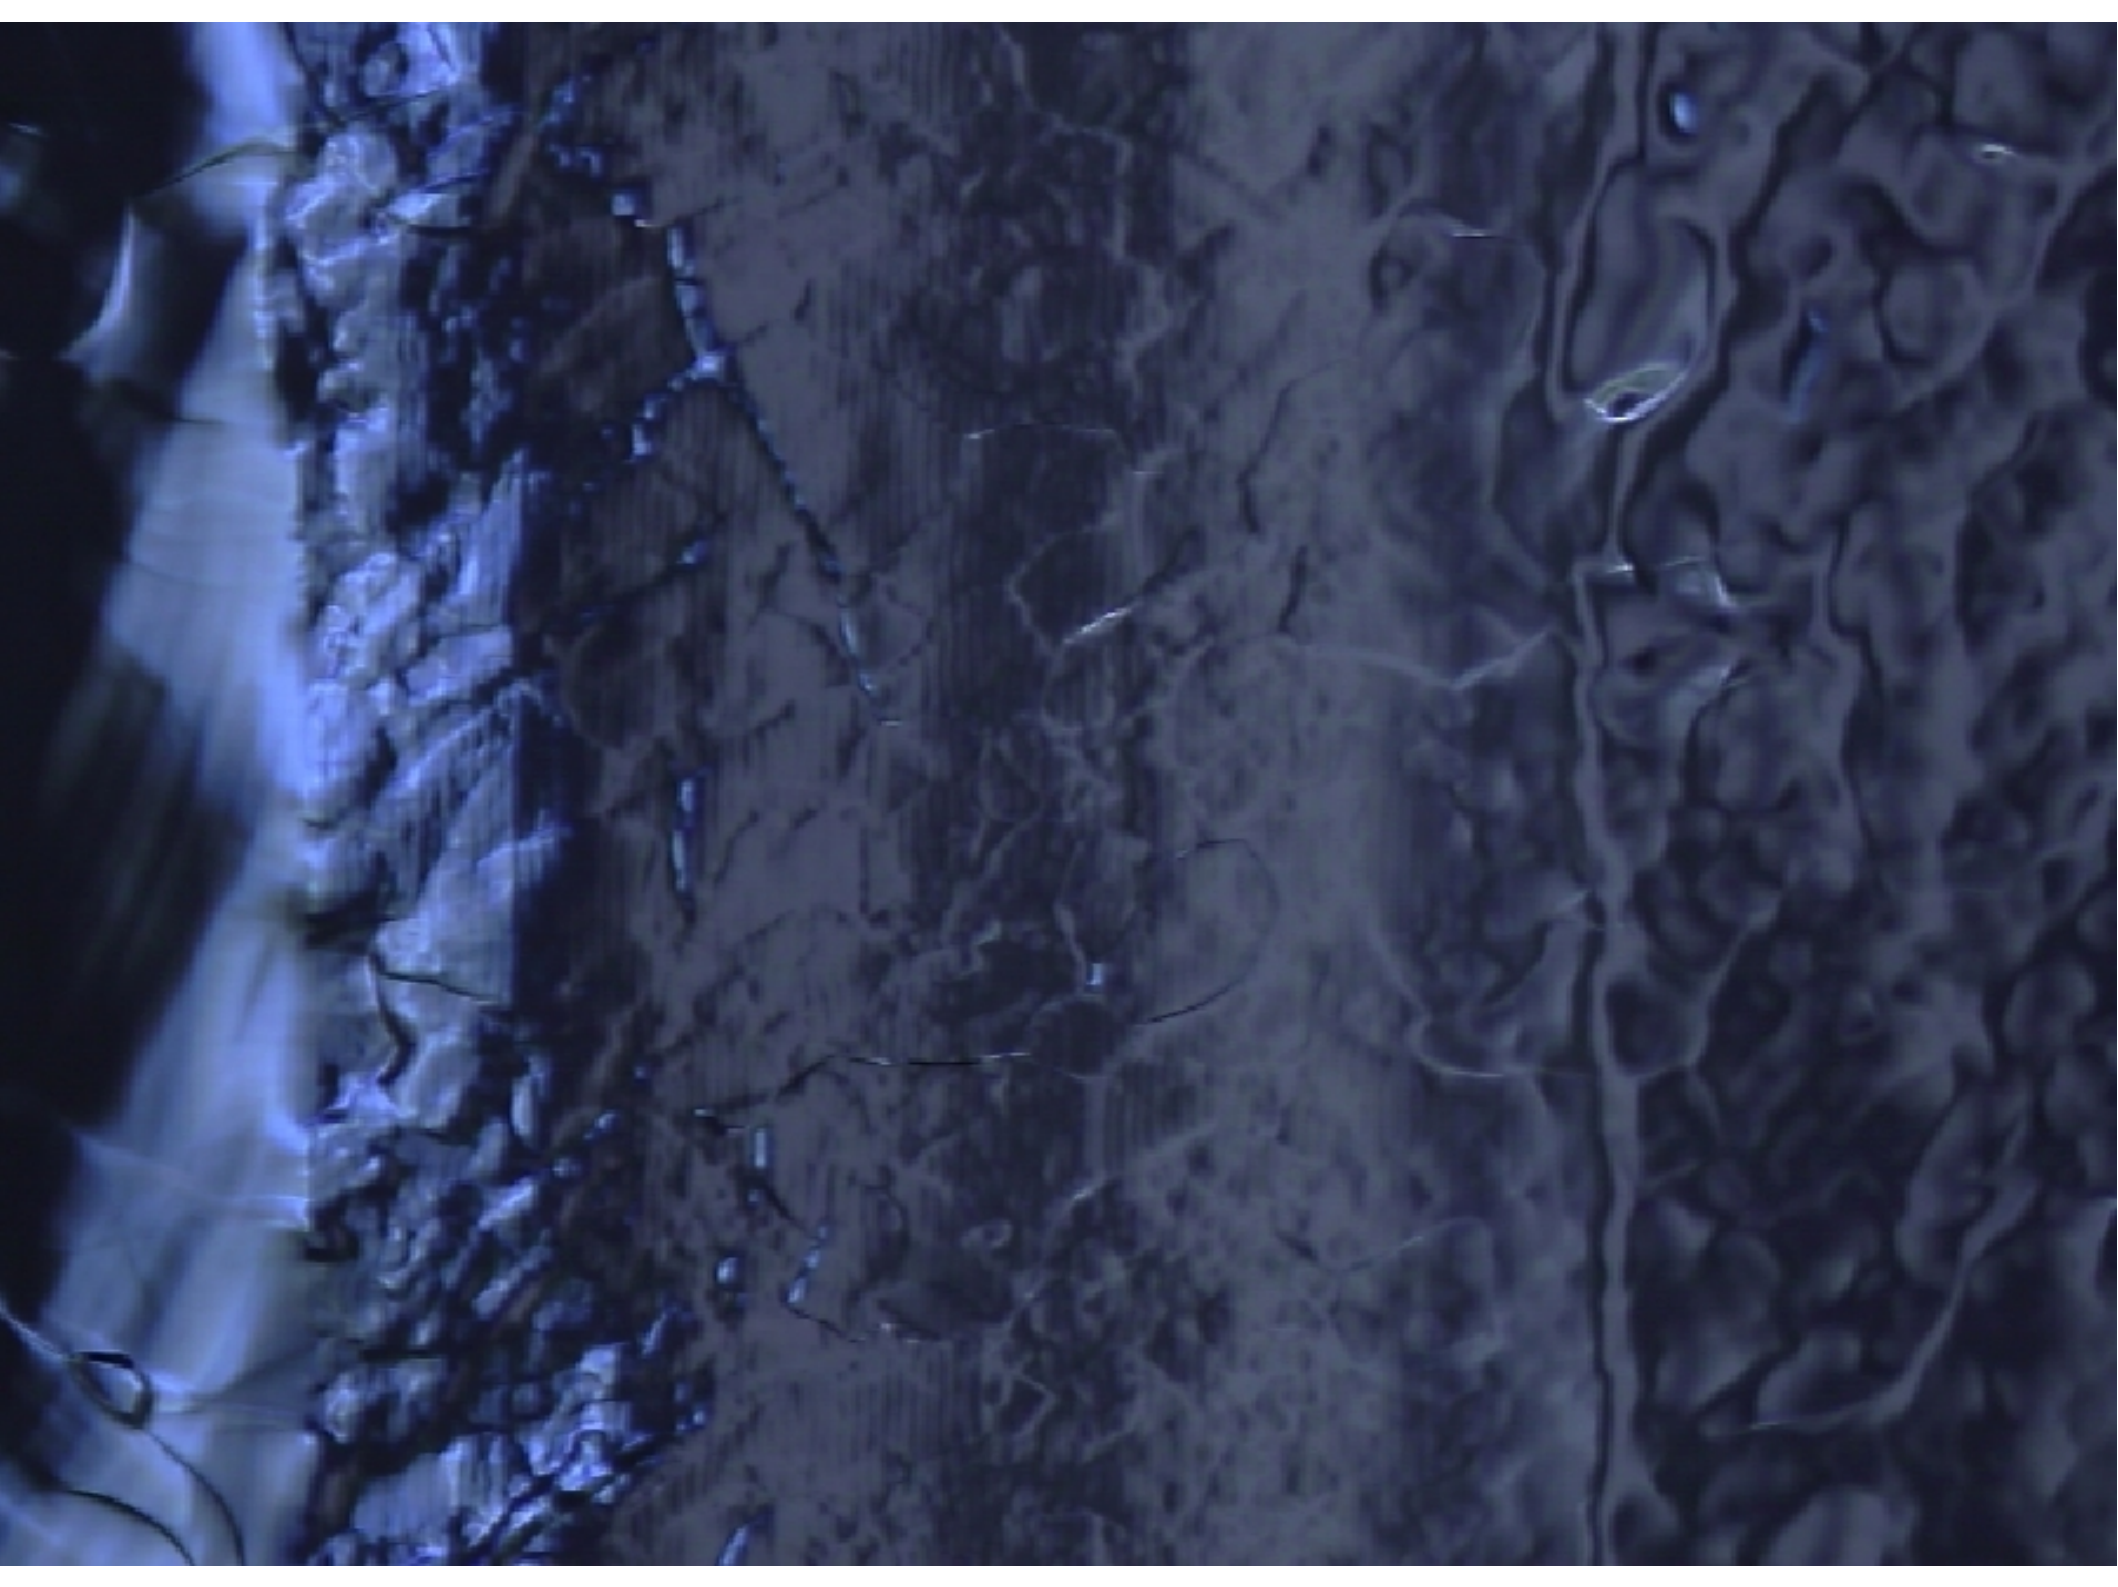
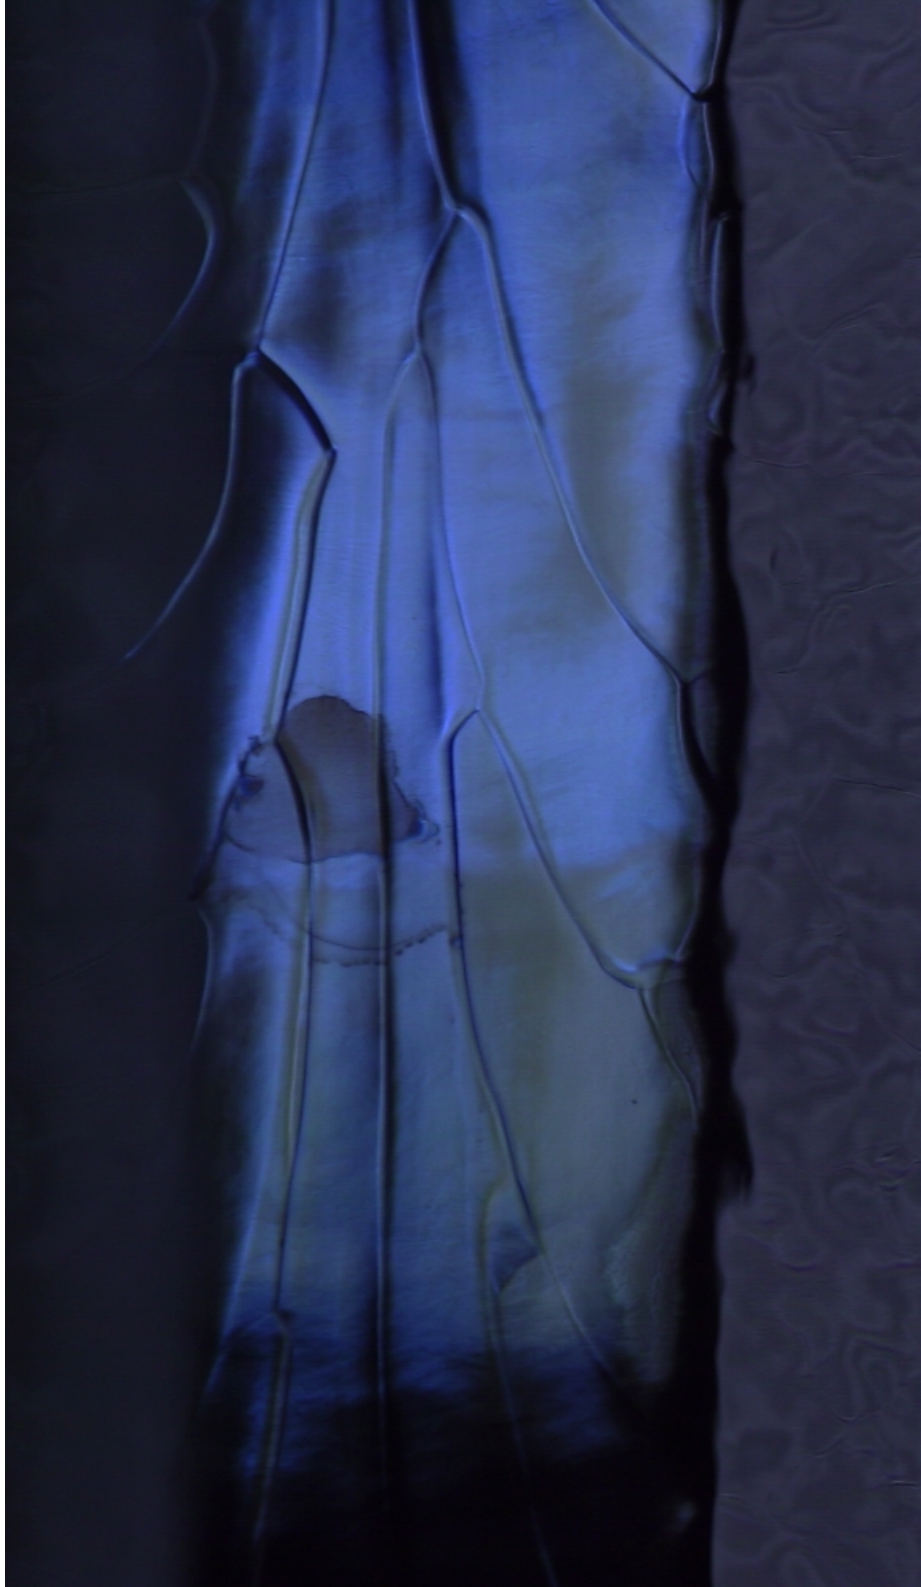
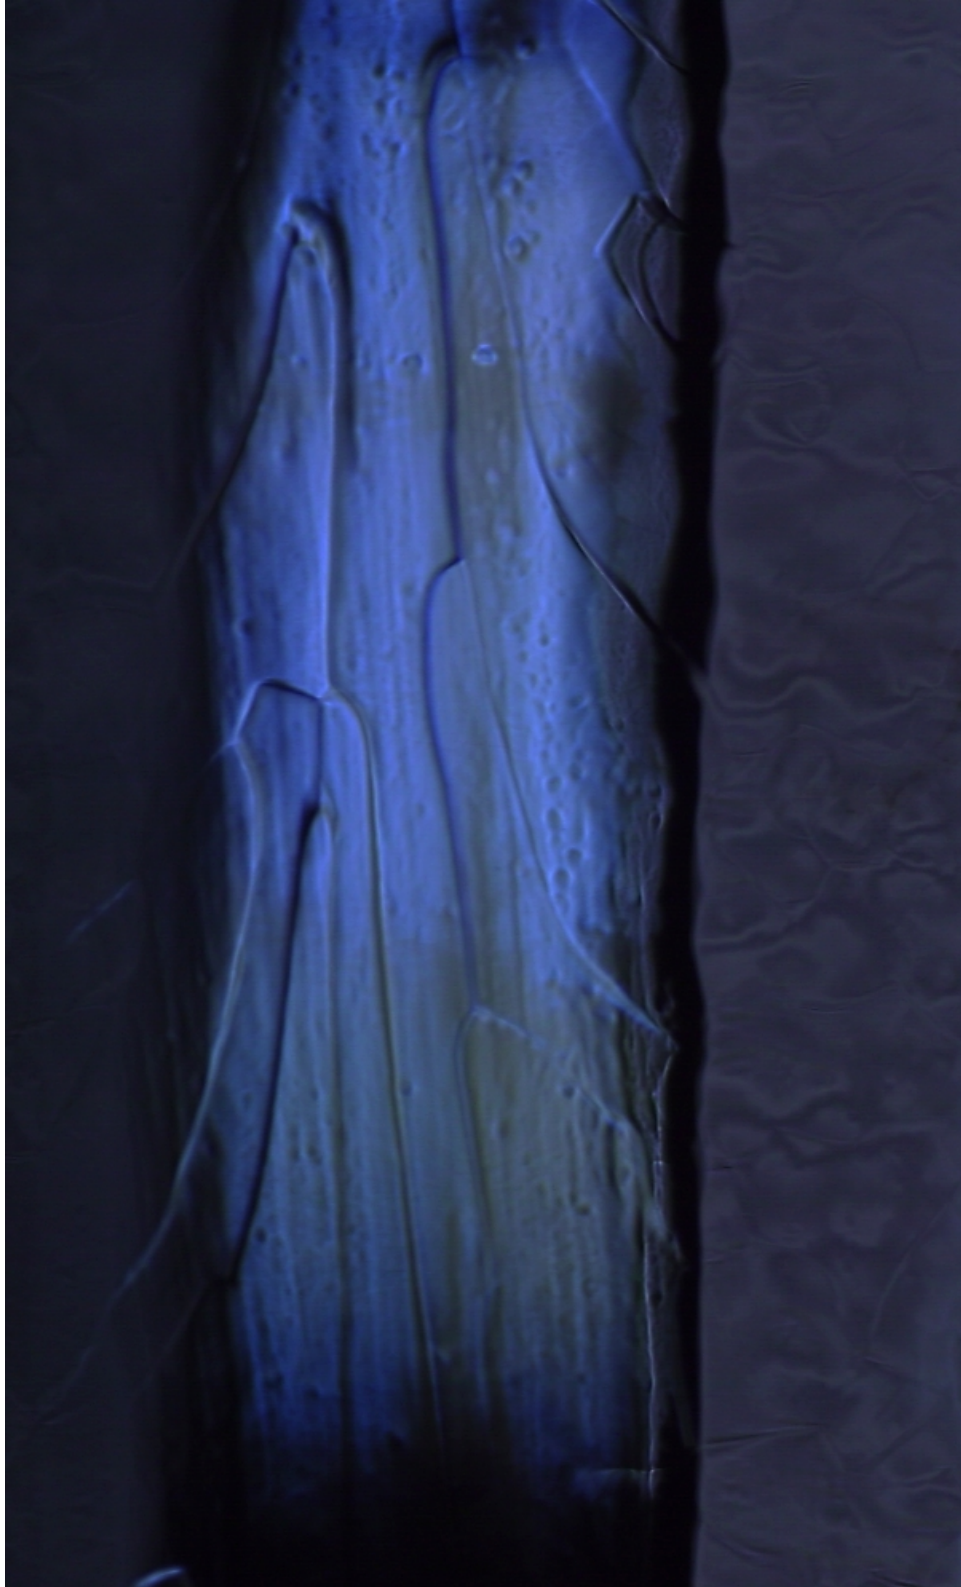
- Surface does not look as good as expected after EP
- Multiple dark spots
- Tooling marks still visible on weld prep area
- Machined iris areas show excessive pitting

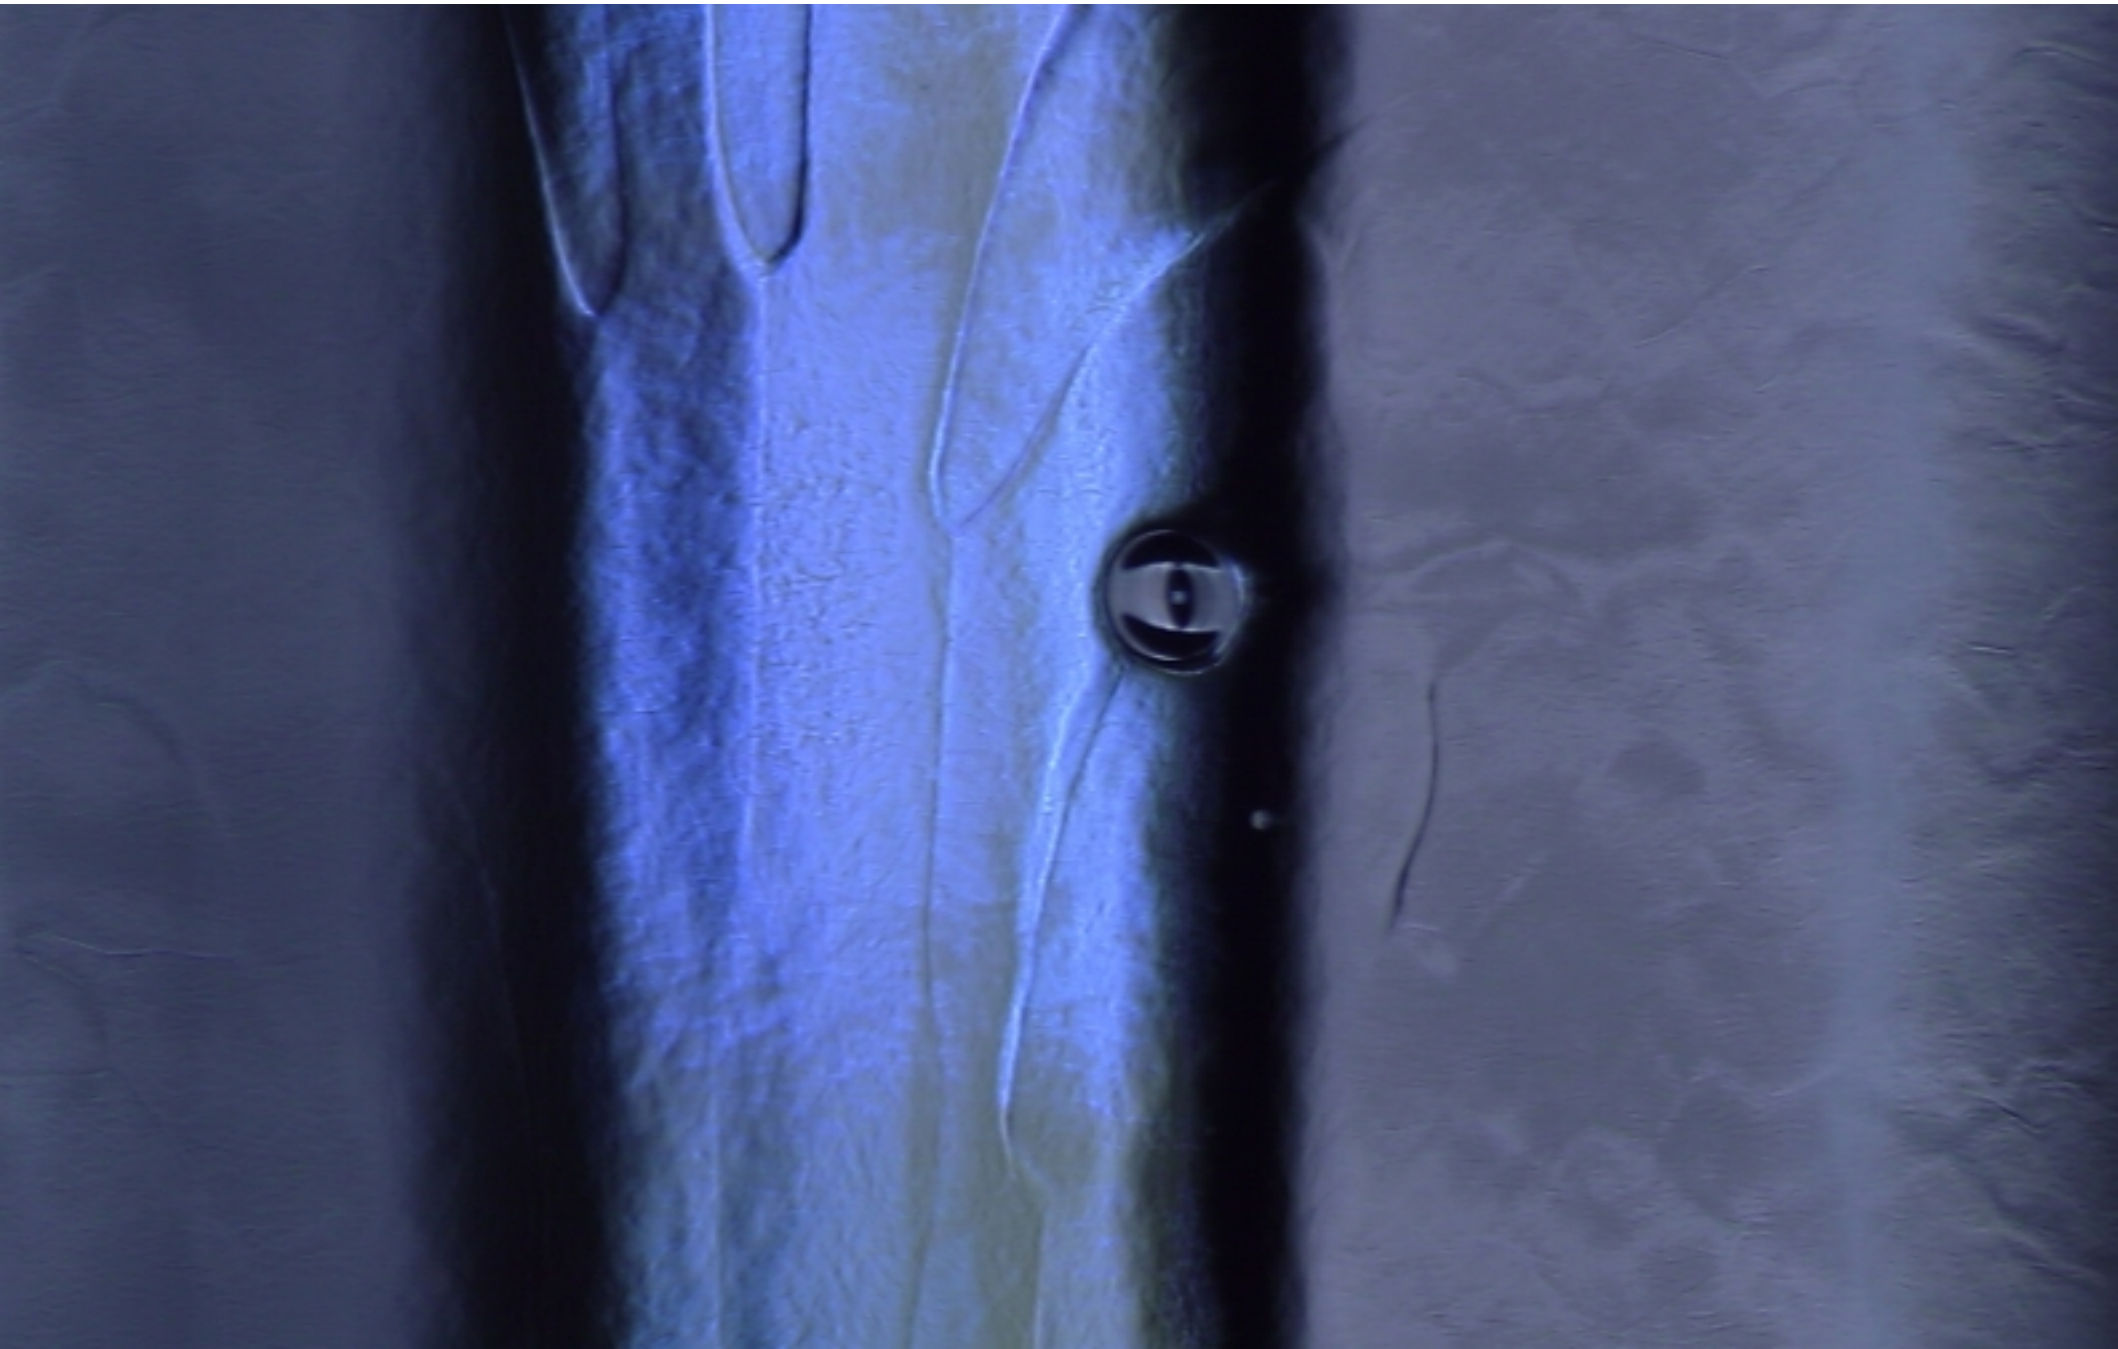
After 2nd EP. Iris89 114 deg.

- Surface looks better (as expected)
- Multiple dark/dirt spots are gone
- Tooling marks mostly gone
- **A large pit (~350 umeters) detected on 8-to-9 iris.**
