Summary report of the fundamental power couplers meeting at SLAC

Tug Arkan, Andrei Lunin, Ken Premo

May 10, 2010

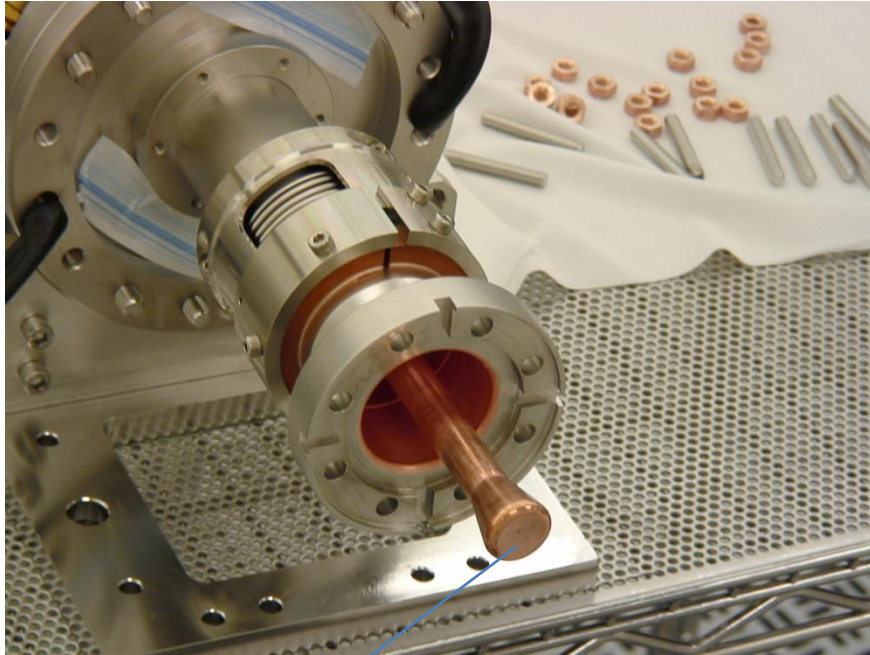
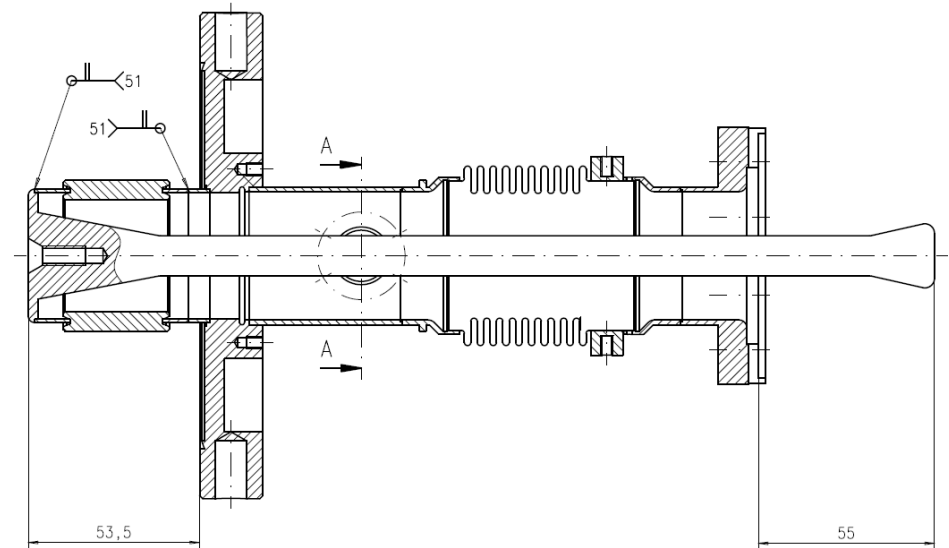
Cold End Antenna Eccentricity

Cold end Antenna is not concentric to the NW40 flange during cold end assembly to the cavity in the CAF cleanroom

- Brazing of the antenna to the CF100 cold end flange is not done properly and/or
- Cold end bellows are twisted; NW40 flange and CF100 flange is not parallel

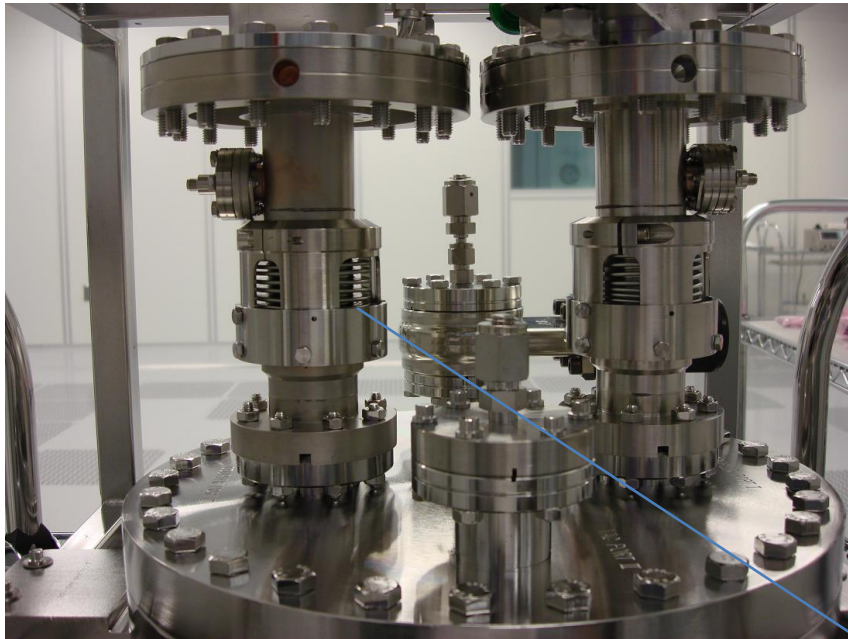
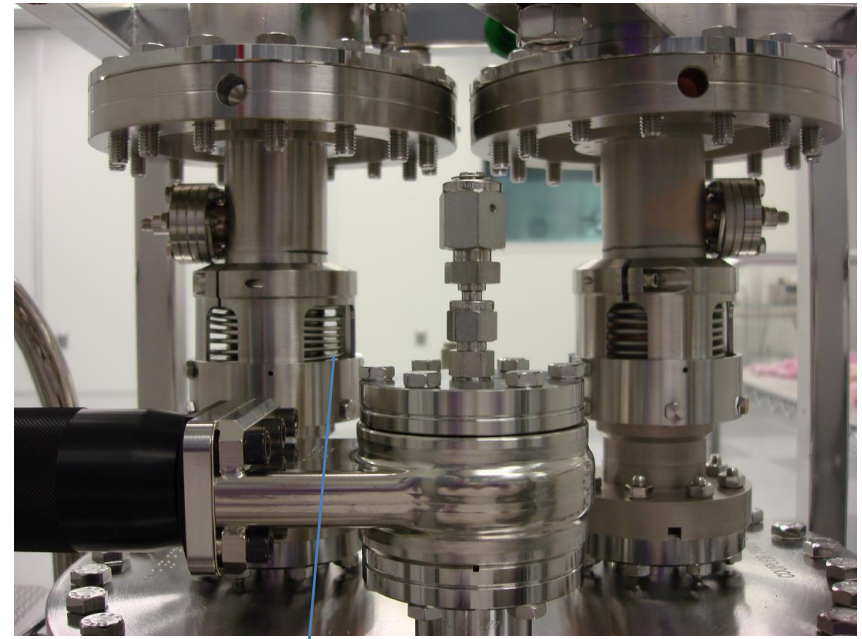
Cold End Bellows

Twisted bellows, convolutions not parallel

- SLAC will conduct a more detailed incoming QA including the mechanical measurements of some critical features.
- Cold end twisted bellows issue was understood and mostly eliminated by SLAC technicians. (A more permanent tooling rather than a counterforce wrench needs to be developed for repeatable results)
- A visit to CPI is planned by the end of May 2010

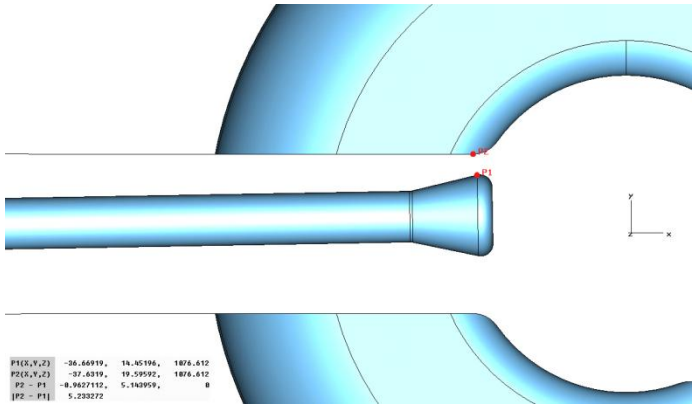
1 degree antenna tilt

1. Both antenna tilt and shift demonstrates the same behavior .
2. The most sensitive manufacturing parameter is a horizontal antenna tilt. Both vertical and horizontal antenna tilts regarding to the 70K flange should be within ± 1 deg ($\sim \pm 5$ mm antenna tip shift)*.
3. The mutual cavity and coupler cold part flanges displacements allow up to ± 5 mm* non-concentricity (could be limited by other factors like a higher electric field).

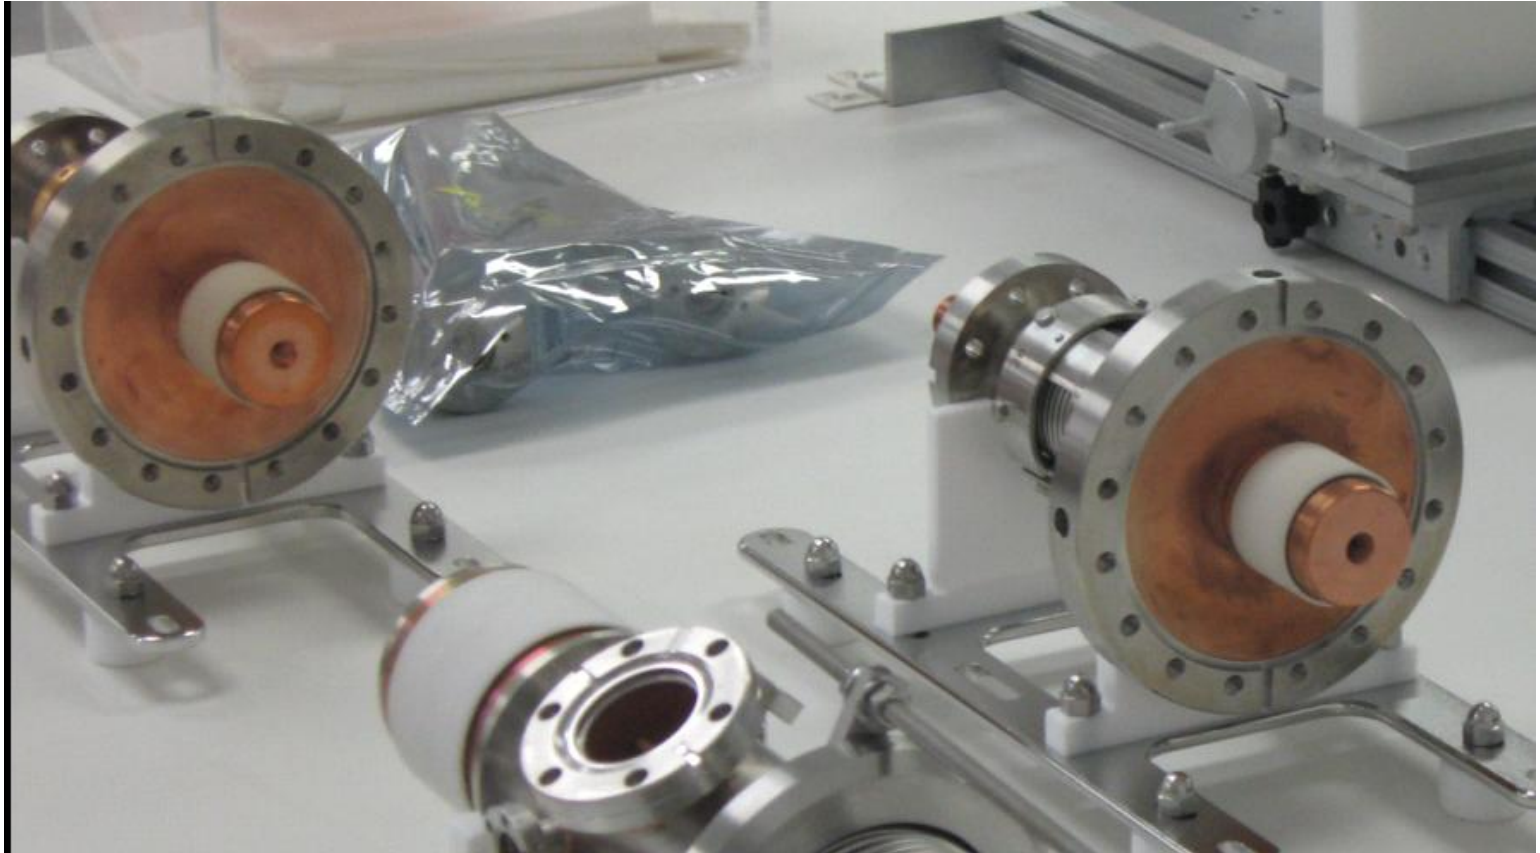
Window ceramic discoloration
