# NR001 & NR002

- **Summary of QC findings**
- Visual inspection
- Optical inspection
- RF measurements
- CMM measurements

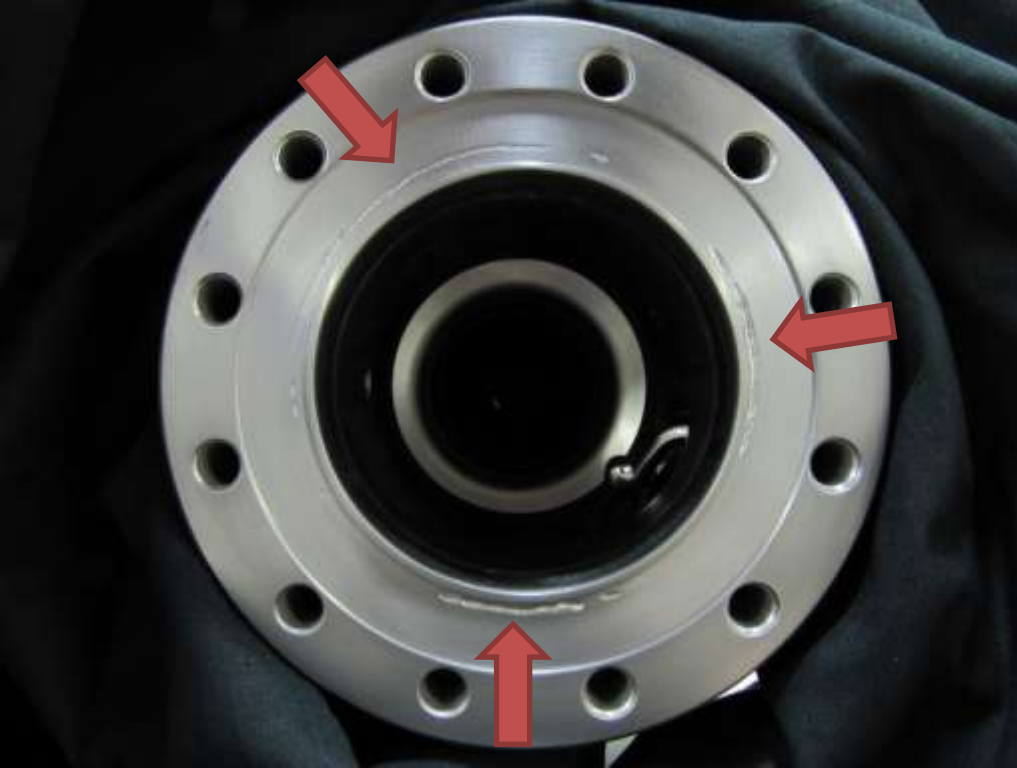
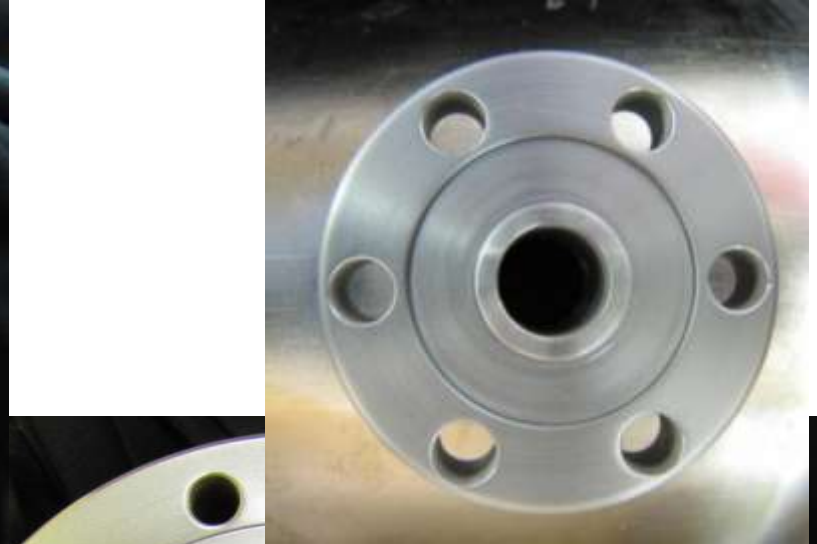
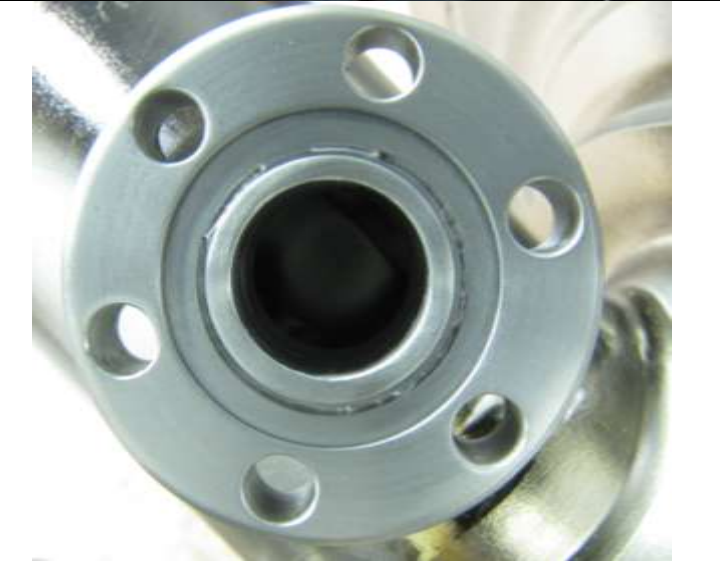
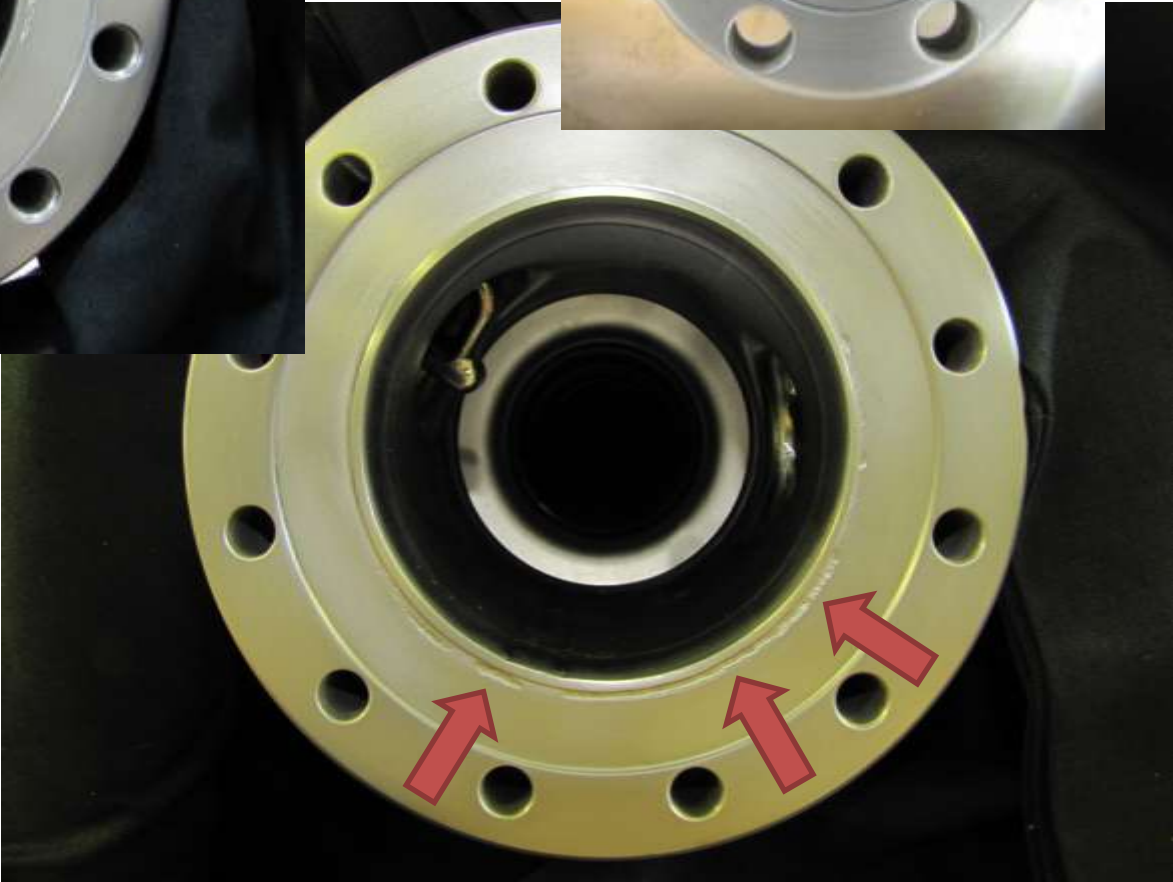
NR001 & NR002: all flanges have weld gaps and show a lot of polishing - **BAD**

- Welding of all flanges shall be performed in order to avoid gaps. Perform tests to qualify each weld.
- Iris welds shall be inspected thoroughly and dumbbells qualified prior to performing equator welds.

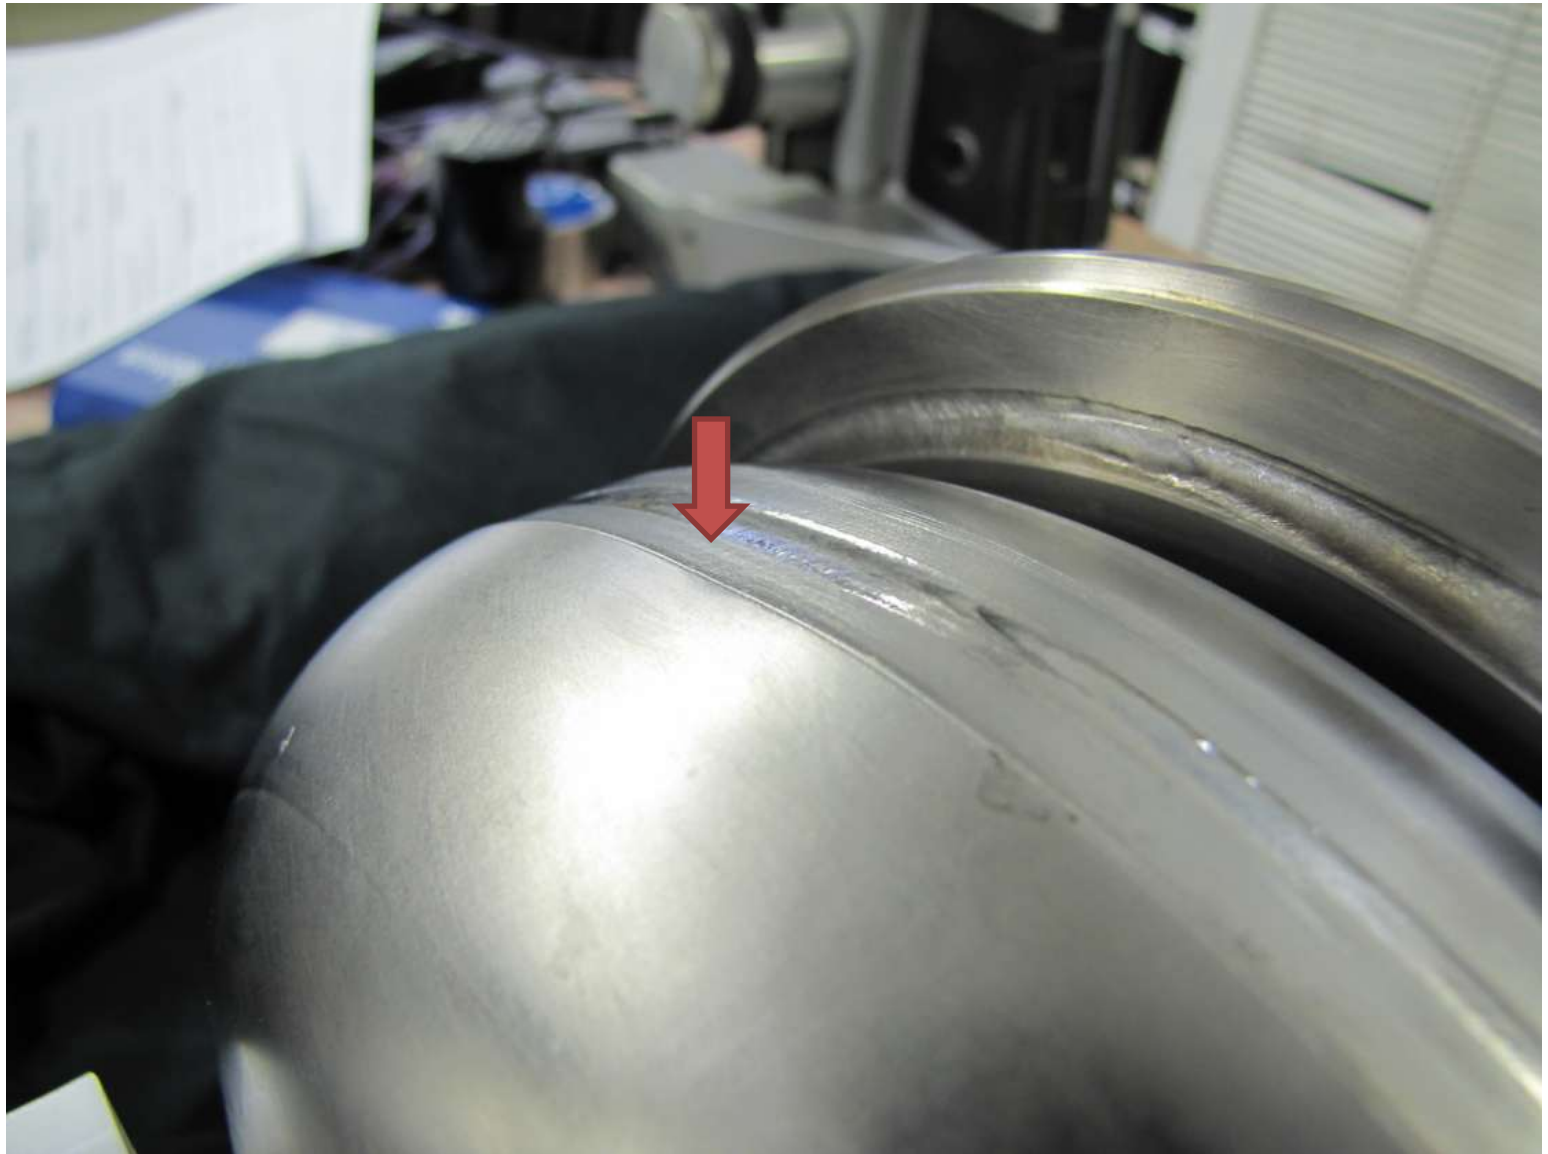
NR001: dent on end cell - **BAD**

- All handling and fixturing operations should be analyzed and improved to avoid any damage to the parts.
- The forming of the half-cells should be analyzed to identify the nature of the atypical horizontal streaks seen near the equator welds

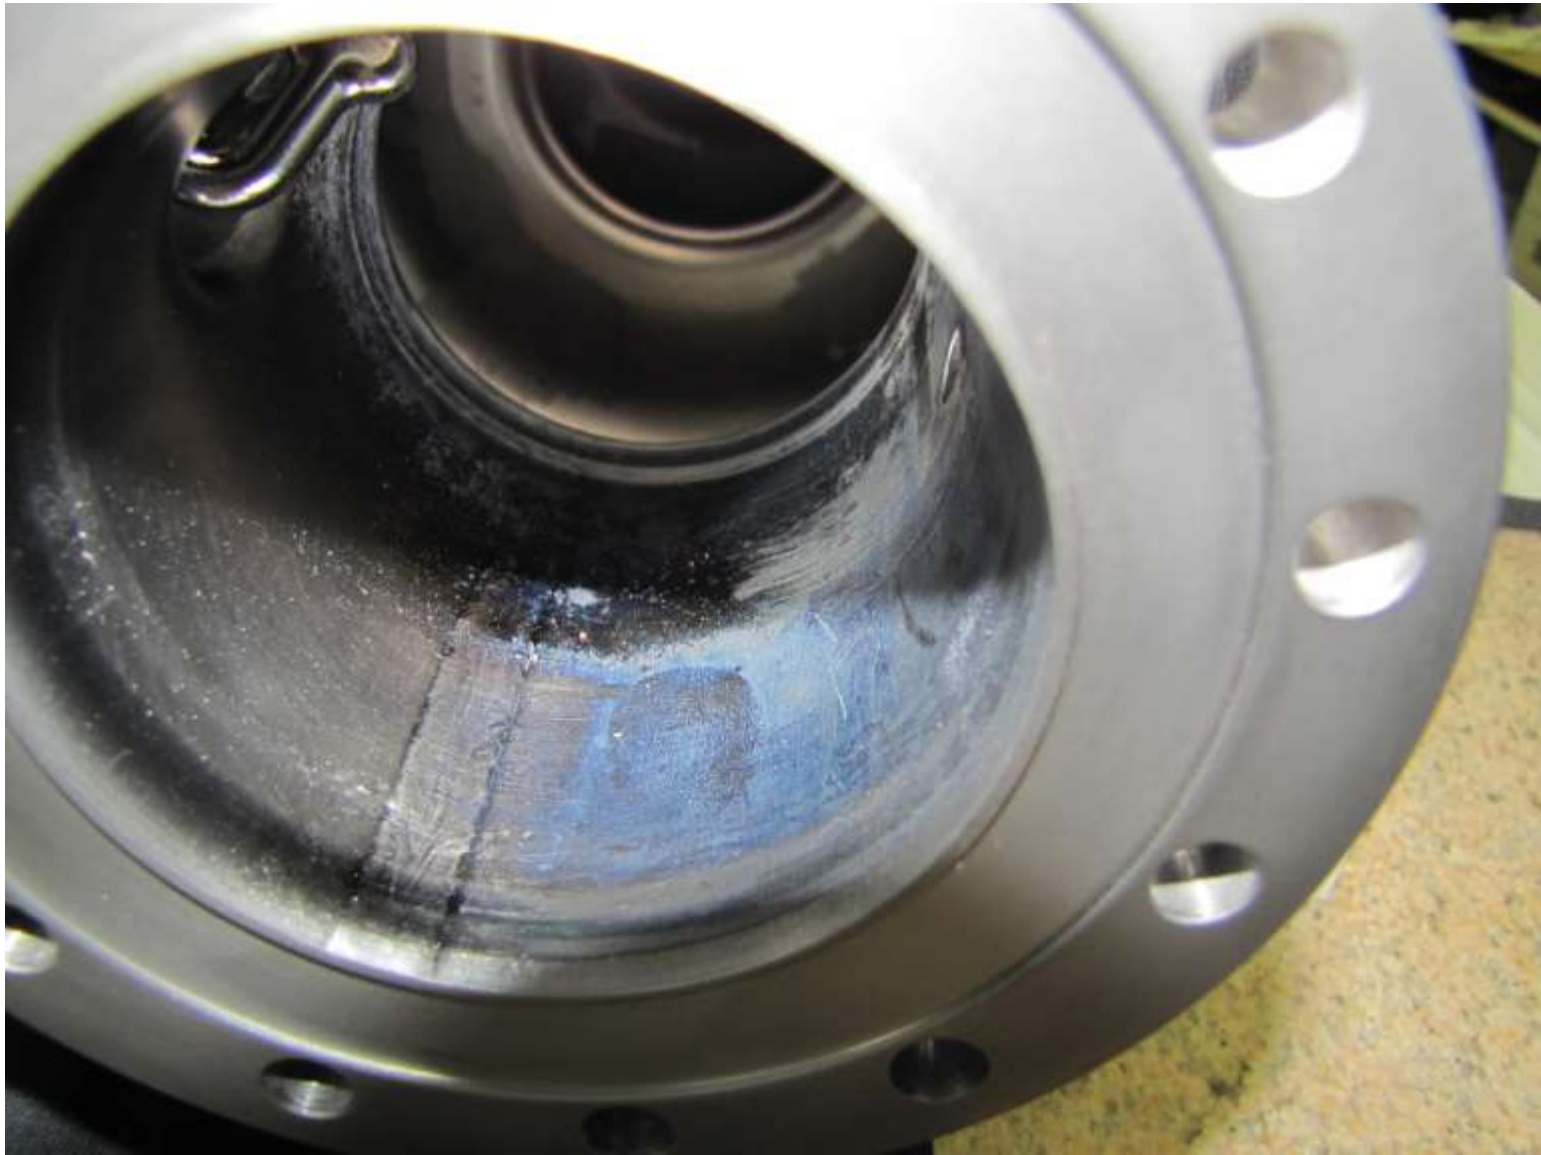
NR002: Discoloration, dirt (?) and fingerprint(?) inside beam tube at probe end - **BAD**.

- The cleanliness of all parts and sub-assemblies shall be improved by large in all stages of fabrication.
- The vacuum level in the EBW chamber should be monitored (possibly improved?).

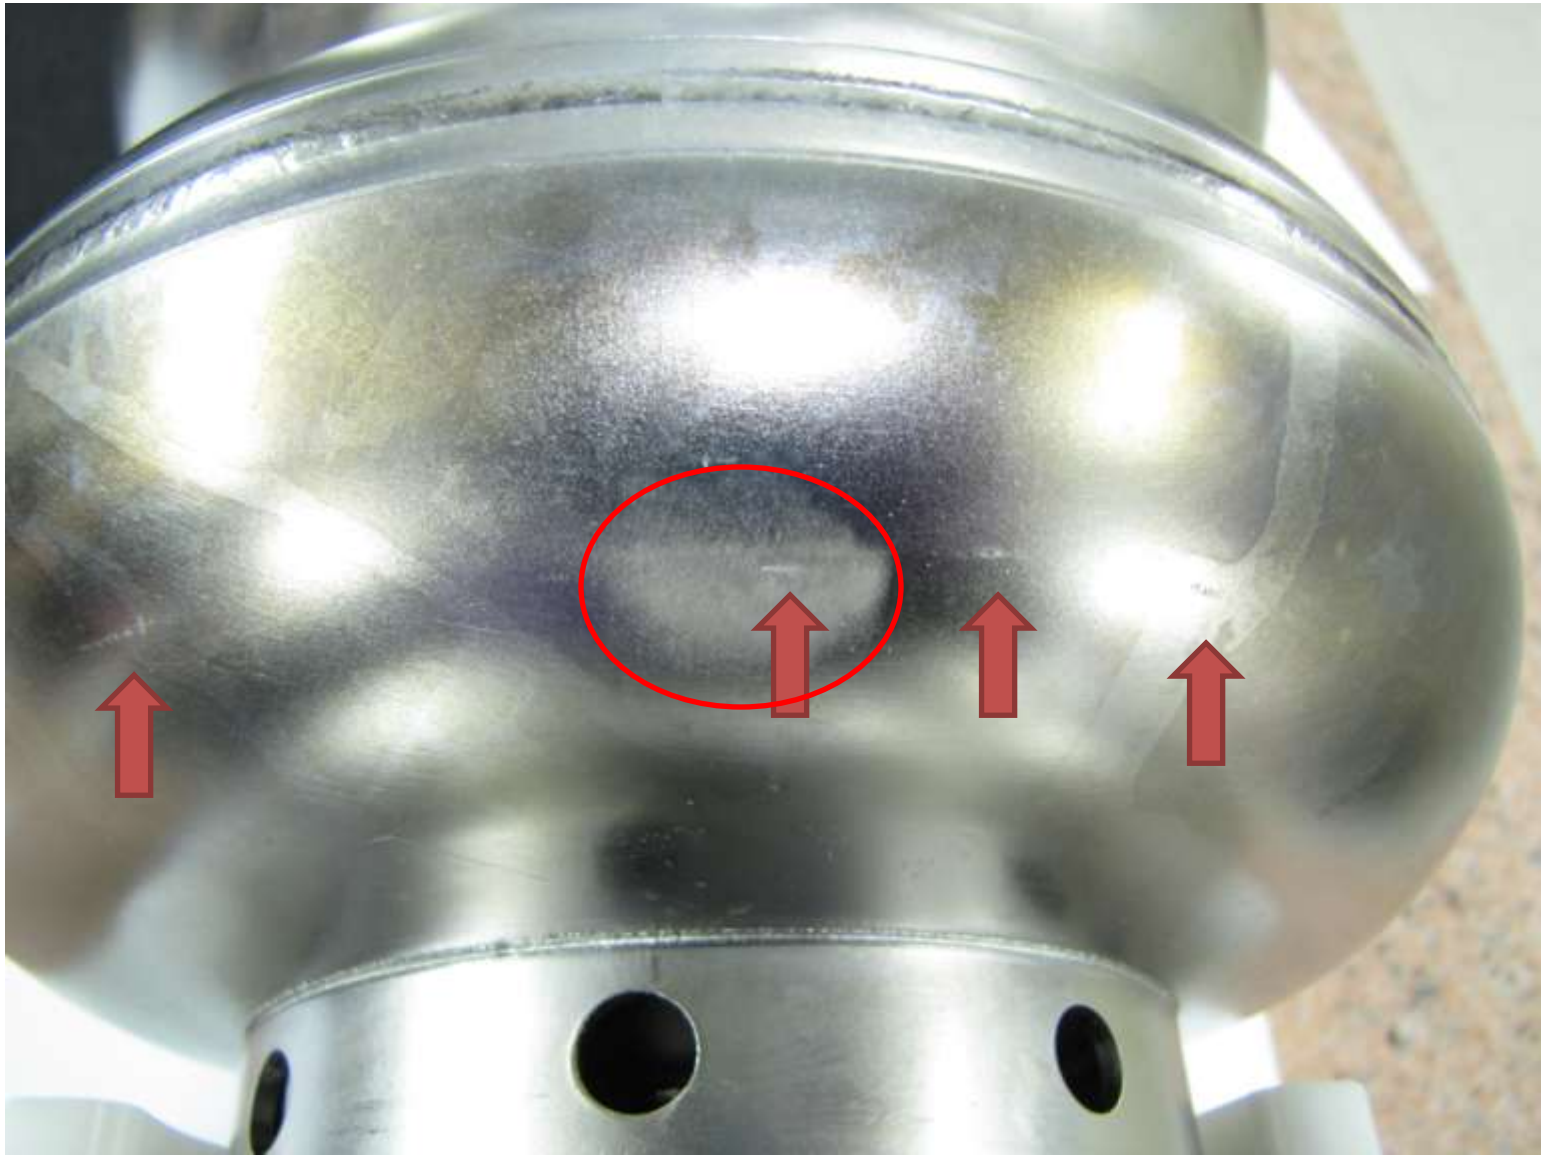
NR001: scratches and buffed area on half cell. Fixturing? – not necessarily bad per se but a sign that fixtures/handling is not appropriate.

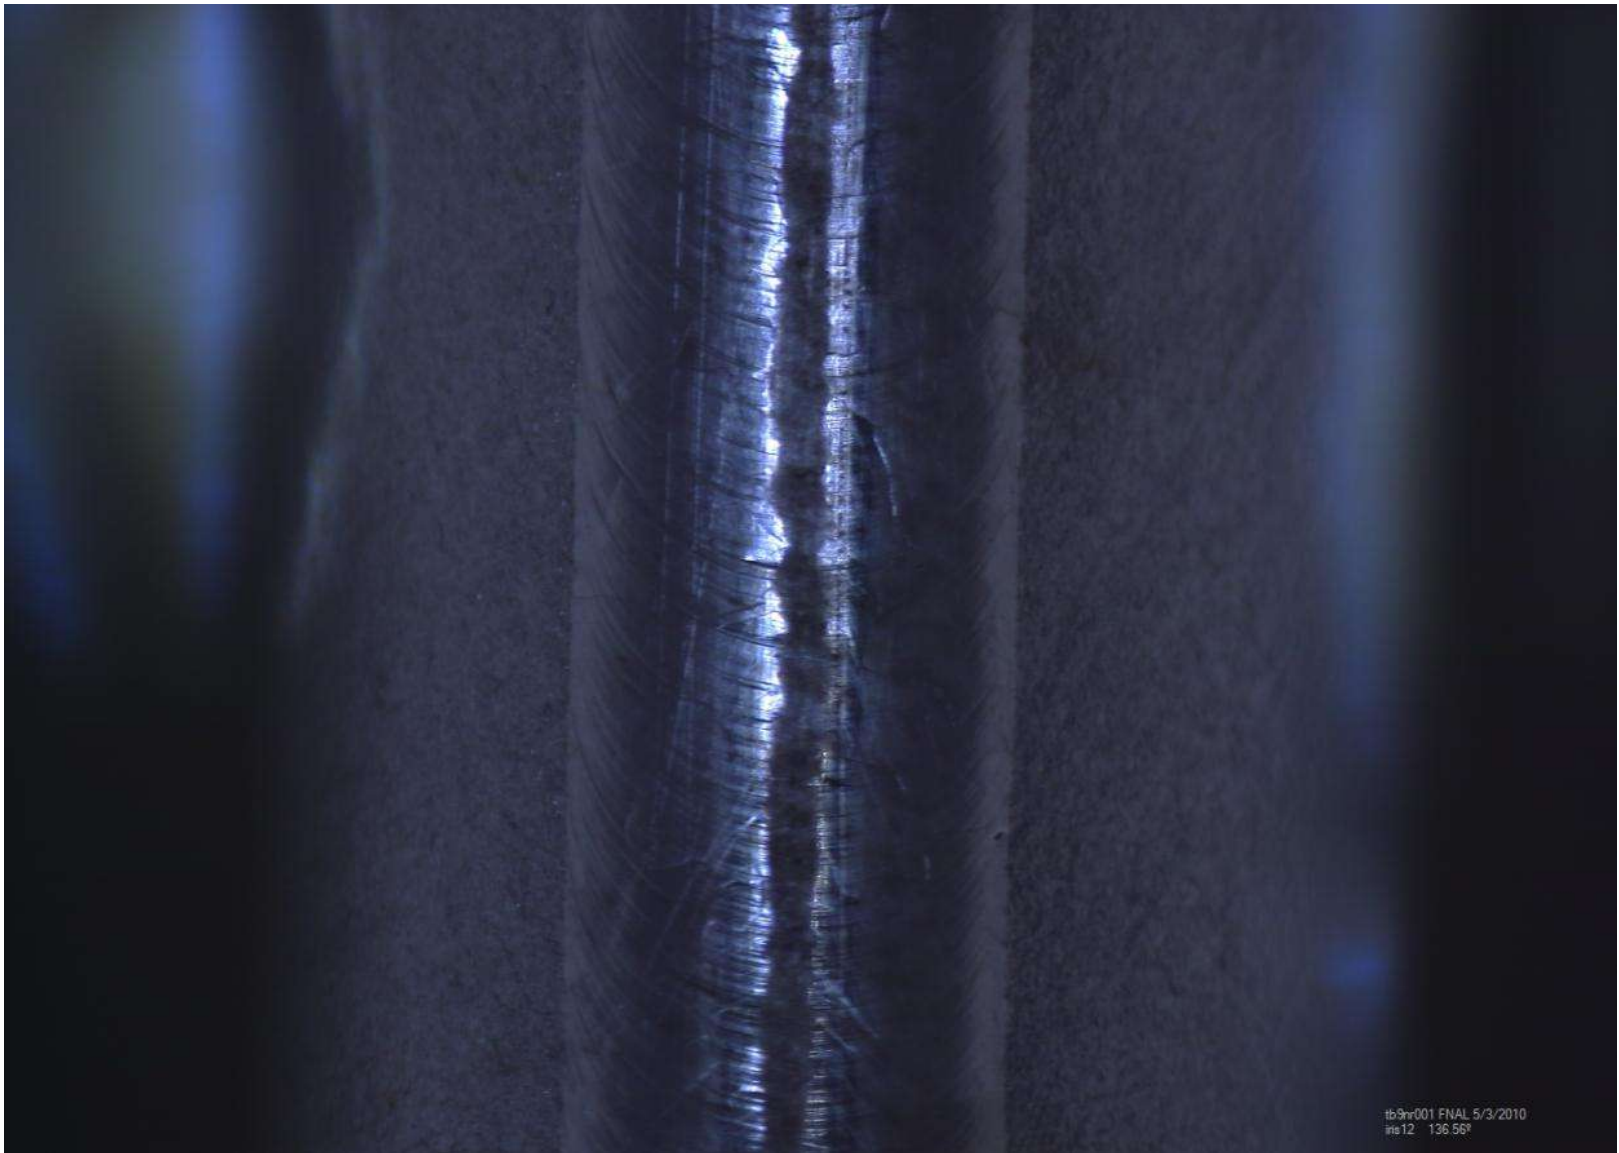
NR001 & NR002: this is a typical iris weld for these two cavities, just for reference.

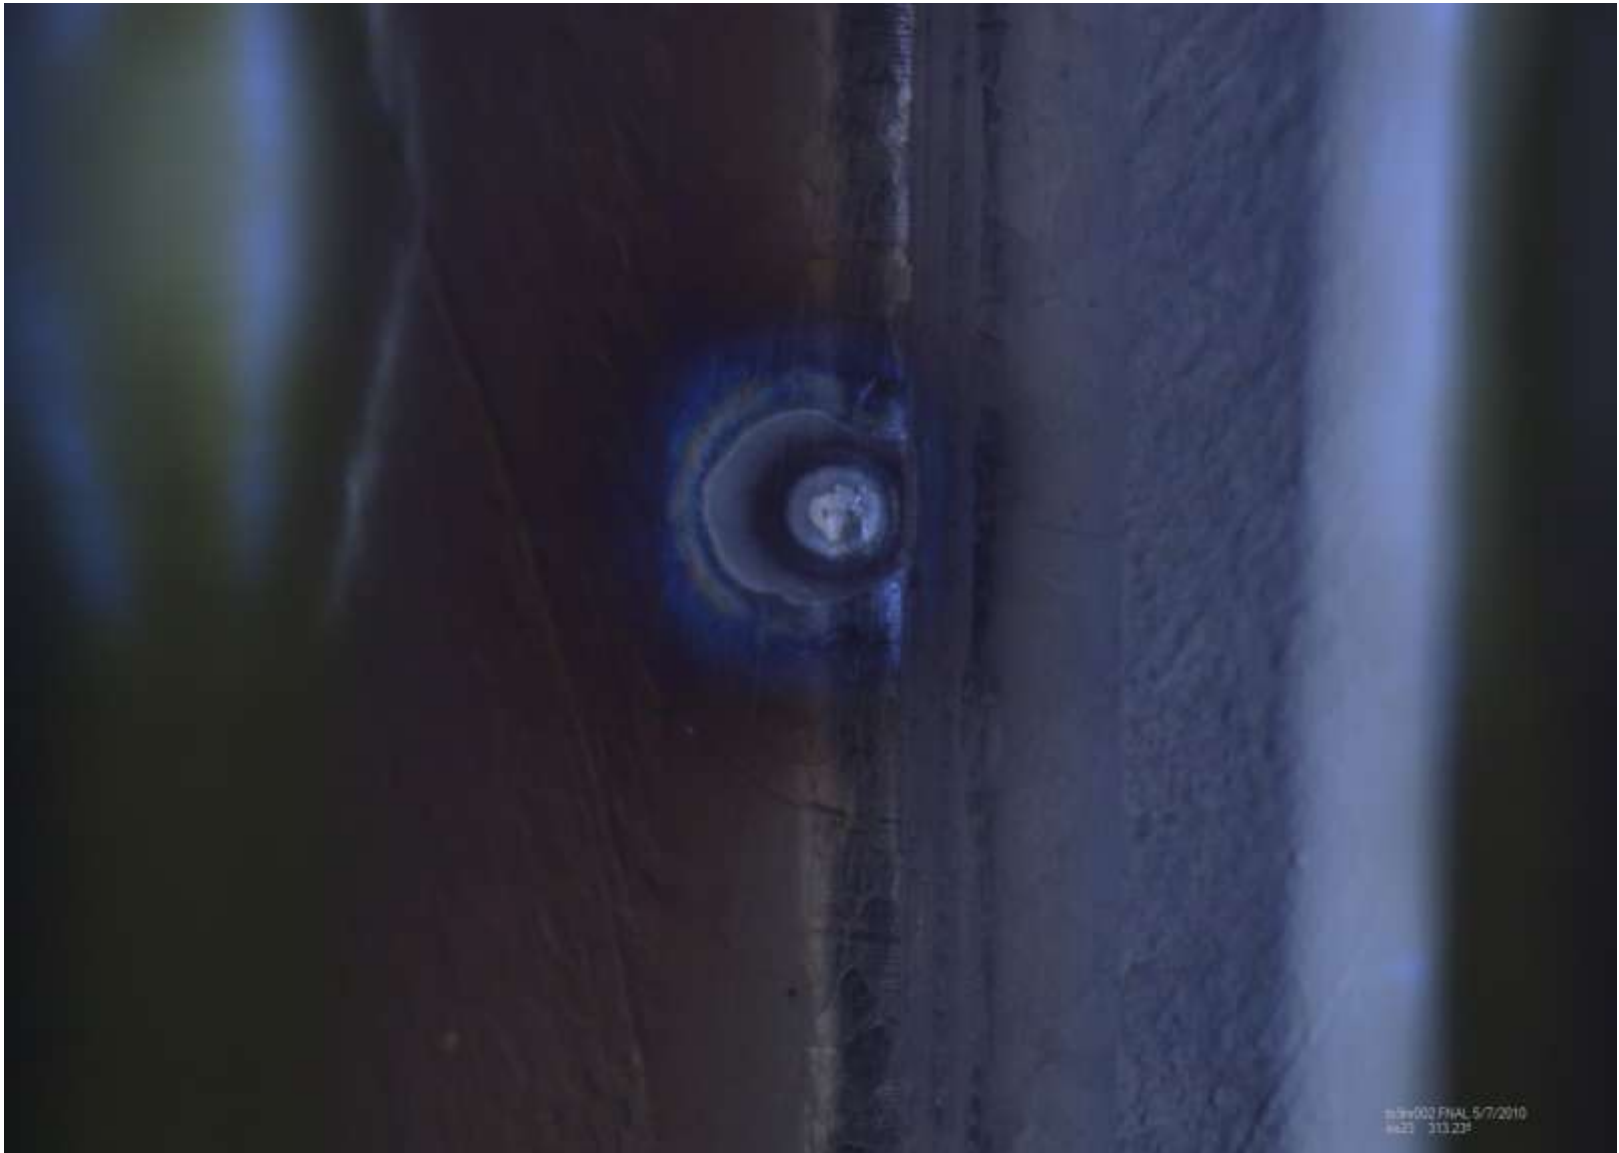
NR002: unique defect on Iris between cells 2 and 3 – **BAD, this should be caught at the dumb-bell stage and the part discarded.**

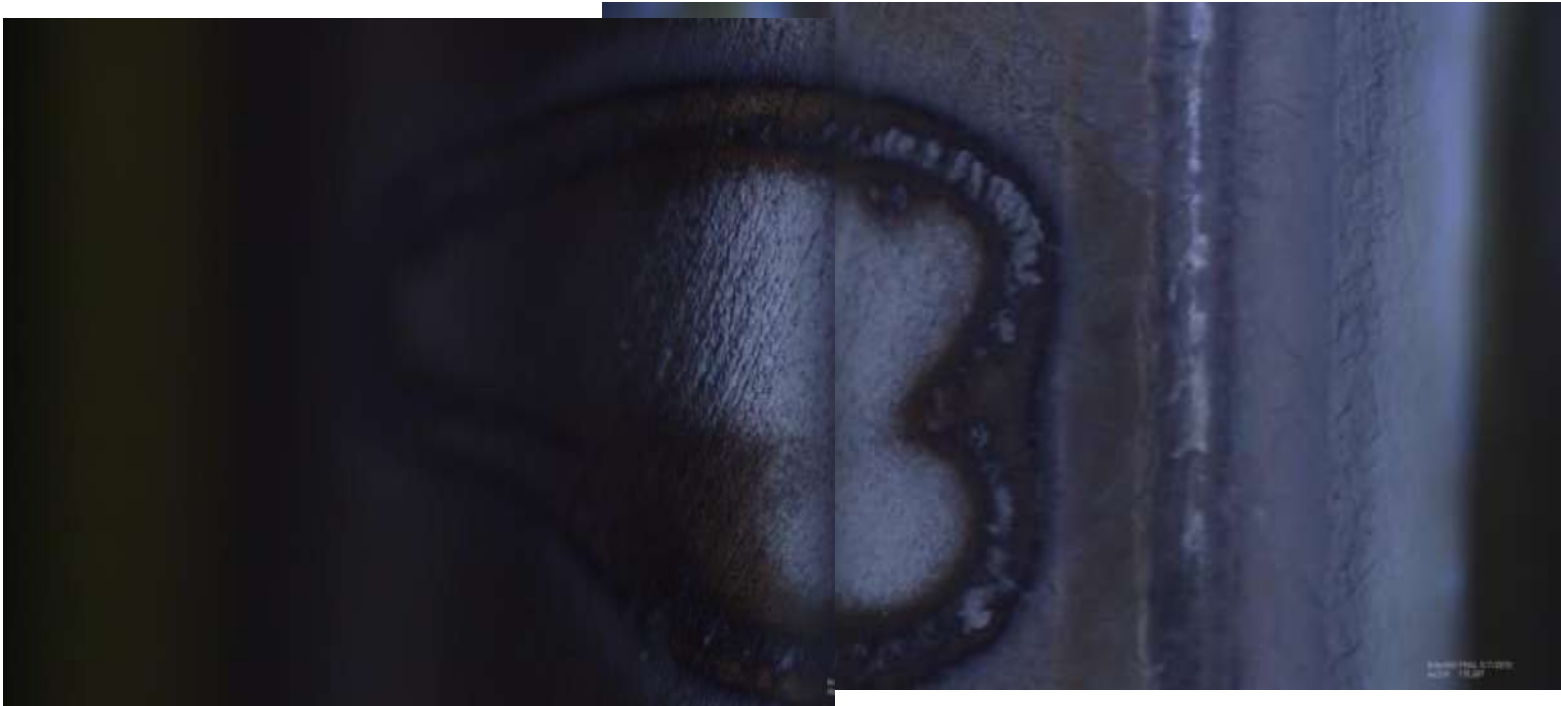
Large spot on iris weld between cells 2 and 3 of NR002.

**BAD – these defects should not be present**

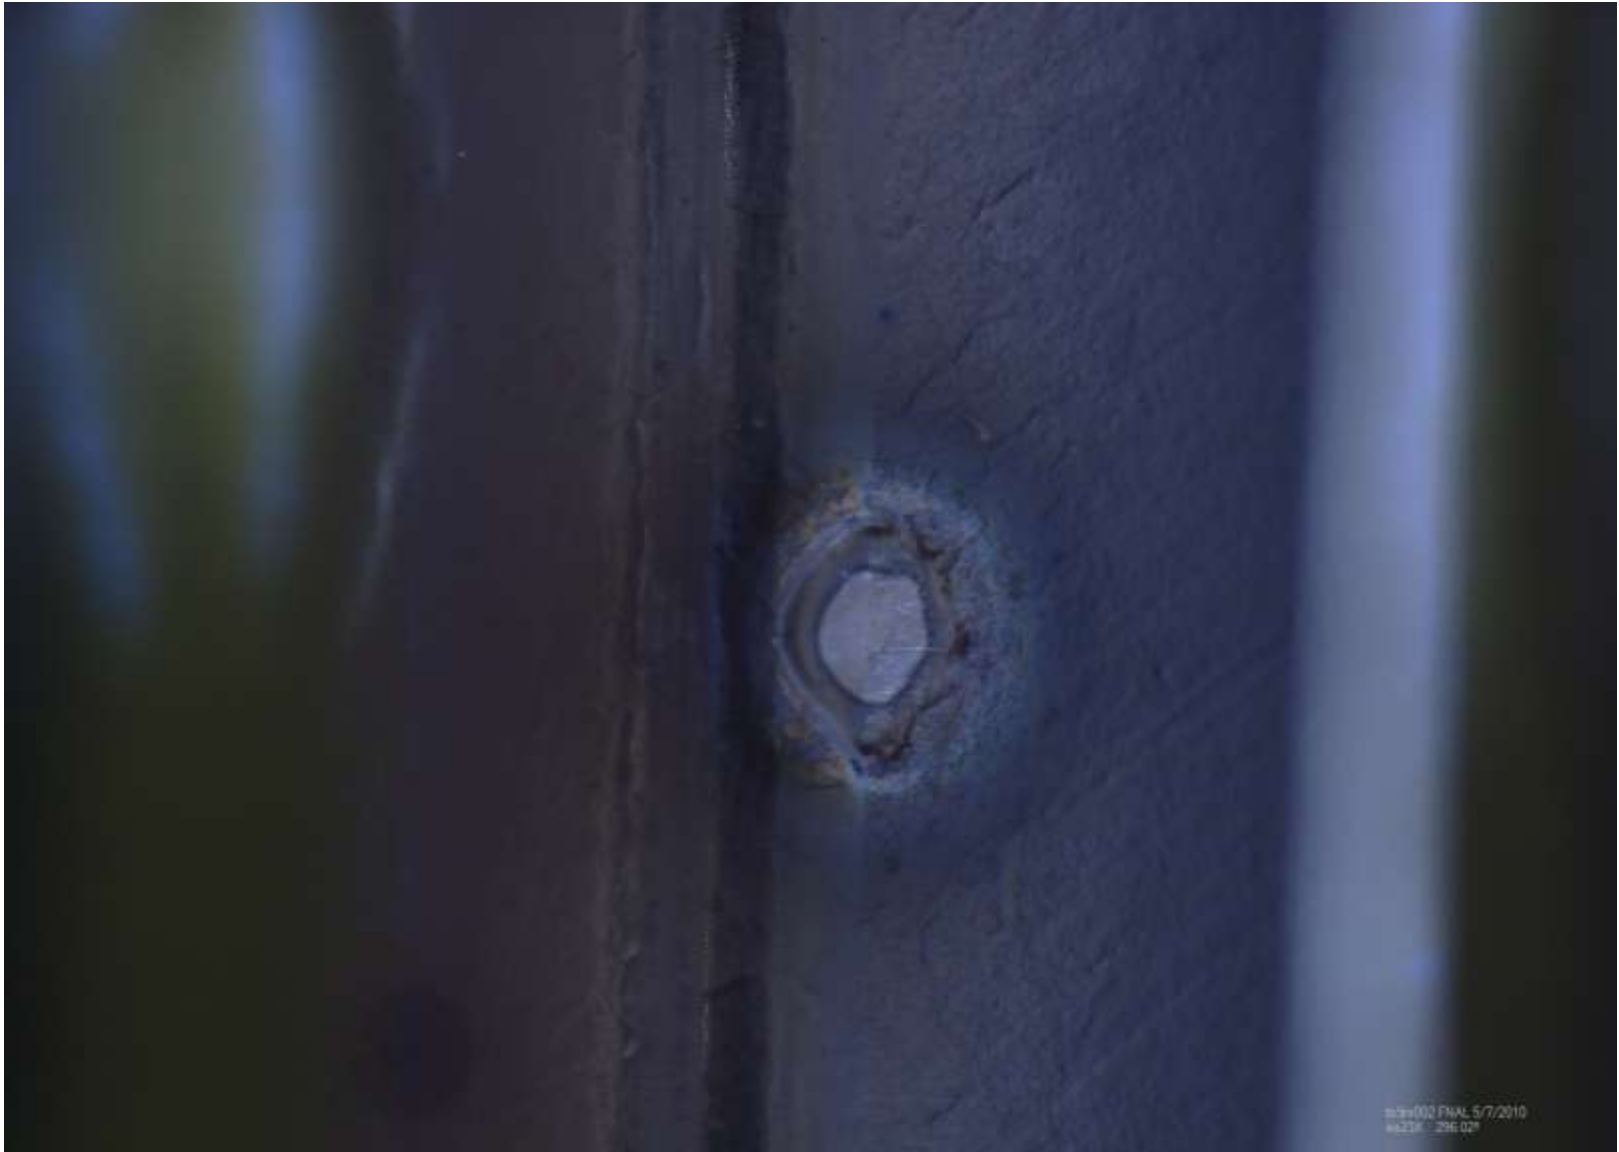
NR002: Few of these spots are present near the welds, looks flat and may be an indicator of contaminations, perhaps bad vacuum during welding. **BAD, these defects should not be present.**

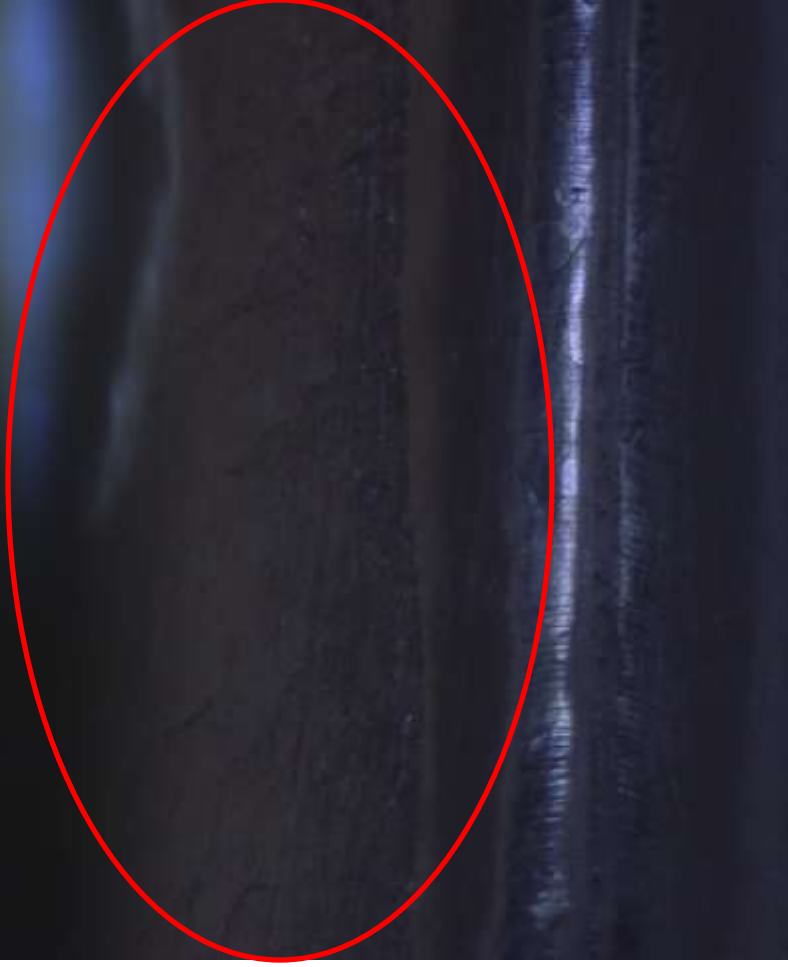
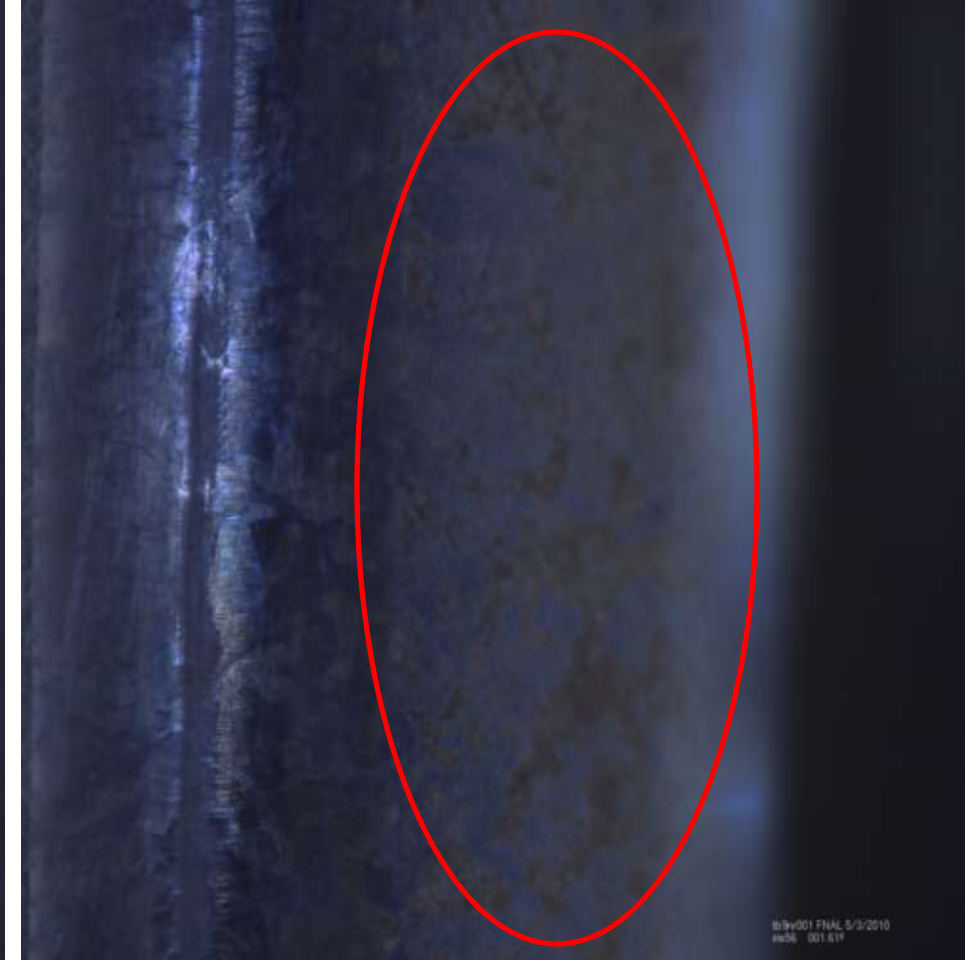
NR001 – iris5/6: reddish/brownish discoloration, perhaps benign but never seen before.

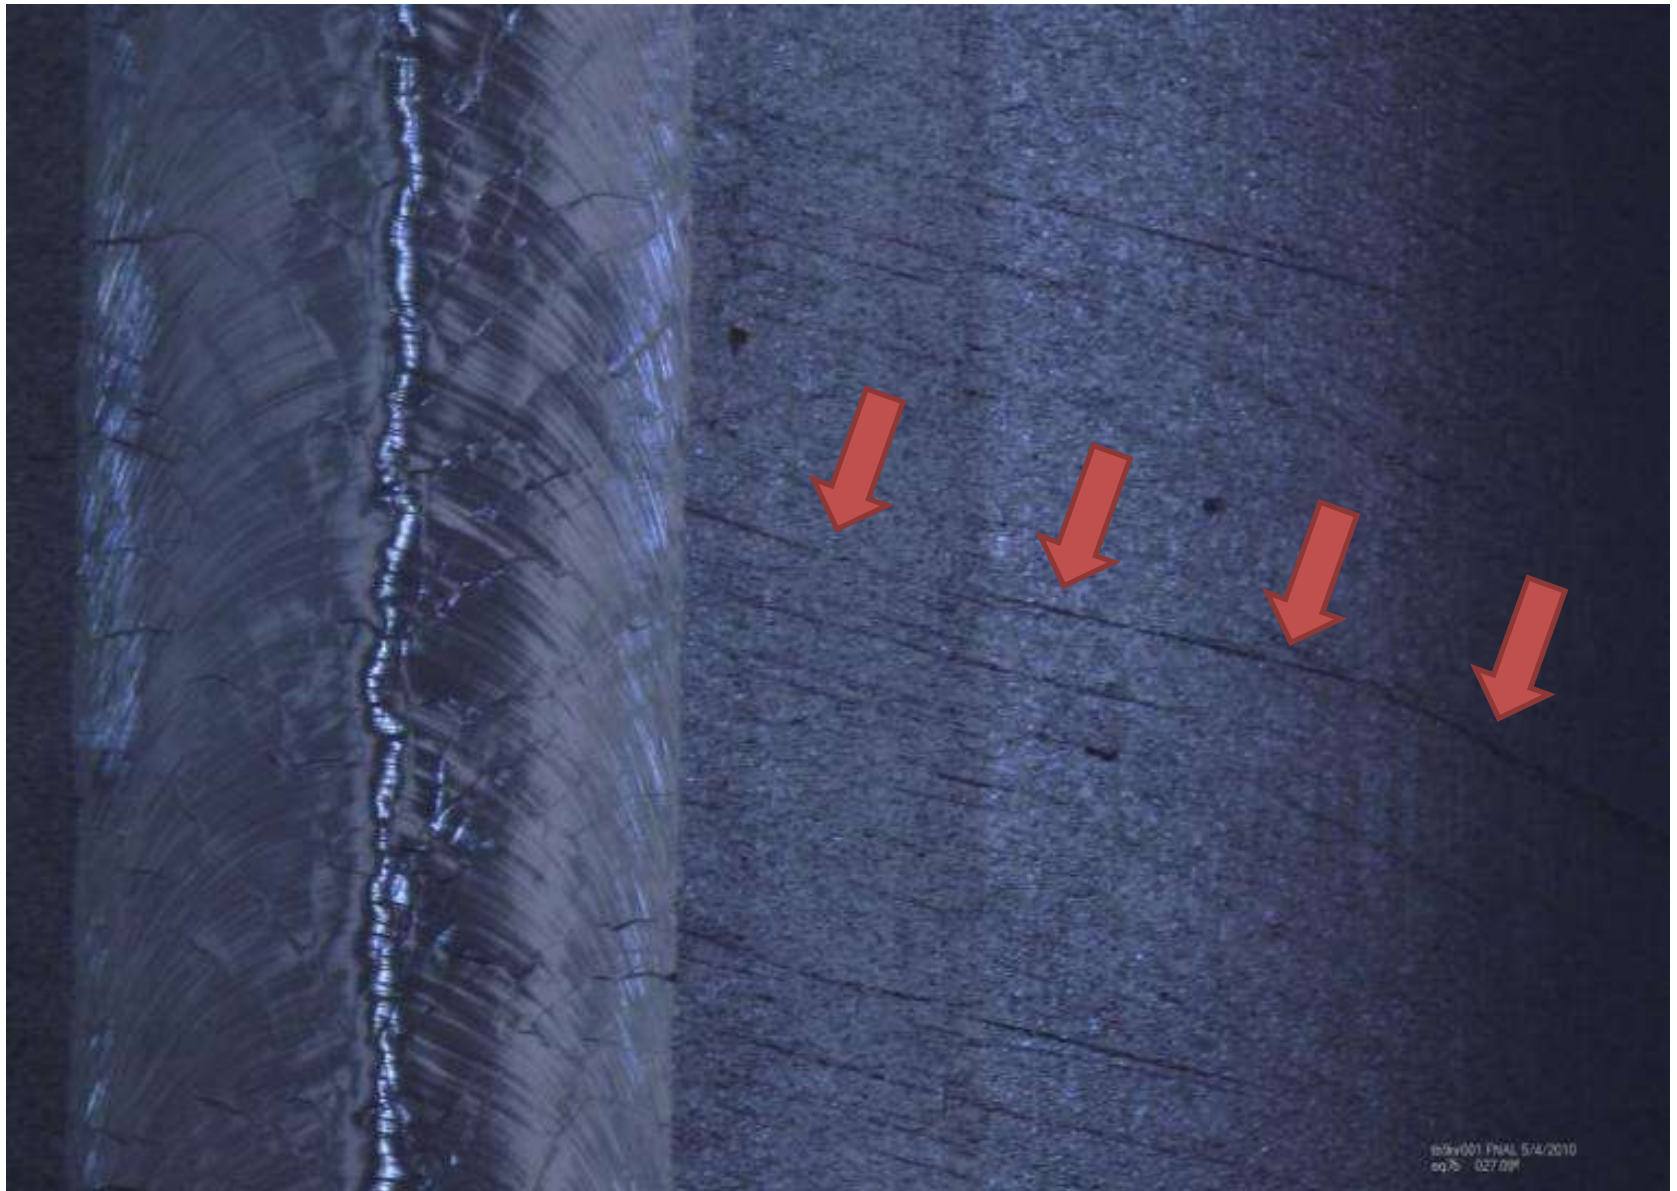
NR001: typical equator weld with non-typical horizontal lines. Not necessarily bad, could be related to the forming process and should be given some thought.

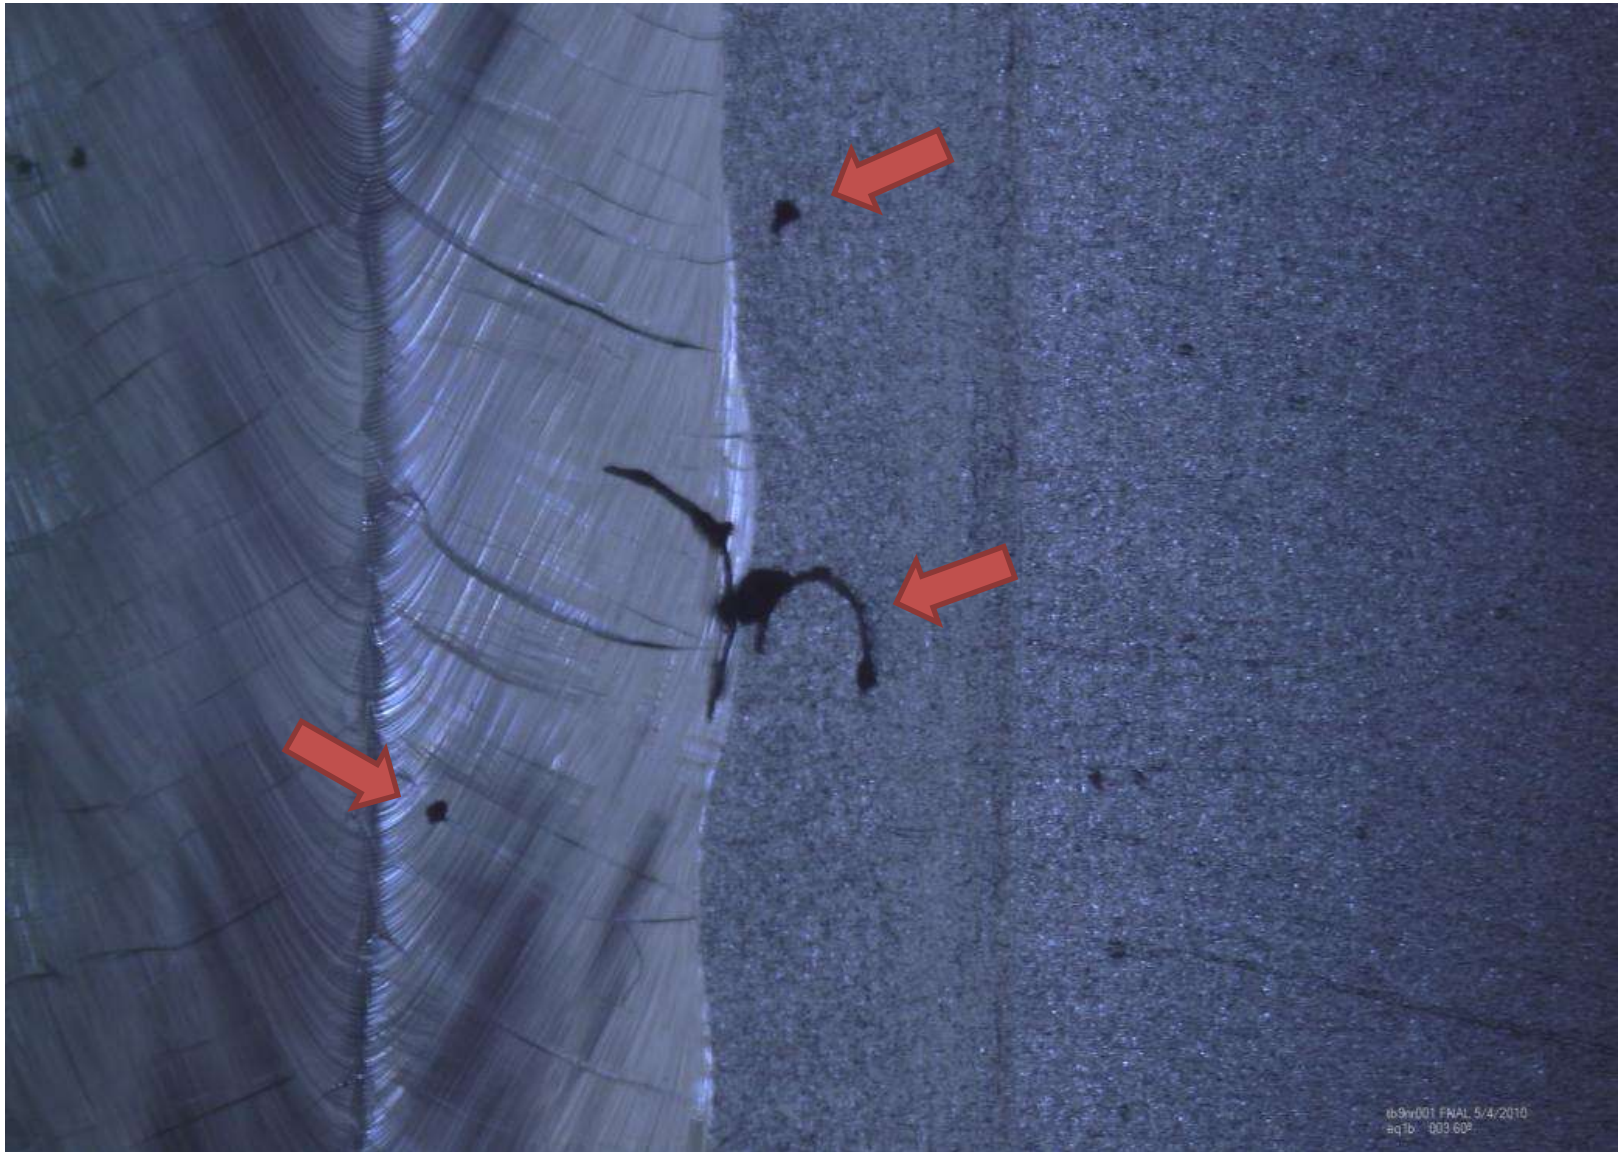
NR001 & NR002: typical dirt and fibers – **BAD**. Dirt should never be present before, during or after welding.

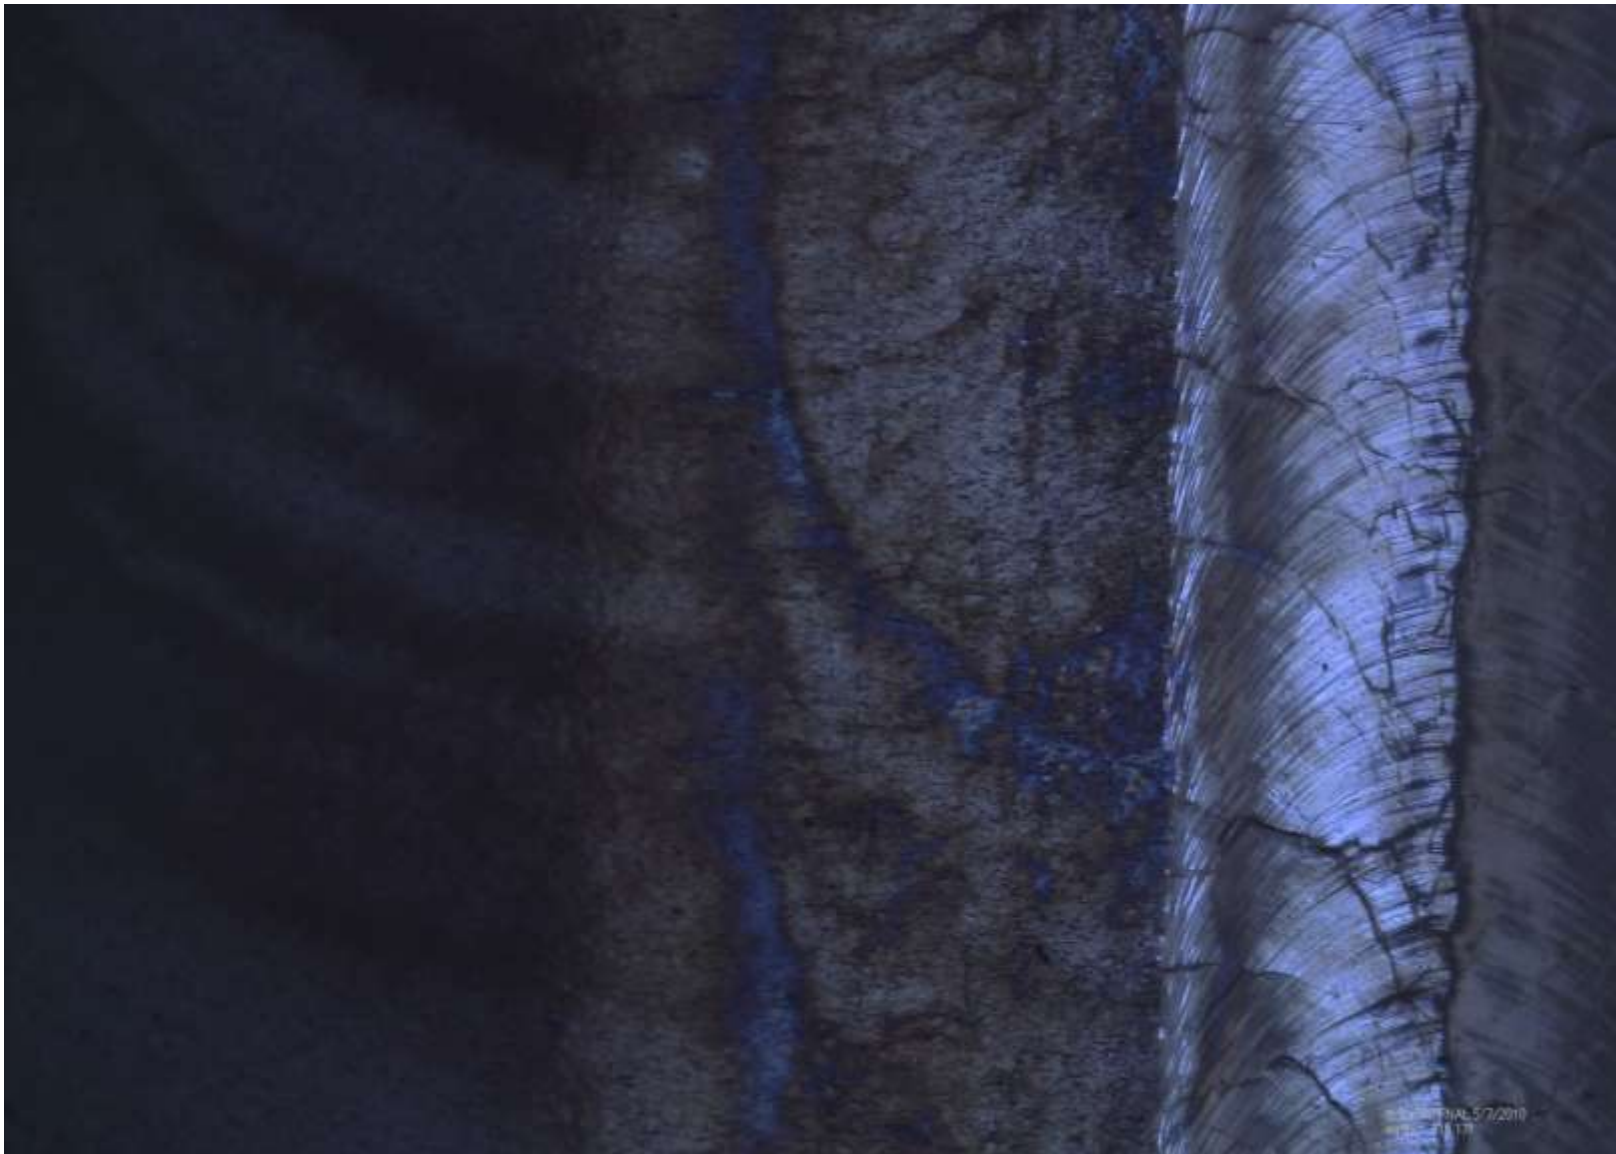
NR002: discolorations on equator weld, pictured is one of the worst extending ~20 deg and on both sides of weld. **BAD – these discolorations should not be present**
