# NR001 & NR002

- **Summary of QC findings**
- Visual inspection
- Optical inspection
- RF measurements
- CMM measurements

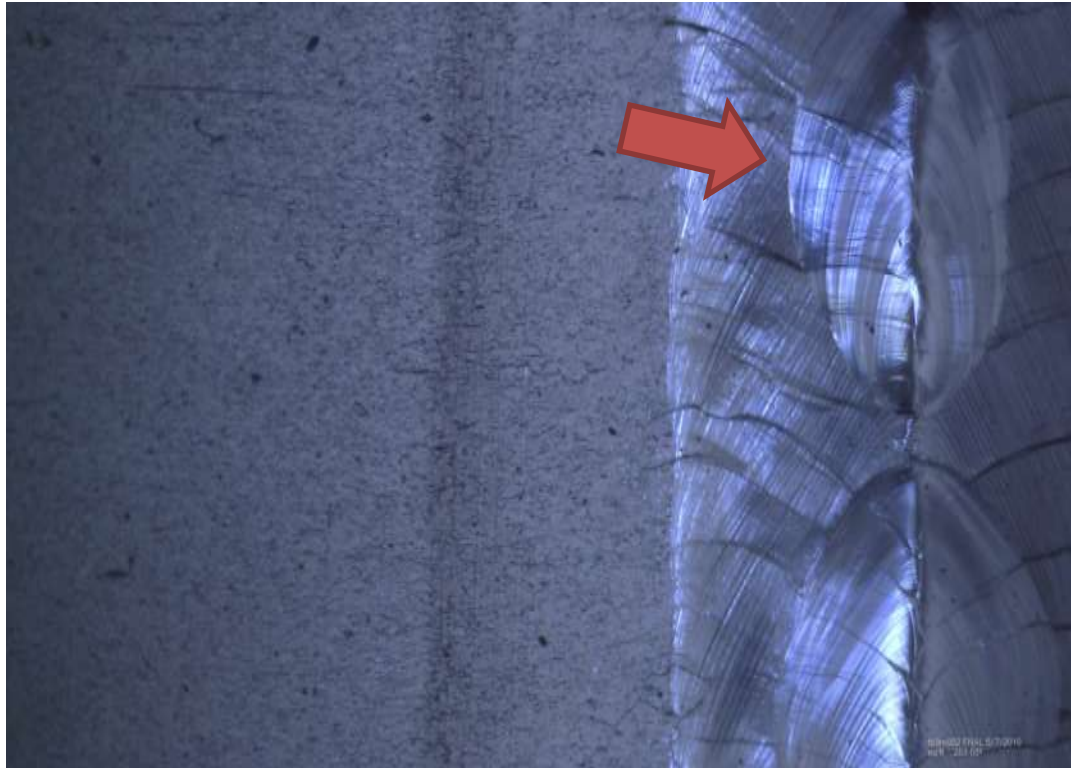
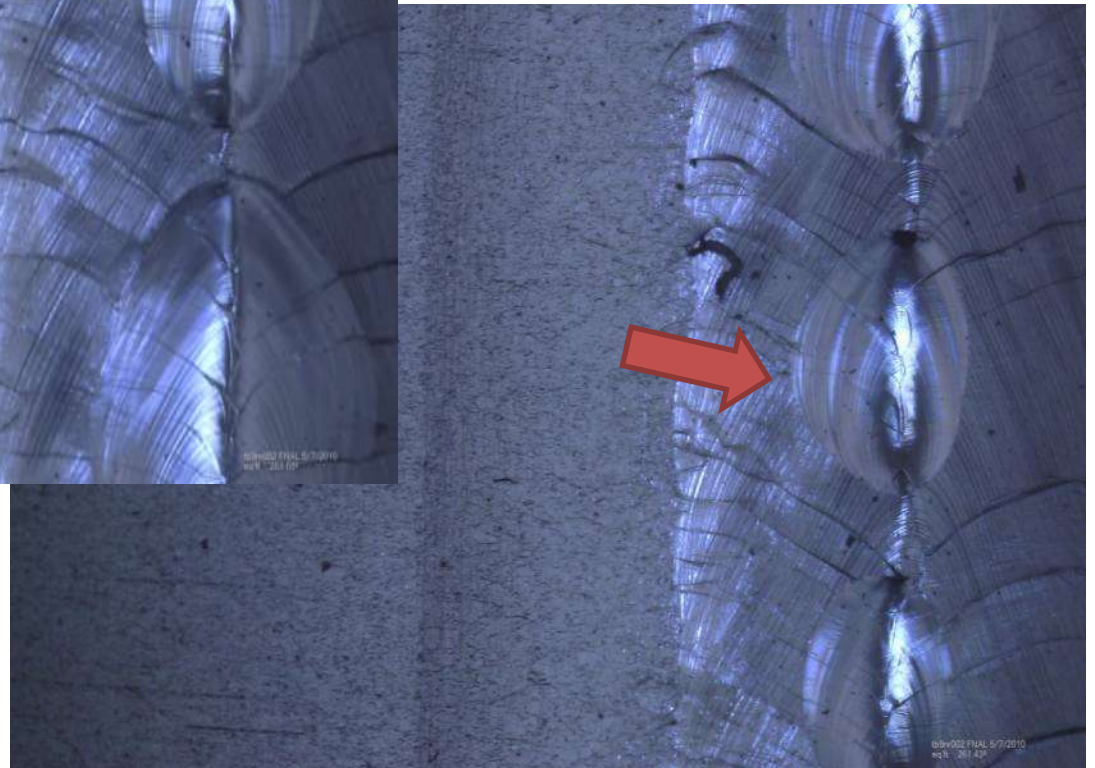
NR001 & NR002: Equator welds on cells 1 and 9 look different from the rest. Welds performed in a different orientation? Bumps are several hundreds of  $\mu\text{m}$  high. **BAD – these features should not be present.**

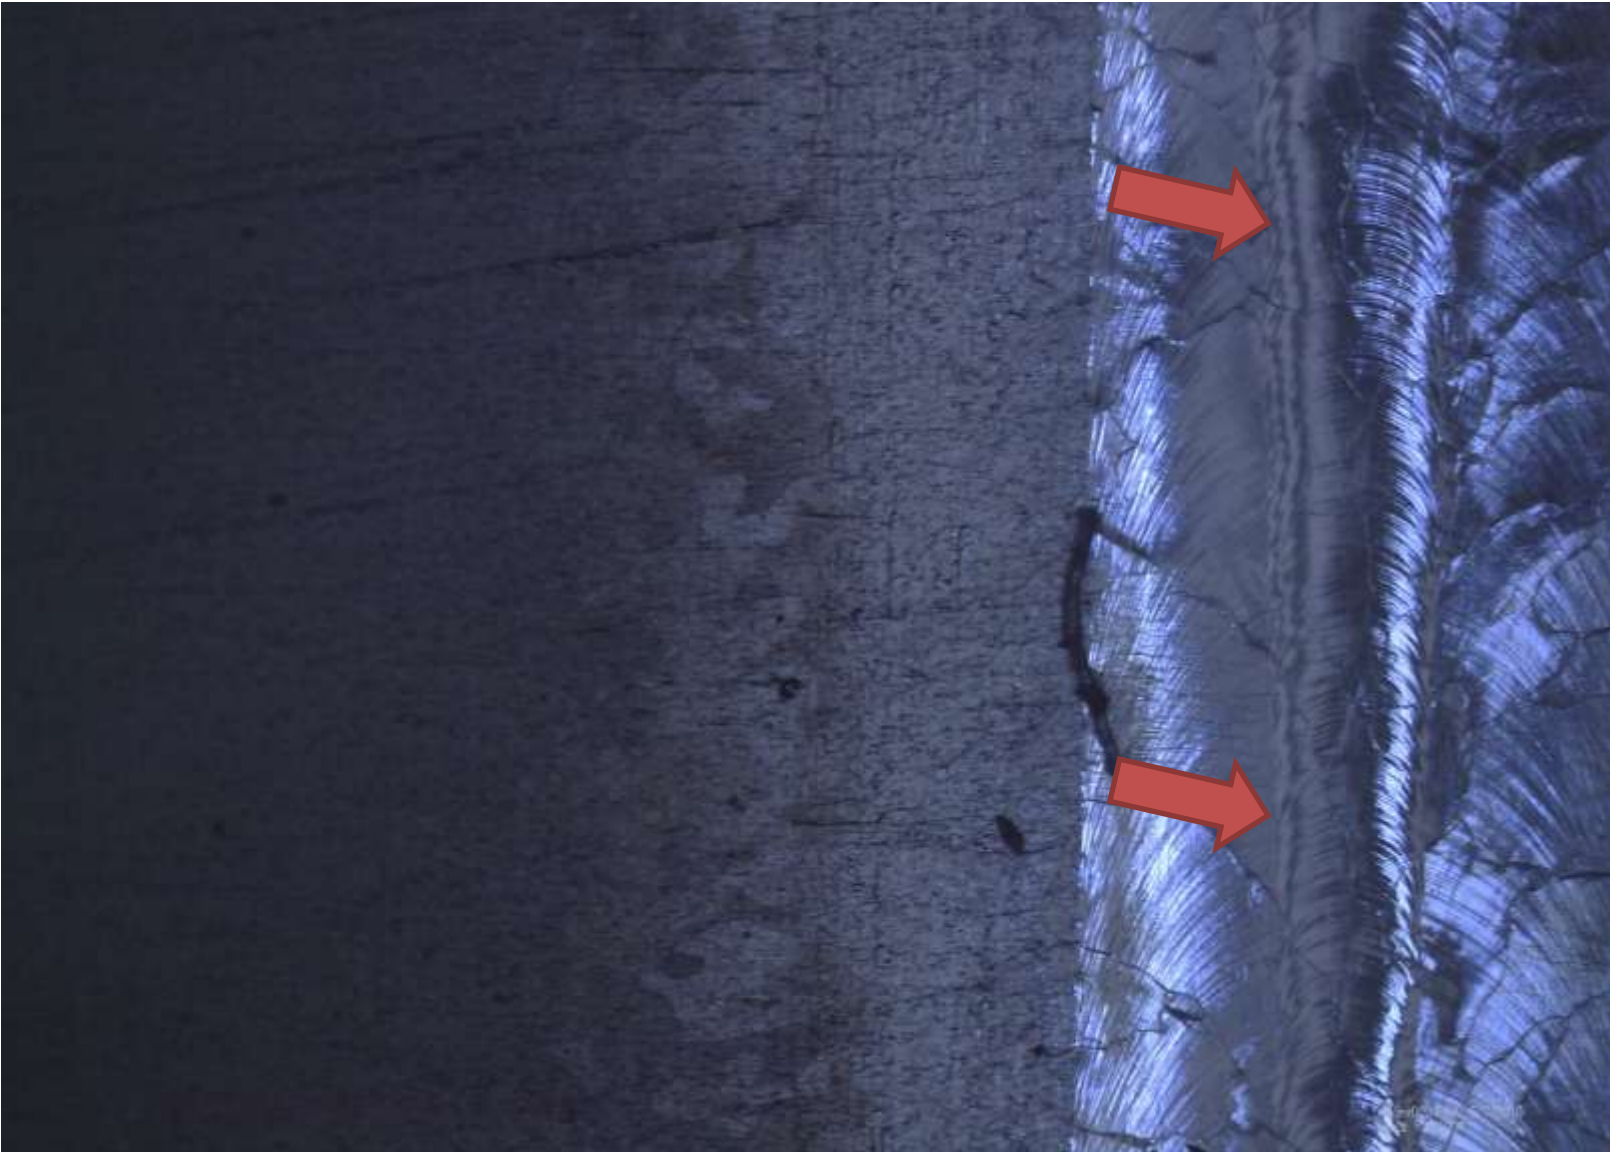
NR001 & 002: perhaps overlapping bead on equator weld, seen on all equator welds of both cavities. It's a bump and could cause quench. **BAD - Overlapping is less pronounced on cavities from other vendors.**

- The effects of the overlapping on equator welds must be studied and mitigated.
- The diameters of all equators appear larger than nominal, this should be studied.

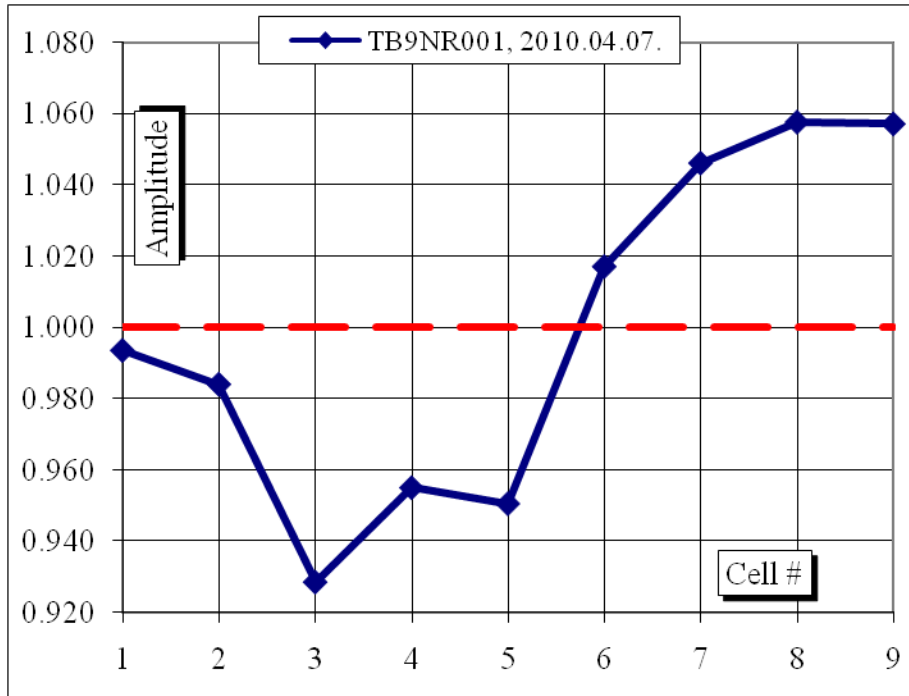
## NR001

Field flatness  $E_{min}/E_{max}=88\%$

Better than typical untuned RI cavities

Worse than typical tuned AES cavities

NB: we will tune the cavities after 800C heat treatment

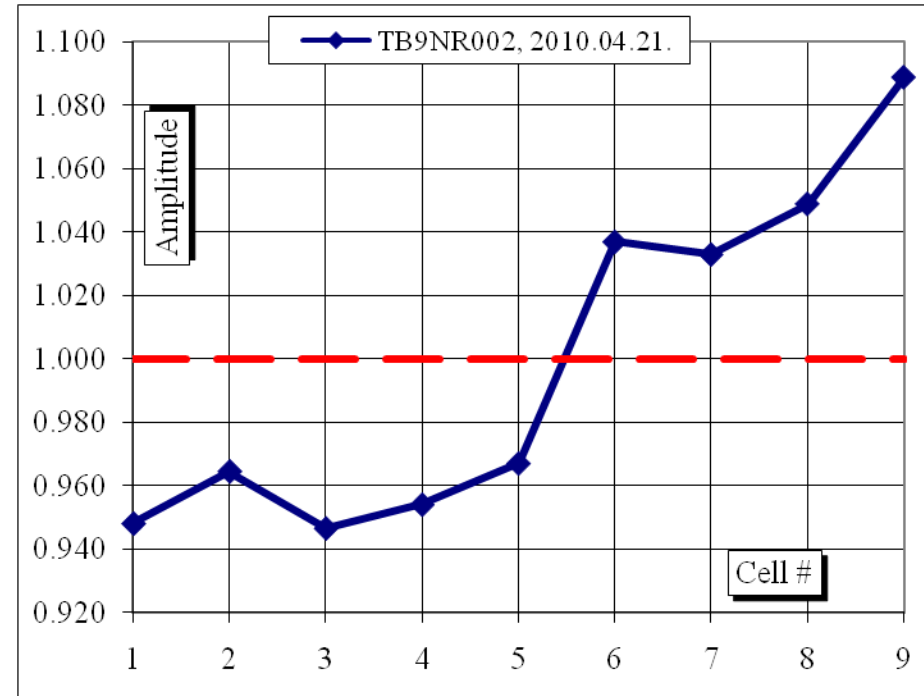
## NR002

Field flatness  $E_{min}/E_{max}=87\%$

Better than typical untuned RI cavities

Worse than typical tuned AES cavities

NB: we will tune the cavities after 800C heat treatment

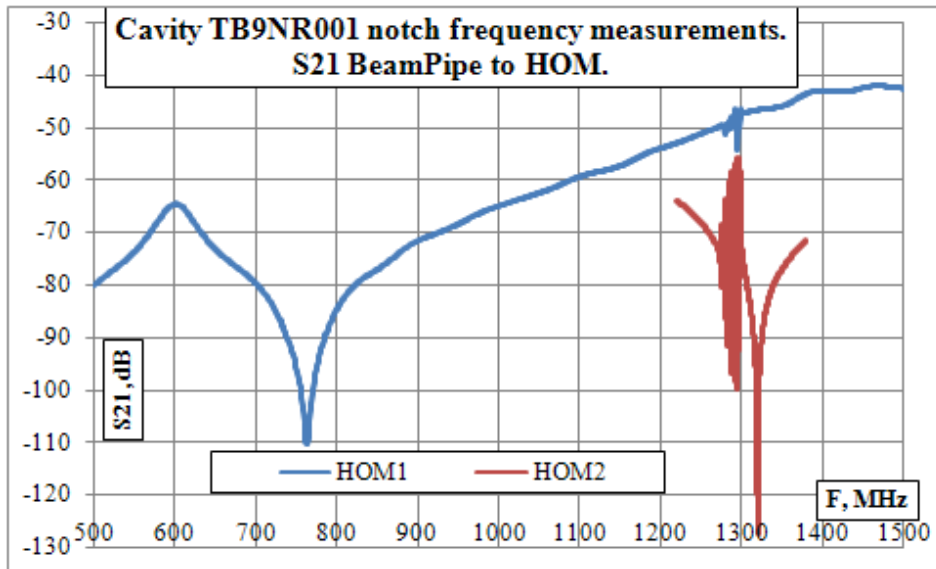
HOM1 notch frequency ~500 MHz lower than design.

- HOM notch frequencies shall be measured and adjusted prior to welding the end groups. The position of the formteil should be monitored and measured after welding.

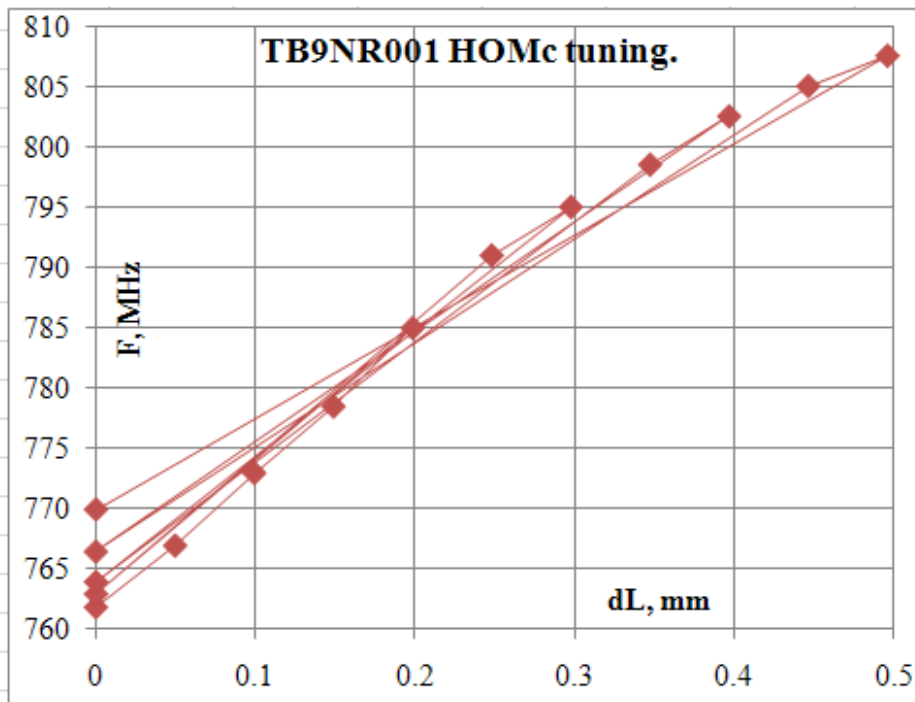
Cavity TB9NR001 HOM1 (HOMc) tuning test. 0.5 mm deformation of tuning gap changed notch frequency only by 45 MHz.

It means that **HOM1** of this cavity can not be tuned safely by usual tuning technique.

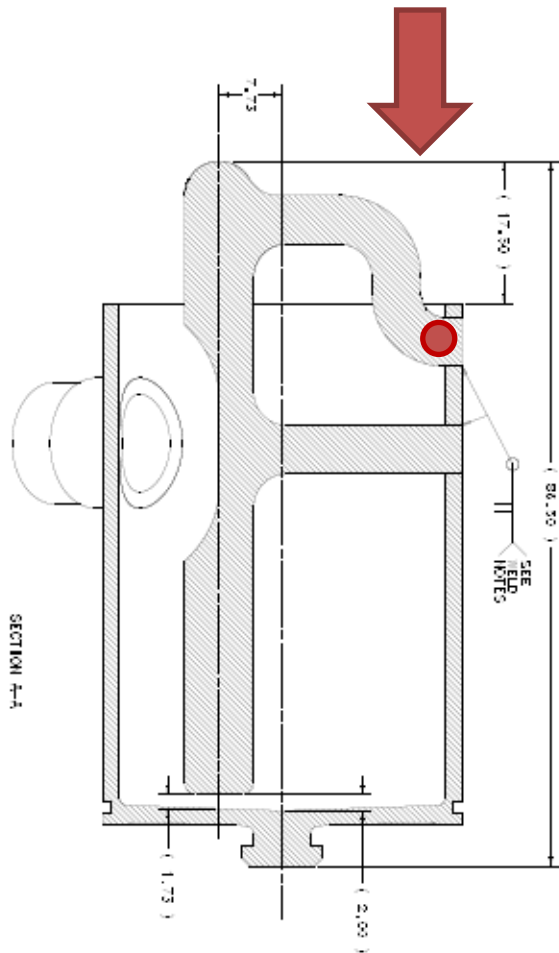
The optical images are not able to show the weld of the near leg of the formteil to the HOM can, this is an indication that the formteil "S" is in the way.

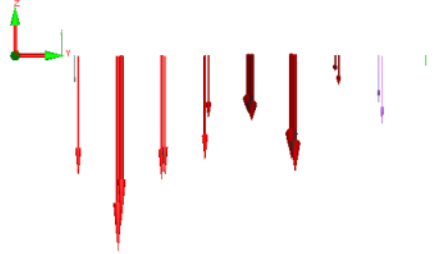
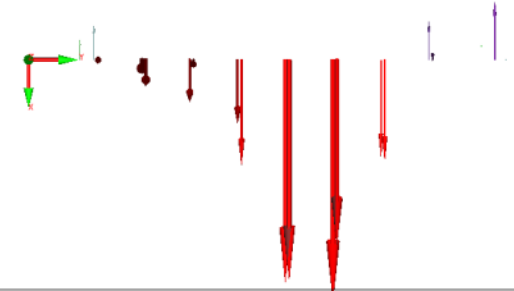
- NR001 is 3.373 mm longer than nominal
- NR002 is 2.710 mm longer than nominal
- Perpendicularity of end flanges from cavity axis is off by  $\sim 0.2$  degrees
- Equator diameters of both cavities are 0.4-0.6 mm larger than normal
- Equators are 0.2-0.5 mm out of round more than normal
- Positions of equators relative to cavity axis are atypical (see next slide)

- The weldment of the end groups to the dumbbell assembly must be studied and representative samples shall be made to qualify this joint.
- The fixturing of the end groups during the final welding should be improved to guarantee a better perpendicularity relative to the cavity axis.
