Cavity status; recent KEK activities

(1) MHI-010, MHI-011; S0 cavities field measurements

(2) KEK-JLAB collaboration; JLAB LG-01 for local grinding

(3) KEK-Saclay collaboration; on 1DE1 single cell sponge-wipe possibility

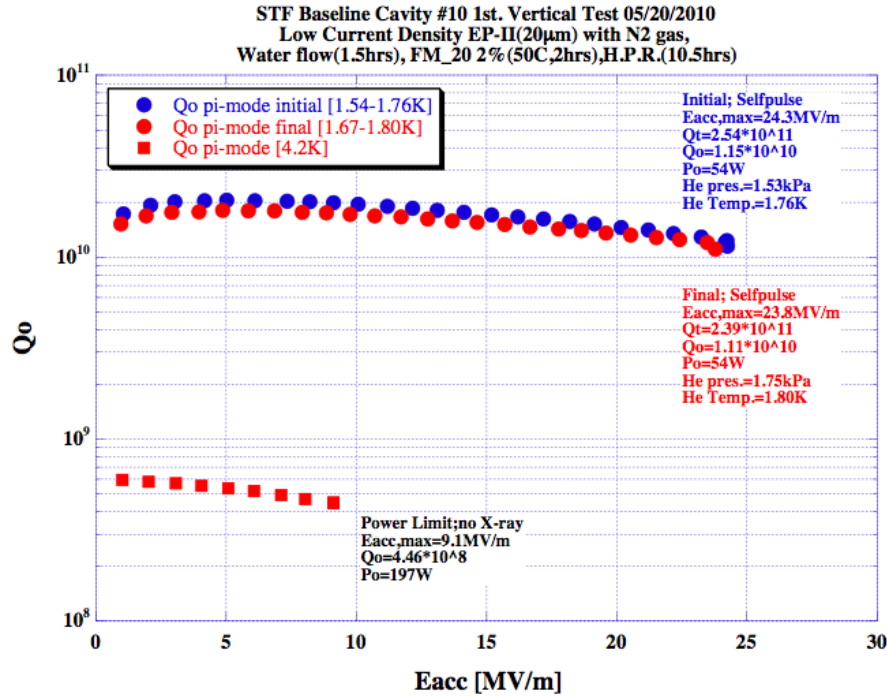
1st VT

23.8MV/m
Q=1.11E10

#1cell equator pits

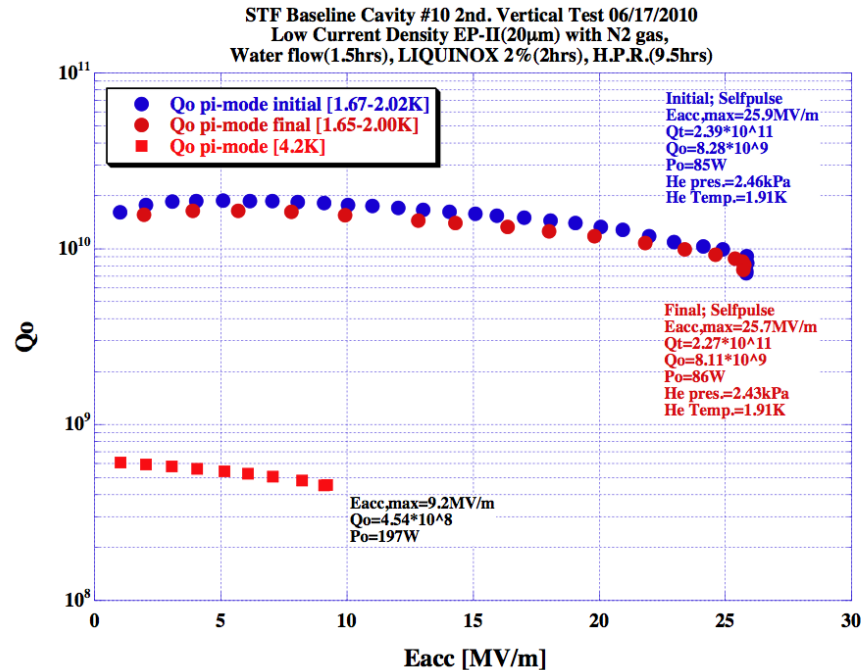
2nd VT

25.7MV/m
Q=8.11E9

#1cell equator pits

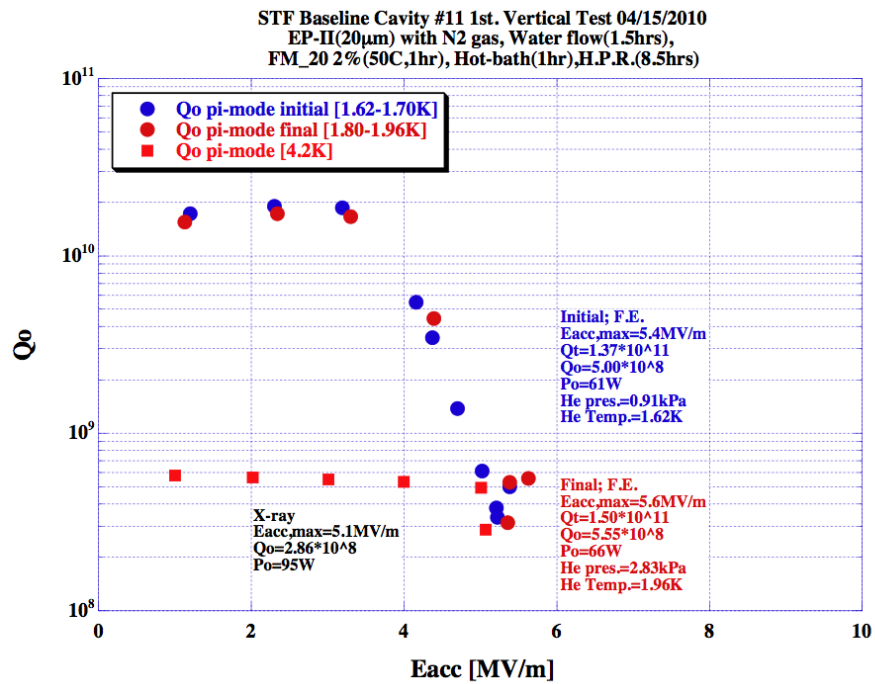
1st VT

5MV/m
Q=5E8

Contamination
during assembly?

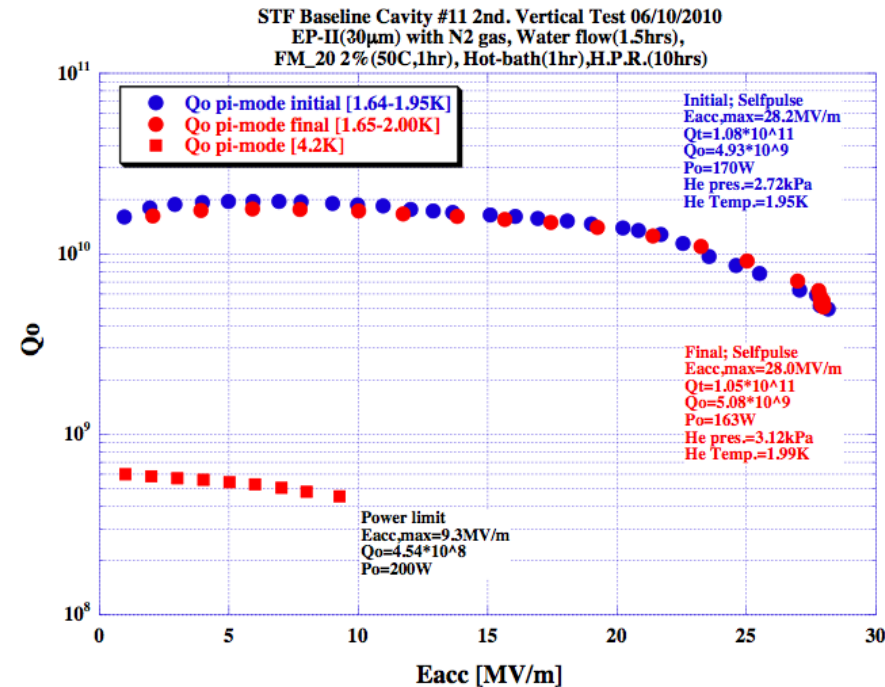
2nd VT

28.0MV/m
Q=5.1E9

Heating at #1cell
equator 270degree

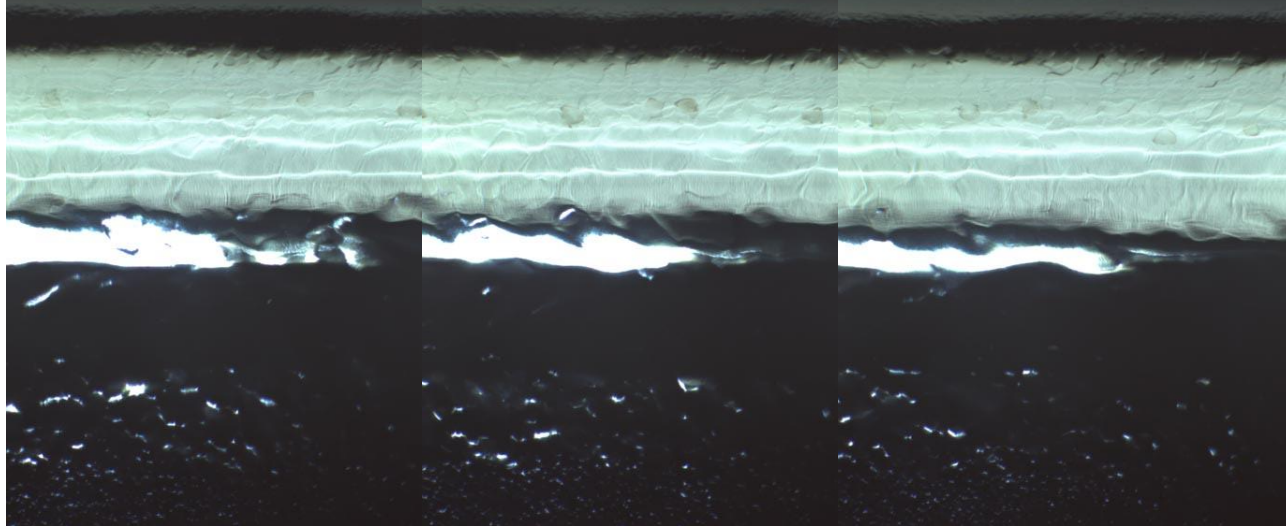
ID number 7

many stain

5um EP, 28mA/cm²

water rinse;
3min supply, 1min dump,
repeat them for 60min

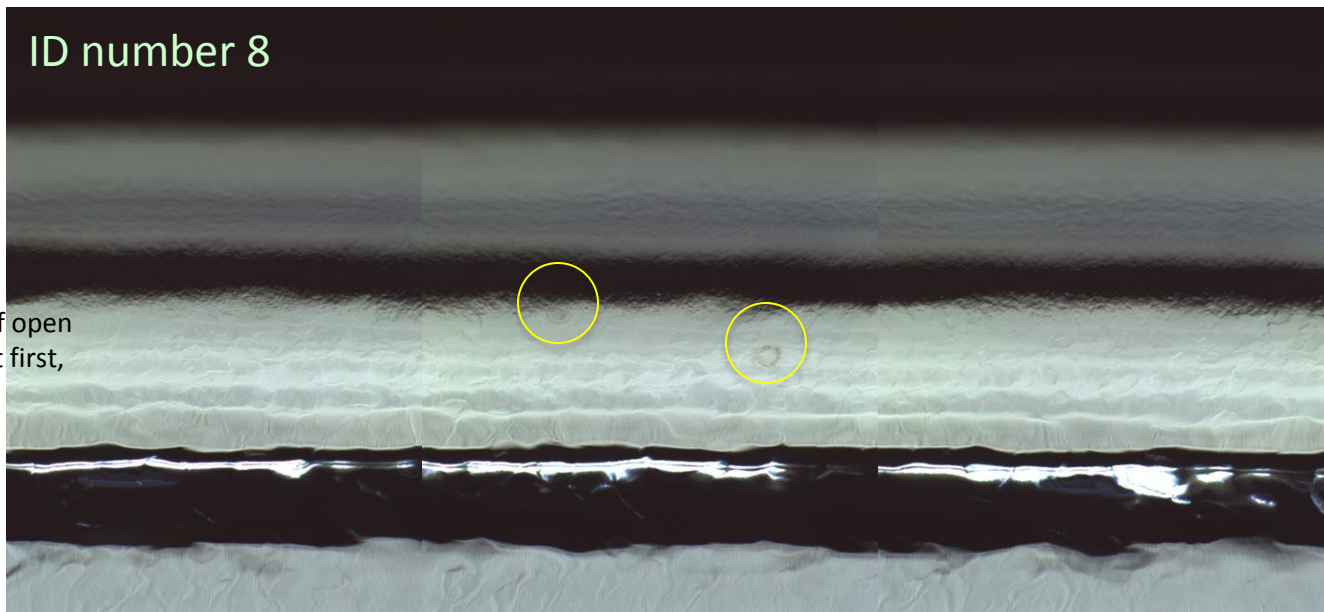
ID number 8

only 2 stains

5um EP, 31mA/cm²

water rinse;
add manual valve with half open
3min supply, 1sec dump at first,
30sec supply, 1sec dump,
repeat them for 70min

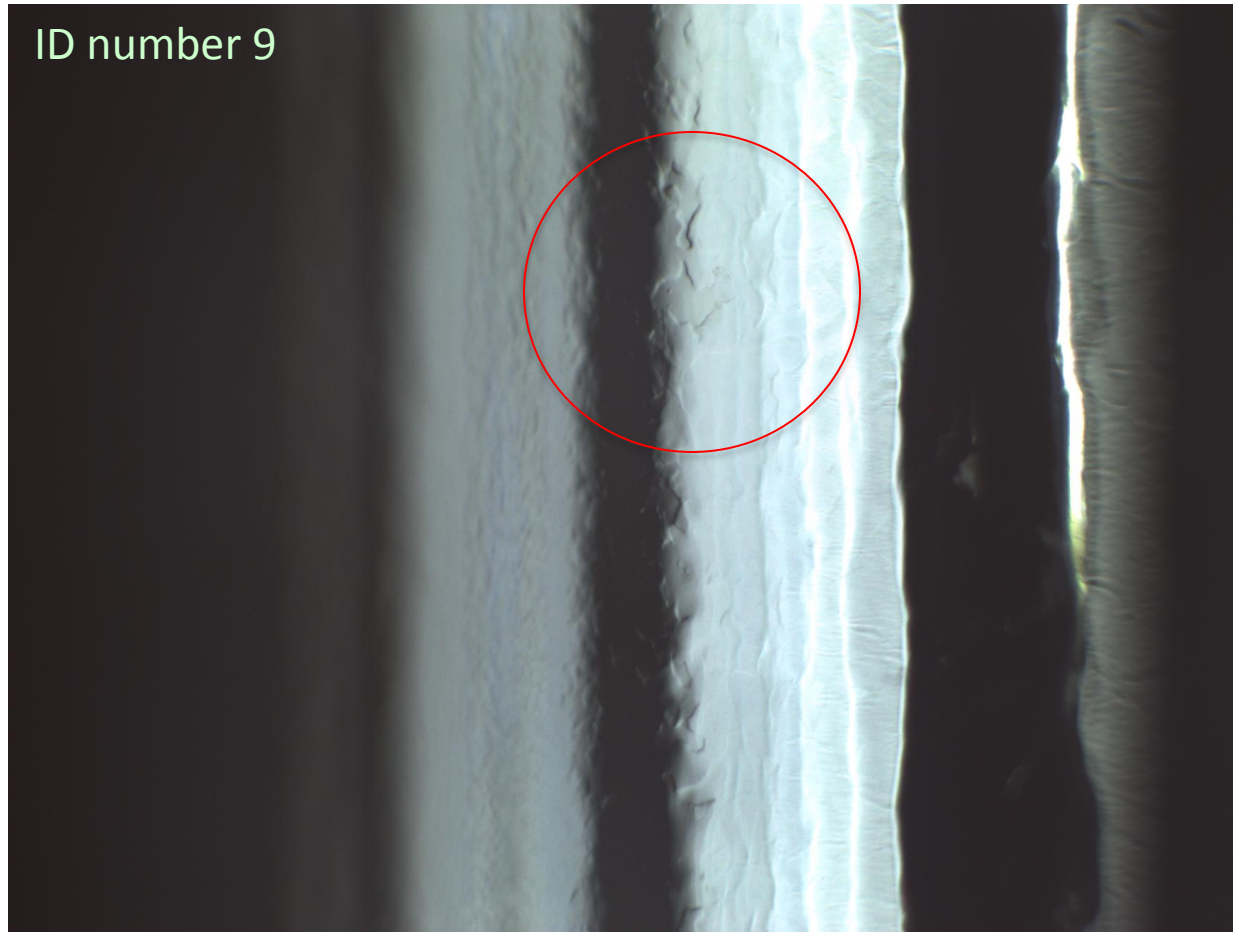
2010. 05.21 EP 30mA/cm² with modified filling of water just after acid draining
morning

water rinse;
add manual valve with half open
3min supply, 1sec dump at first,
30sec supply, 1sec dump,
repeat them for 90min, 3rpm rotation in rinse.

upstream : 1~2? faint stains
downstream : 0 stains
