TE1AES004 JLAB T-map test

G. Ciovati, M. Morrone, G. Wu

AES004, TESLA Cavity Shape, single cell

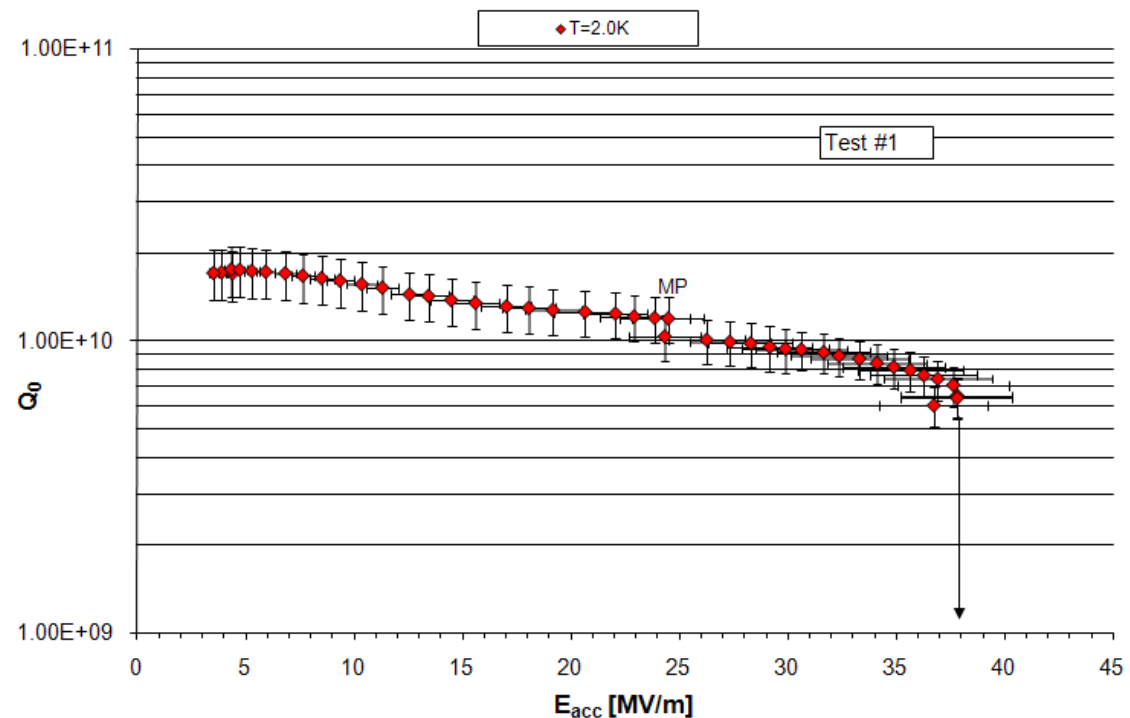
Defect

Previous
quench site

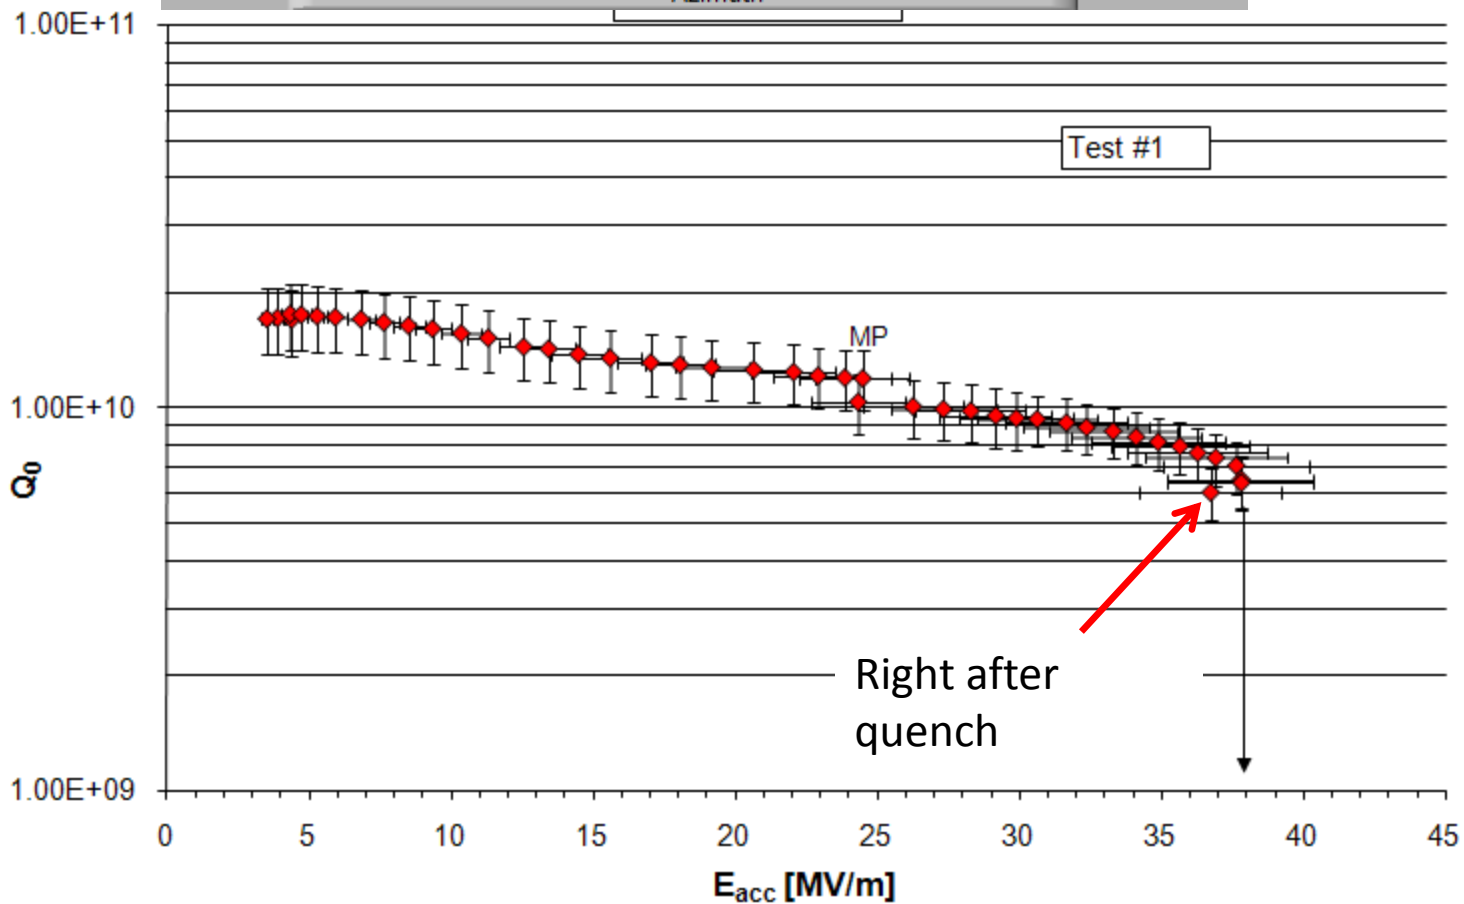
Quench at
new location
