PAVAC cavity 001, 002, 003 optical inspection report

Mingqi Ge and Genfa Wu

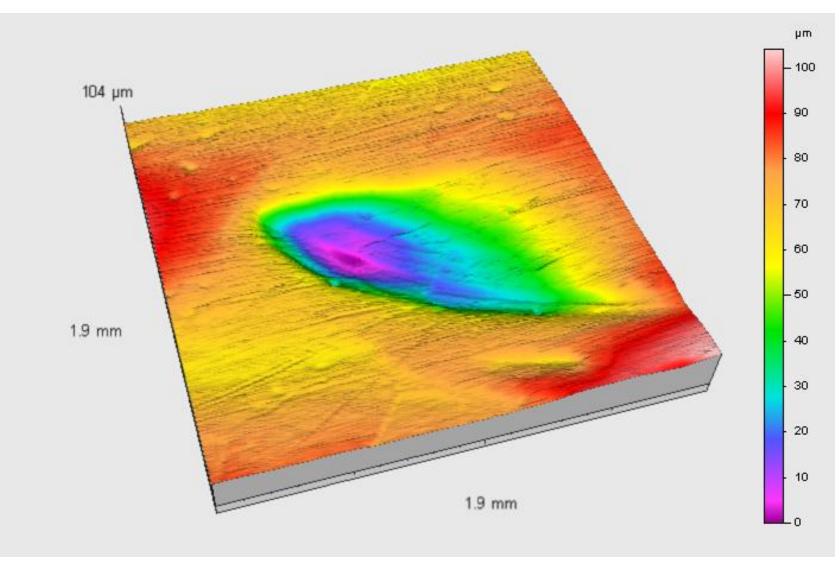
TE1PAV003 area 1 replica result

$60 \ \mu m \ deep$, sharp edged tool mark
