Tumbling of JLab-2 Status

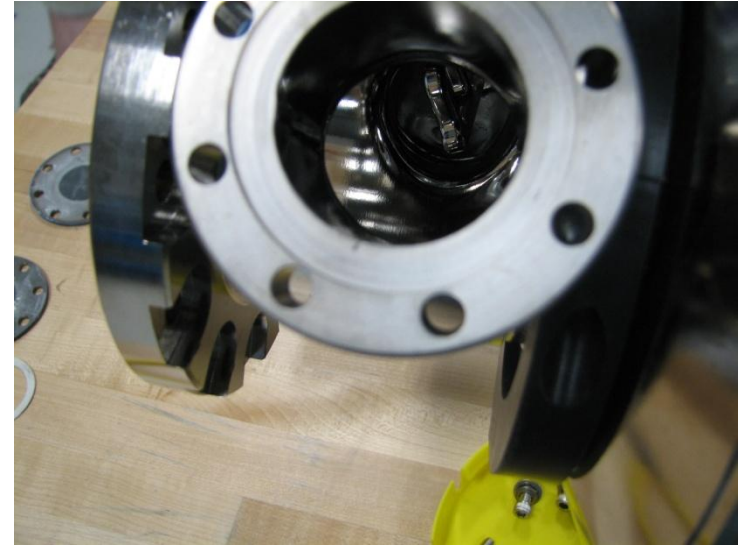
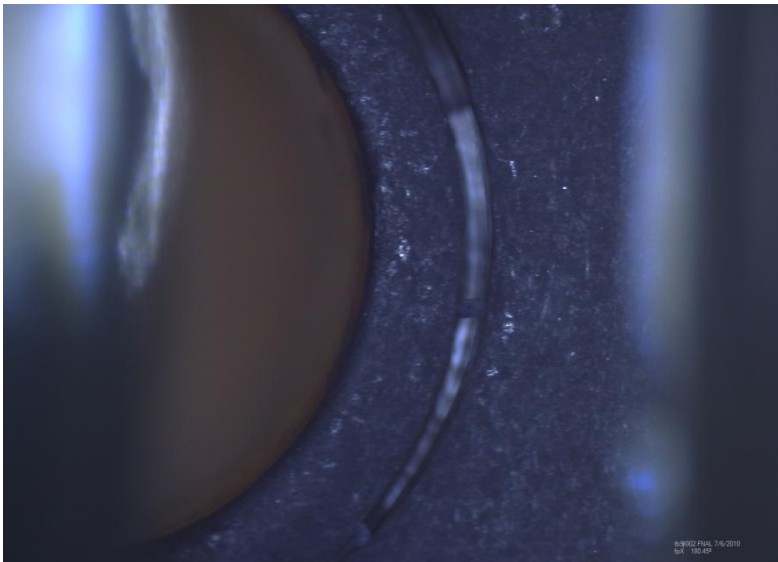
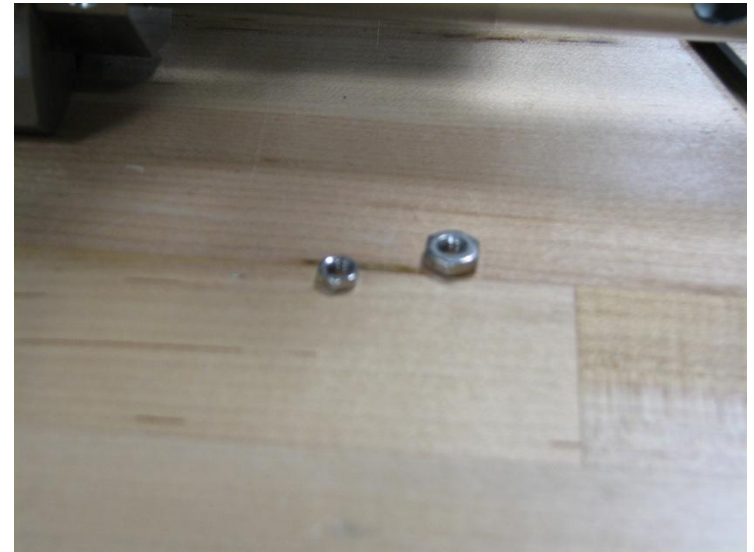
Cavity Defects

- Pit on Input Coupler Sealing Surface
- Scratch on Sealing Surface on Field Probe Side
HOM Can Flange
- Bad etching on inside and outside of HOM cans
- HOM Can ID too big.
- Clearance between HOM can flange and beam tube too small.
- Field Probe weld not full penetration
