# Problems with AC151

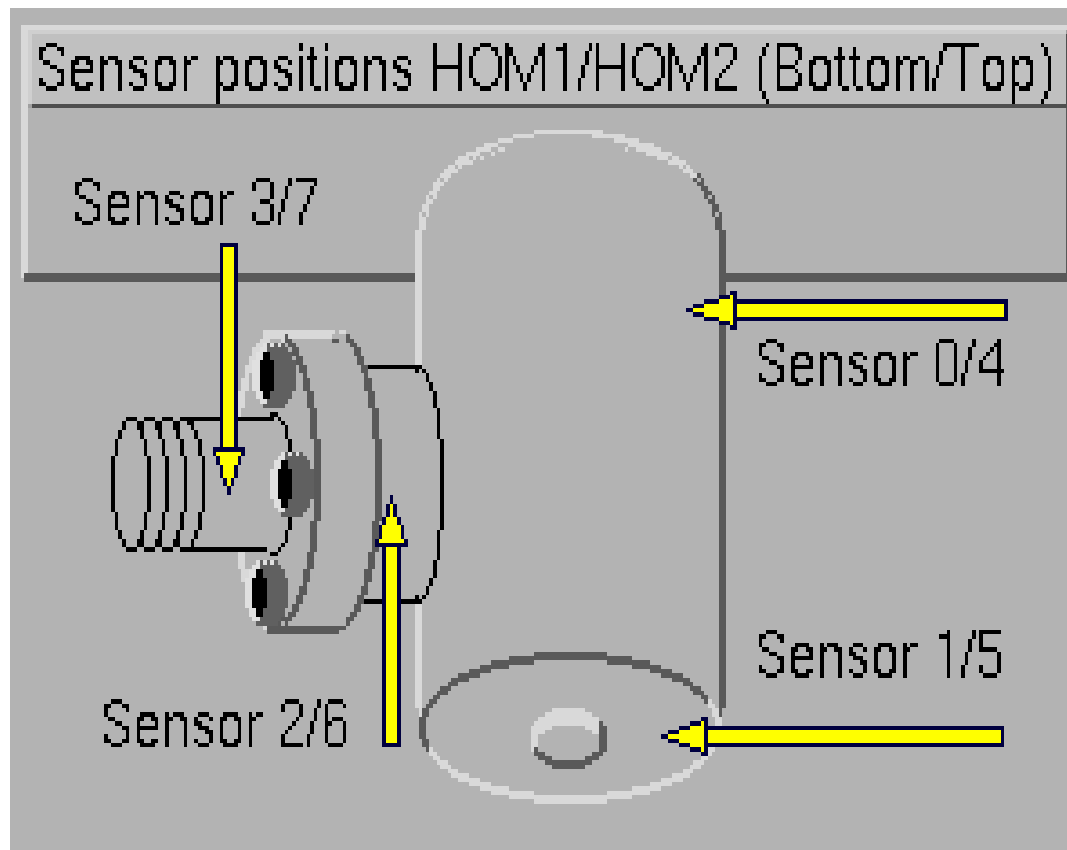
# T-sensors on HOM

Sensors 76-79, HOM 2,  
corresponding sensors 4-7  
on presented picture.

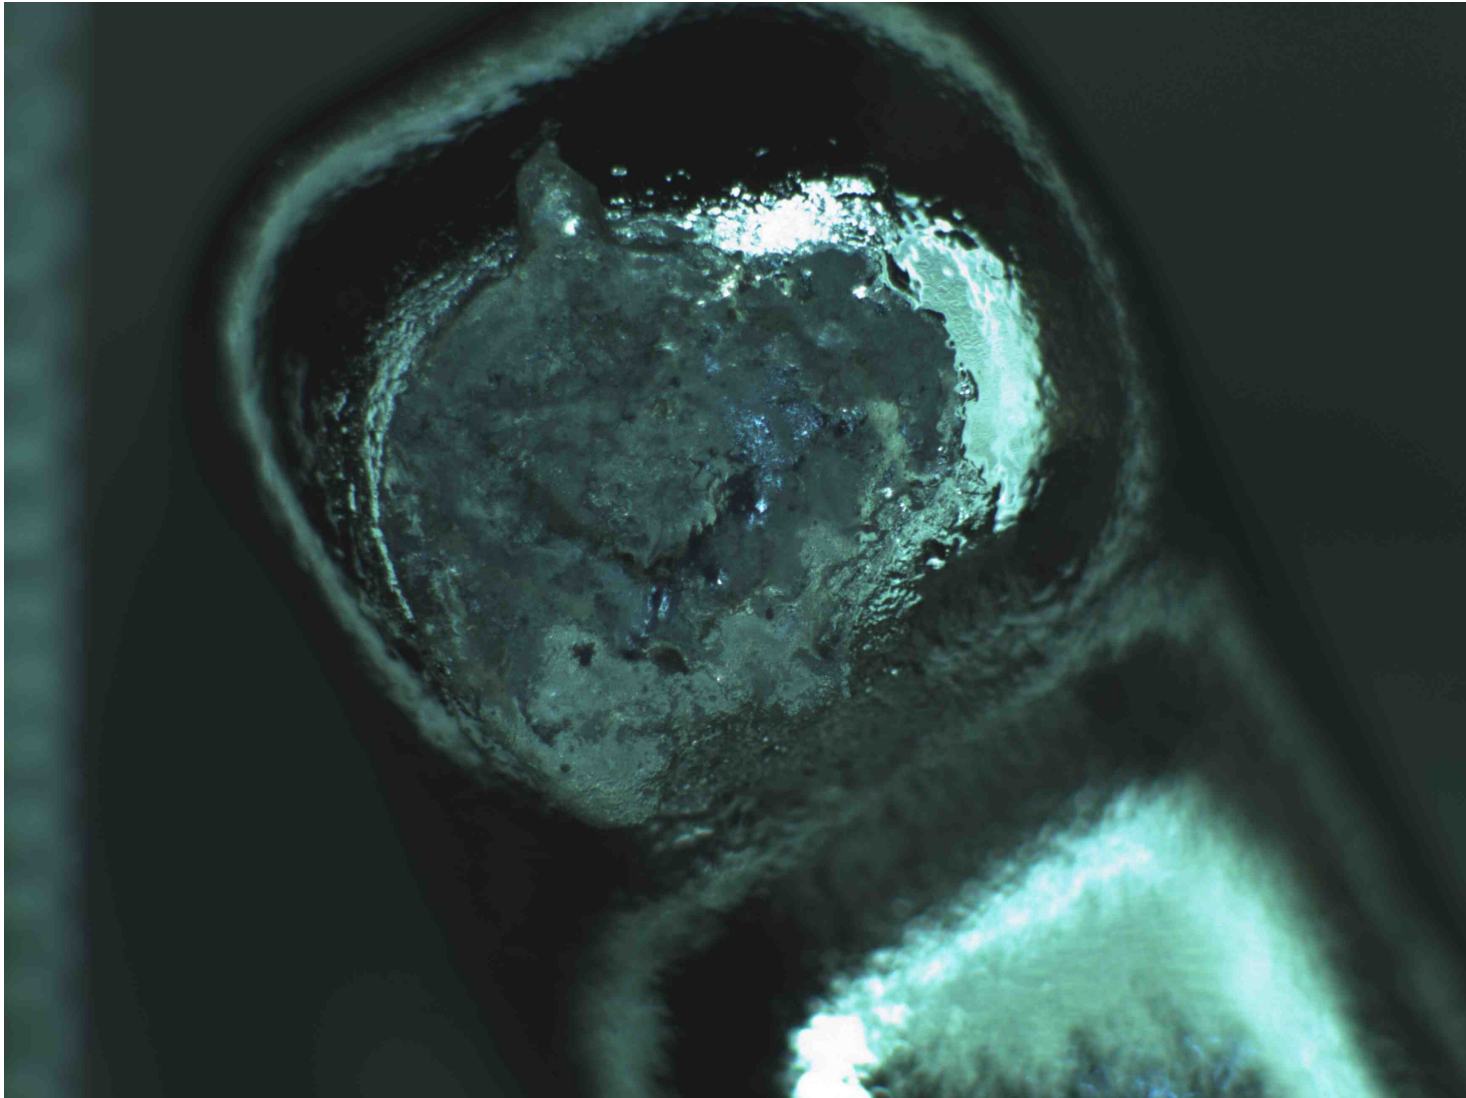
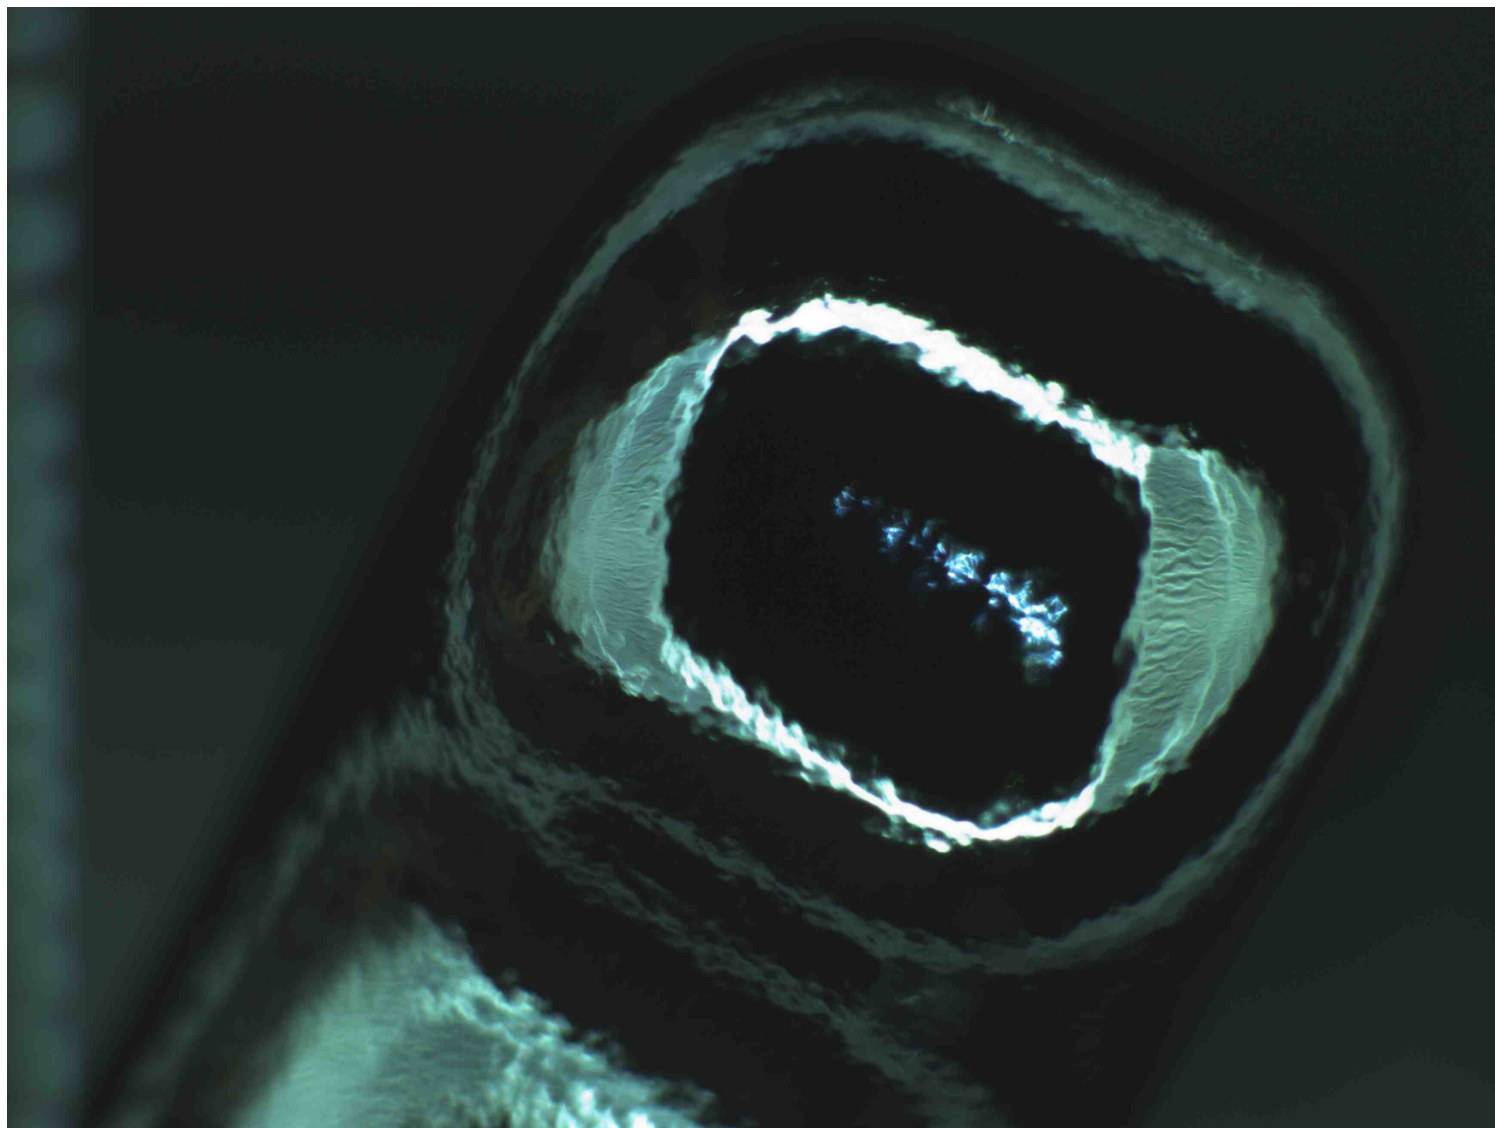
# Inspection from inside, HOM2

- **Damage of Teflon-insulation at location of HOM2**

Belt for rotation of cavity was displaced during EP-process → non-circular movement of cavity

Next step: new EP and re-test
