NML/RFCA002 Status

ILC Cryomodule meeting
3 July 2012
E. Harms

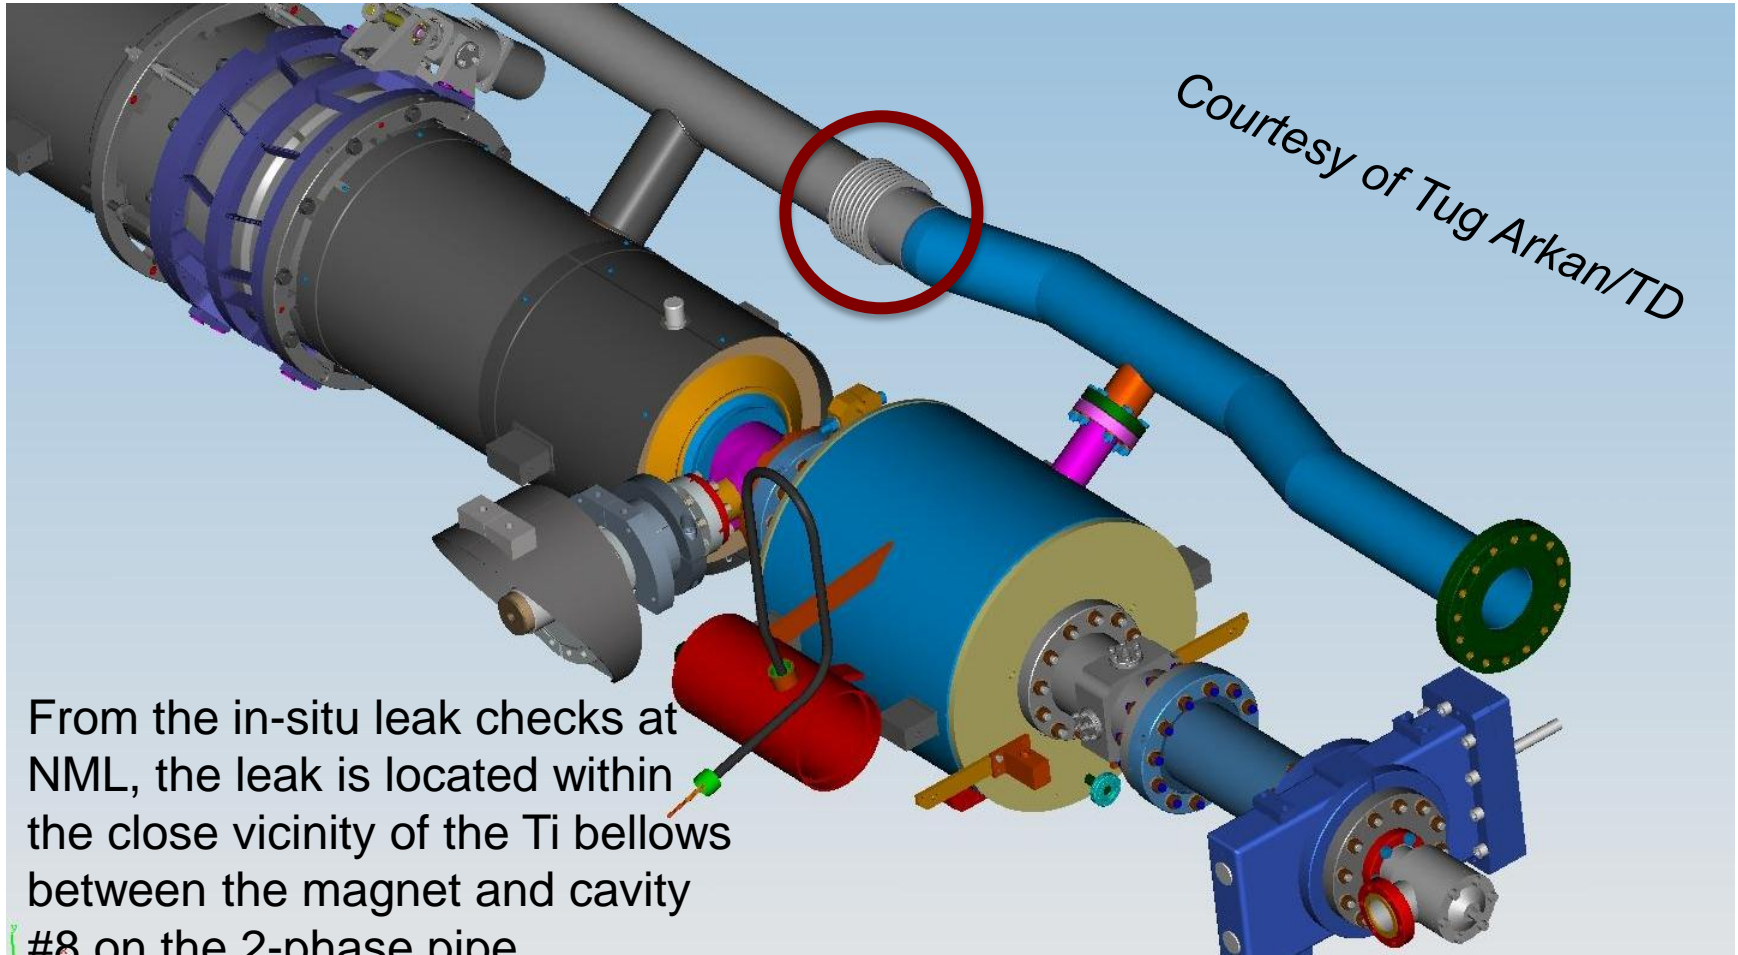
2 ϕ leak

- Couplers installed
 - <1 week from beginning warm conditioning
 - Couplers under vacuum
 - Warm RF measurements completed, coupler motion verified
- All signal connections made and verified
- Vacuum leak discovered on 2ϕ circuit during final leak check at NML

1. In-situ in the NML cave – not feasible due to tight space and reachability limit (~1 meter inside from downstream end) to the area to locate the exact location of the leak
2. In-situ at NML floor – does not seem feasible due to reachability limit to the area for any kind of repair even we can locate the exact location of the leak
3. At CAF-ICB (partial cold mass disassembly)
4. At CAF-ICB and CAF-MP((full cold mass disassembly)

- CM-2 prepared for removal and transport including leak checks on all circuits – *no other leaks found*
- Transport from NML to ICB – *completed 26 June*
 - Max. quad acceleration = 0.23 g (vertical)
 - Max. isolation fixture acceleration = 0.2 g (vertical)
 - Max. base frame acceleration = 0.45 g (vertical)
- Diagnosis, repair, and full checkout – *estimate 7-9 weeks*
 - RF checks and cable disconnects in progress
 - Plan for disassembly prepared by Tug
 - Estimate 2 weeks to extract cold mass assembly
 - Diagnosis and repair to follow
