Damage on Field Cage by Slipped Module

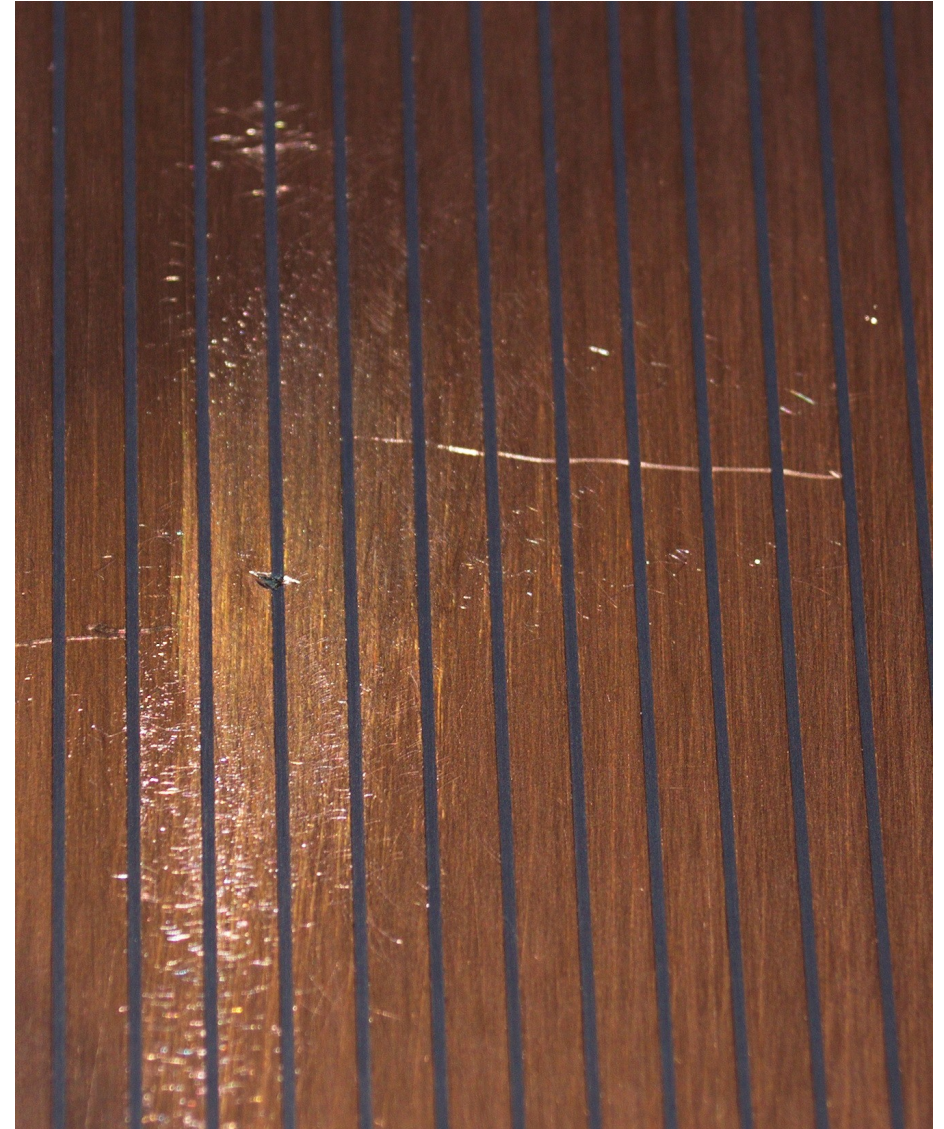
All resistivity values OK, no disconnection.

After grinding with very fine sandpaper
