Large Prototype and HV

How to spent a week dismantling and re-attaching an anode end plate

WP Meeting 158, 13.Sep.2012 R. Diener, F. Müller, C. Rosemann

LP HV Problems

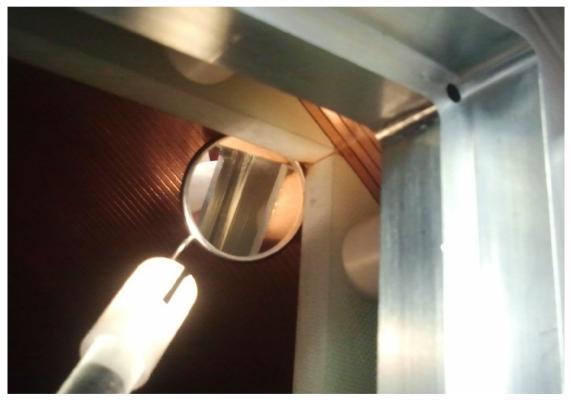
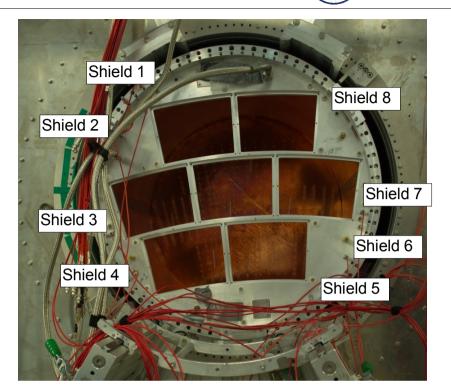
- Seen strange tripping all over the end plate when channel voltage about 2100-2200V
- Setting all to 2000 and raising one by one: shield 8 didn't stand it
- First inspection:

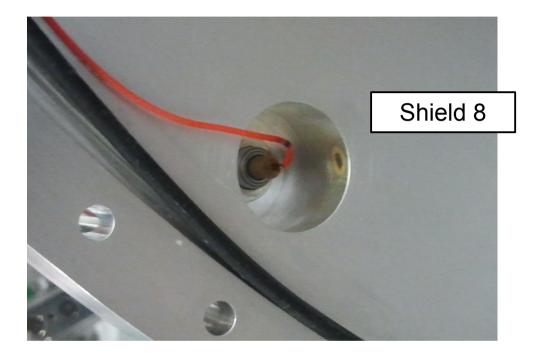
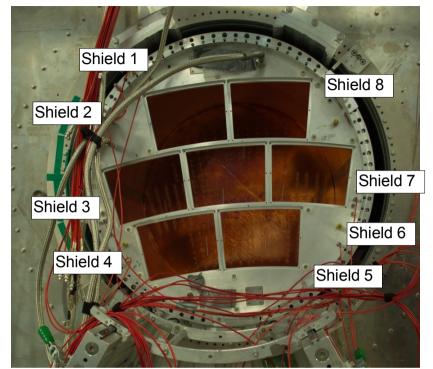
- Monday:
 - Opening end plate

• Fixed by cutting out damaged part and re-attaching cable

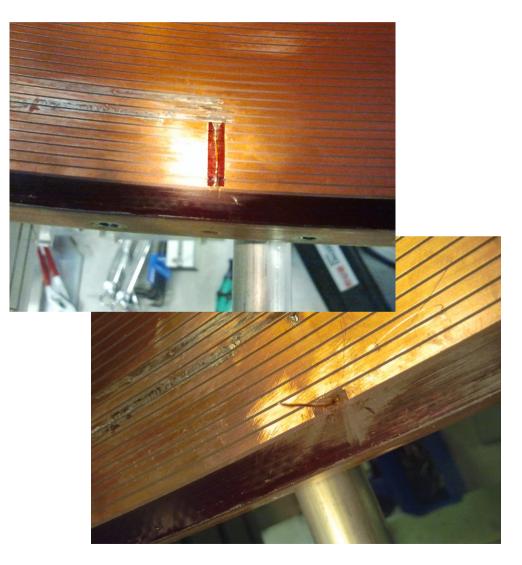
- Tuesday:
 - Next test: shield 5 had connection to ground (clamped the cable between end plate and field cage → repaired)
- Wednesday:
 - Problems with 7th strip:
 - insulation showed scratches
 - put Kapton on top
- Thursday:
 - More problems with 7th strip
 - Now complete reworking of the insulation (top and bottom):
 - bigger Kapton piece below
 - epoxy around hole in 1st strip
 - shrinking tube
 - some Kapton tape on top

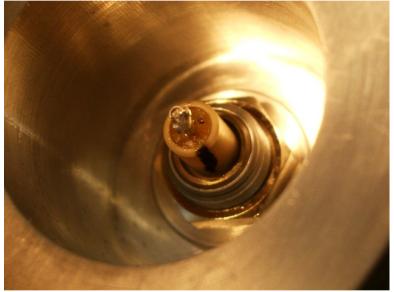
- Friday:
 - 7th strip OK, but shield 4 can't go over 1200V
 - Opening LP for the 5th time
 - Carbon bridge at Fischer receptacle

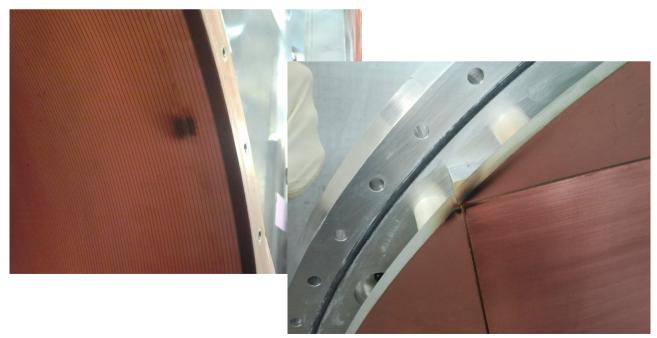
- Saturday:
 - Field cage powered up again and everything works
 - Shield set to 2250V, cathode at 16kV
- Sunday:
 - Trip after 9 hours, no currents on the shields or dummy modules → Modules are safe, problem at another place of the LP
 - Fault: unfortunately "trip" was not connected to "kill" on the CAEN power supply
 → tripping has lasted some time
- Monday:
 - Opening field cage to check
 - Cleaning carbon spots
 - Field cage still working
- Starting testbeam preparation
