LP HV / Part II

Destroying and Fixing the
Cathode Side HV Connections

WP Meeting 163, 22.11.'12
R. Diener / FLC-TPC

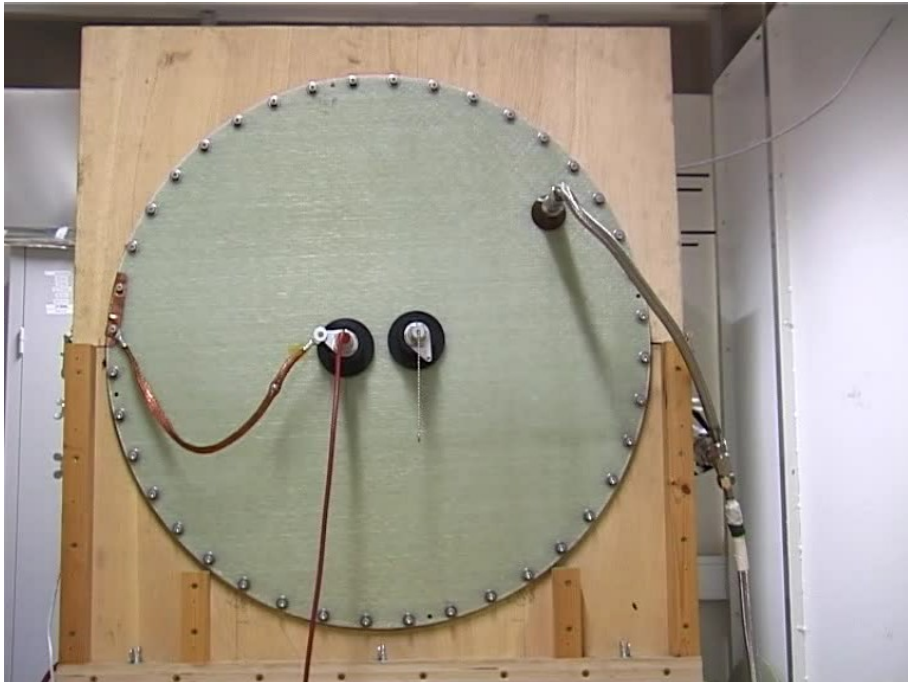
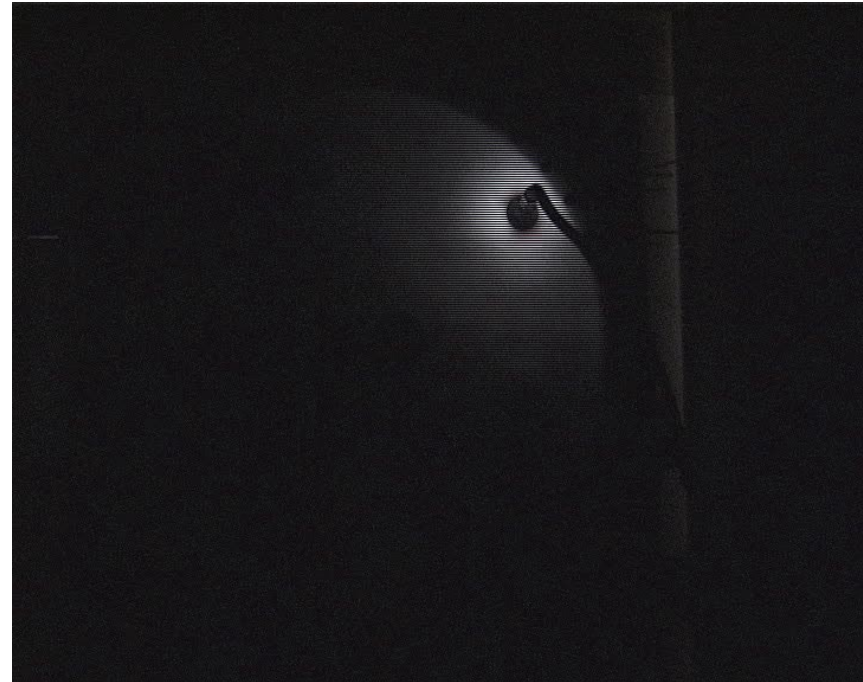
- Test of HV delayed after test beam in September: both CAEN multi-channel power supplies broke and had to be repaired
- After this, we set up everything in our lab as it has been at the test beam
 - Surprisingly we could ramp up the cathode higher than 10kV again
 - But it was still not stable
- With a video camera we were able to see the location of the discharge: the gas inlet
(test at 2250V at anode side and 18kV at cathode side)

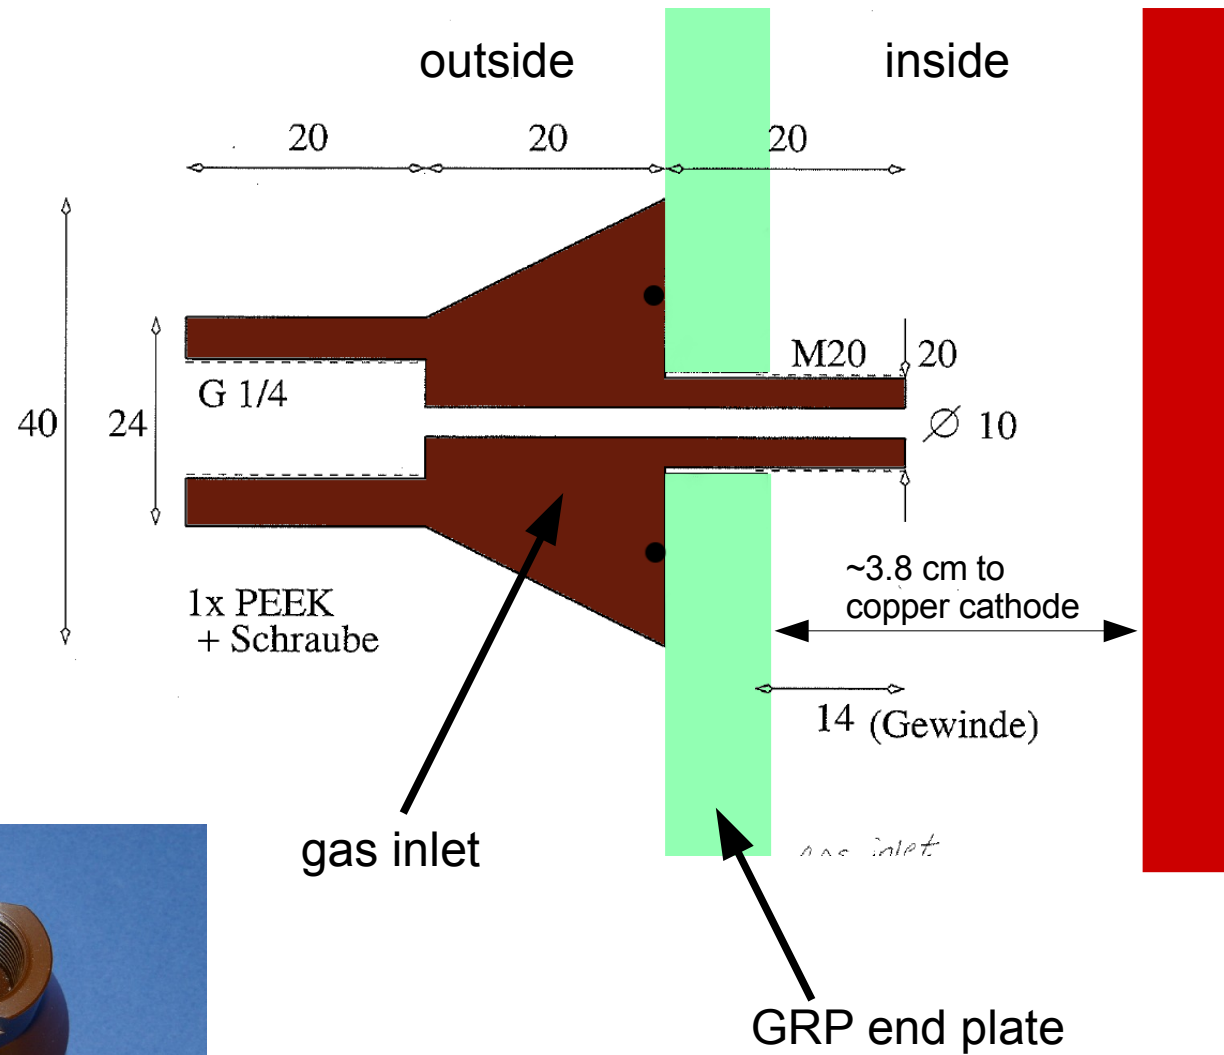
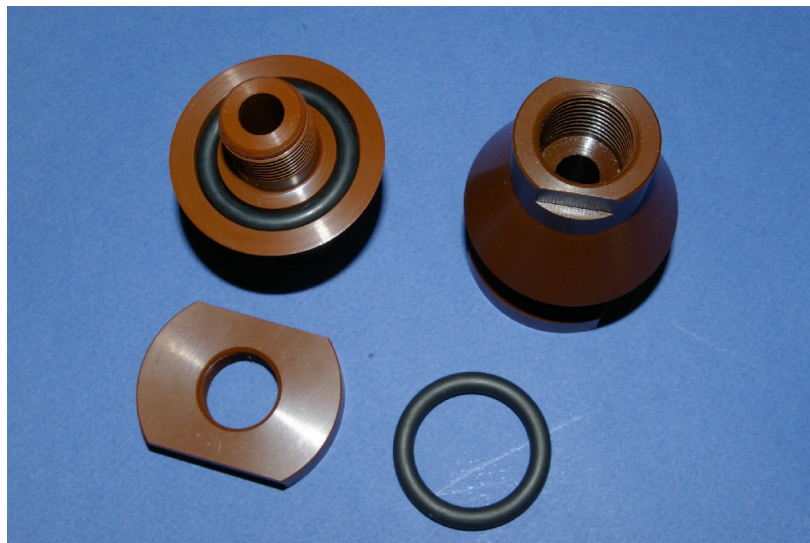
- Gas inlet:
 - Made from Vespel
 - Distance of gas line (metal) to copper plate of the cathode theoretically enough to avoid sparks in Argon

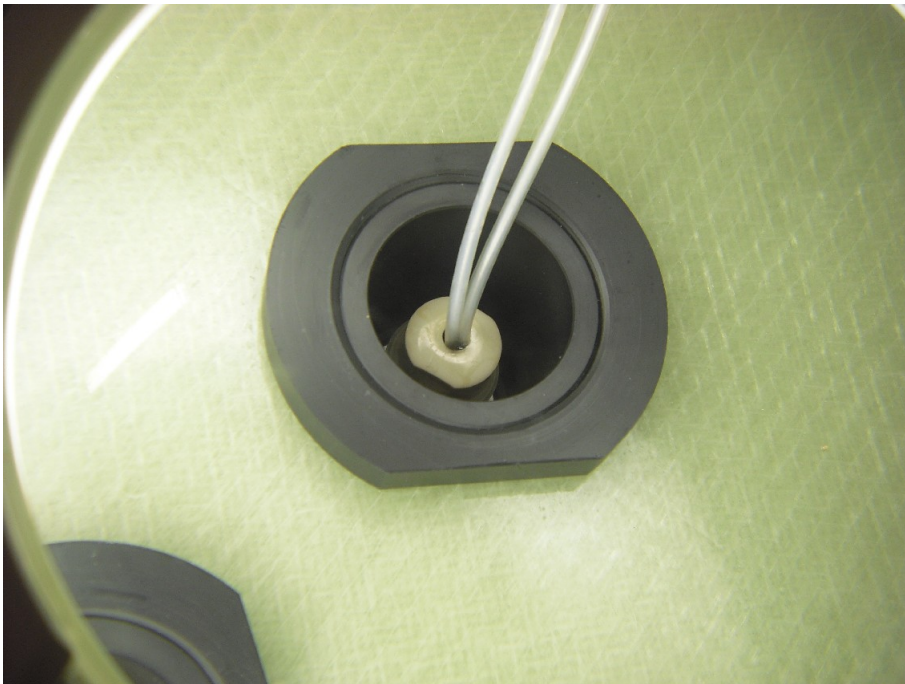
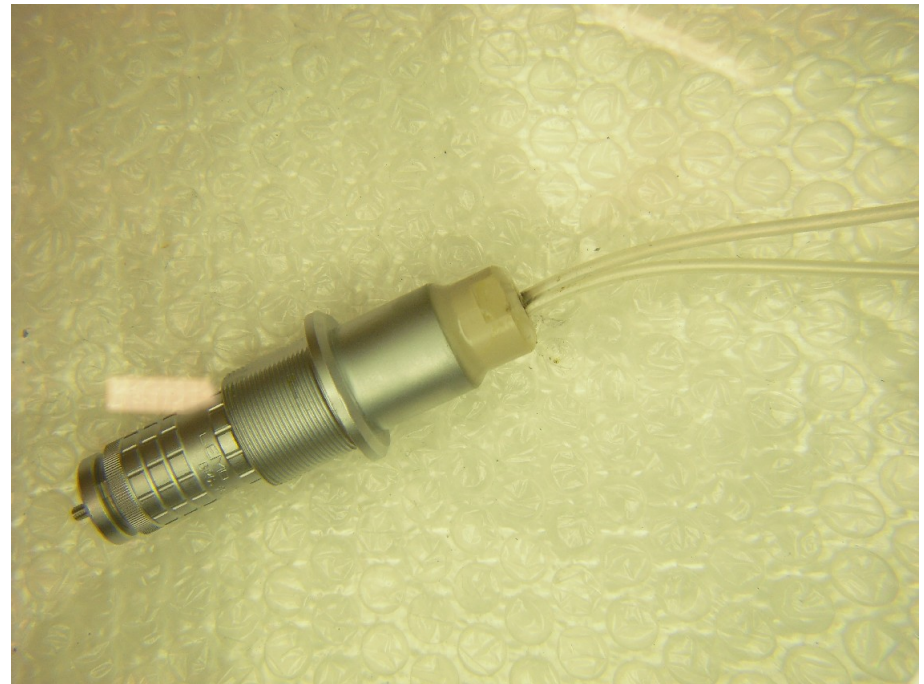
- First, the test with the modification ran stable but tripped after ~20h
- After this, field cage tripped immediately at ~10kV (carbon bridge?!)
- Open the cathode end plate again:
 - Carbon Bridge in the HV plug, why now and not before is unclear
 - Plug casted in Stycast, not possible to open/repair it without destroying it
