# PXFEL2\_2

## Disassembly inspection results

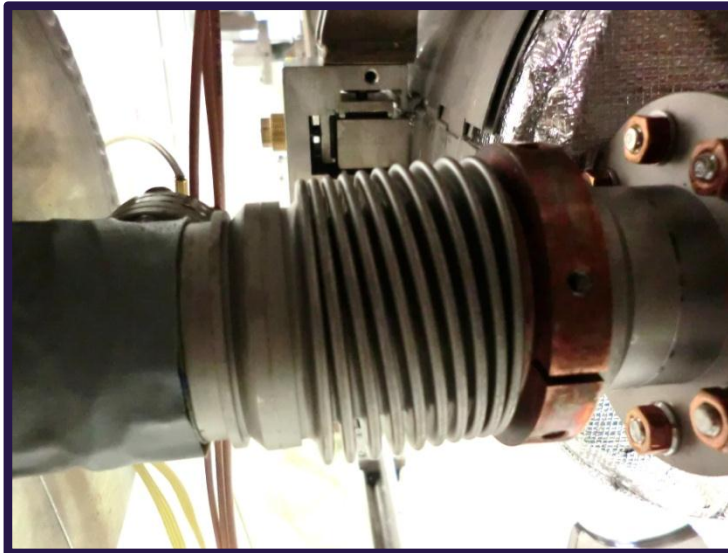
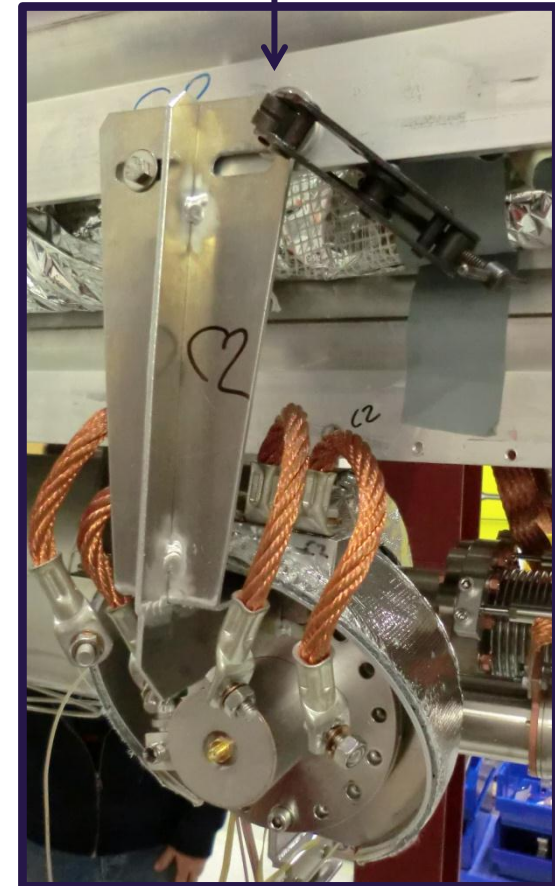
Coupler position PXFEL 2\_2:  
couplers are rotated up to 0.44 degrees

The screws for the assembly of the temporary  
coupler support cannot be assembled
