Status report from Lund

8.1.2015

Test set-up for testing SALTRO16-chips on Carrier Boards

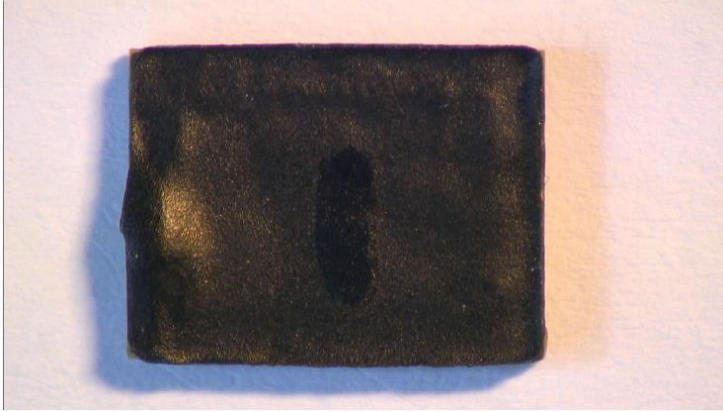
Carrier board 1

- Observation:
- The glob did not have a straight edge (see the left side)
⇒ the board did not fit the test socket
 - The upper surface was not flat
⇒ A rubber piece had to be put on top so that the pressure was more evenly distributed

- After carefully machining off the additional material the board was made to fit the test socket

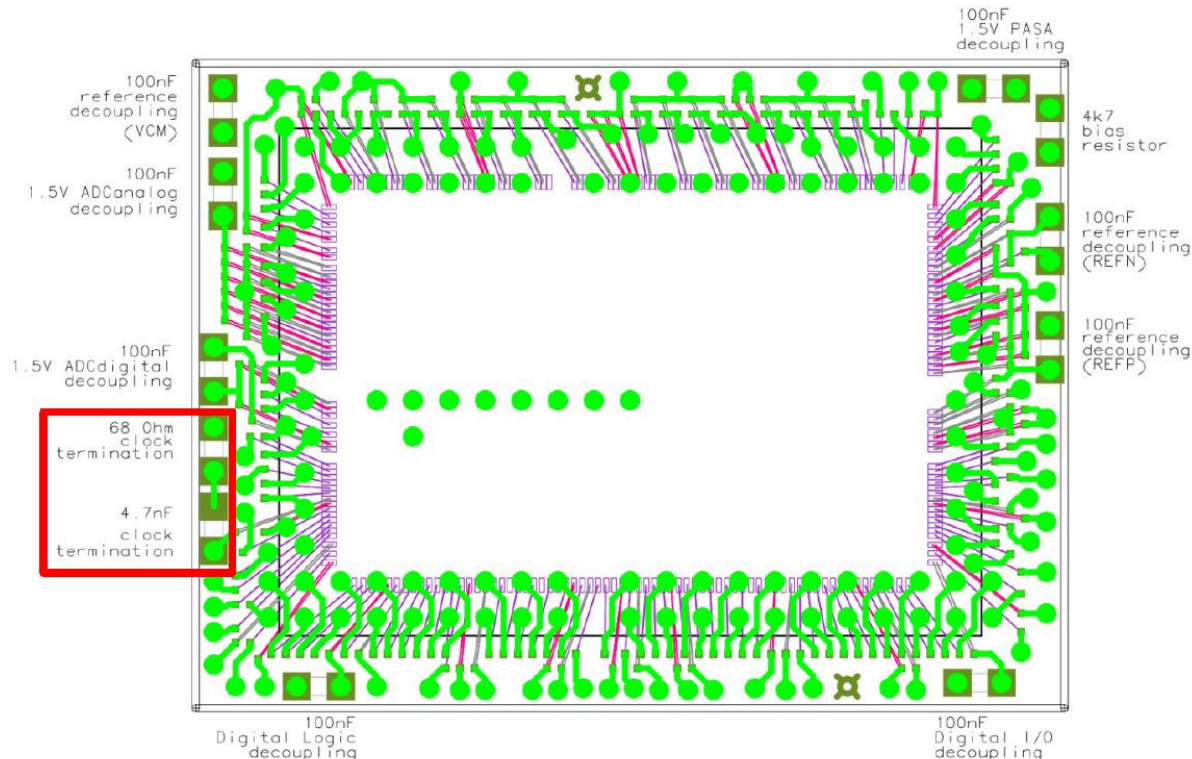
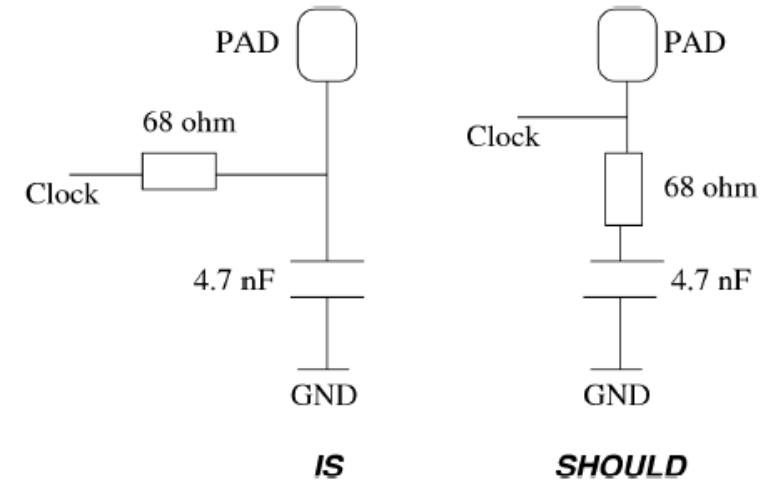
Testresults of carrier board 1

- Two shorted pair of bond wires were found
- A capacitor was wrongly mounted \Rightarrow the sampling clock was wrongly terminated so that the clock pulse did not appear (see picture below)
- \Rightarrow The SALTRO-chip does not work without the sampling clock
- \Rightarrow Due to the shortages the chip is going into non-usable mode i.e. a communication with the chip was not possible
- \Rightarrow Problems with noise, the reason for which is not known

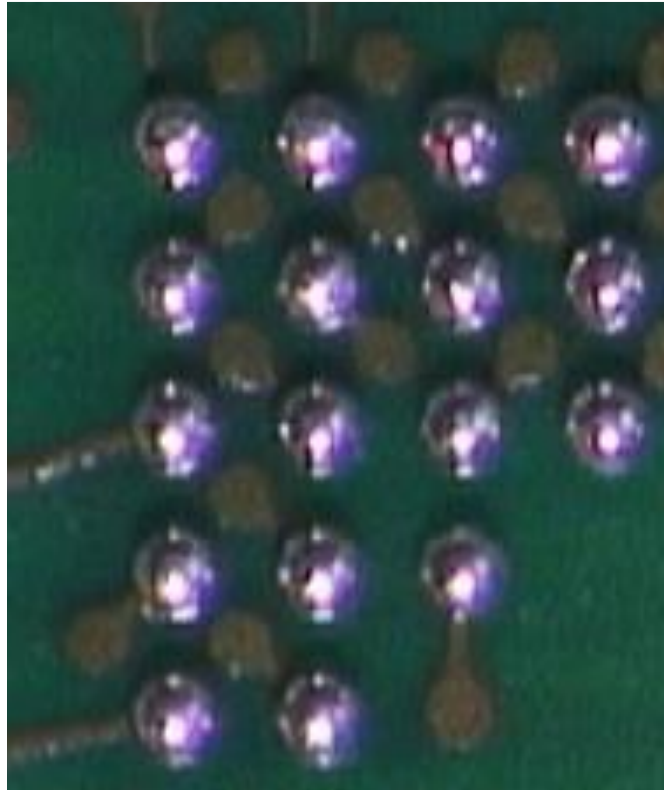
Before tests

- After the tests the tin balls were inspected and one could see small marks after the sensor pins
- We don't think that this will influence the soldering procedure but this has to be discussed with the company.
