Status of the carrier board

17.3.2016

Leif Jönsson
Lund University

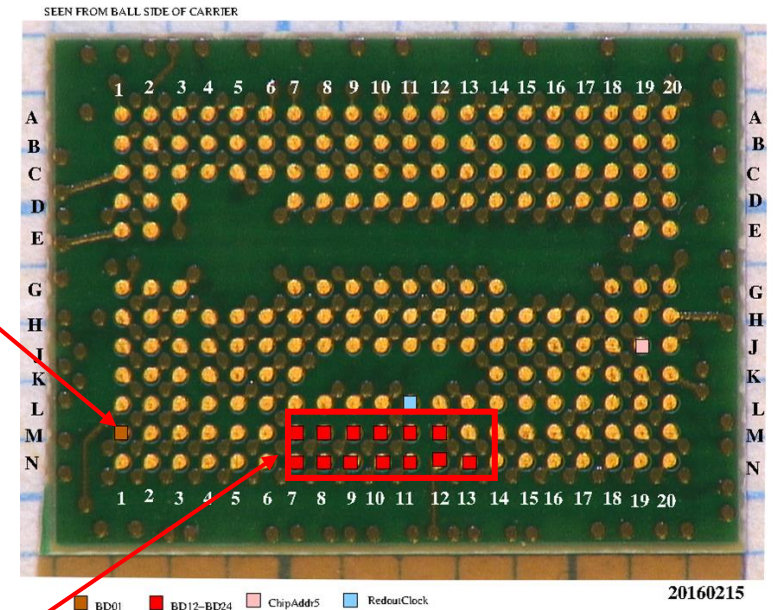
Carrier board; bottom view with tin balls in BGA pattern

The first test of the carrier board mounted on the adaptor board showed that one data line didn't have a connection. This was the only error found. The first test with readout was otherwise promising.

After further tests the situation got worse and we ended up with an area with no connections. We suspect a problem with the soldering

The board has been sent back to the company for re-soldering
