# Investigations of the long-term stability of a GEM-TPC

Oleksiy Fedorchuk  
FLC TPC group  
2016, Hamburg

# Goal of the Study

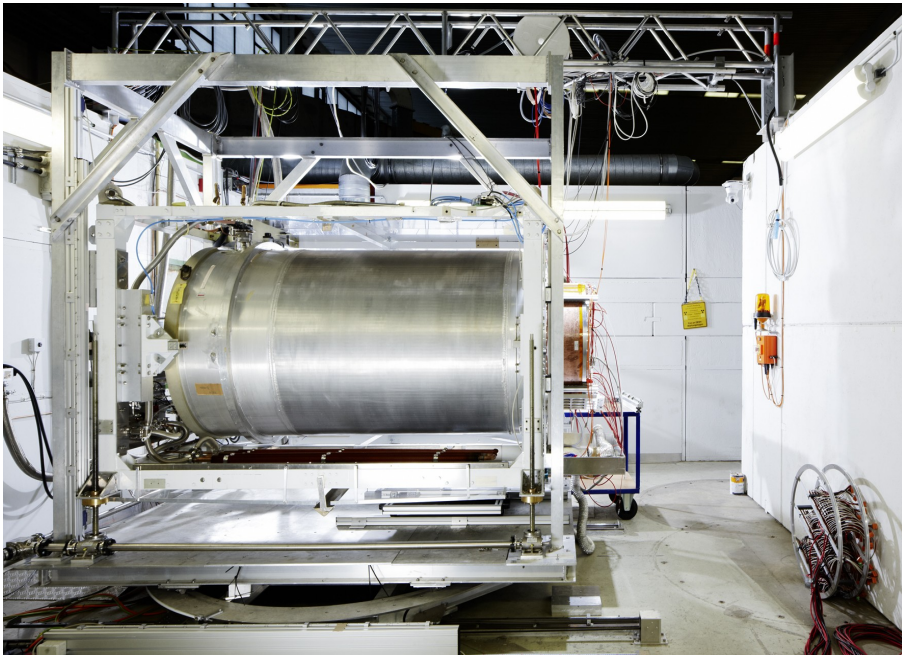
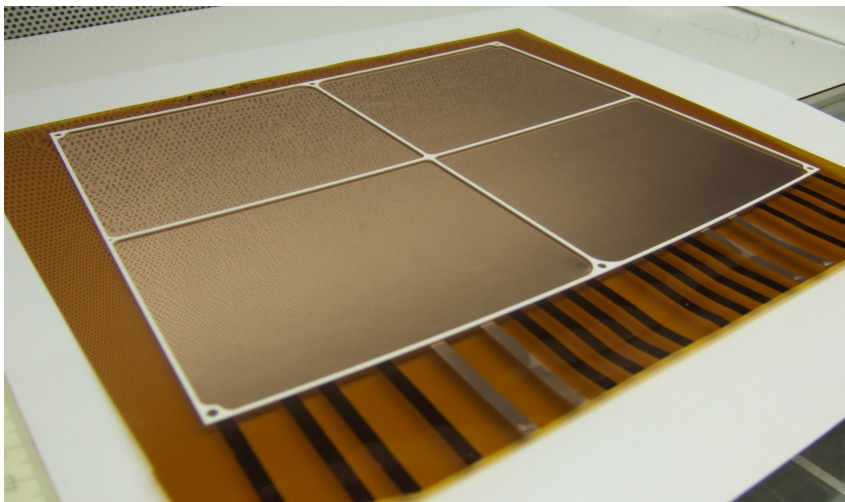
- Have built and operated TPC with triple GEM readout
- Test beam in March 2013 and later in Fall 2013 showed a problem with the high voltage long-term stability
- After several weeks of stable operation
  - Several observed discharges
  - 2 destructive discharges at the end of Test Beam
  - 1 destructive discharges which extreme conditions

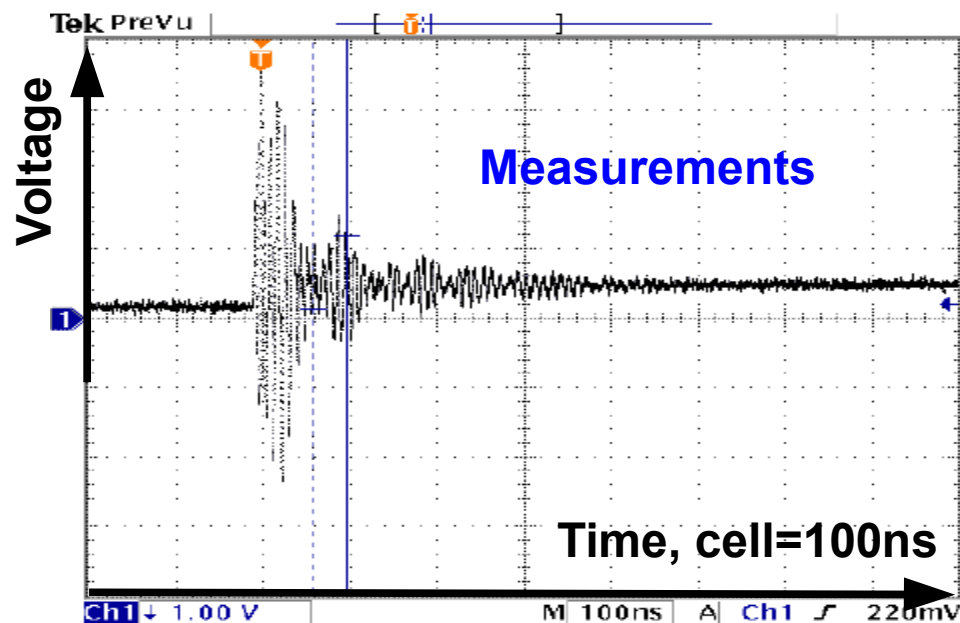
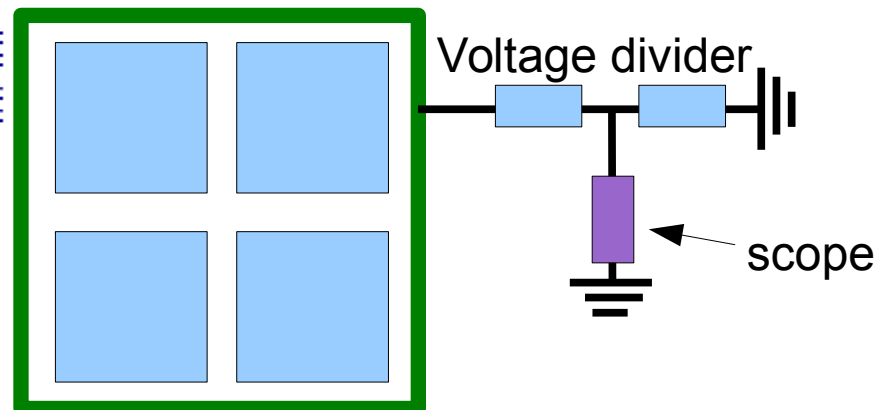
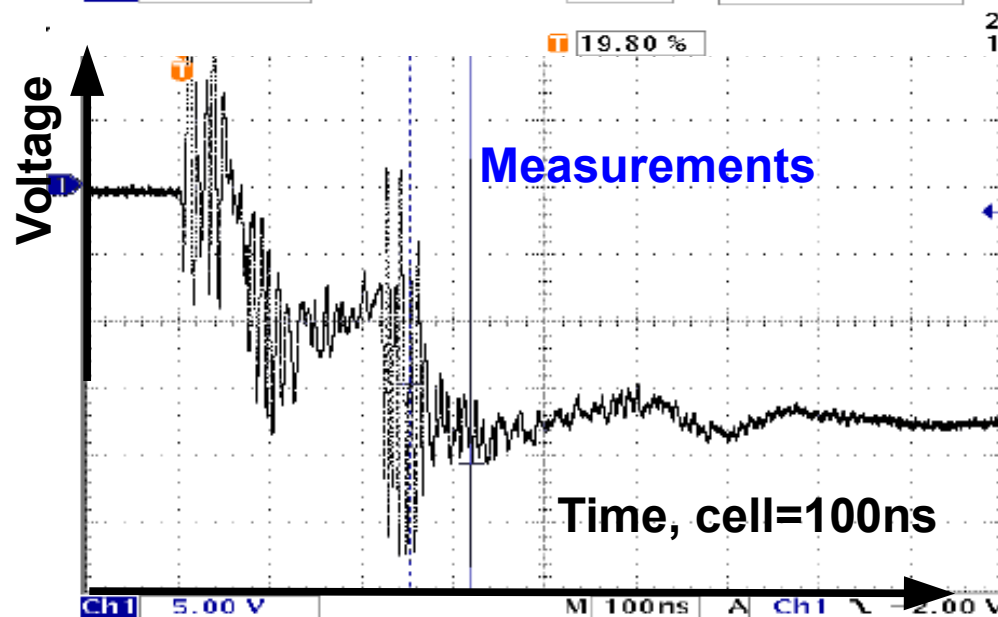
- we observe oscillations of the potential after a spark
- we observe a clear sequential behavior of multiple discharges
- we suspect that the oscillations enhance the probability for multiple discharges

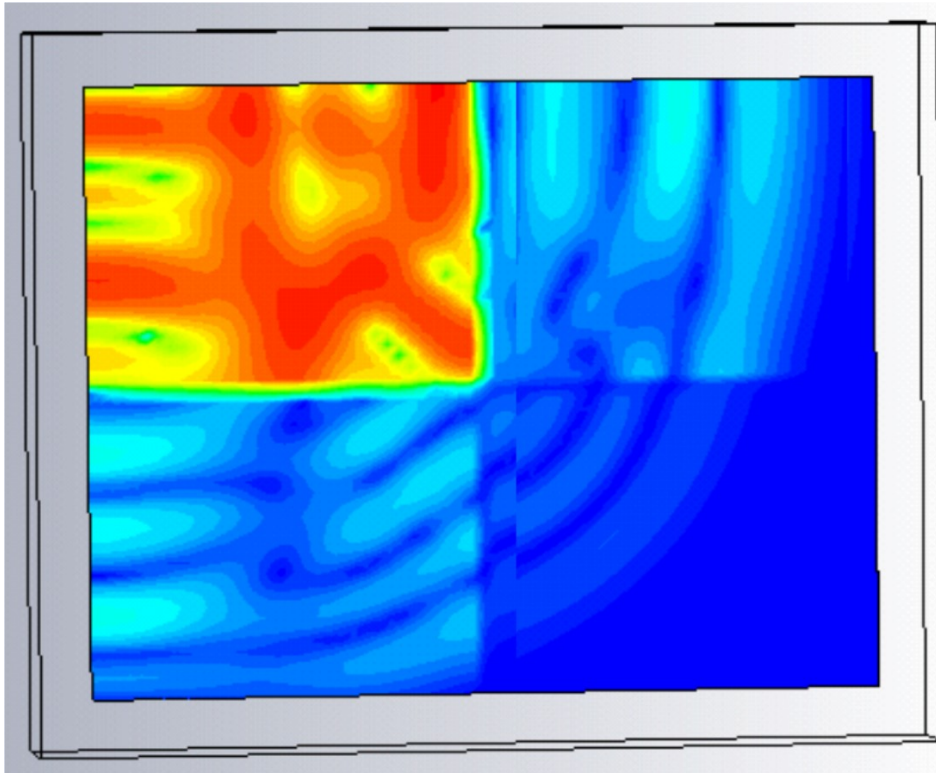
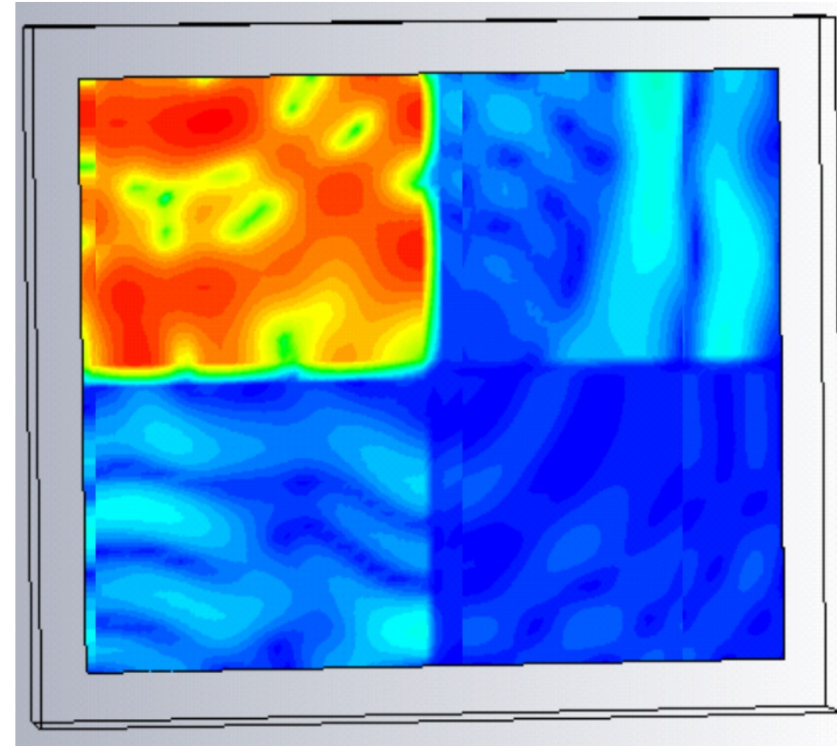
- Discharge causes current oscillations on GEM surface in different sectors (CST<sup>®</sup> simulations)

- **Voltage oscillations caused by electromagnetic wave reflected from borders.**

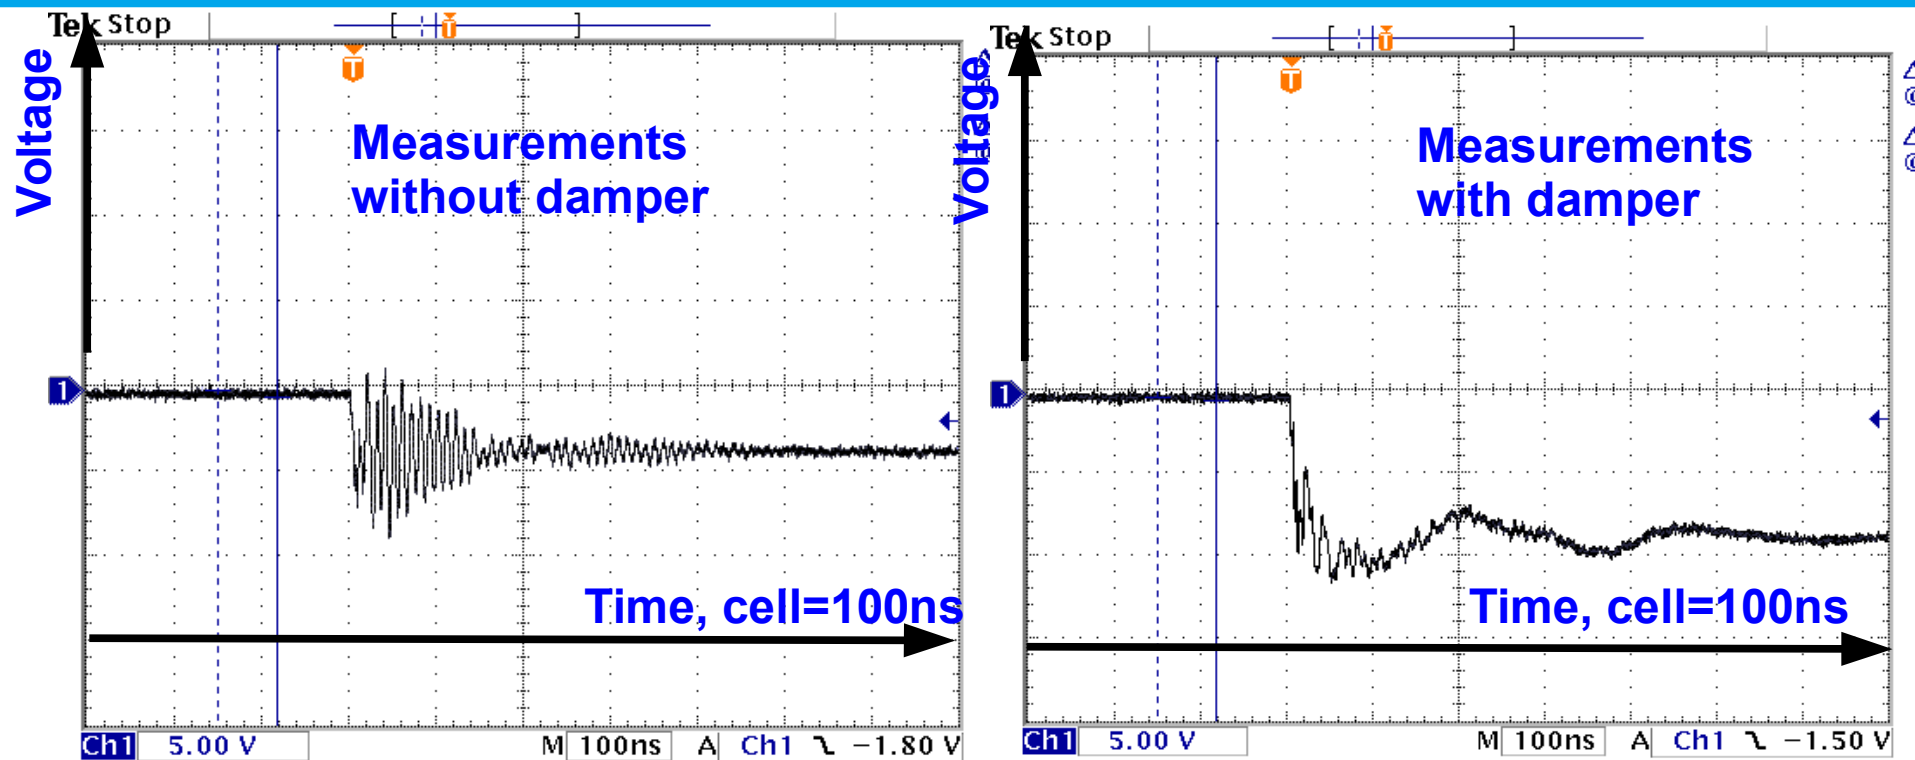
520V	Without RC (22hours)	With RC (47hours)	Without RC again (63hours)
Registered discharges	166	75	75
Multy discharges among	13	0	5

➤ **Filtering of oscillations helps to get rid of multiple discharges**

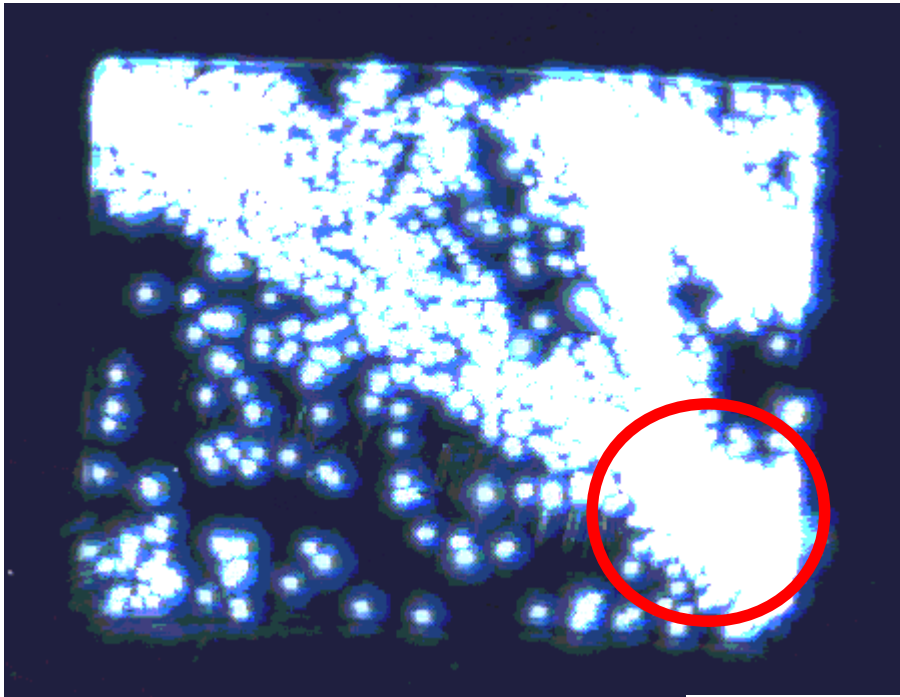
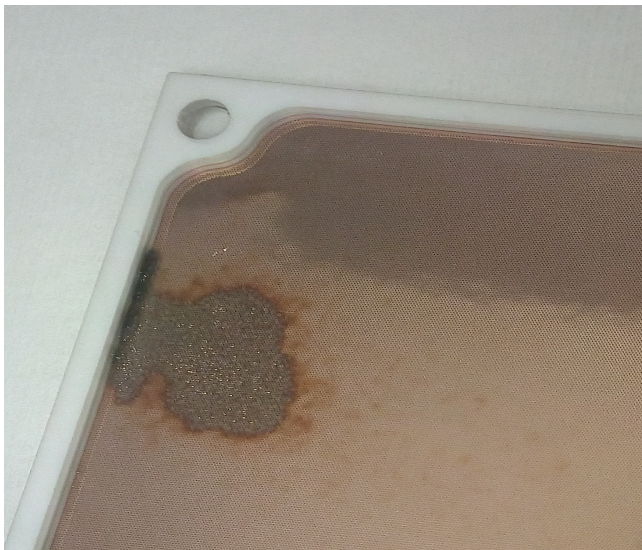
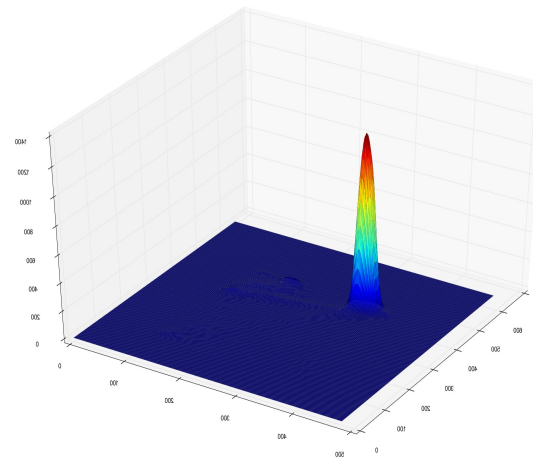
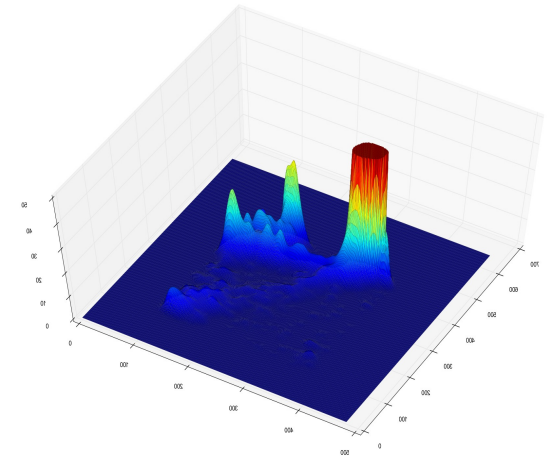
- operated double framed GEM under extreme conditions with protective circuit
- recorded about 30000 discharges
- towards the end deterioration of performance, constant current
- physical damage to the GEM observed, details are under study

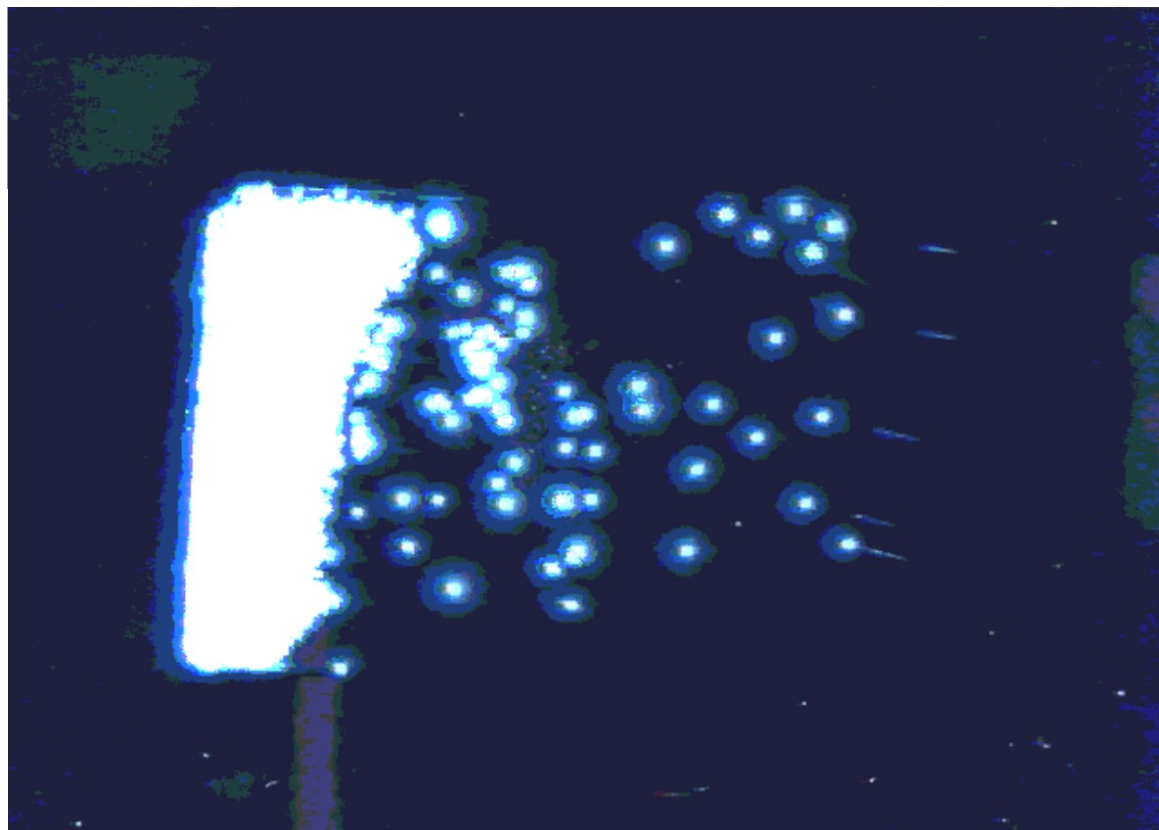
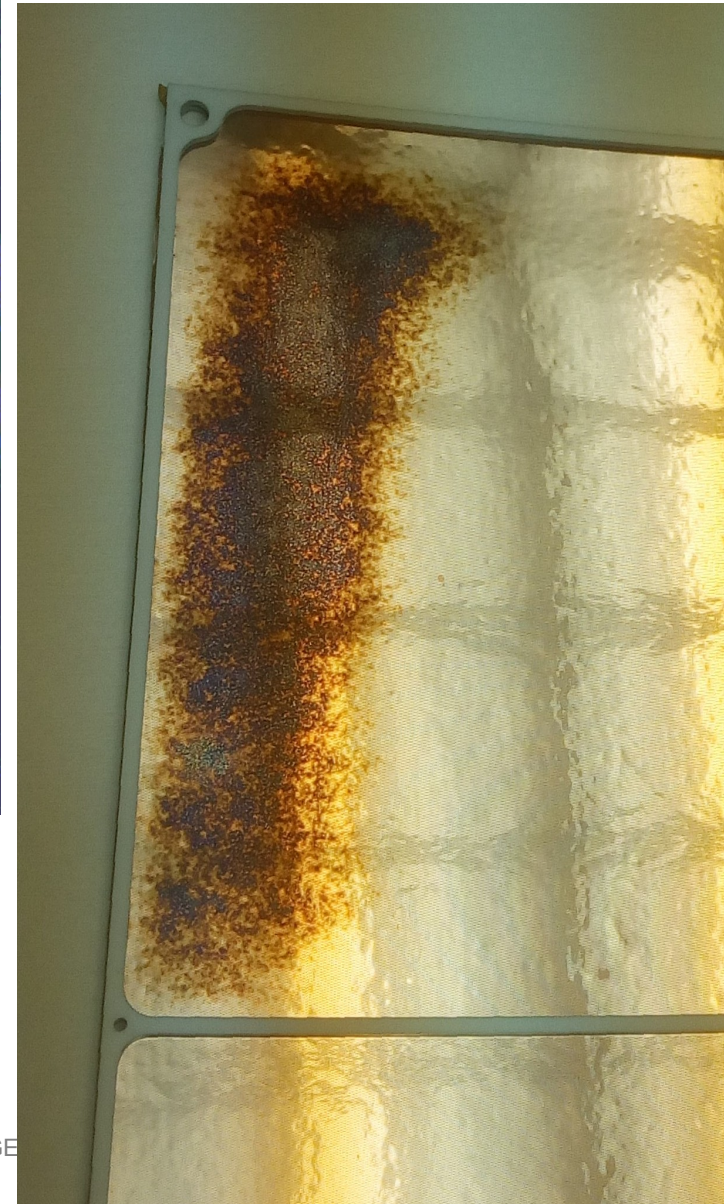
- About 150,000 discharges.
- Stage of testing the protective circuit
- Sector died at the end

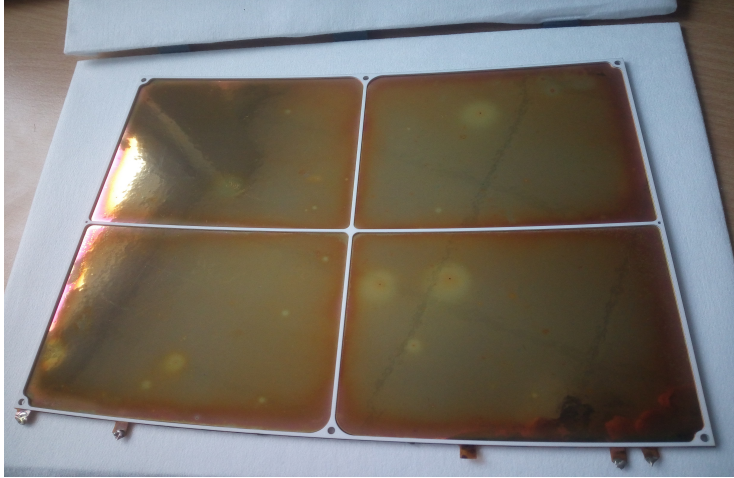
➤ Presumably covered by CuO(black)

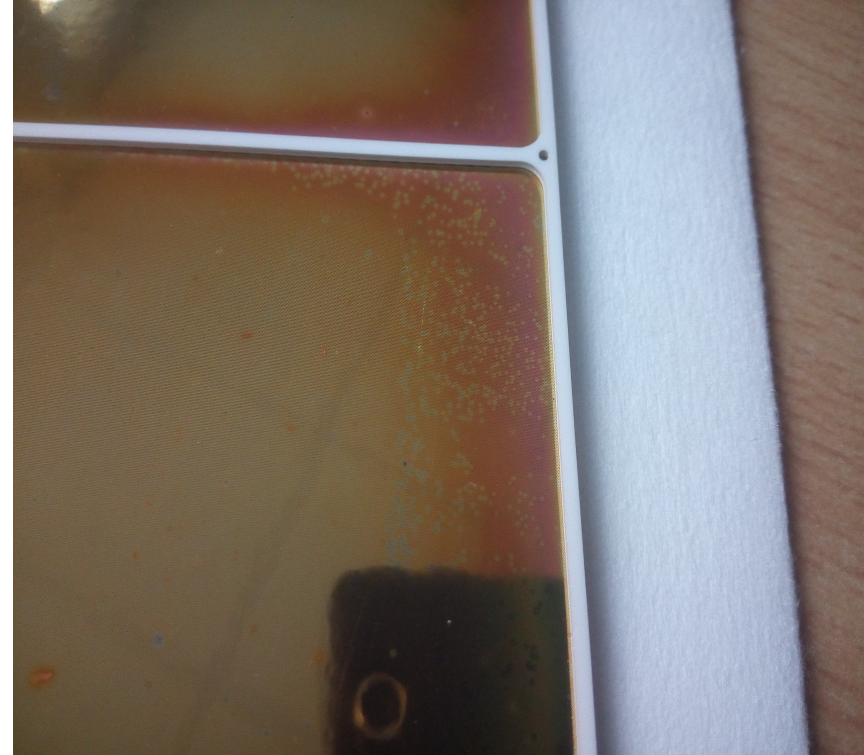
➤ Presumably trace of previous sparks

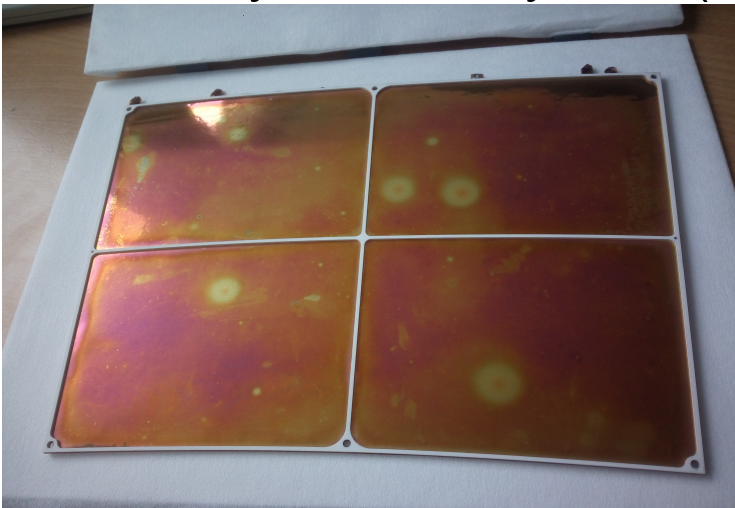
➤ Presumably covered by Cu<sub>2</sub>O(red)

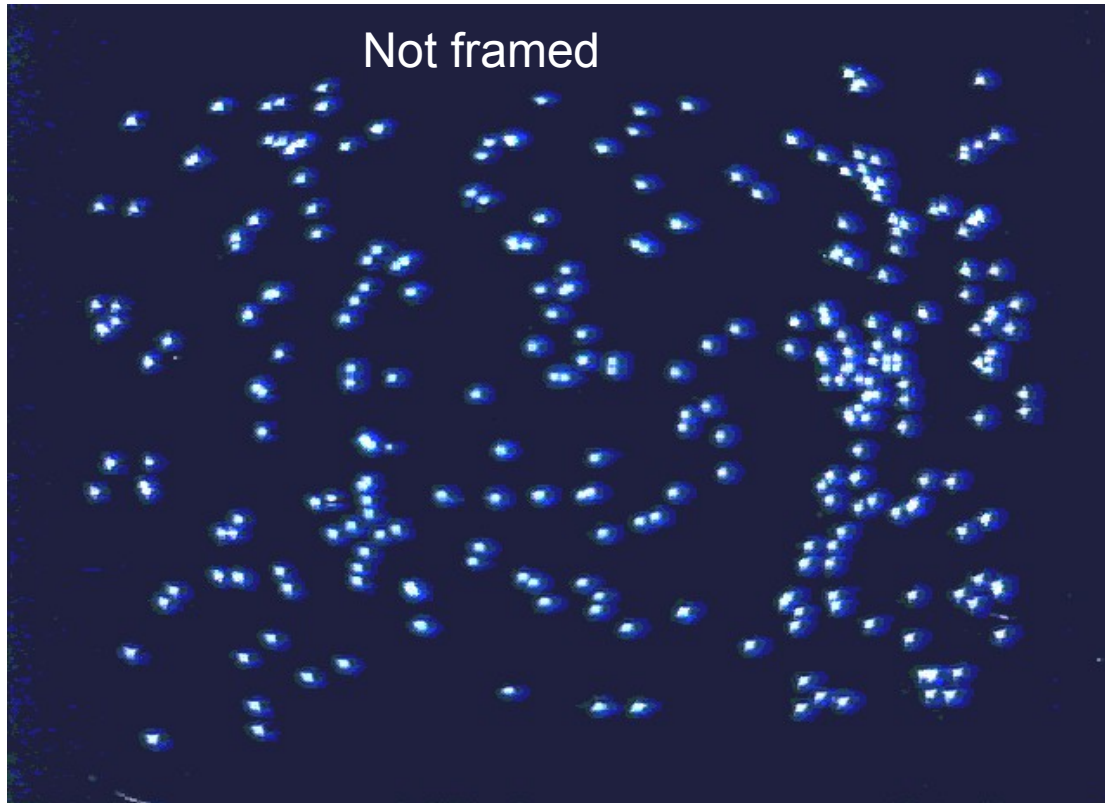
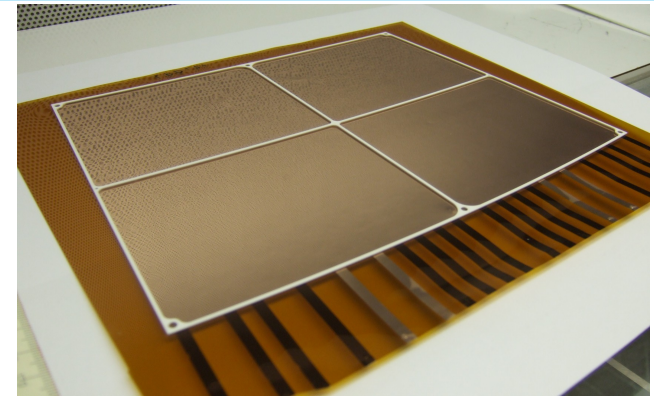
Not framed

- Unframed GEM.
- 247 events at 620 V for 20 hours. **4 Sectors**
- Framed from both sides
- 2503 events at 600 V for 24 hours. 2 Sectors

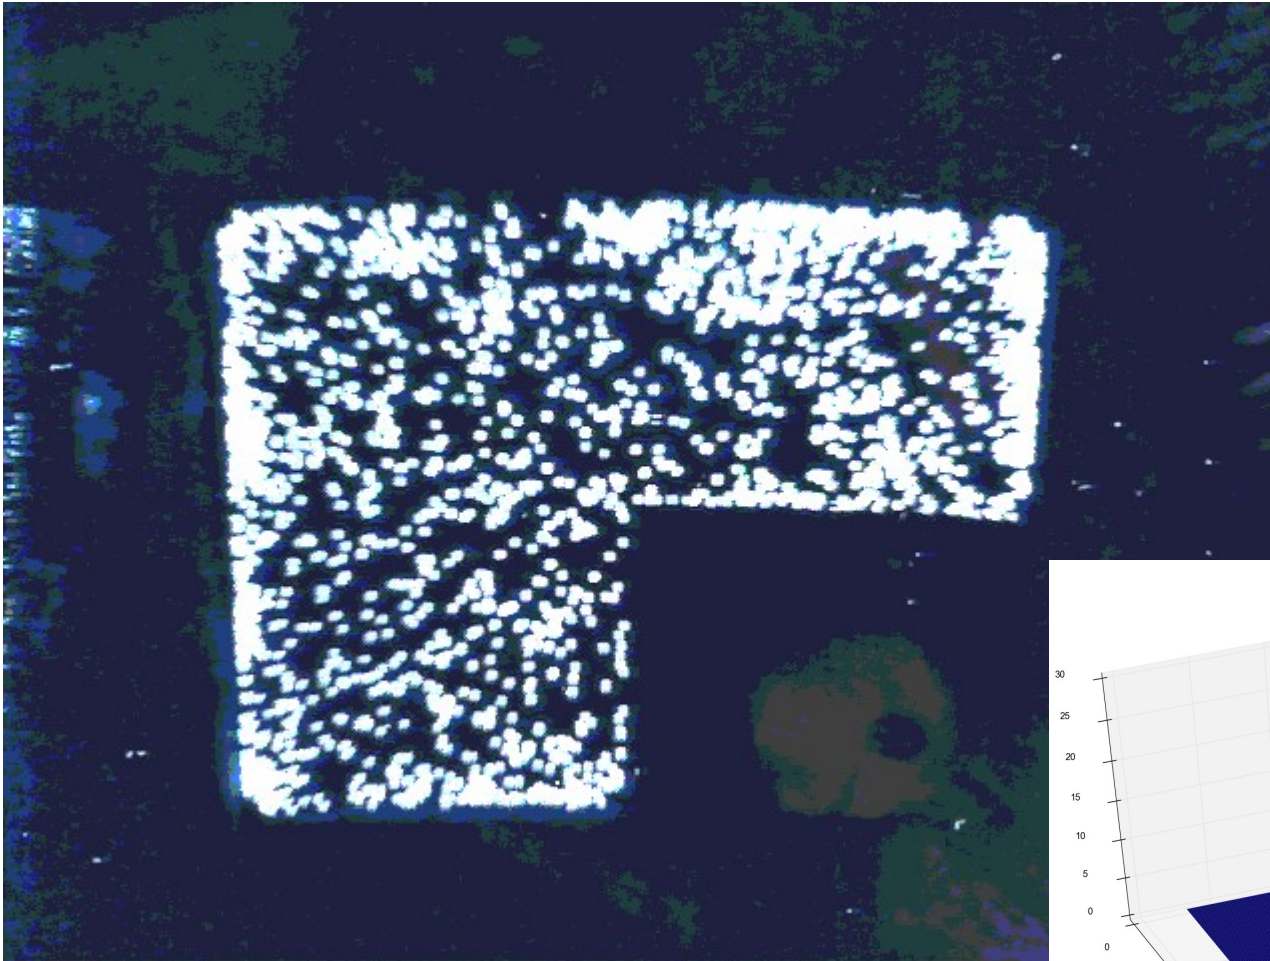
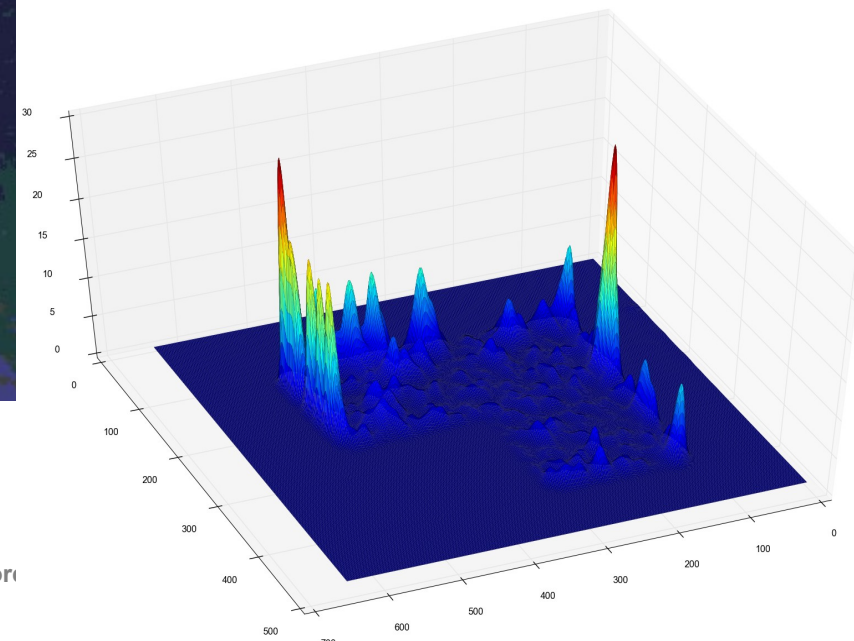
5573 trips has been detected. The fatal trip is a usual single trip.

- > 1-488: <640V
- > 489-849: 640V
- > 850-1688: 660V
- > 1689-3707: 680V
- > 3708-5573: 700V

Further testings show that problem has not been solved
