# Alice TPC Review

### **The ALICE Review of TPC Distortions**

17-November-2016

## Distortions in the ALICE TPC

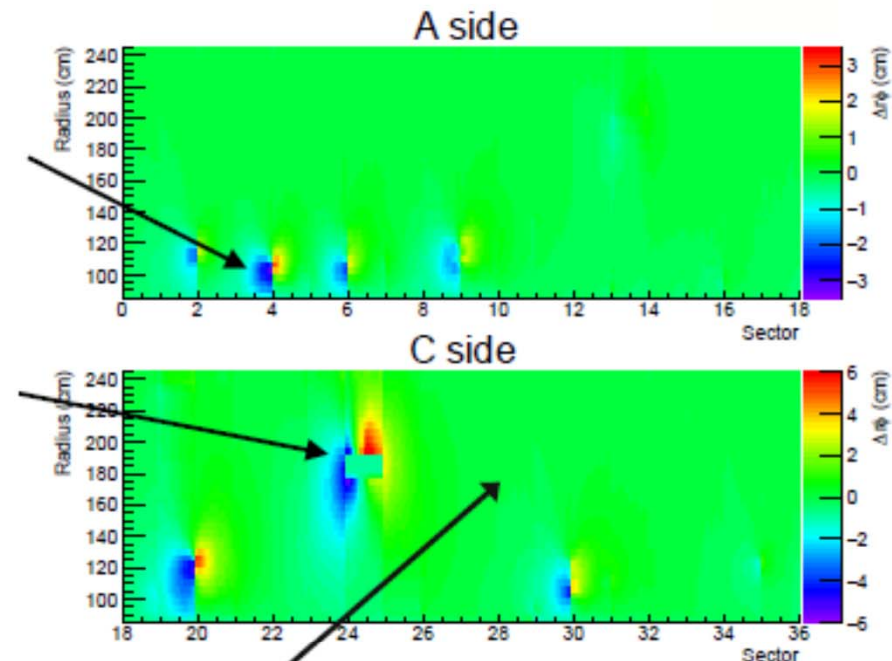
## Distortions in RUN2 at high IR

Large local distortions up to 5cm  
localized at chamber edges of IROCs:  
Origin not understood

Large local distortions („hot spots“)  
in the center of OROC C06:  
Likely due to floating GG wire(s)

„Bulk distortions“ consistent with  
expectation from gas properties

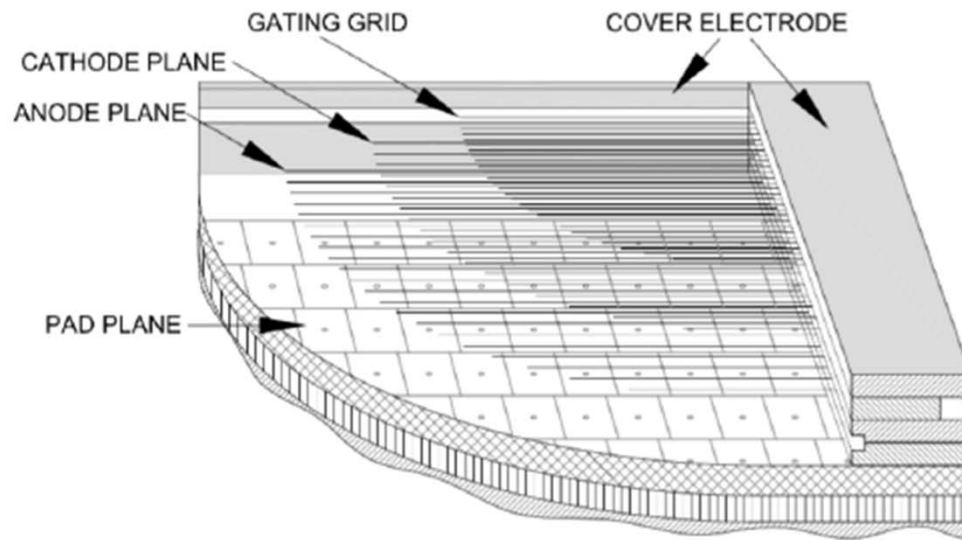
# Wire ledges

Potential on GG,  
cover and skirt  
match the drift field.  
Fine tuning done  
with data

- Wires are soldered on a ~3 mm Cu tape stripe on alternating sides of the ledges
- Wires are glued on their ledges as the next ledge is laid
- Both sides are passivated with a 0.5 mm layer of epoxy
- Anode wire grid 'terminated' by two thick wires
- A cover electrode matches the drift field and prevents ion leakage

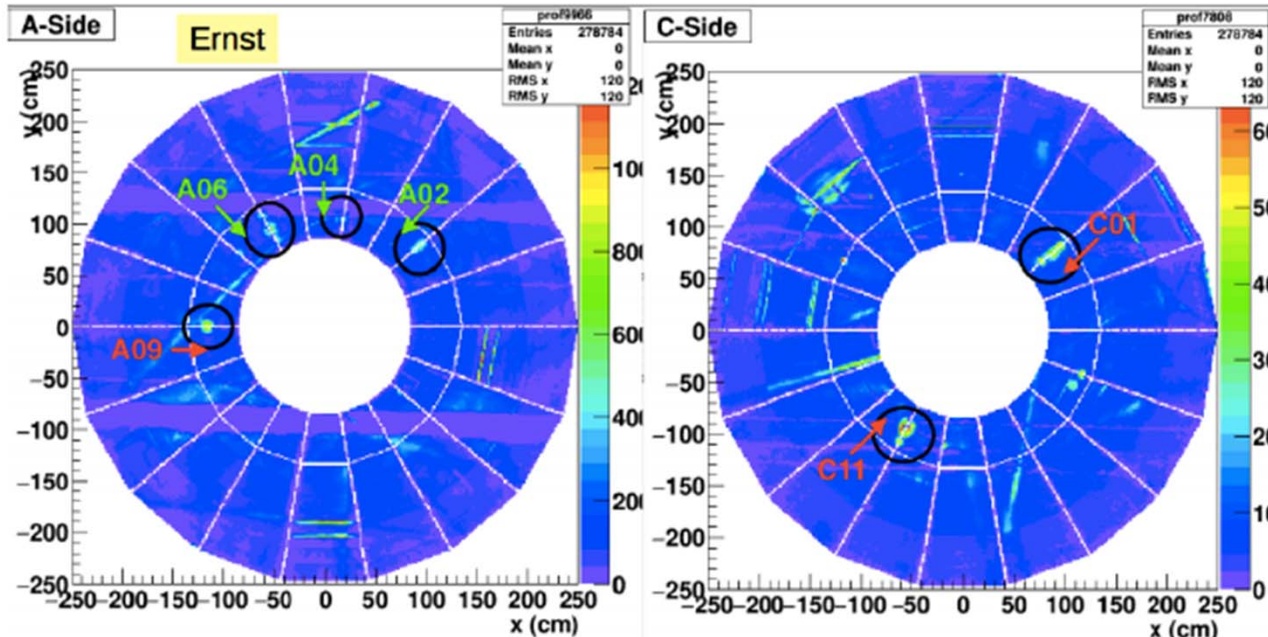
# Central Electrode

- Distortion hot spots occur always at the same side of the ROC (C-Side is mirrored)
- Individual chambers could be associated to a specific batch during chamber production

- The CE is composed of 3 Al-mylar foils glued together and stretched
- Stray laser light extracts photoelectrons to provide an image of the CE onto the ROCs, for drift velocity calibration
