# Sensor delamination

On behalf of the SiW ECAL Groups in CALICE:

CALICE Meeting – October 2022

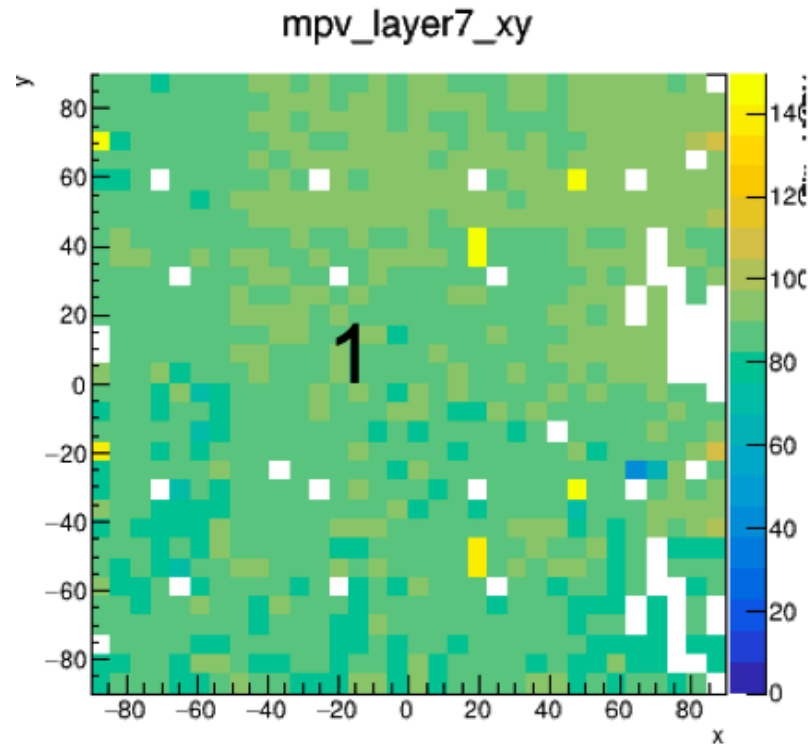
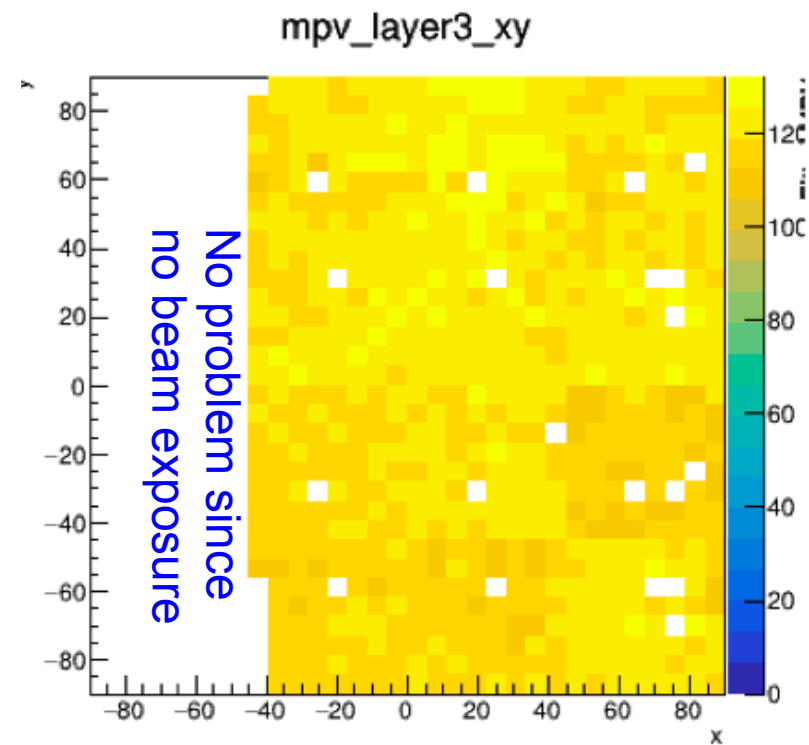
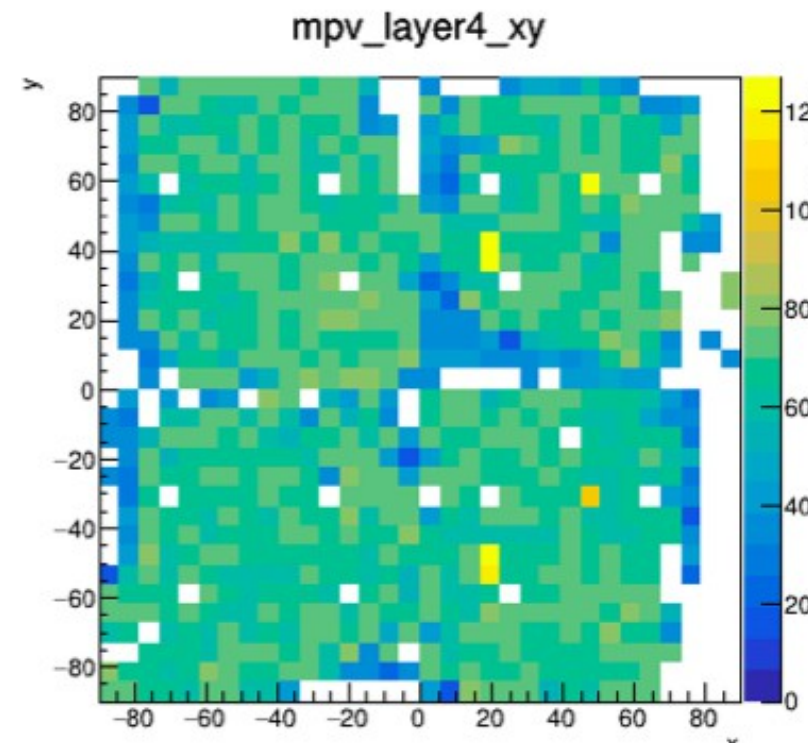
- We have good layers ...
  - Homogeneous response to MIPs over layer surface
  - > 90% efficiency for MIPs
  - Here white cells are masked cells due to PCB routing
    - understood and will be corrected

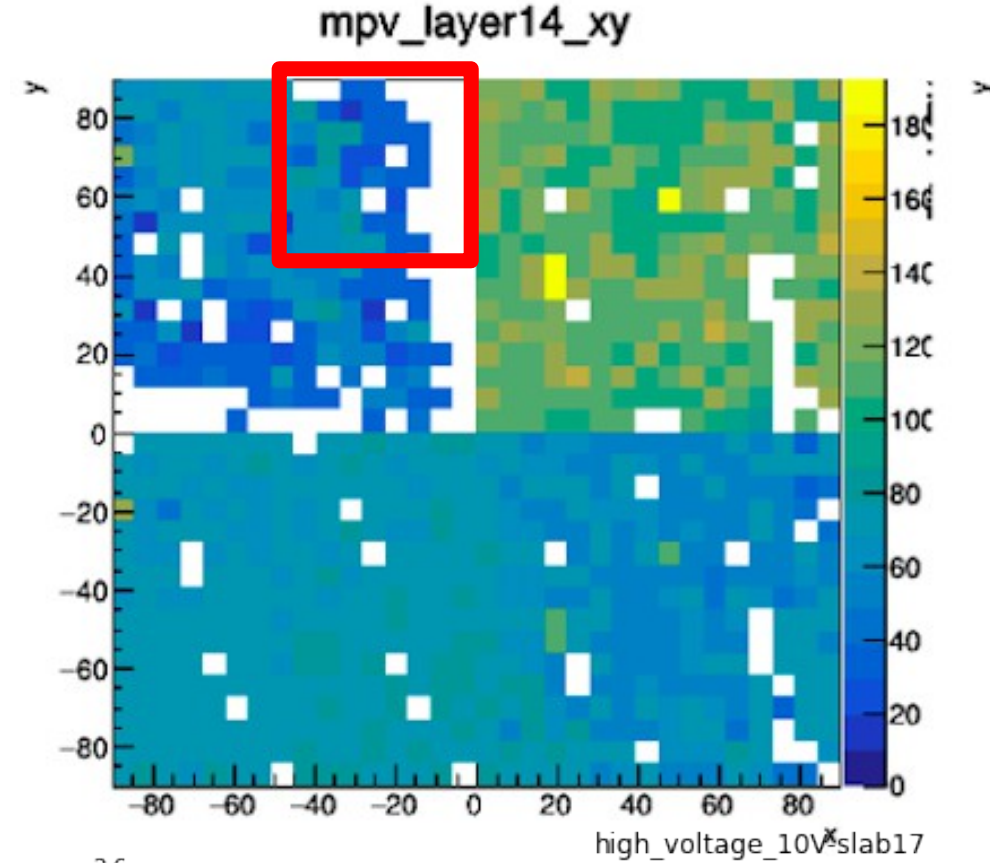
... and not so good layers

- Inhomogeneous response to MIPs
  - Partially even no response at all, in particular at the wafer boundaries
    - See also talk by Hector on Thursday
  - Not seen in 2017, degradation already observed during 2018/19
  - Upon visual inspection delamination could be seen by eye
- Since Summer 2022 access to the different stages of the ASICs
  - => analogue probes, major debugging tool

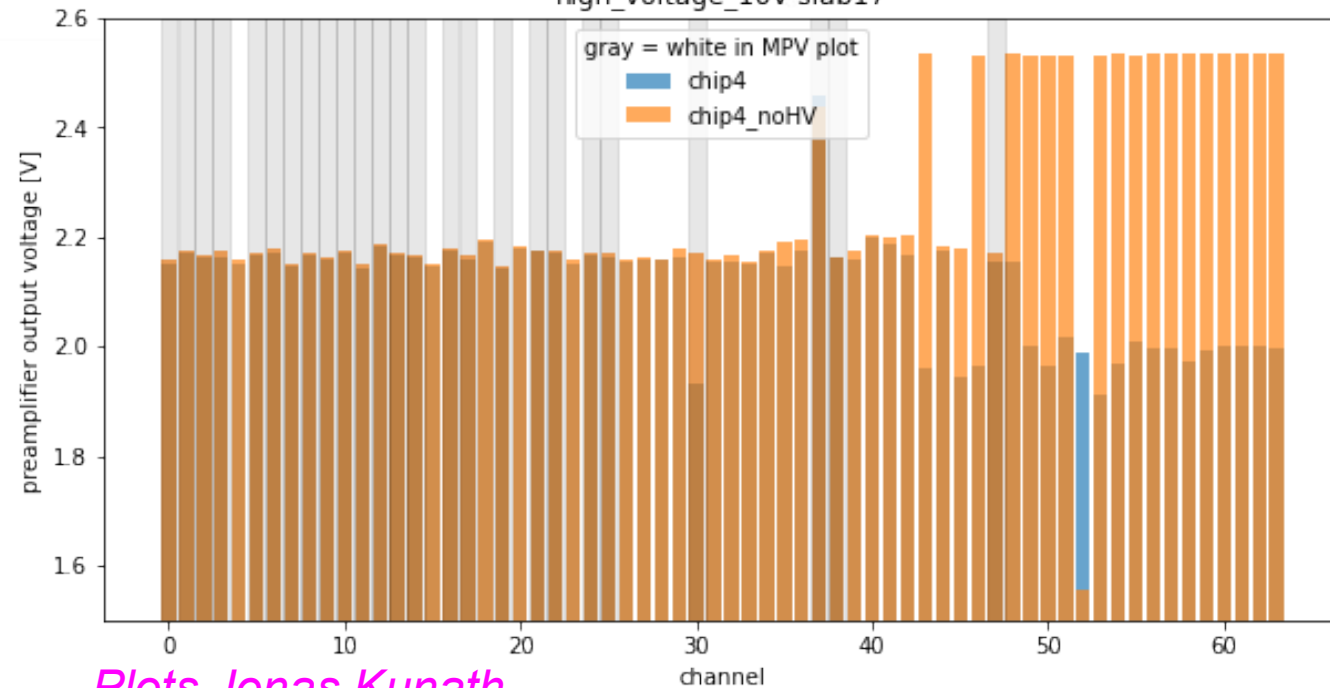
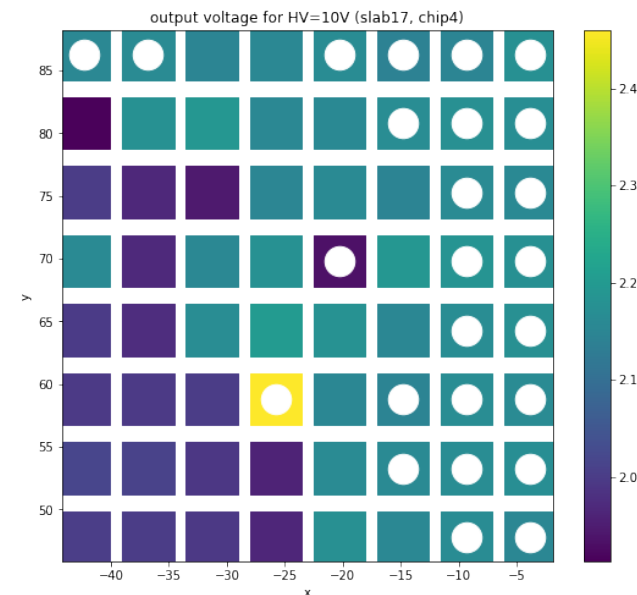
- Clearly spotted non connected Si pads
- One to one correspondance between “White cells” in MPV plots and AP measurements
- “Strange MIPs” in MPV plot could also be identified as not connected  
=> Analogue probes allow for identifying Si pad status
- Here: handish measurement with voltmeter
- Future: Automatised reading with DAQ
