First report from FONT4 at ATF Week of the 21st of April 2008

Sampling errors from March 2008

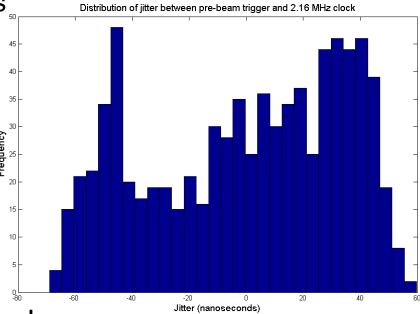
Trigger jitter causes missing pulses

Pre-beam trigger jitter wrt 2.16MHz ring clock ±60ns

c.f ring clock period of 463ns

- Trigger close to ring clock edge
 - → Wrong ring clock cycle sometimes selected
- Solution: implement trigger delay in firmware (to do)

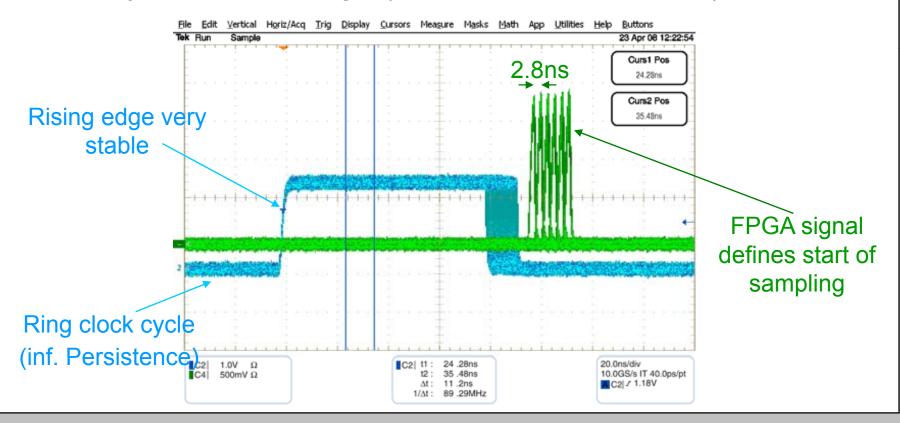
Sample time variation in 2.8ns steps

- We use 2.16MHz ring clock to begin sampling process
 - In March, cycles of 357MHz counted wrt falling edge
- ±6ns jitter on this edge (see below scope trace)

- Carefully timed pre-beam trigger
- Modified FPGA firmware (modification #1)
 - Sampling now begins wrt 2.16MHz rising edge
- Sampling issues resolved

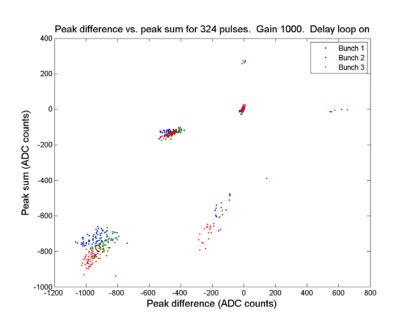
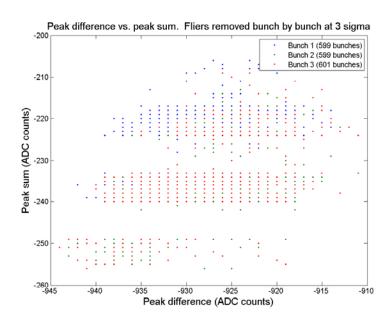
March data (left), modified firmware #1 (right)

New results much more sensible!

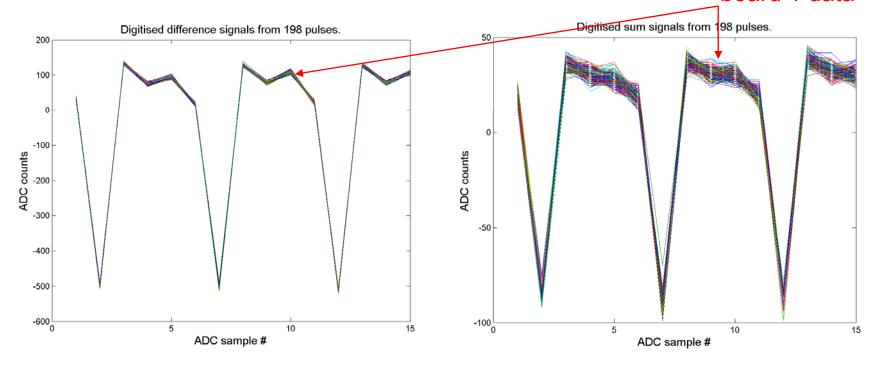
Prior to trip, difference between digital board 1st and 2nd generations noted

Ran board 3 with modified firmware #1

Slight difference from board 1, but still works

'Slanting' not present on board 1 data

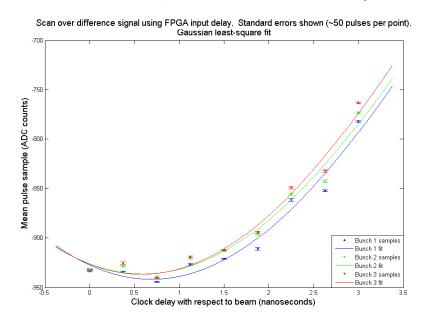
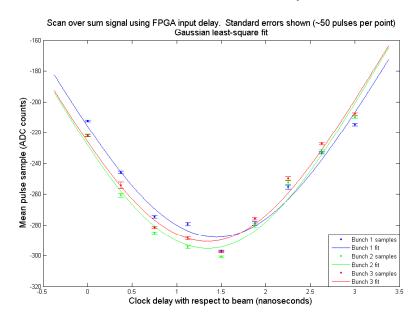
Scanned sum and difference signals by delaying clocks with respect to beam (used modified firmware #1)

- Systematic variation beyond standard errors visible
- Gaussian fits give $\sigma_{\Lambda} = 5.5 5.7$ ns and $\sigma_{\Sigma} = 2.7$ ns
- c.f scope data fits σ_{Δ} = 4.13 ns and σ_{Σ} = 2.68 ns
- Consistent Δ vs. Σ time offset of 0.76ns (due to BPM processor)

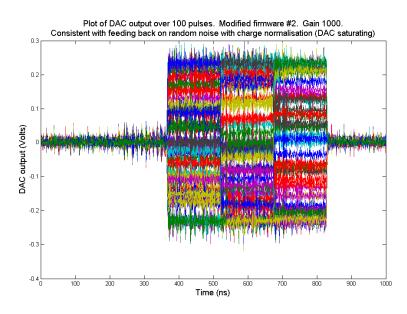
- Now for the bad news...
- Ran feedback without driving kicker while monitoring DAC
 - Modified firmware at Glenn's suggestion (modified firmware #2)
 - Intended to correct for DAC timing issues

Most likely explanation is wrong sample sent to DAC

1. Main priority is DAC timing

- MUST ensure that correct feedback signal is generated
- I will pursue this via simulation and tests using ATF signals
- I'll also liaise with Glenn on this
