Result of Optical Inspection at STF

(MHI-05 and MHI-06)

Ken Watanabe (KEK) TILC09 in Tsukuba 19-April-09

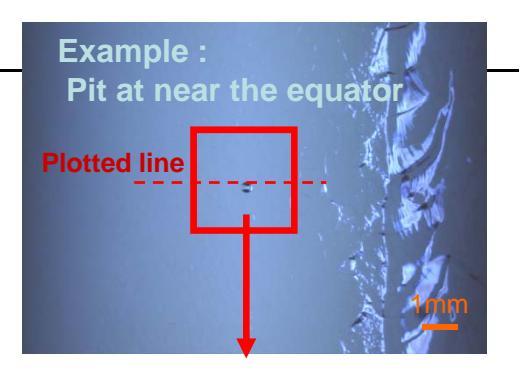
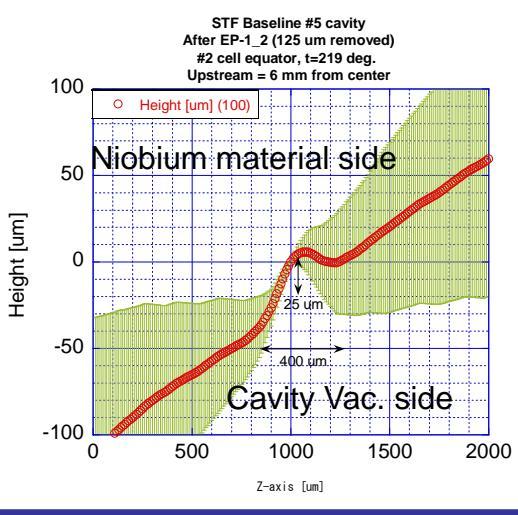
Two type of spots (Suspicious spots) were observed in MHI-05, MHI-06

- 1) Bump at near the equator (diameter: ~ 800 um)
- 2) Pit at near the equator (diameter: 300 ~ 500 um, depth : ~ 30 um)

Location : Outside Weld area between 15mm from joint of equator.

-> No heating these suspicious spots at ~ 39.9 MV/m

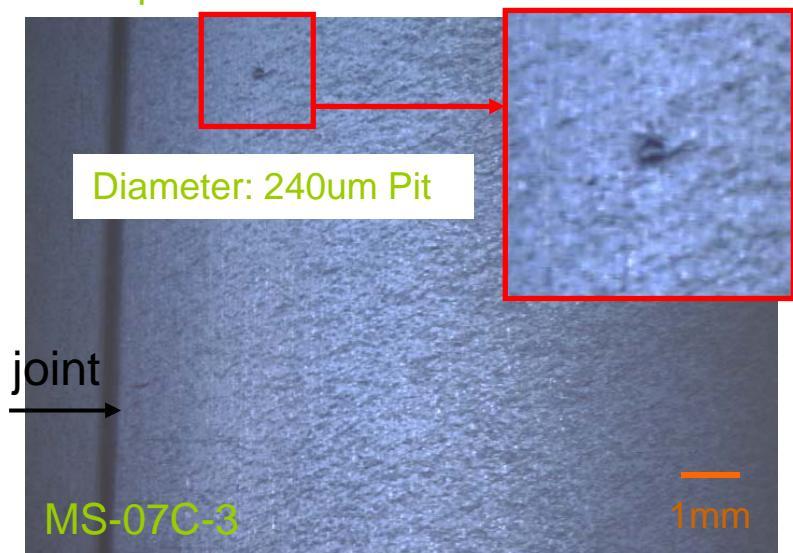
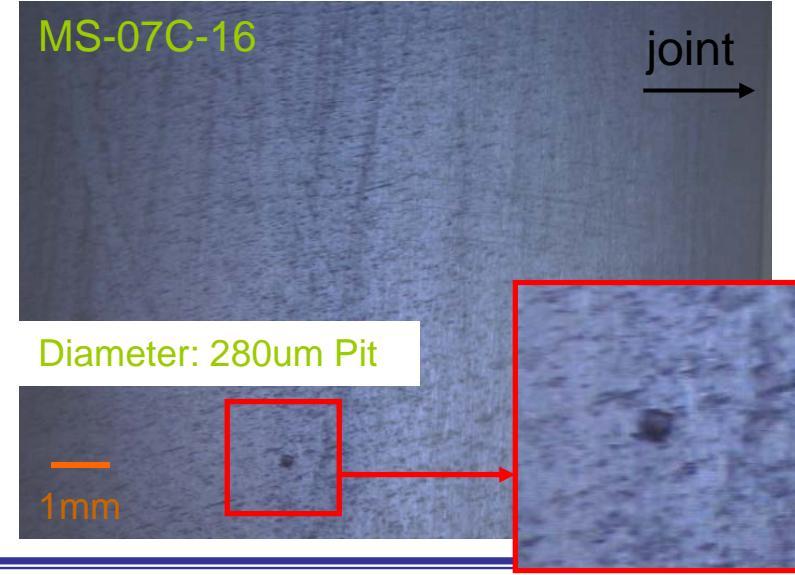
Example:

*The spots were observed on the surface at point of the dambels.

(The spots does not occur in the Surface treatment.)

*The location of the spots are between 15mm from a joint point.

However, a heating of similar spots are not detected at V.T. for MHI-05 and MHI-06

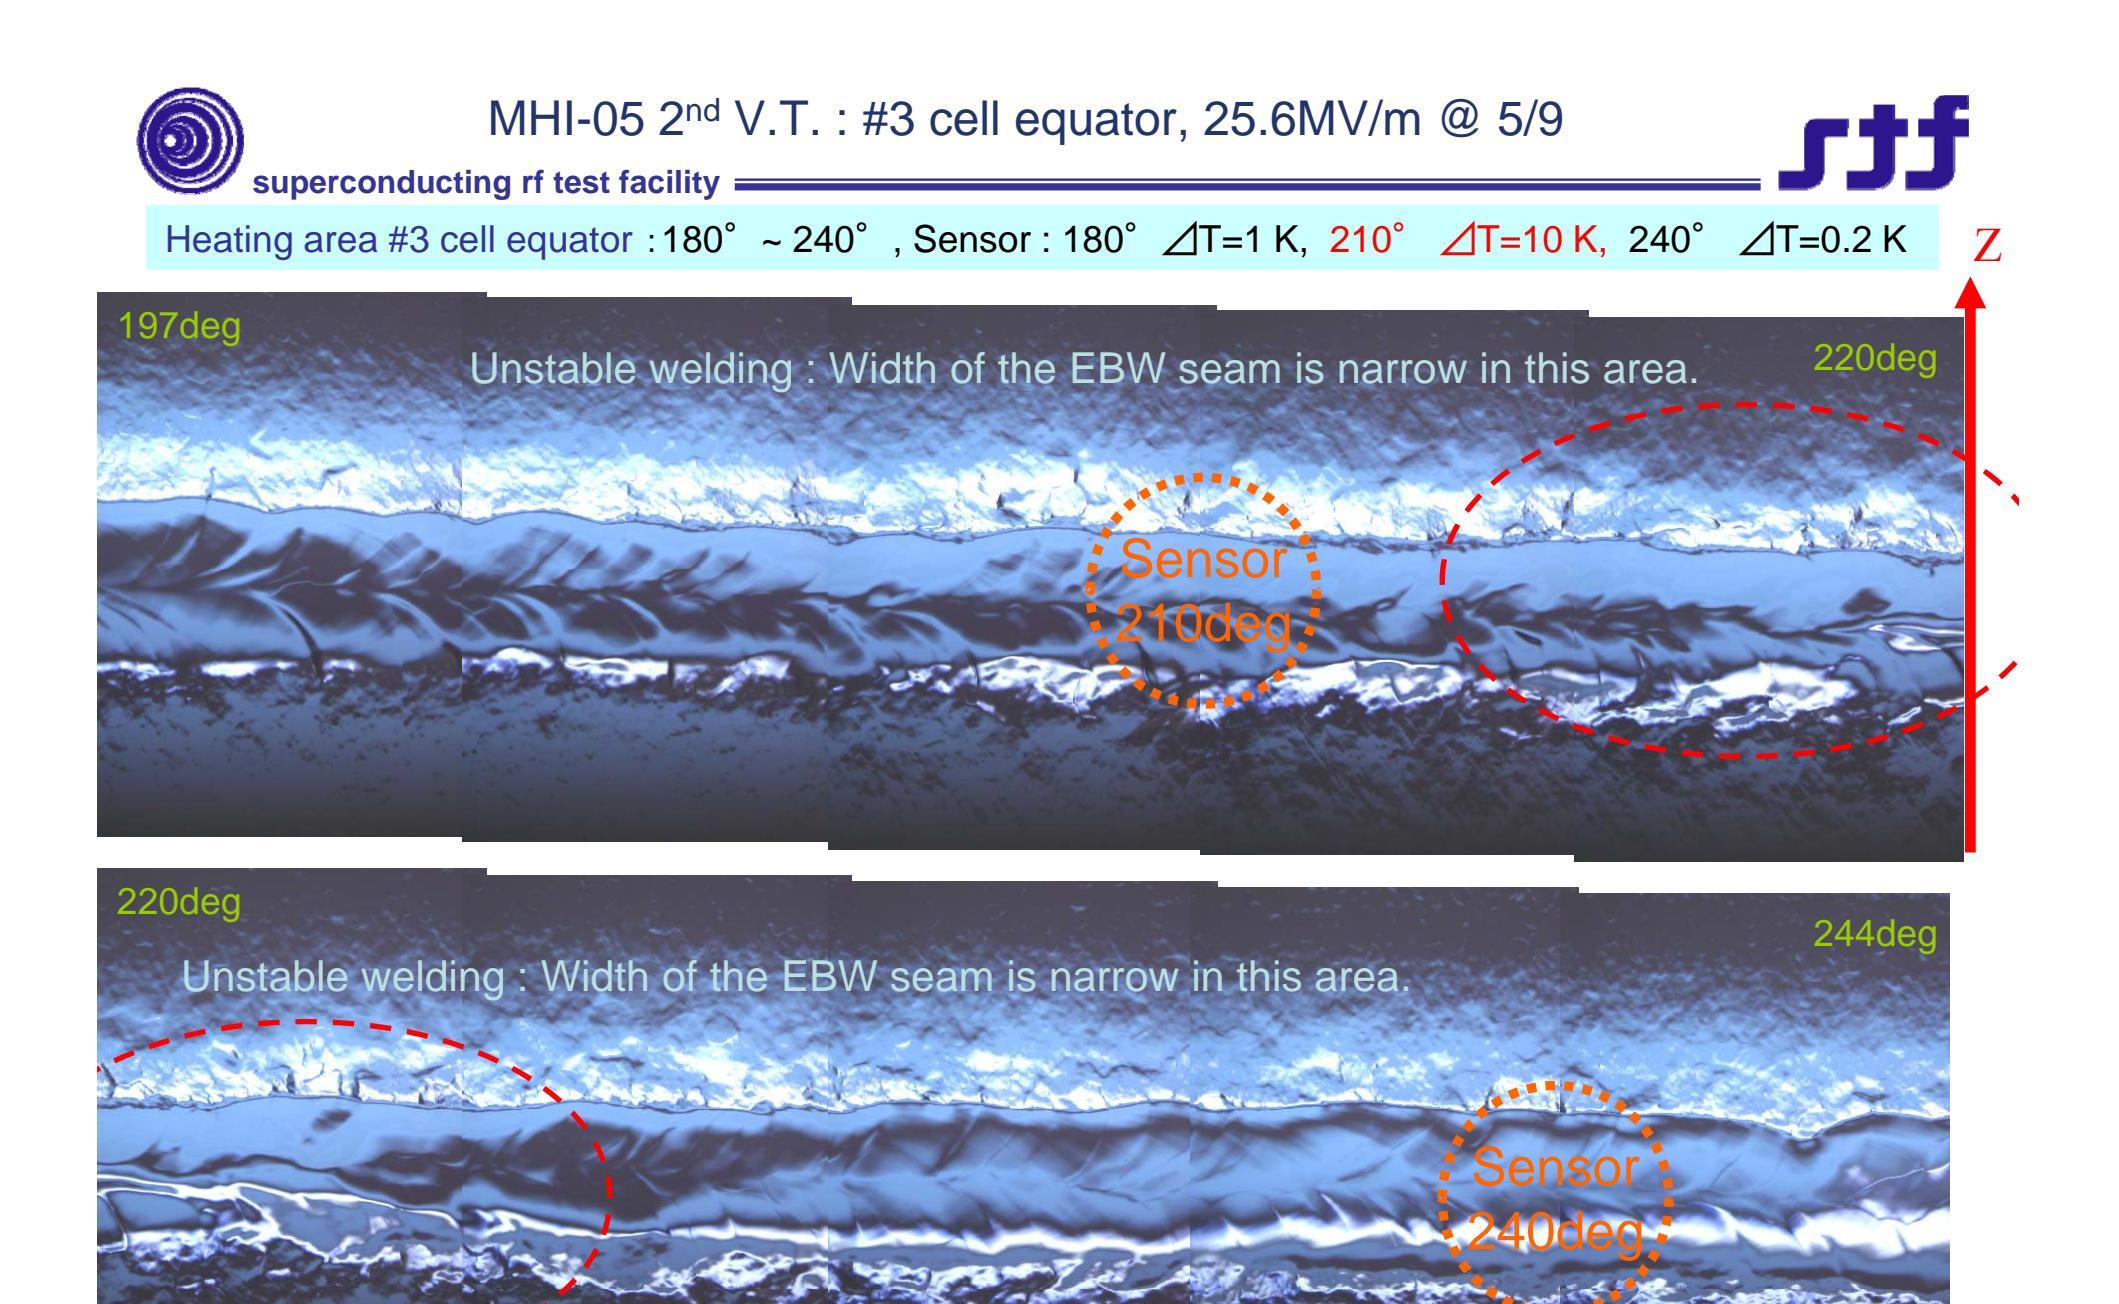
MHI-05 cavity

* The observed heating location at high field were near unstable area of the EBW seam at equator.

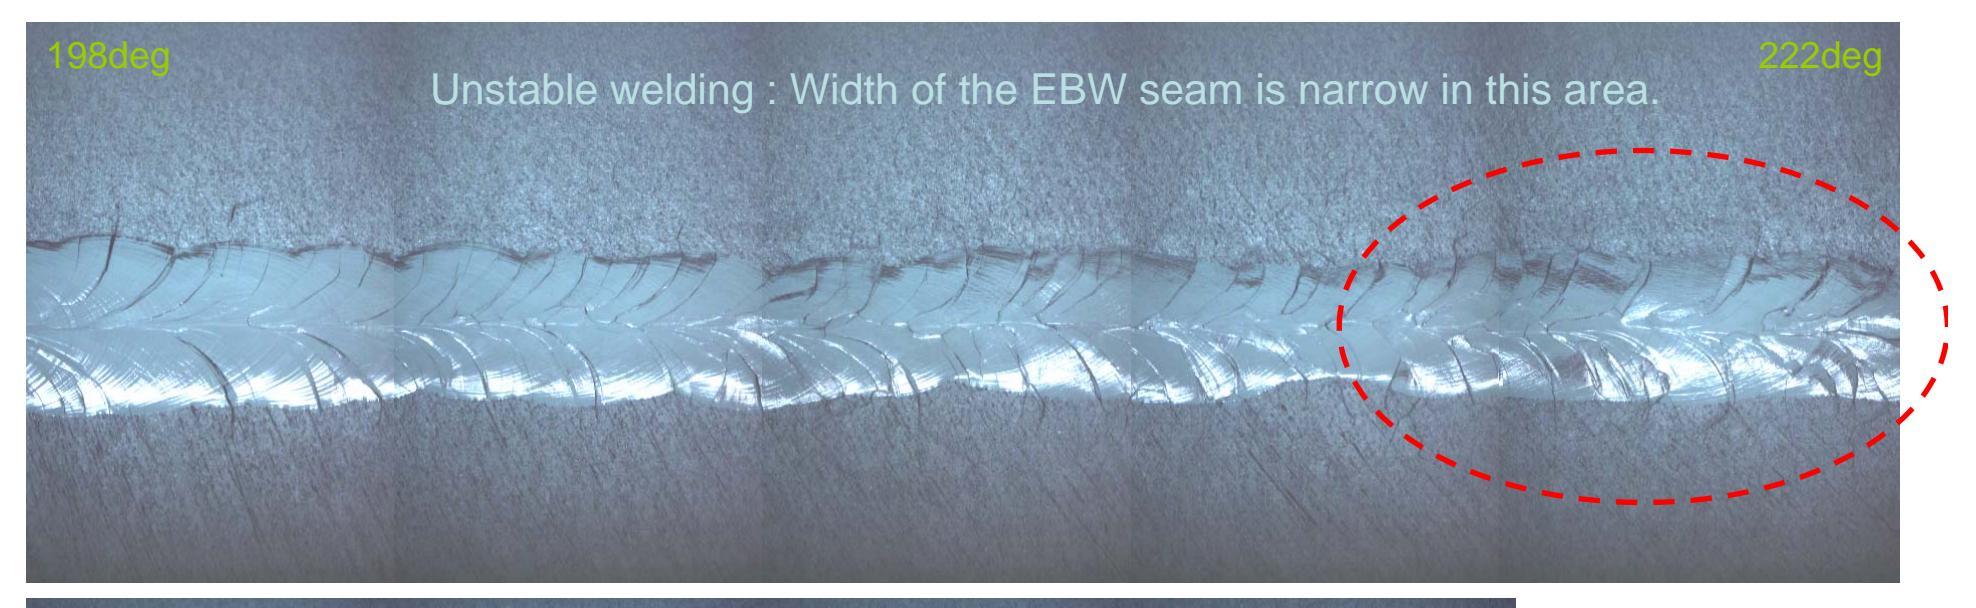
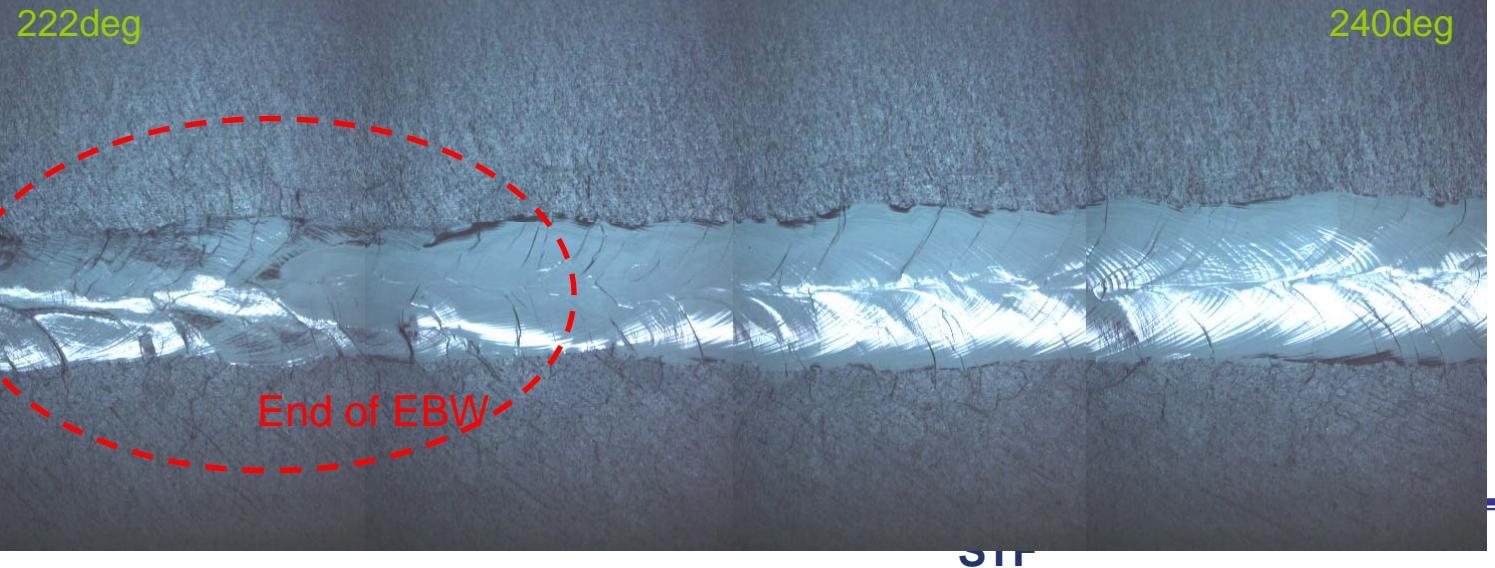
#3 equator, 198 ~ 240 degree. Condition : As received.

25.6 (max 32.9) @ 5/9 Quench	#3 cell equator, t=180~240deg.	Unstable : Width of the EBW seam is narrow. No defect in outside weld area.
		29.2 @ 7/9 Quench	#5 cell equator, t=120~180deg.	Unstable : Width of the EBW seam is narrow. No defect in outside weld area.

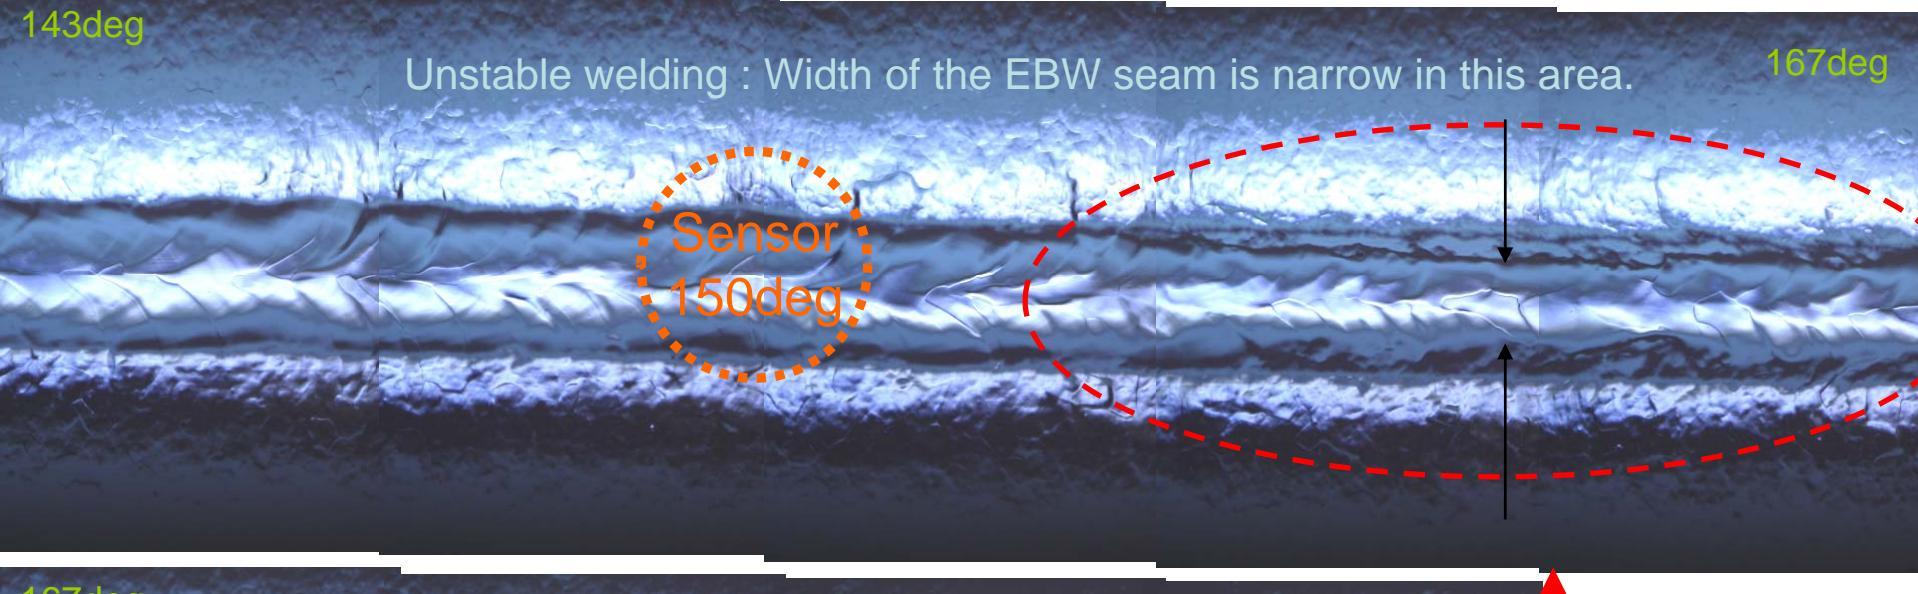
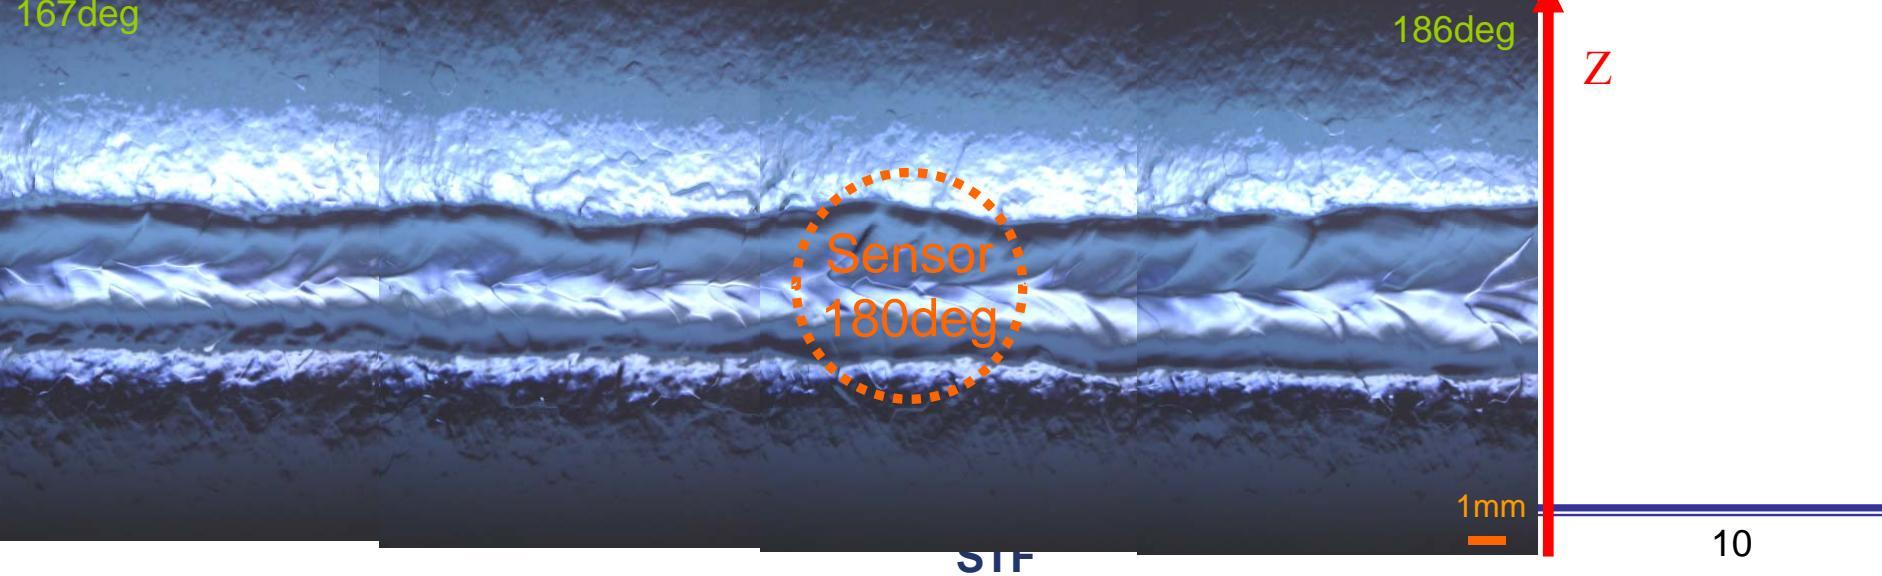
Heating area #5 cell equator : $120^{\circ} \sim 180^{\circ}$: Sensor $120^{\circ} \angle T=1 \text{ K}, 150^{\circ} \angle T=10 \text{ K}, 180^{\circ} \angle T=5 \text{ K}$

#5 equator, 150 ~ 173 and 279 ~ 302 degree. Condition : As received.

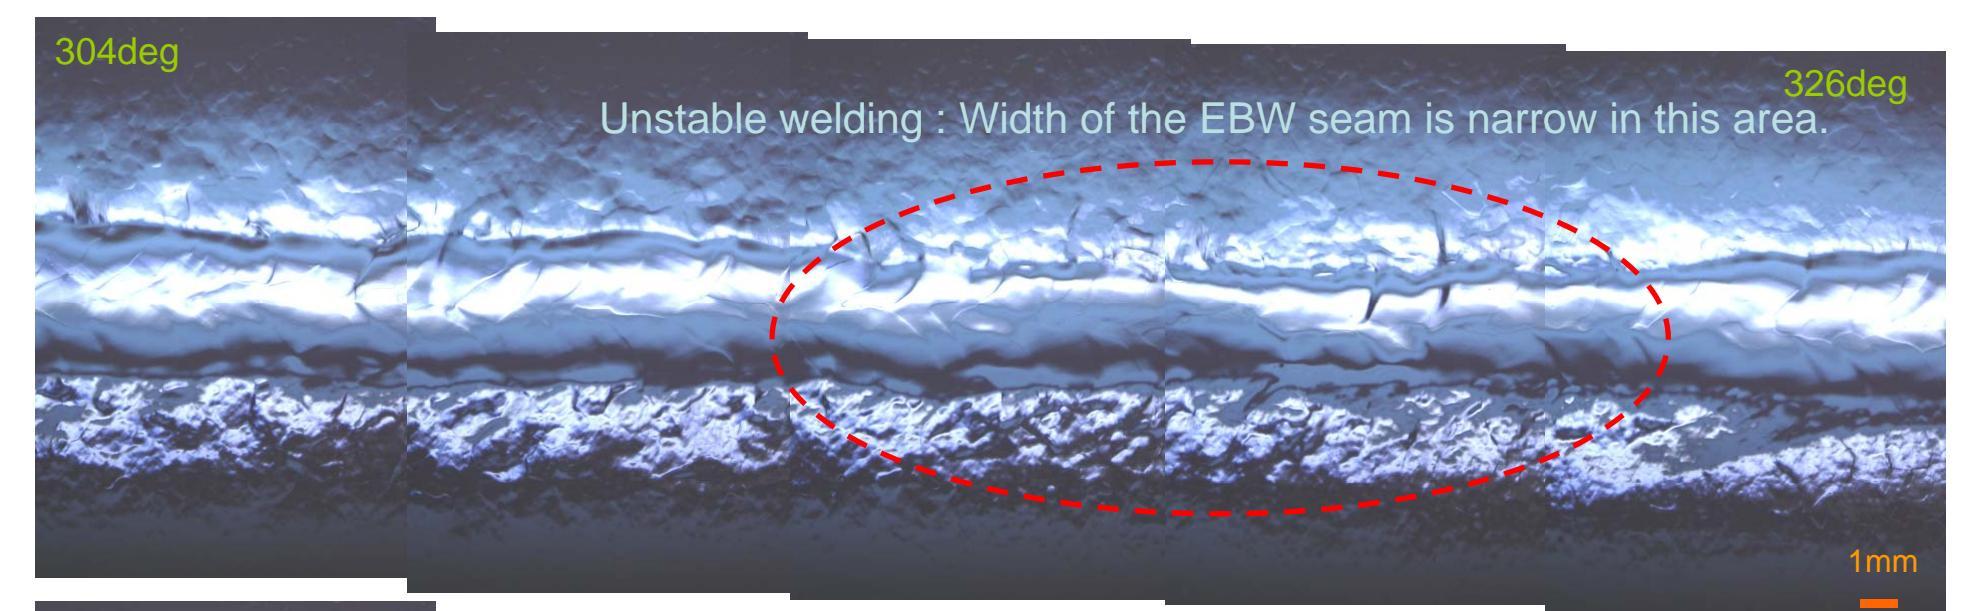
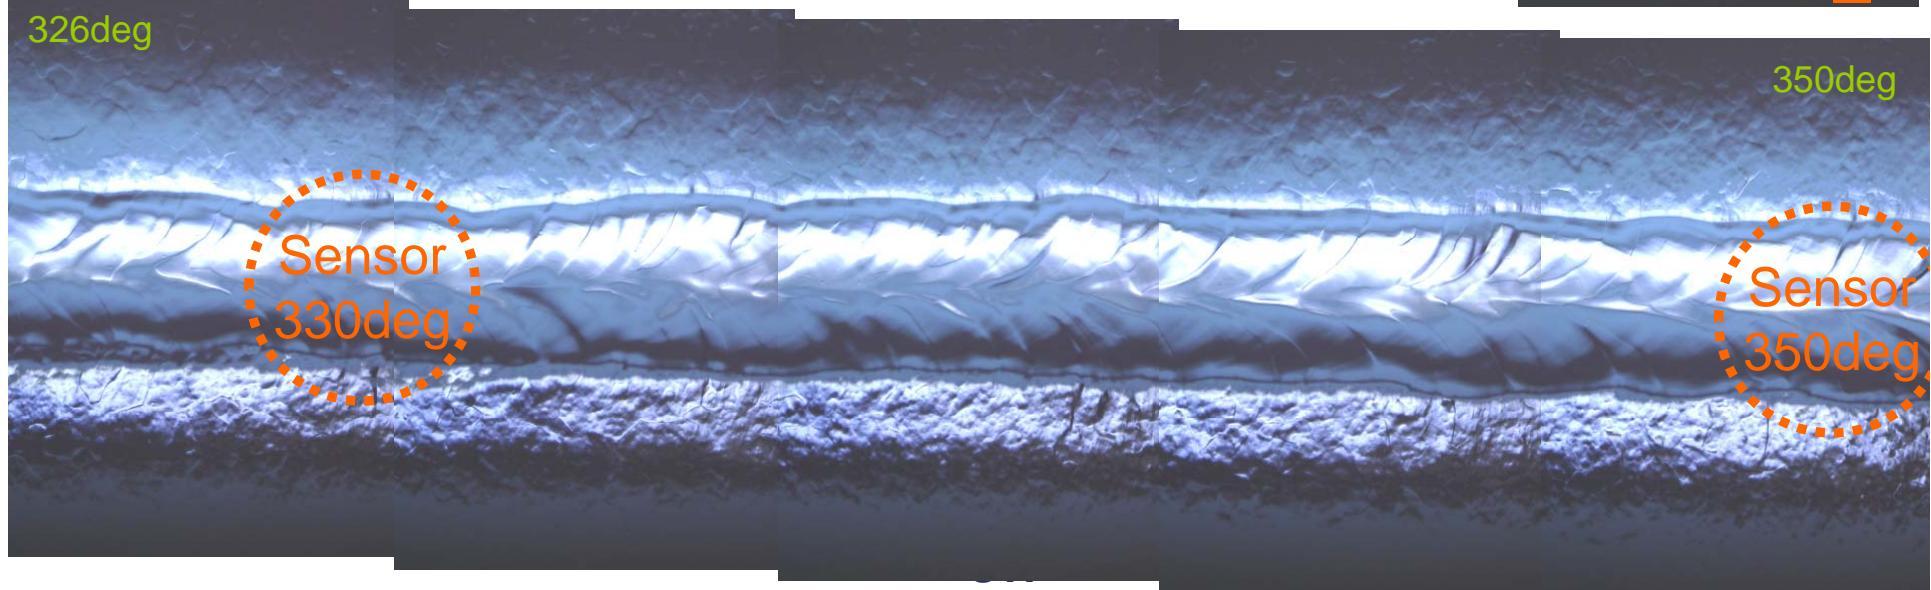
Heating area #6 cell equator :270° ~ 360° : Sensor 300° ∠T=10 K, 330° ∠T=10 K, 350° ∠T=8 K

#6 equator, 279 ~ 325 degree. Condition : As received.

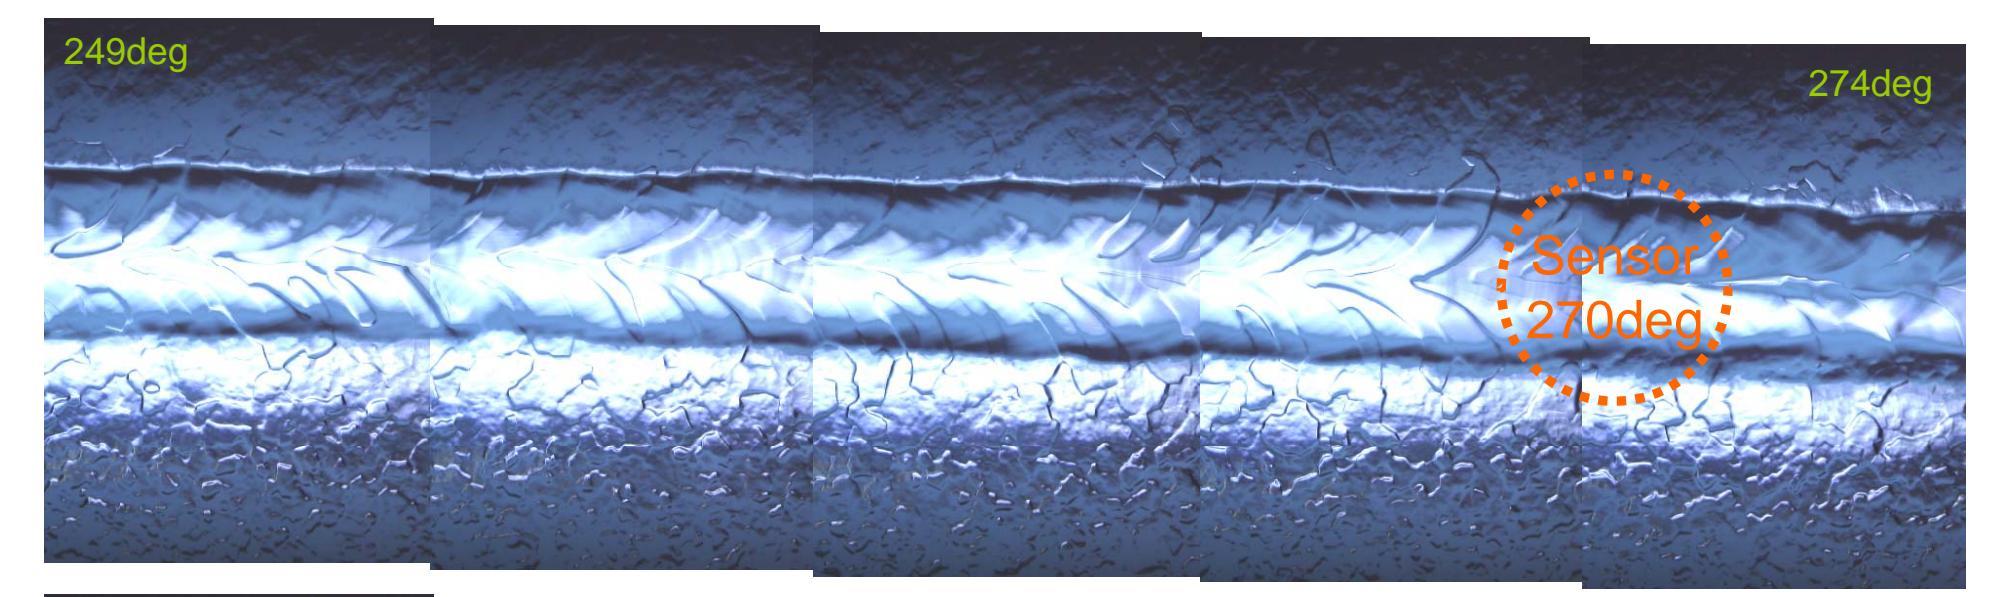
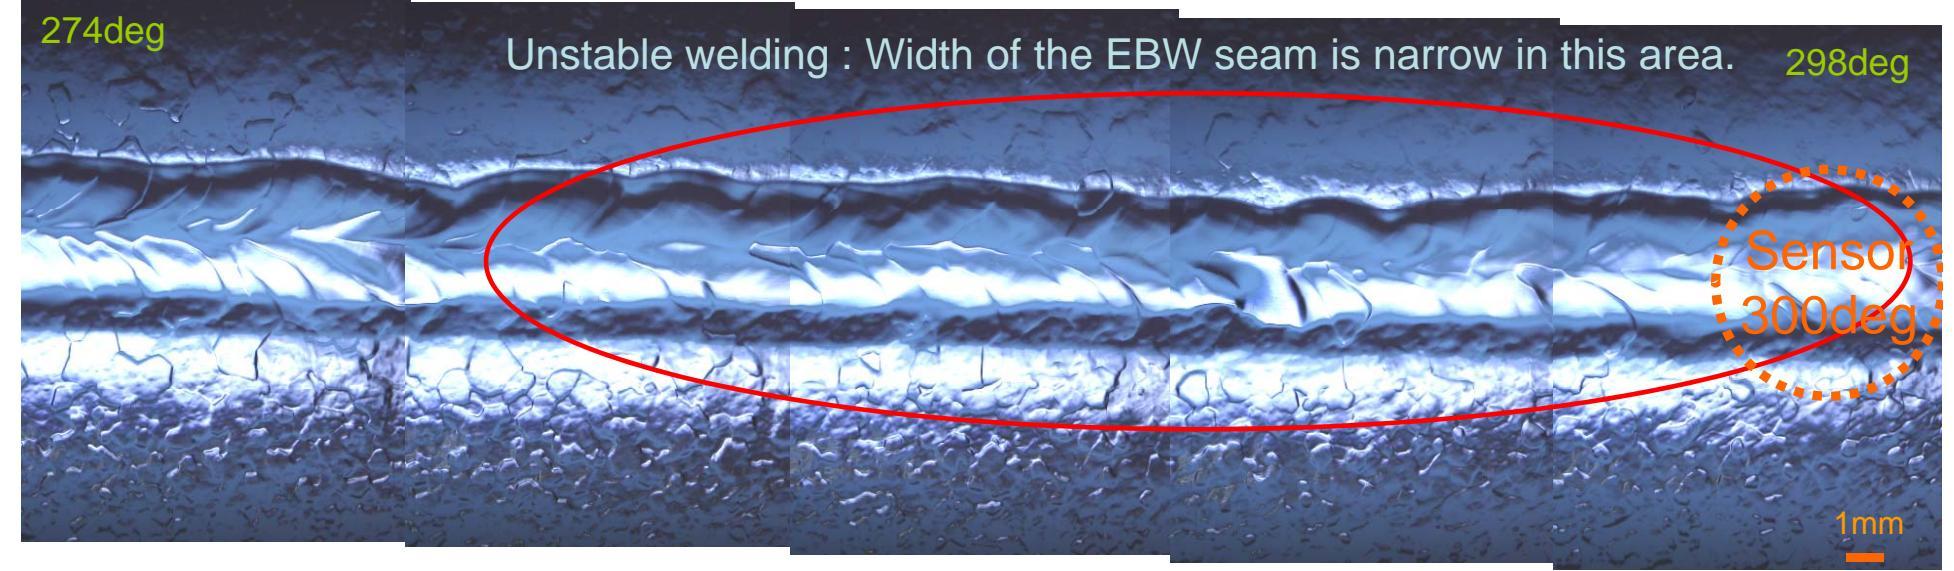
Heating area #5 cell equator : 240° ~300° : Sensor 240° ∠T=2 K, 270° ∠T=10 K, 300° ∠T=1 K

#5 equator, 251 ~ 299 degree. Condition : As received.
