# Status of the DHCAL 1m<sup>2</sup> GRPC Acquisition

C. Combaret

IPNL

## Status on january 20th

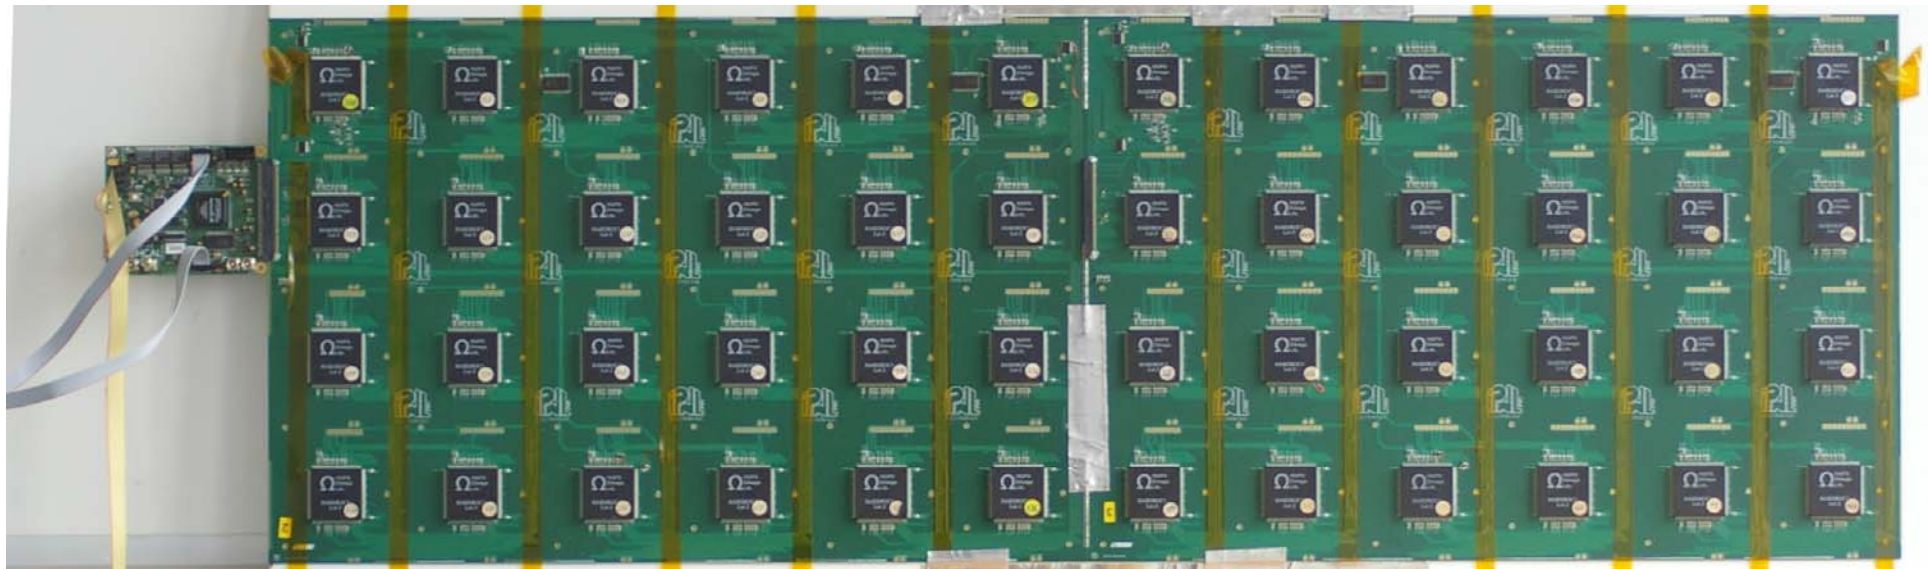
2 PCBs with 24 hardrocs have been connected together.

→ Works OK (SLC and digital readout) after a few weeks of tests and adjustments

PCBs conected  
with 0 ohms  
resistors
