## Status of GEM panel

# Under-grad. students had measured X-talk on PCB and gain check of module 1/2

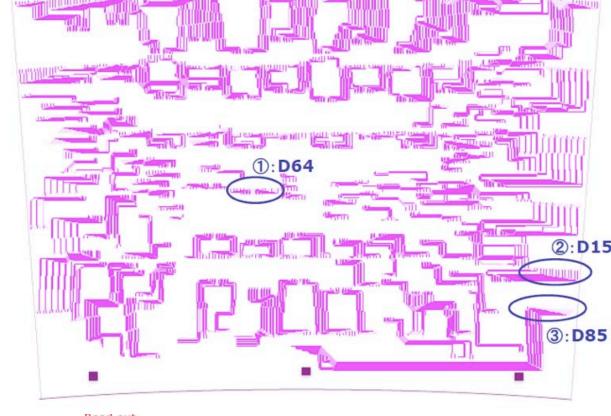
~6% at neighbor channel @ good/nominal routing

10% at neighbor @ long routing

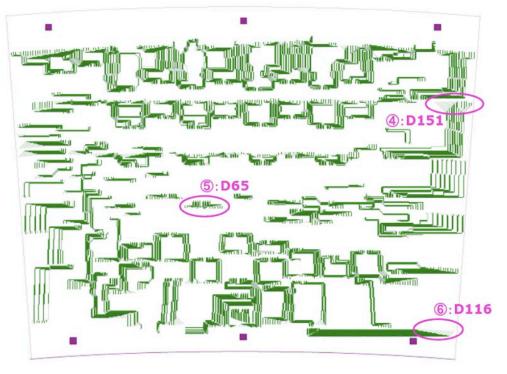
~6% at neighbor channel @ good/nominal routing

10% at neighbor @
long routing
(worst 13%)

6:D116 MAX:11.1% MIN:3.6%

There must be X-talk from connector/readout cable.. other than from PCB We know readout flex-cable has X-talk (but I forgot how much )

good channels have ~6% X-talk which must be coming from other than PCB worst routing has 13% -> ~7% x-talk from PCB ==> reasonable from pre-proto study

There must be no serious X-talk problem

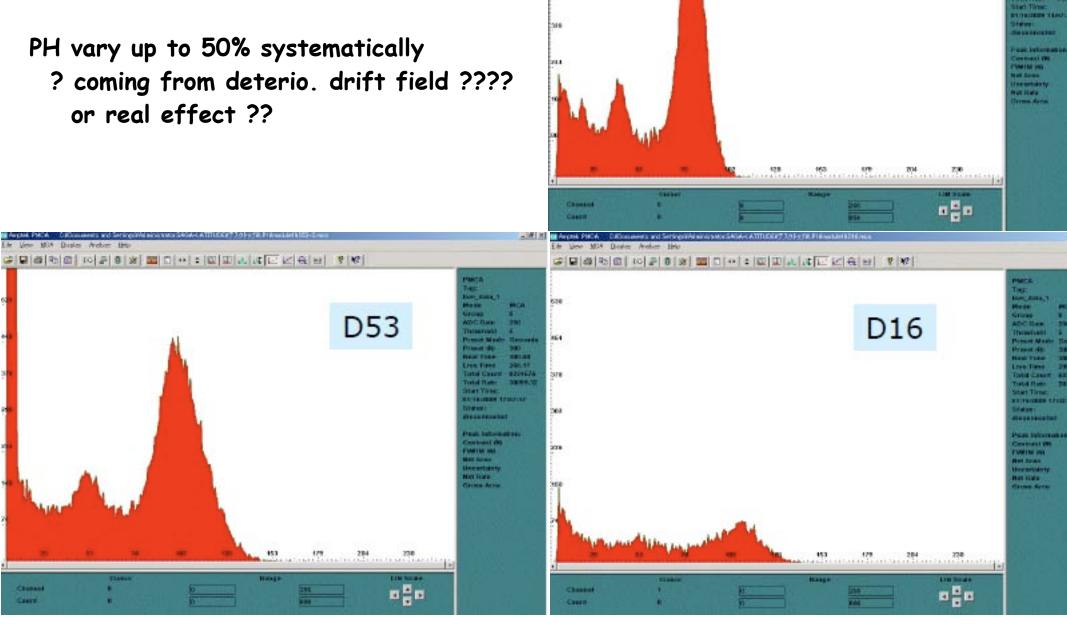
some are good, some are not so good

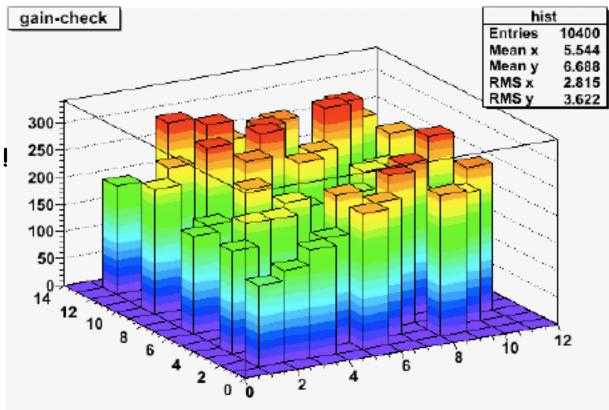
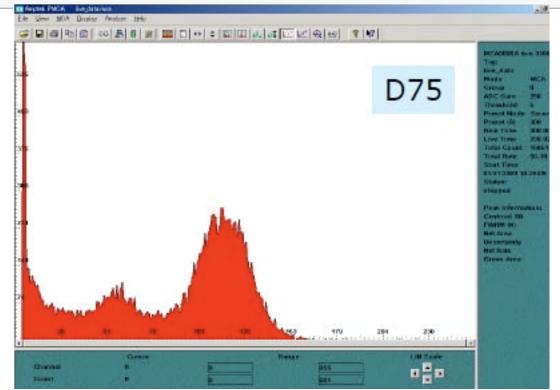
module 2 has also large variation

1 GEM sheet is dead after discharge!

replaced GEM is not well stretched.

we will fix this later
