DESY Infusion R&D

Results and status at DESY

Bate Christopher on behalf of the SRF Team Sendai, 31.10.2019

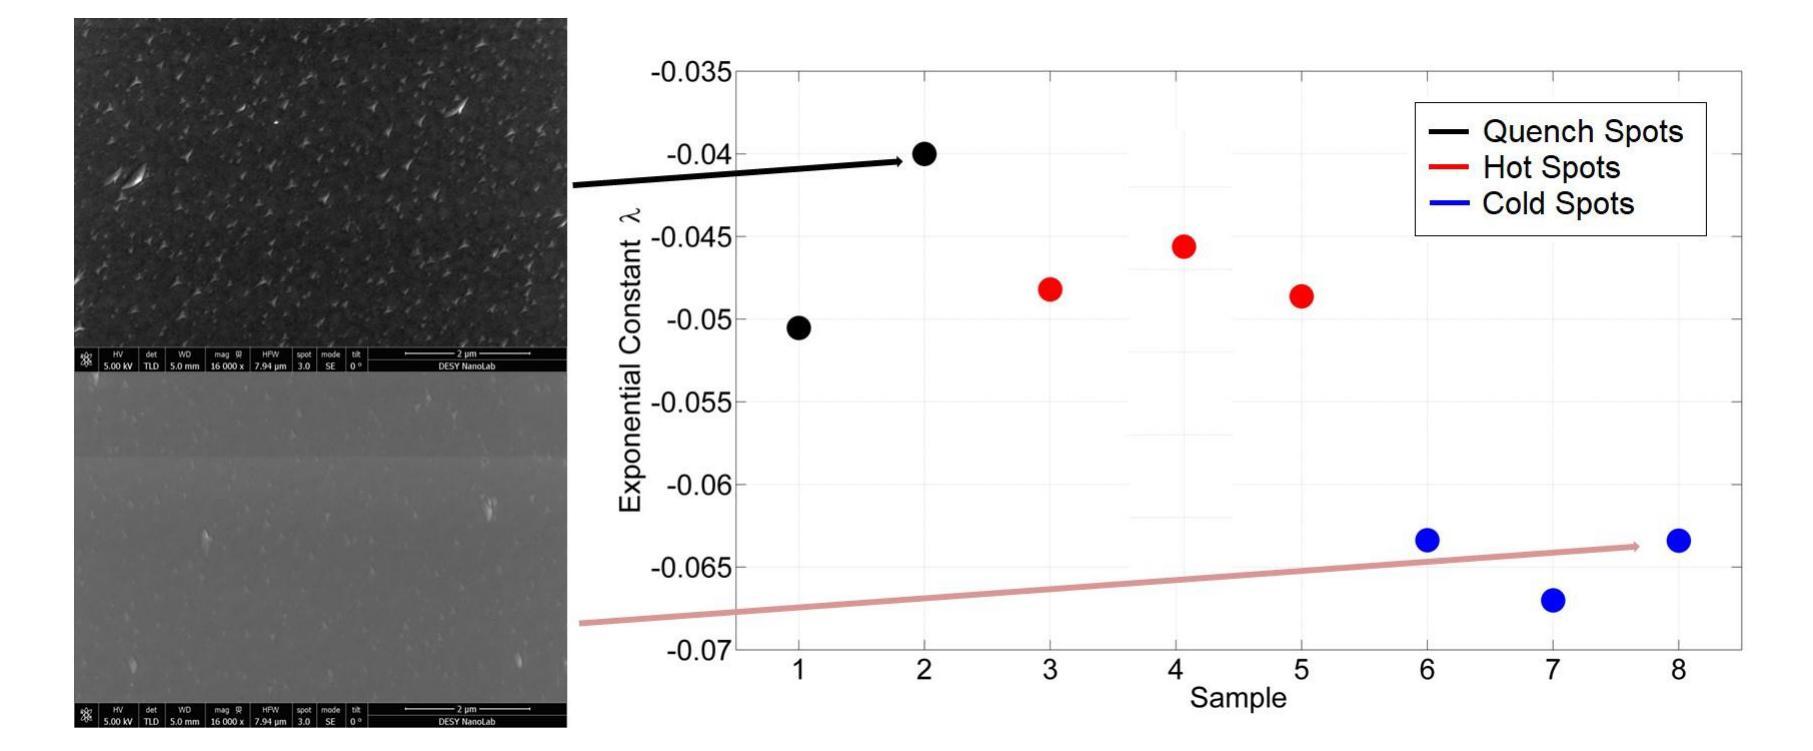
Cavity cutout

Analysis of cutouts from degraded cavity

- Cold and hot spots were identified via Tmap and Hmap at HZB
- SEM image analysis shows higher size distribution of carbides on quench and hot spots compared to cold spots

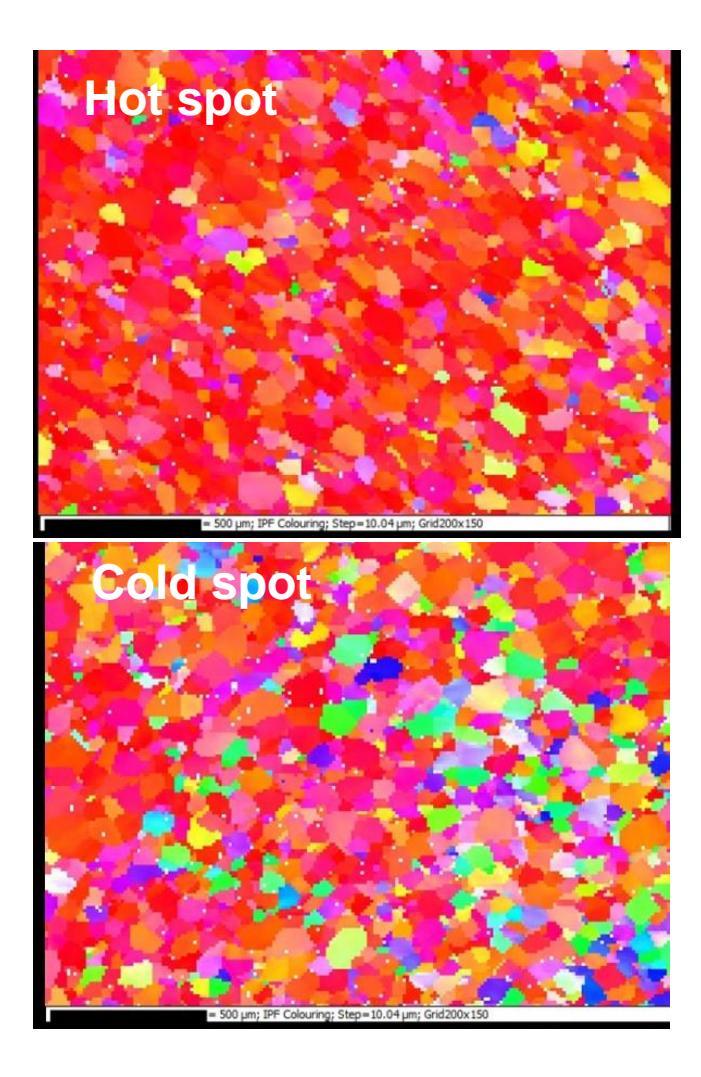
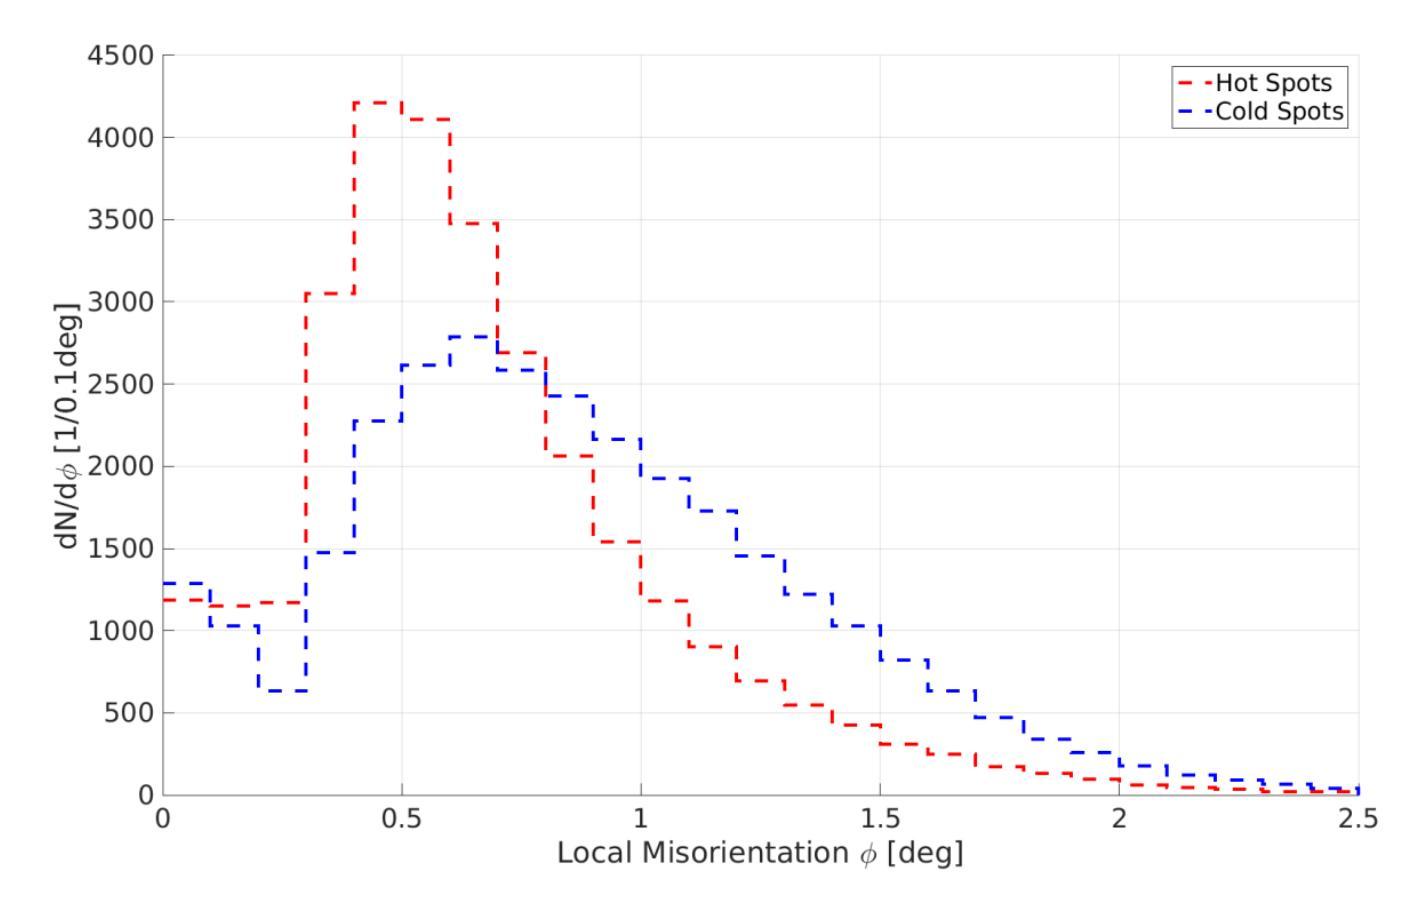
Cavity cutout

Origin for locally different carbon aggregation

• Electron backscatter diffraction measurement shows more low angle grain boundaries for hot spots compared to cold spots

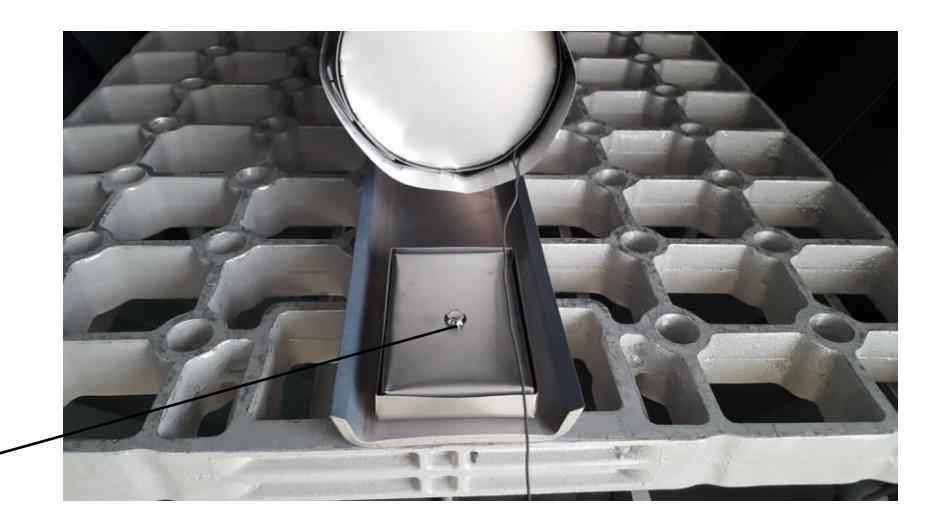
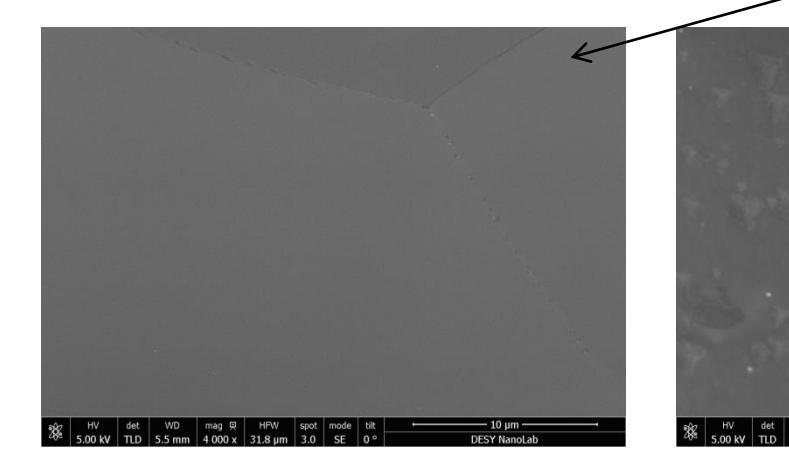
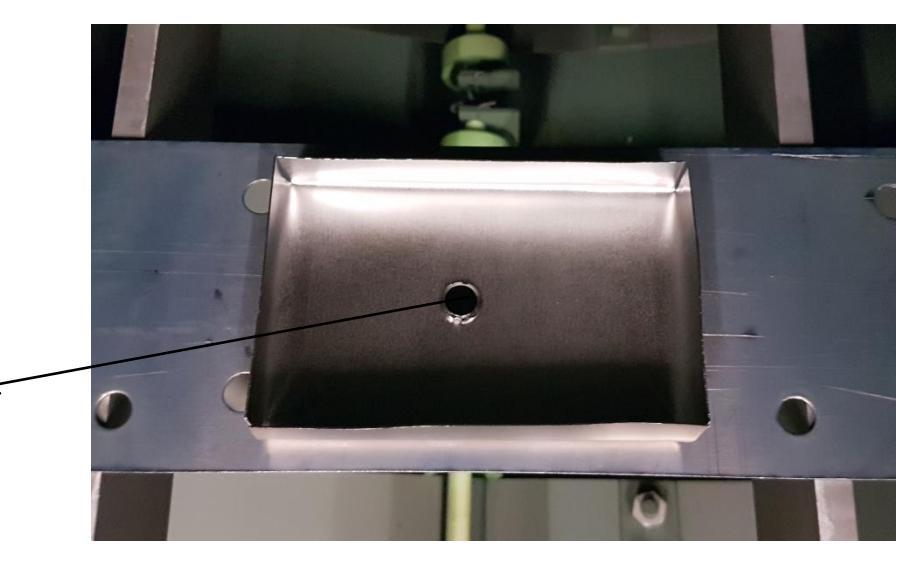
Carbide precipitation occurred on niobium samples

- A niobium box for the samples was used to mimic the 'line of sight' protection of the niobium caps for the cavities
- For most runs sample inside the box showed carbides while the sample outside showed none
- The box was bcp'ed before each treatment just as the caps

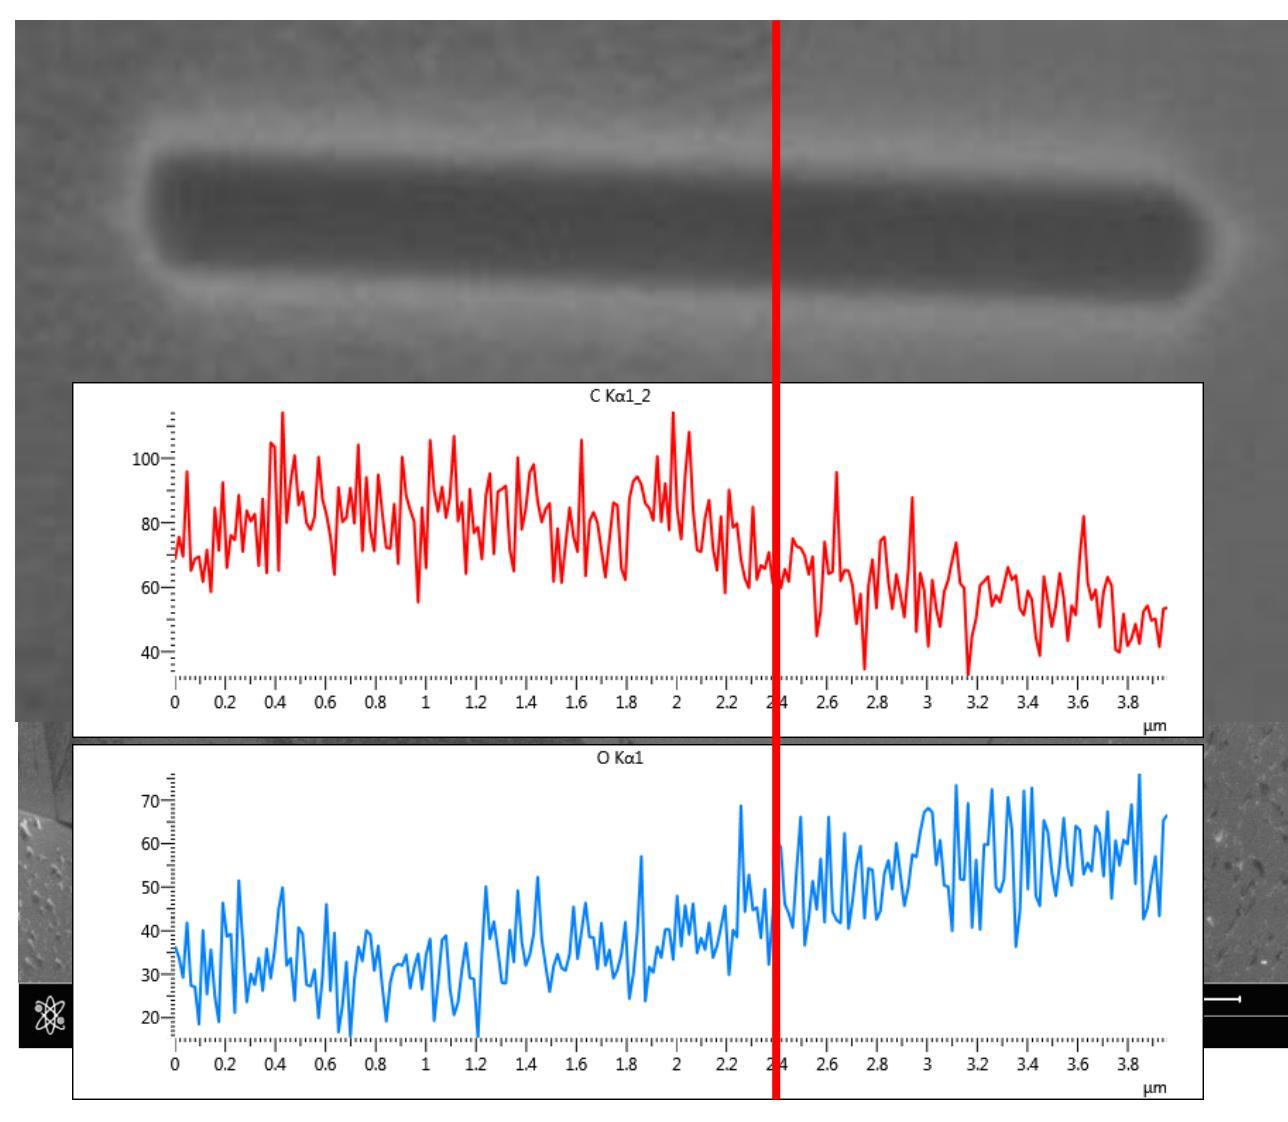
Carbide precipitation occurred on niobium samples

- Besides carbides, dark areas on sample surfaces can be found in the SEM images
- EDX line scan show increase in carbon signal on those areas showing this must be some thin carbon layers that accumulated on the surface
- The carbon layers avoid grain boundaries and some certain kind of precipitates
 - This shows the diffusive absorptive behavior of grain boundaries for carbon
 - In agreement with known importance of grain boundaries for the N diffusion process

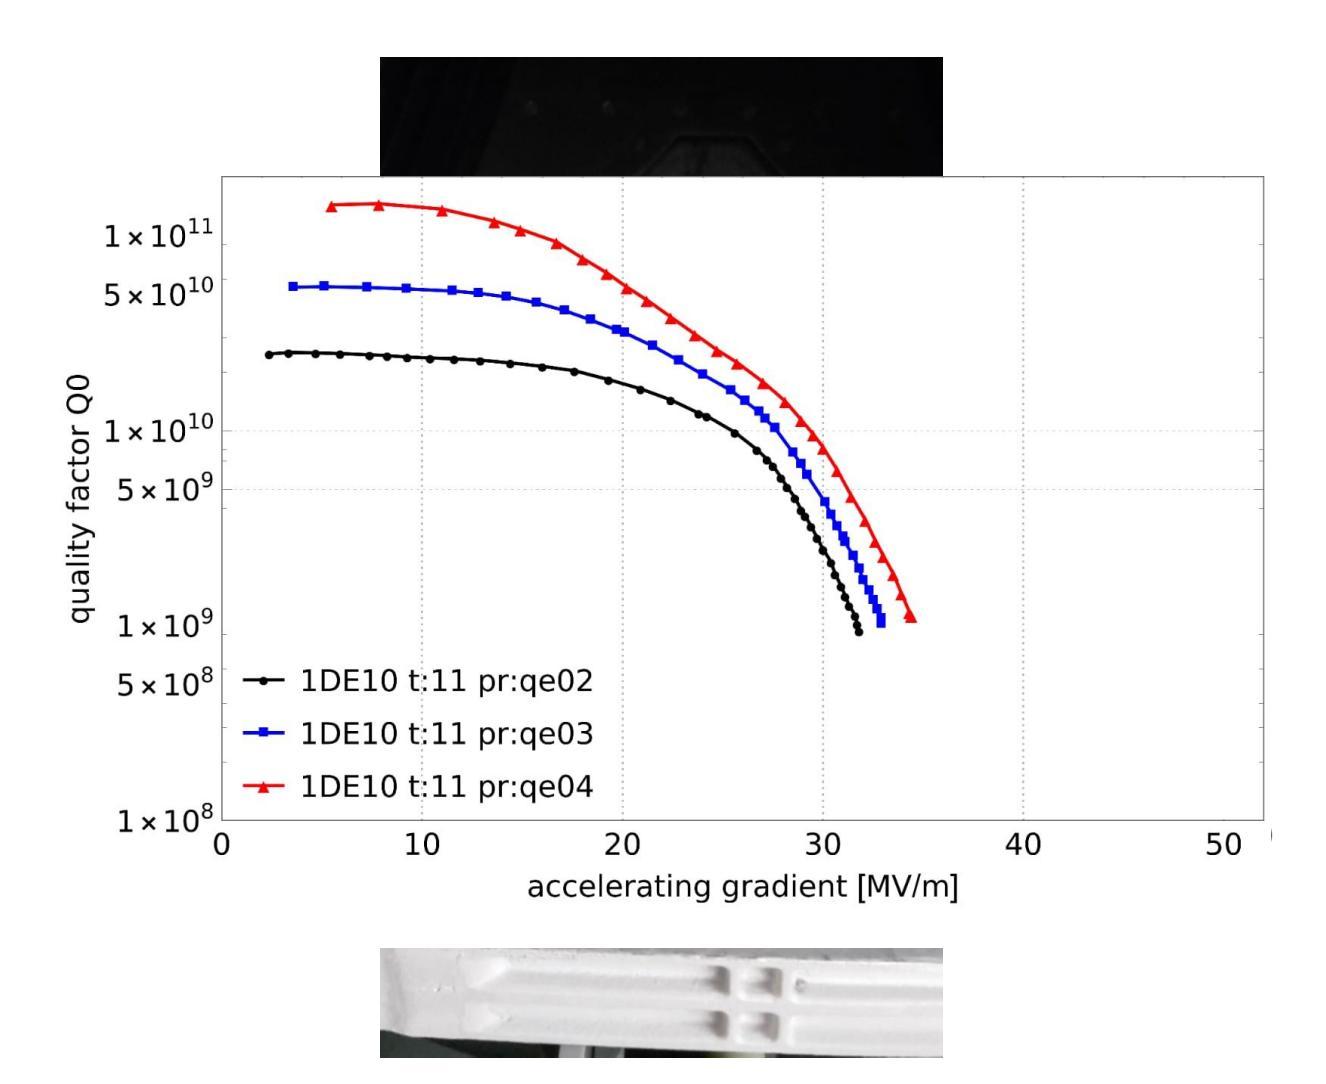
- 1. 800°C w/o caps and w/o Nitrogen:
 - Expectation: A clean furnace would simply re-set the surface to a status prior to 120°C bake; HFQS should re-appear
 - Observation: Strong degradation of Q at low fields, similar to first infusion runs
- 650°C with modified caps and w/o Nitrogen:
 - Expectation: Lower T leads to a better pressure but T is sufficient to outgas the cavity and break up the oxides. Hence, HFQS should re-emerge.
 - Observation: HFQS re-emerges. Measurements at 1.8K and 1.5K show another loss mechanism kicking in at ~18MV/m before HFQS starts.

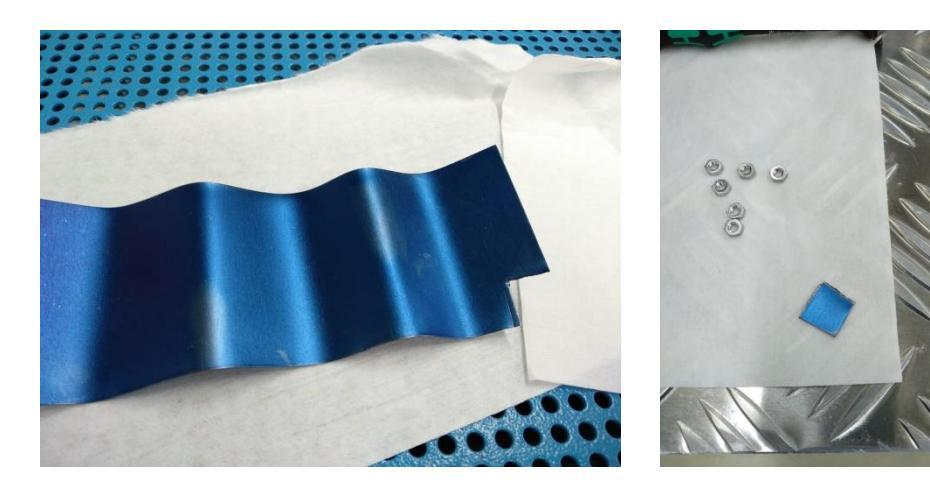
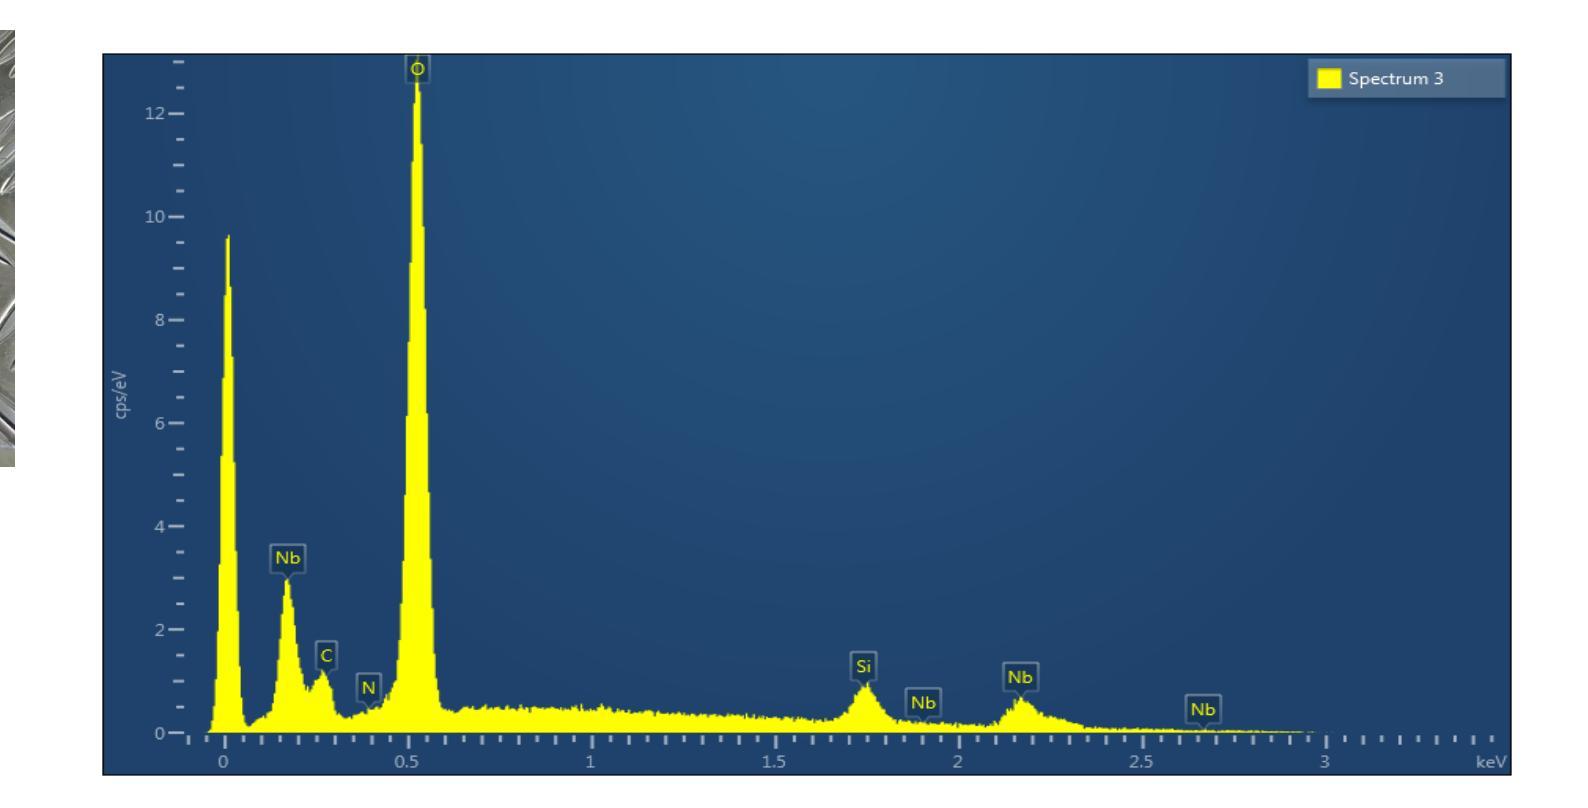
• EDX of sheet cutout shows high oxygen peak
