Progress Report ILC 9-cell Cavity EP and Vertical Test at JLab

Rongli Geng SRF Institute, Jefferson Lab

ILC main linac R&D meeting

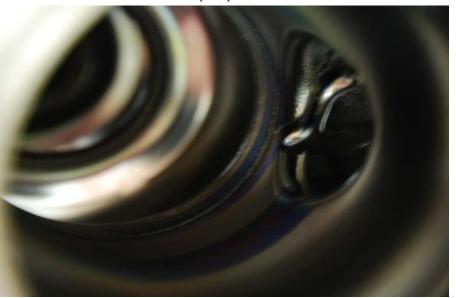
AES3 Q-decline

- 2 rings of discoloration (Nb oxide) in field probe side beam tube – caused by 12 hour HPR water jet bombardment.
- Not removed by 3 um BCP etching.
- AES3 3rd EP 20 um done, oxide rings removed.

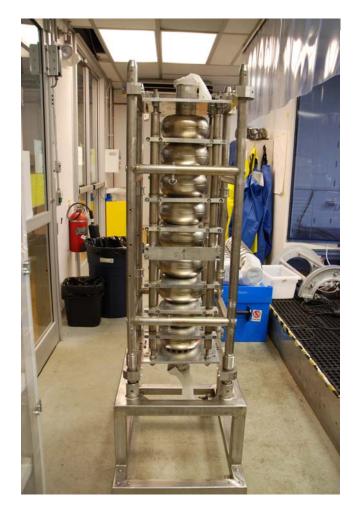
ICHIRO#5 in progress for RF test

- Field flatness tuning completed (significant change obvious during transportation).
- Tuning completed.
- Adjustable input coupler Qext value set.
- Cavity/supporting fixture fitted into HPR/VT cage.
- Base line test after HPR only.
