**Design and Prototyping of the ILC
Positron Target System**

Oct 22, 2012 - LCWS 2012

We are doing design and prototyping of the rotating shaft seal and the capture magnet

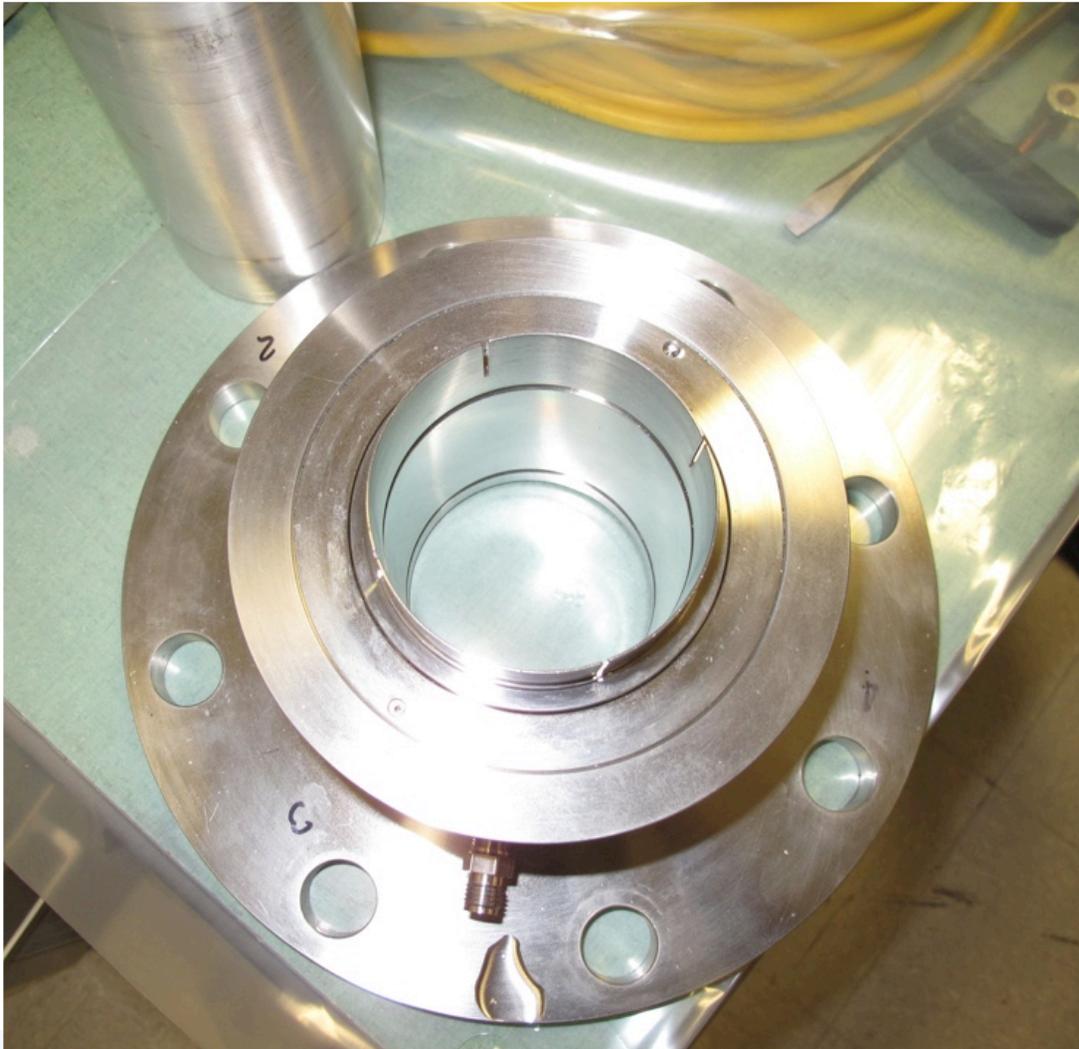
We started testing of the Rigaku Ferro-fluidic Seal for outgassing when it arrived

- A magnetic fluid is held between the inner and outer ring by permanent magnets
- There is significant torque and heat dissipation
- The ferrofluid can be expected to outgas

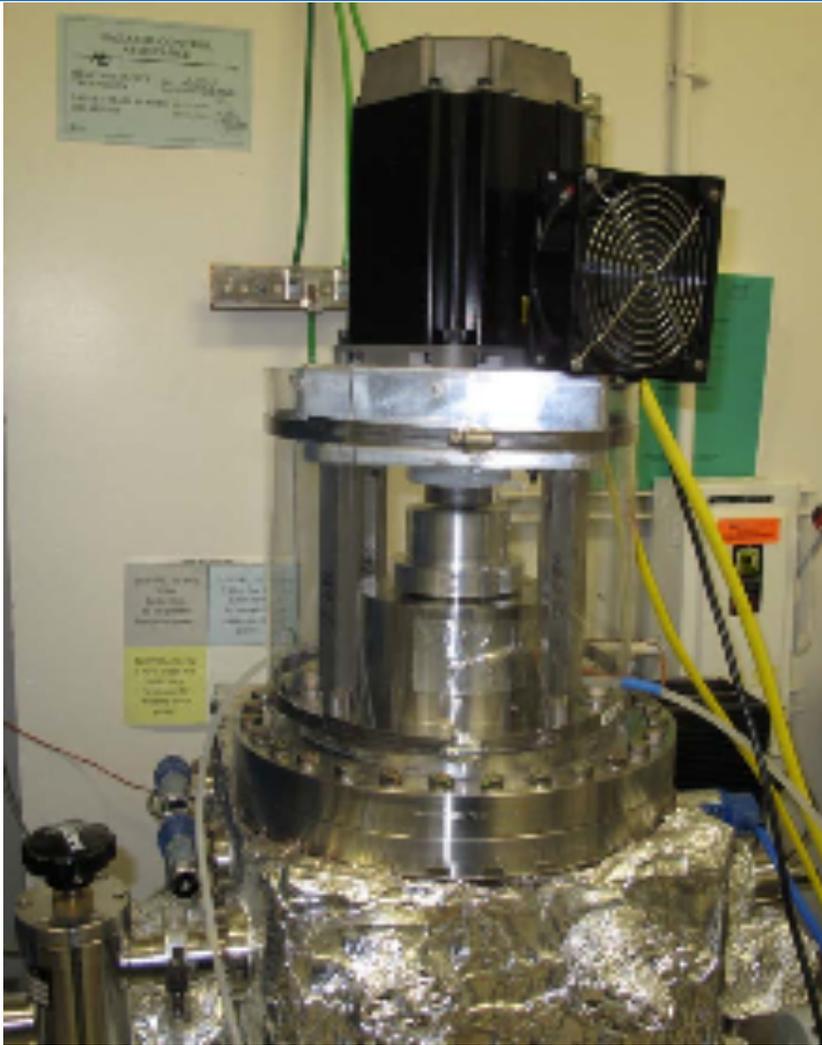
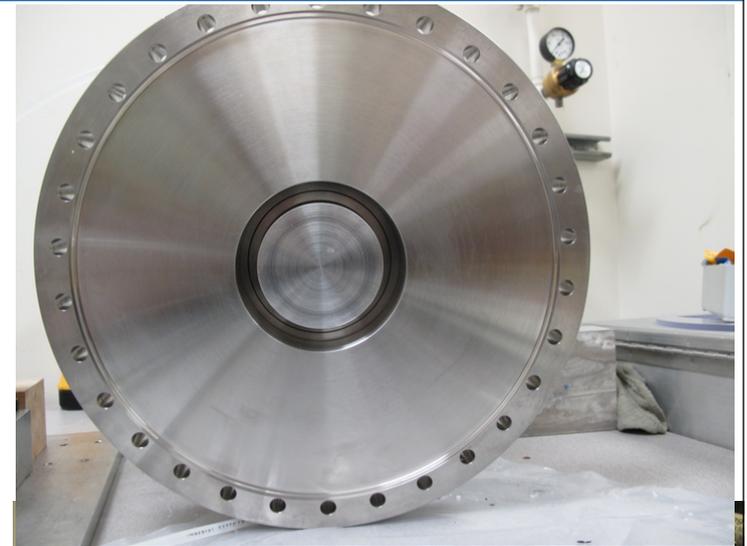
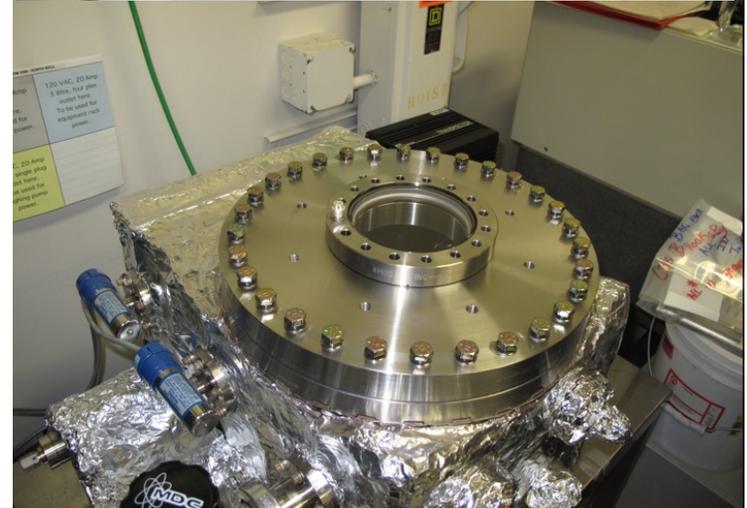
The test stand allows us to rotate the seal up to 2000 RPM with pressure and outgassing measurements

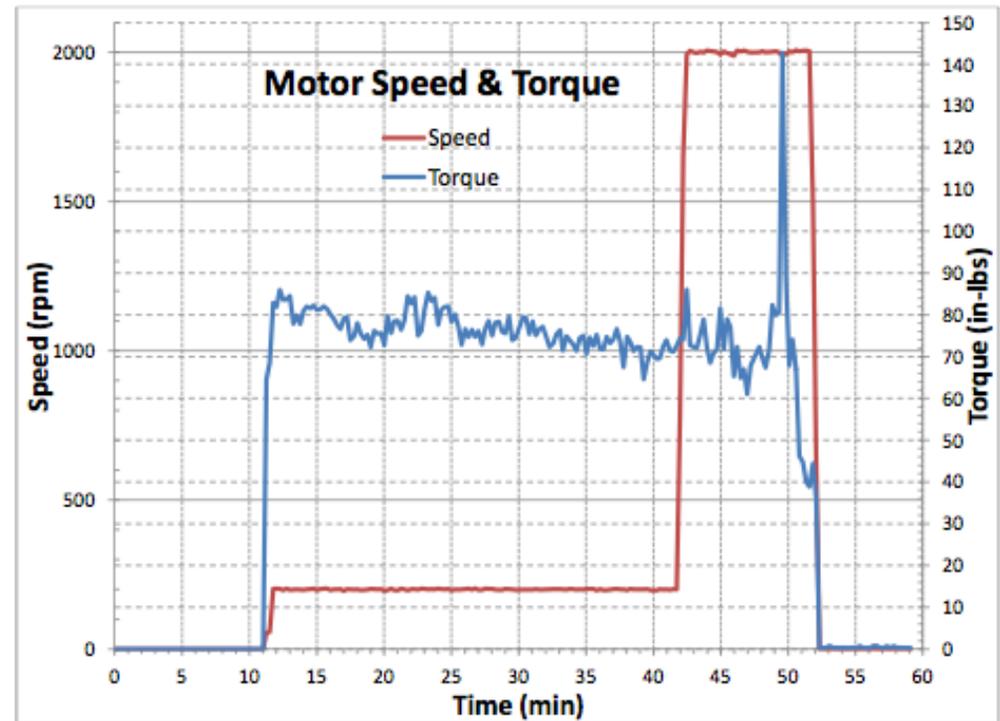
October 3rd, 2011 we did our first full test of the Rigaku seal

... and we killed it.

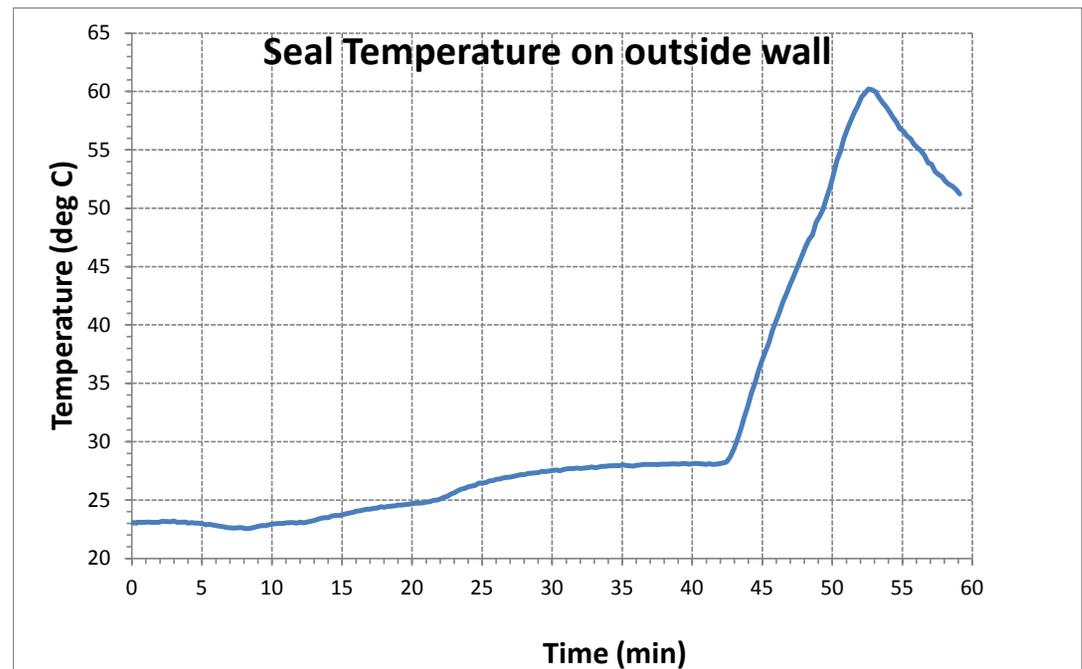
Temperature data was disturbing

- Rigaku reported running at 55 °C without problems
- Temperature was still rising when we turned it off

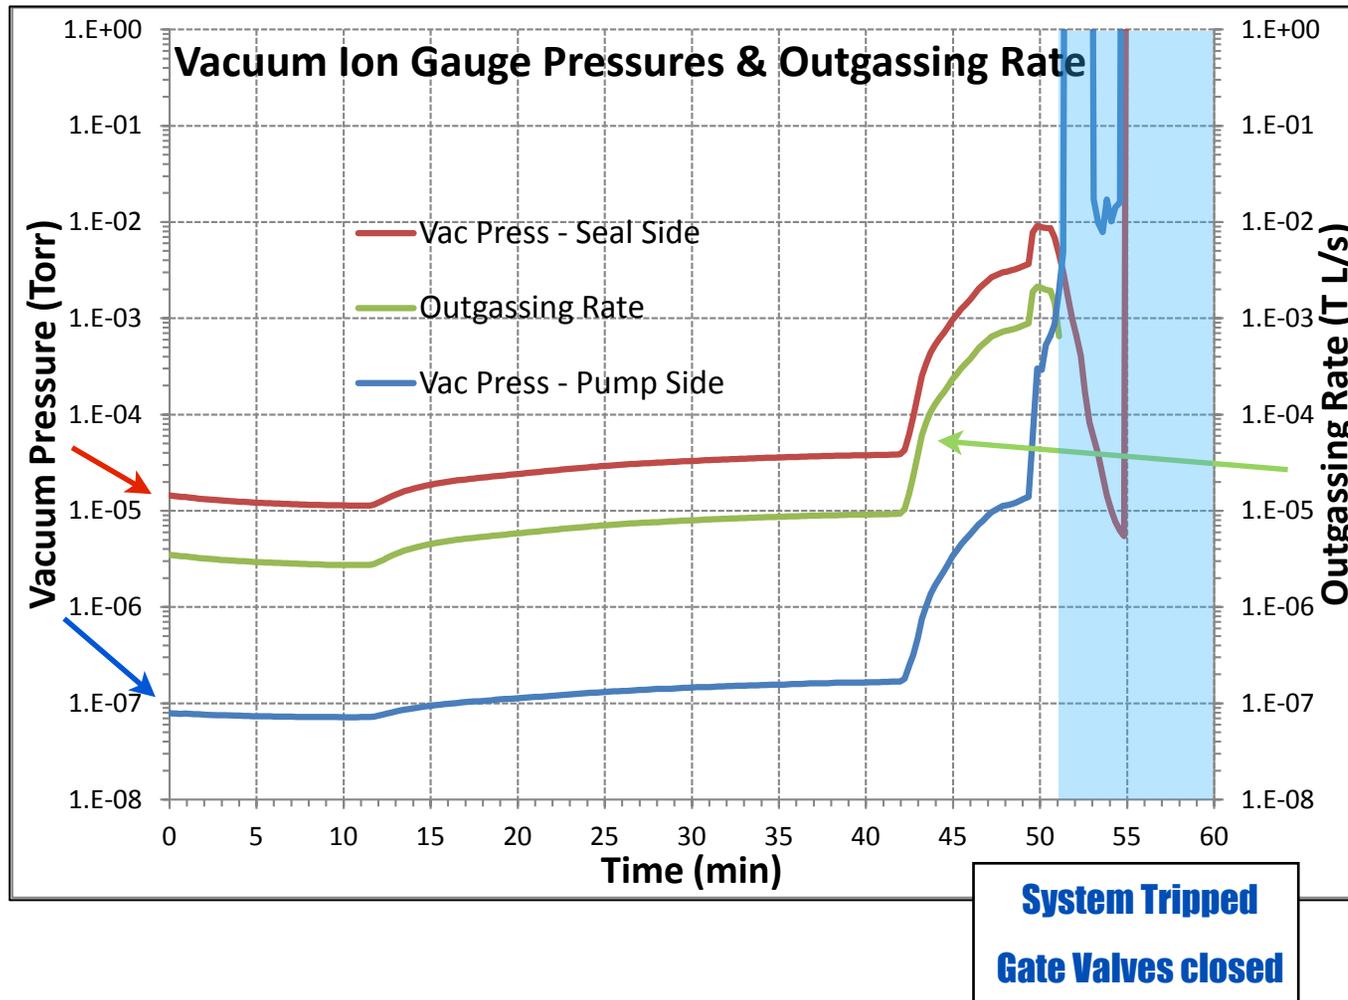
Outgassing looked like it was stabilizing when the seal failed

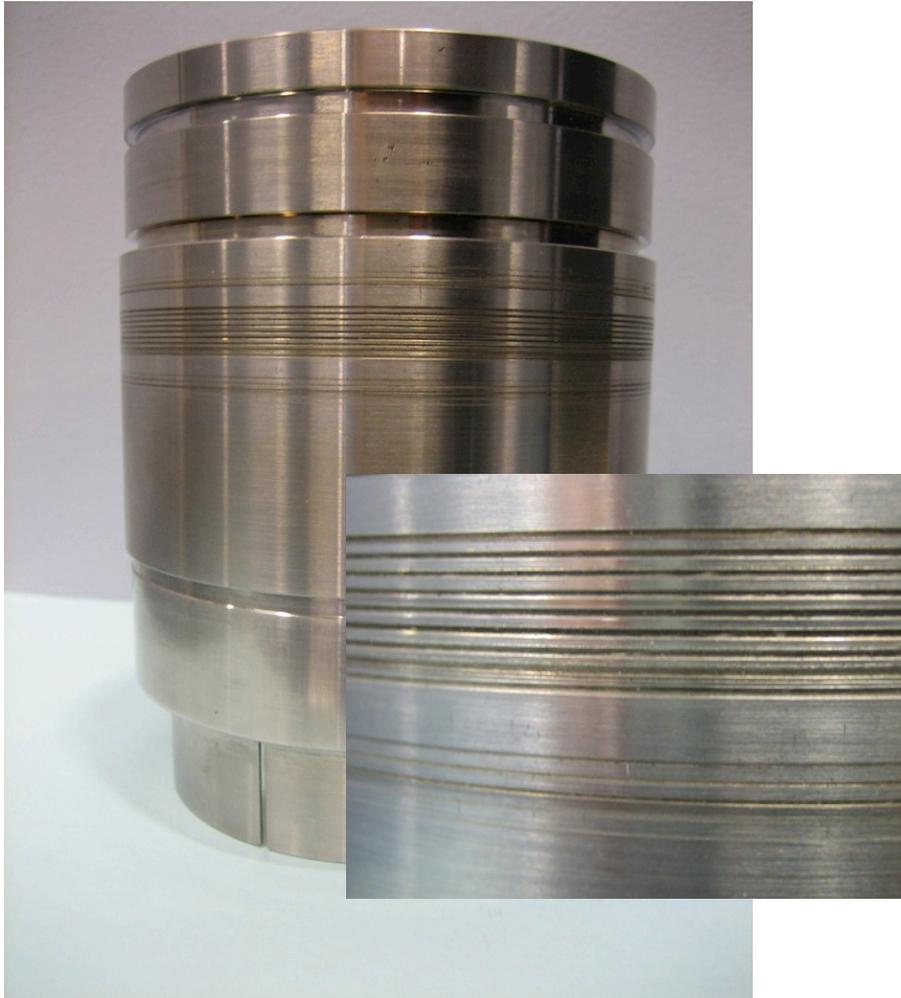
Rigaku post-mortem shows a design flaw

- Differential expansion between dissimilar metals caused contact between pieces at high temperature
- Grinding occurred leading to failure
- Rigaku agreed to rework the piece under warranty

- Rigaku #1
 - Catastrophic failure after 15 minutes at 2000RPM on the outgassing test stand
 - Rigaku analysis indicates differential expansion of components lead to failure
- Rigaku #1 reworked
 - Switched fluid for low viscosity type
 - Unacceptable behaviors seen on the test stand
- Ferrotec #1
 - Low viscosity fluid
 - Normal operation for 38 hours at 2000 RPM on the outgassing test stand
 - Higher outgassing than Ferrotec expected
 - Ran normally on the test stand until O-ring failure, damaged during rework
- Ferrotec #2
 - Ran rough on the outgassing test stand, better outgassing than Ferrotec #1.
 - Returned to Ferrotec for analysis
- Ferrotec #3
 - Currently mounted on the test stand
 - Good vacuum
 - Vibration spikes

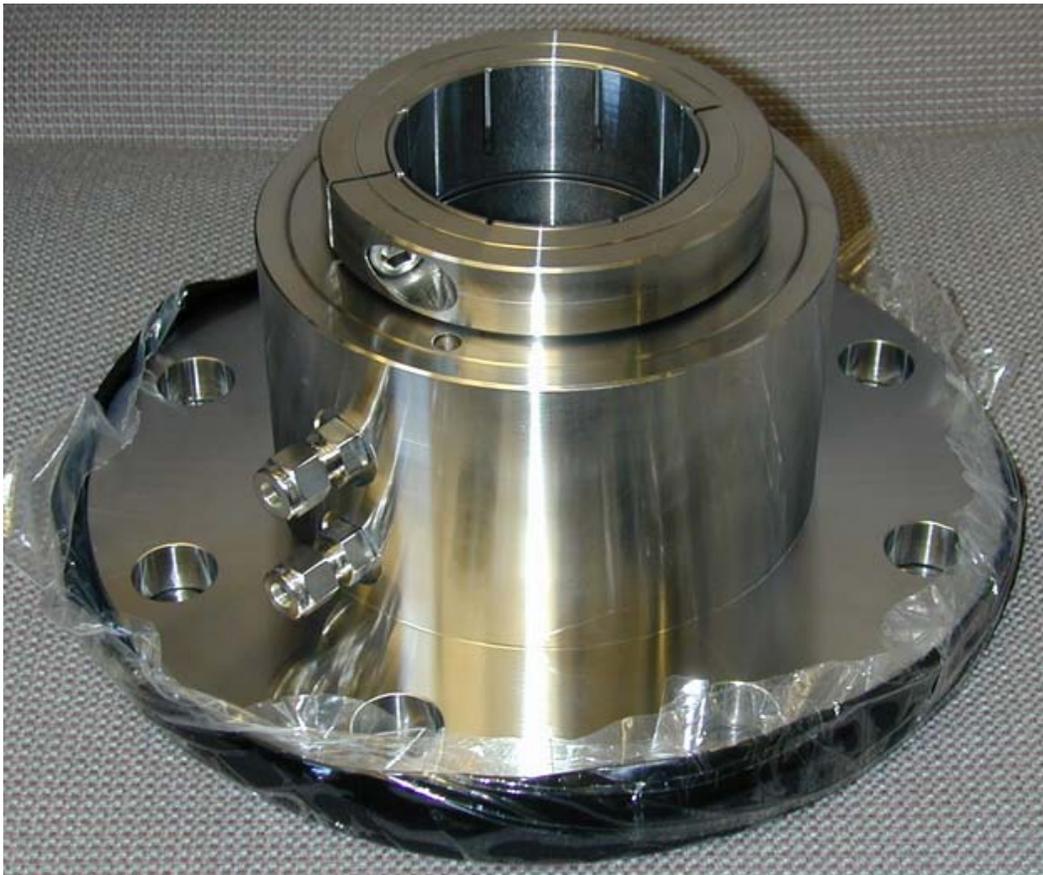
While waiting for feedback from Rigaku we acquired a second plug compatible seal from FerroTec

- Since it seemed that we had a heating problem with the Rigaku seal we chose a lower viscosity / higher outgassing ferrofluid.

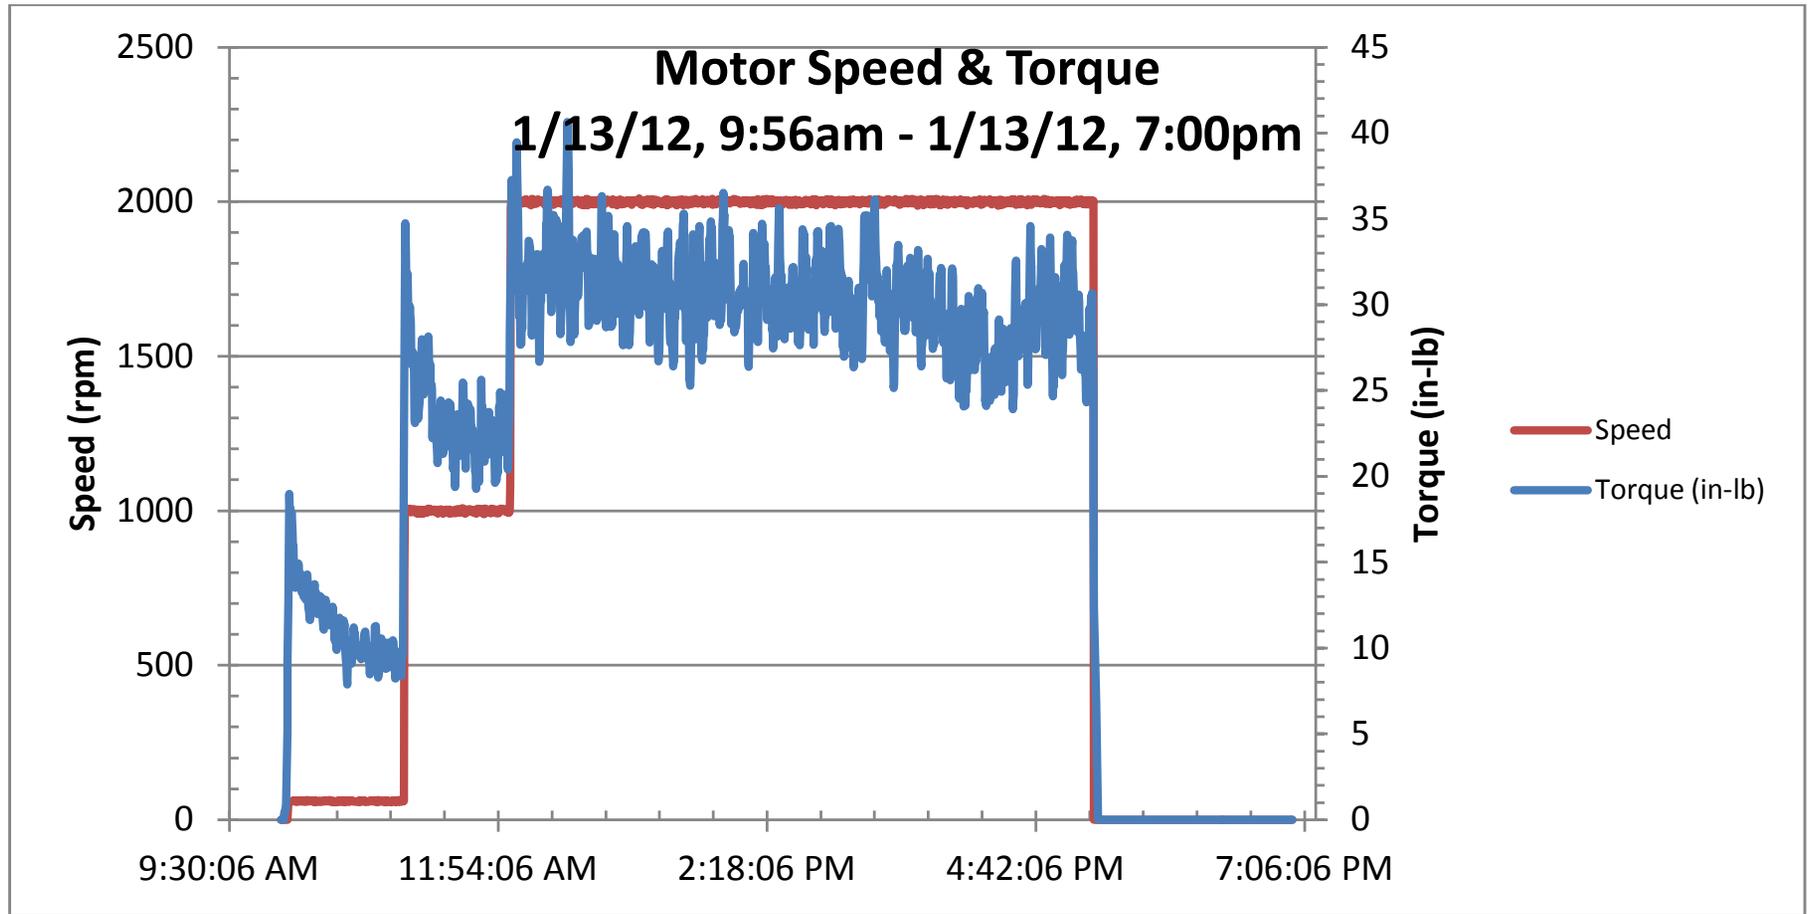
The ferrotec seal ran without significant problems at 2000 RPM

We logged about 38 hours total running time at 2000 RPM

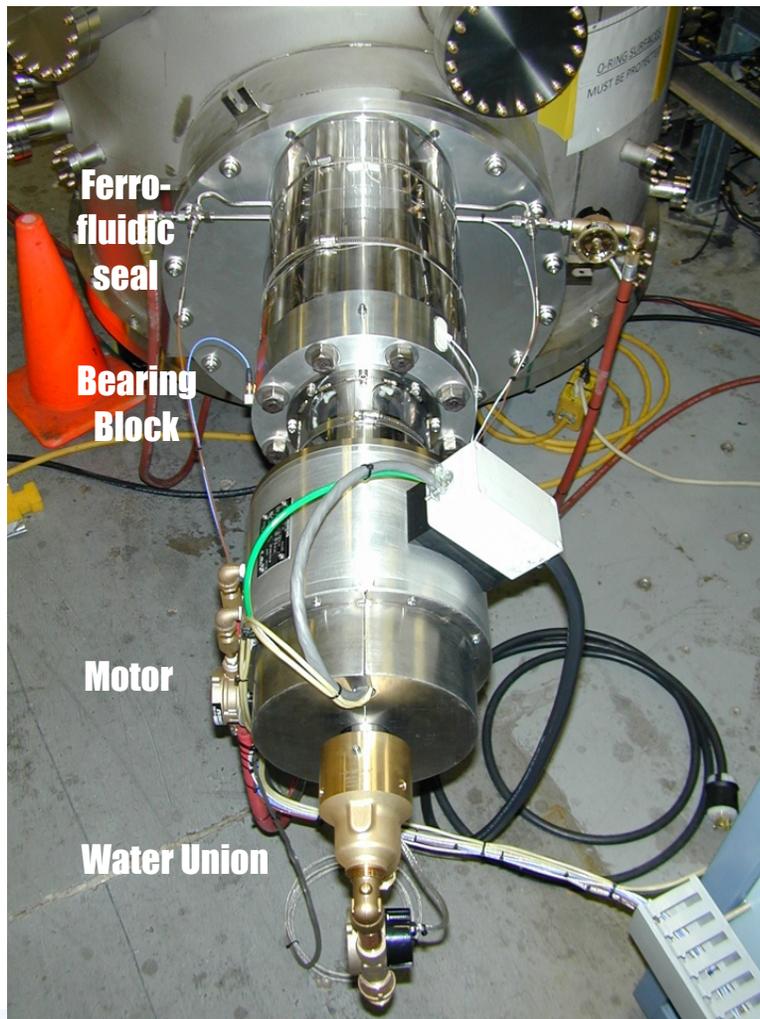
Operation of FerroTec seal #1 on the full test stand began in May 2012

- The DAQ records the system state every 30 seconds.
- Slow control is designed to shut down the wheel if any limits are exceeded
 - Unmanned operation is standard

- Motor
 - RPM
 - Power
 - Torque
- Vibration
 - Three axis sensors on motor, bearing block, seal
- Vacuum Pressure
- Temperature
 - Ambient, Seal, Bearing Block, Motor, Cooling water inlet and outlet
- Residual Gas Analyzer currents
- Cooling water flow rate
 - Seal, Bearing Block, Motor, Shaft

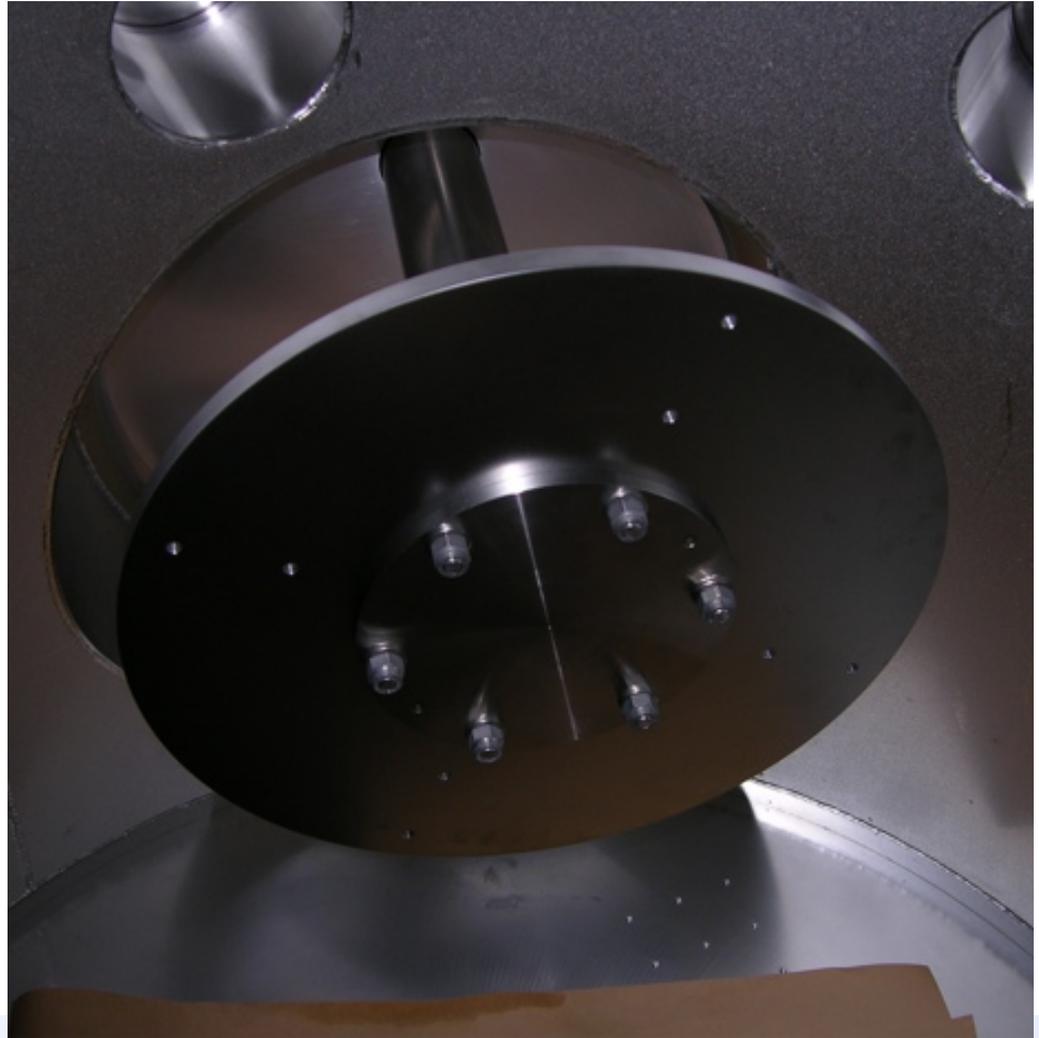
Medium disk was installed and balanced

- Same weight as titanium wheel
- No shielding required for safety
- Cooling water in the shaft has an effect on the balancing
- Not quite as stable a balance point as a solid shaft would have

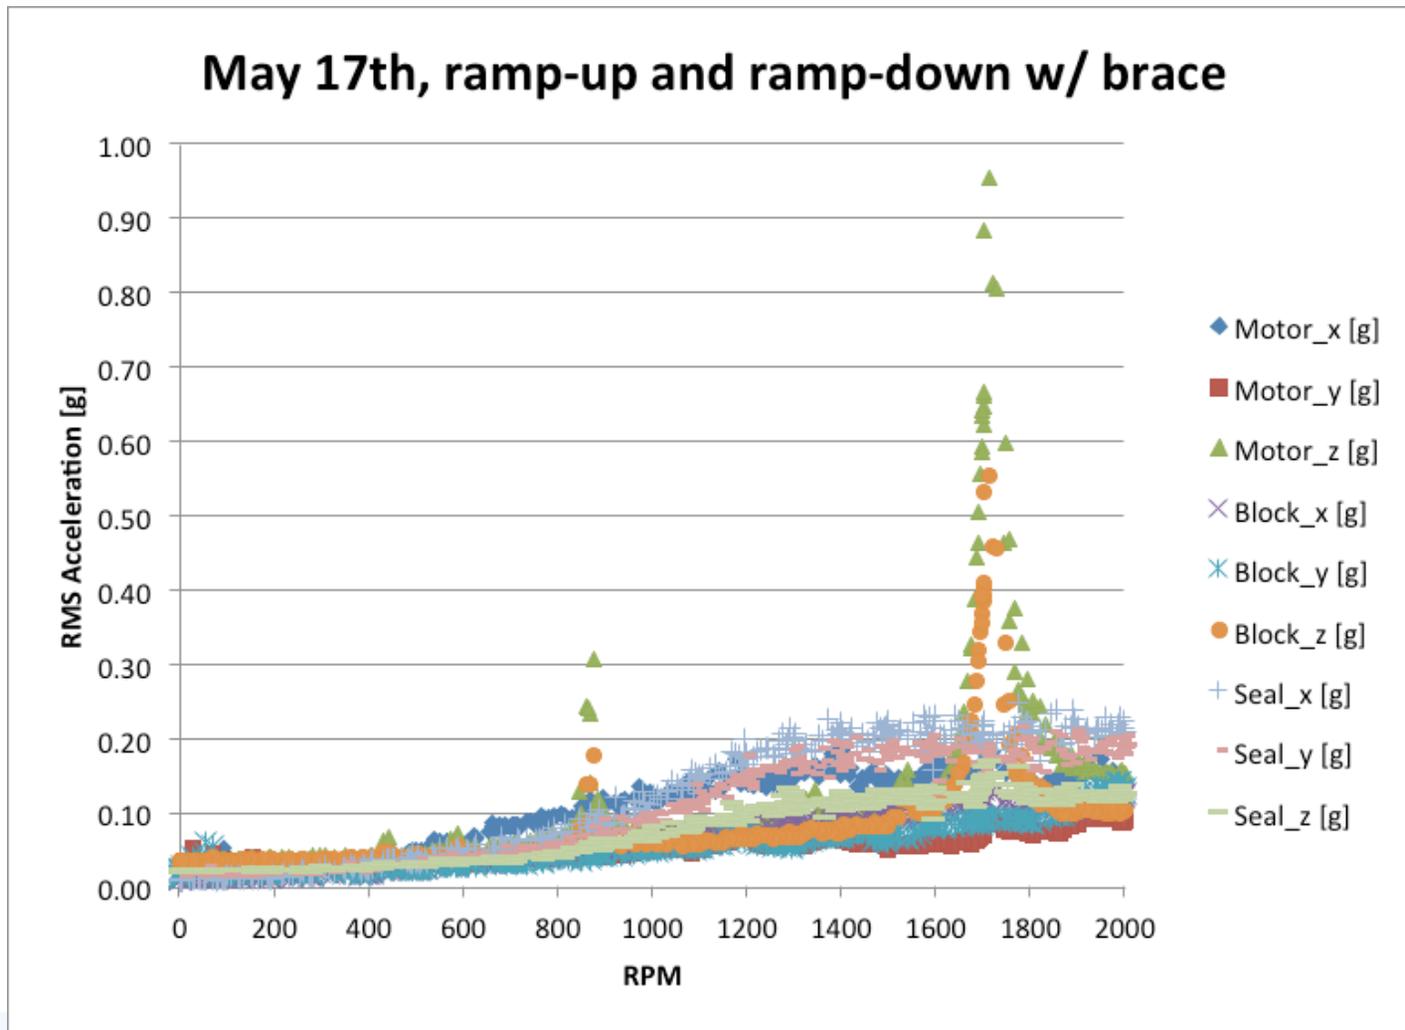
Balancing data from the FerroTec seal

x = along shaft
y = vertical
z = horizontal

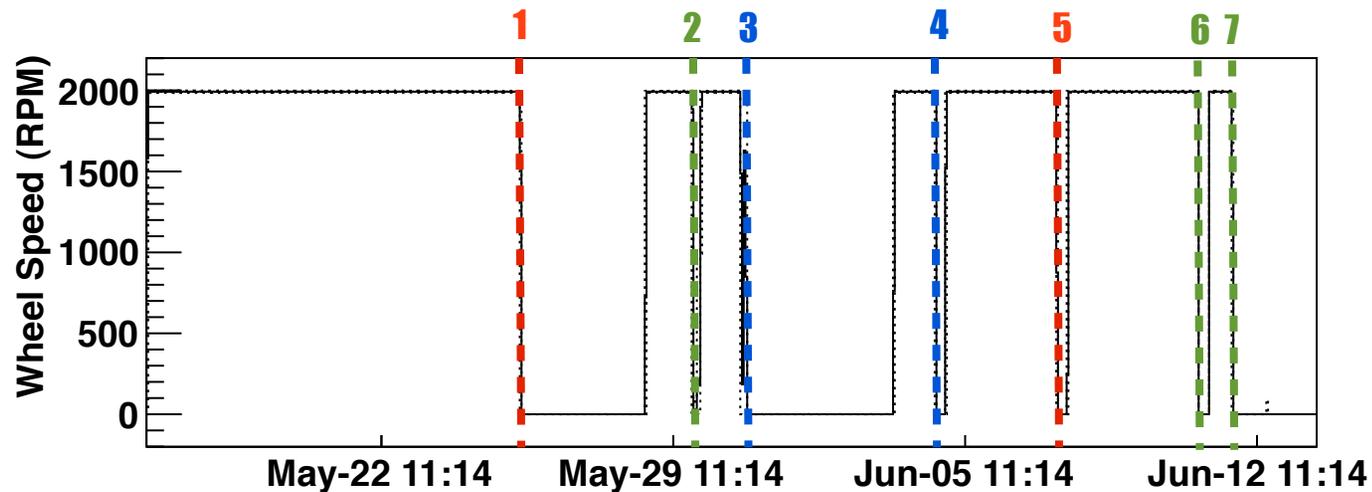
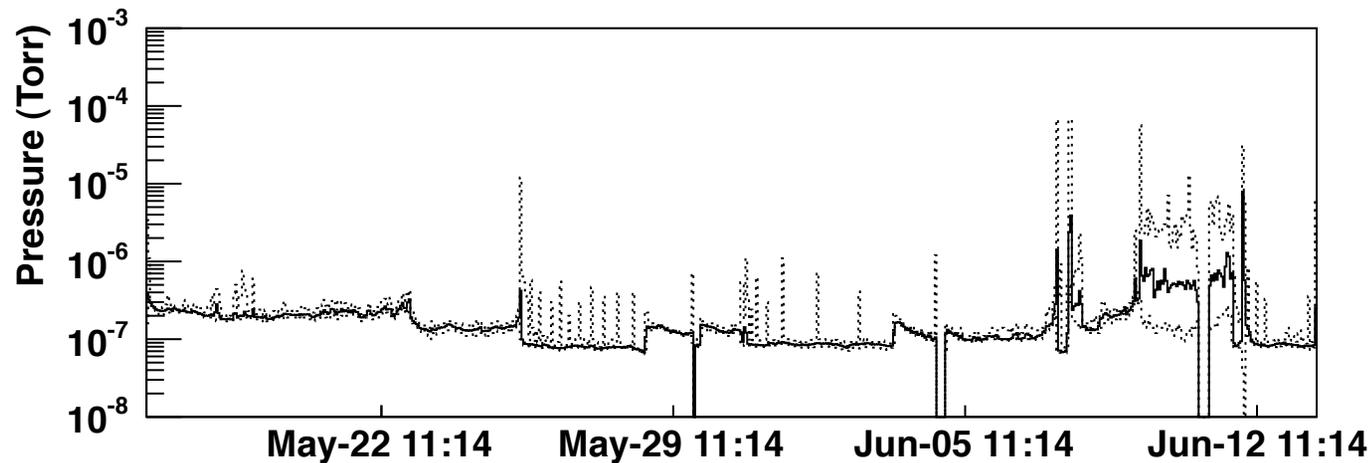
FerroTec Seal #1 ran for 1 month (450 hours up)

Pressure Trip
System Trip
Planned Down

- 1 - Pressure Spike**
- 2 - DAQ software change**
- 3 - Cooling water flow**
- 4 - Vibration Limit**
- 5 - Pressure Spike**
- 6 - Wheel stopped for pressure test**
- 7 - System down for rework**

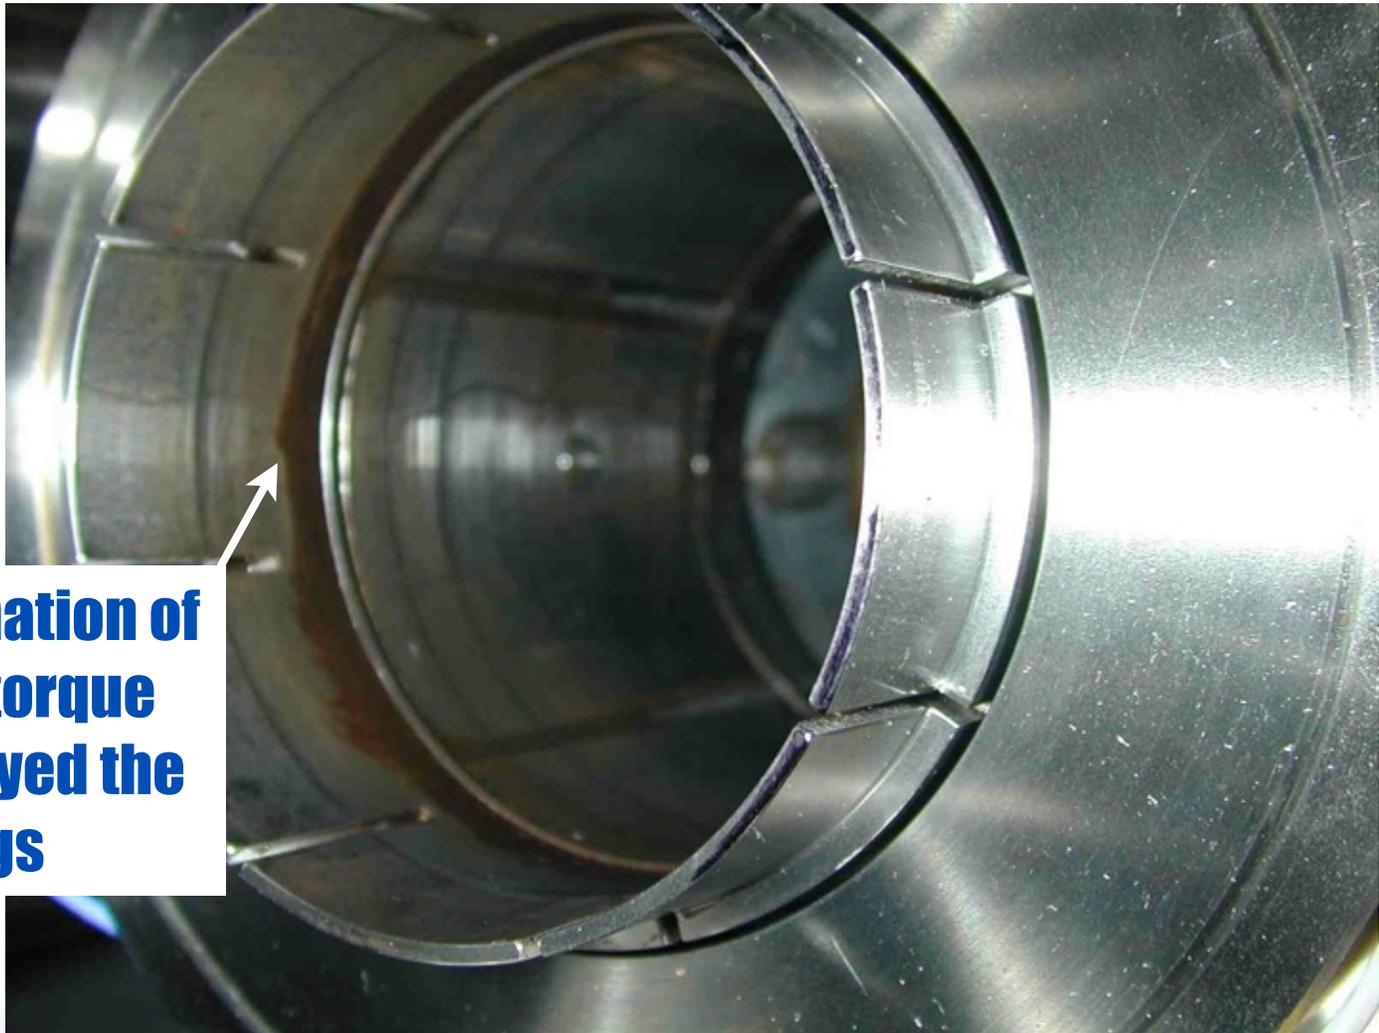
We dismantled the shaft to look for failure of the O-rings that sit inside seal

The combination of heat and torque had destroyed the O-rings

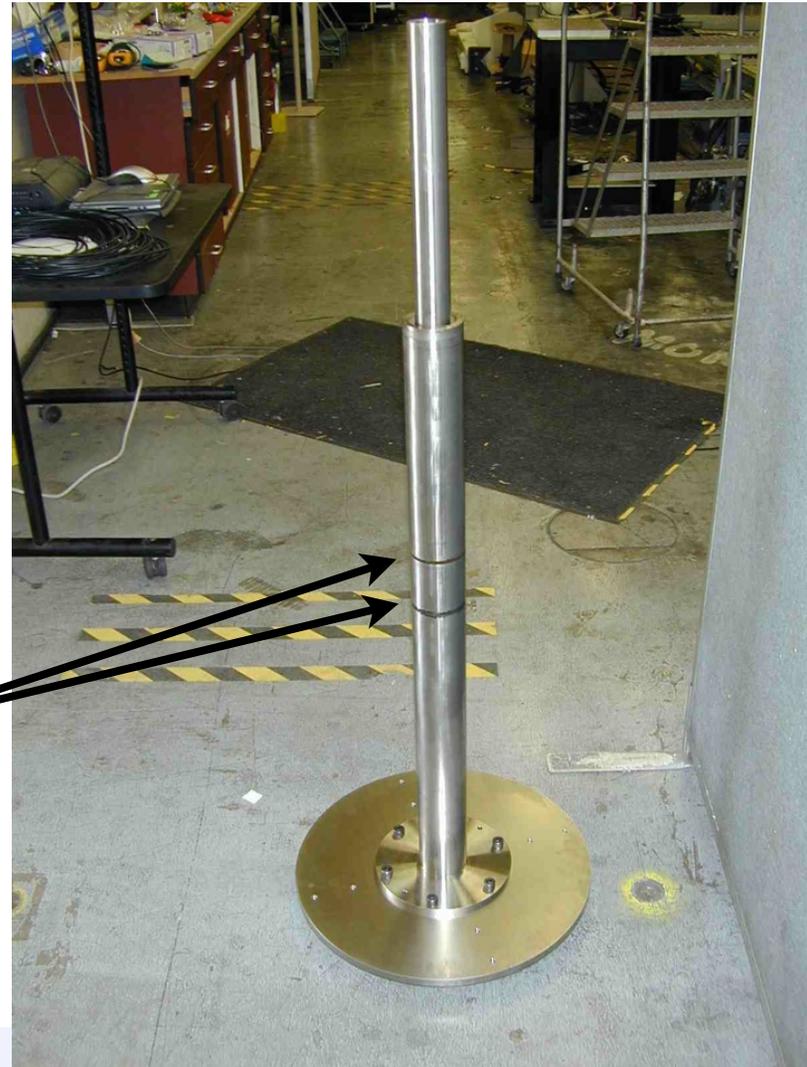
The ferrofluid seal didn't fail

- The collar which is supposed to clamp the seal to the shaft had been left off
- The O-rings became the components that transferred torque from the shaft to the seal
- Eventually the O-rings were destroyed

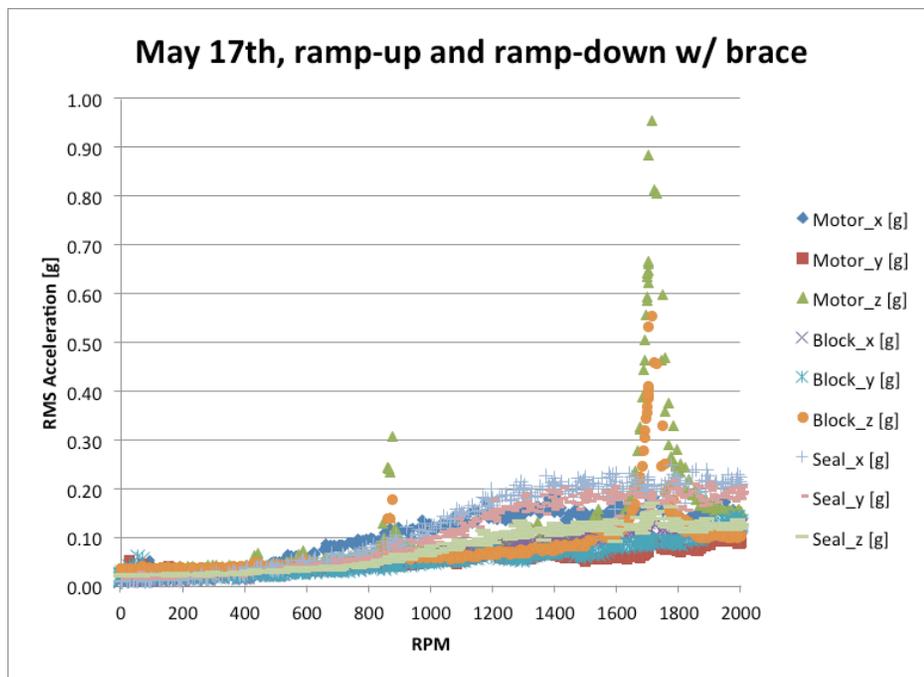
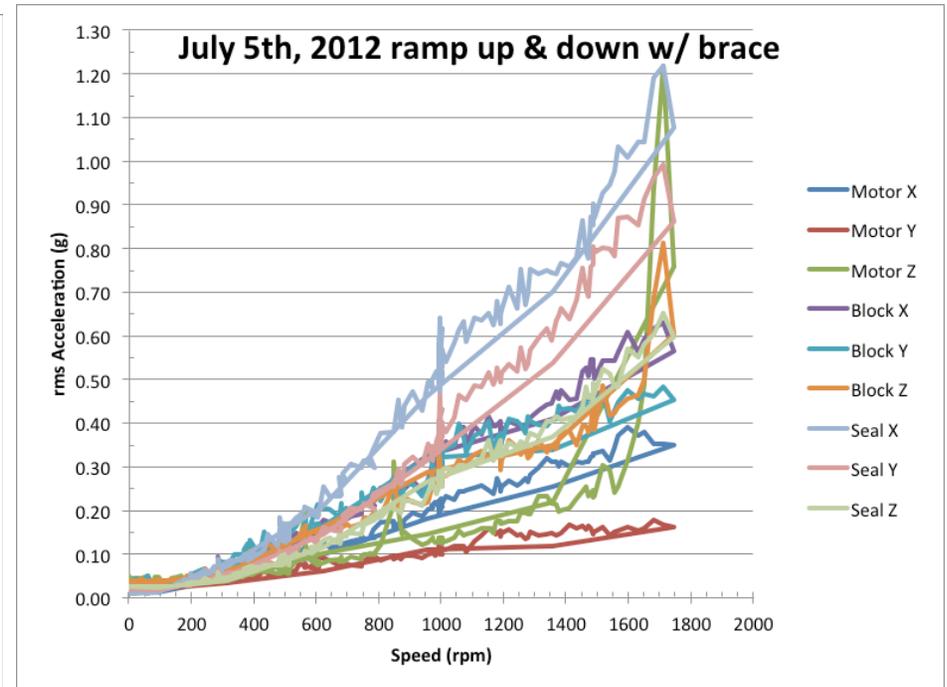
The vibrational characteristics of the seal changed dramatically after the rework

Vacuum was still good but system vibration became unacceptable

After investigating other possible sources of vibration we concluded that the force of extracting the shaft had damaged the seal bearings

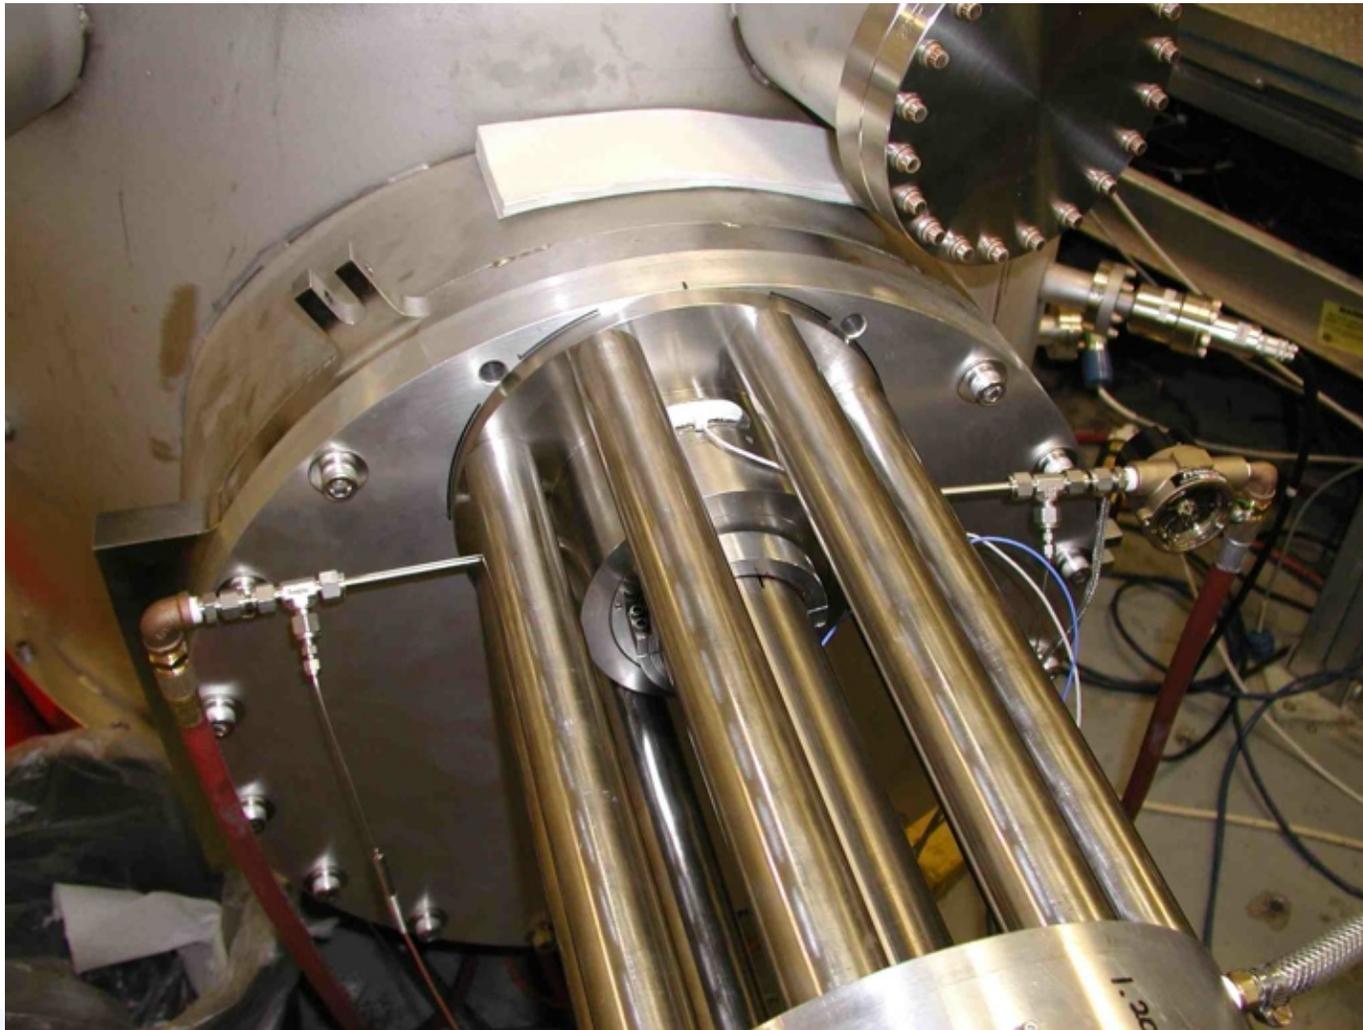
The FerroTec seal #1 was dismantled and the refurbished Rigaku seal was installed

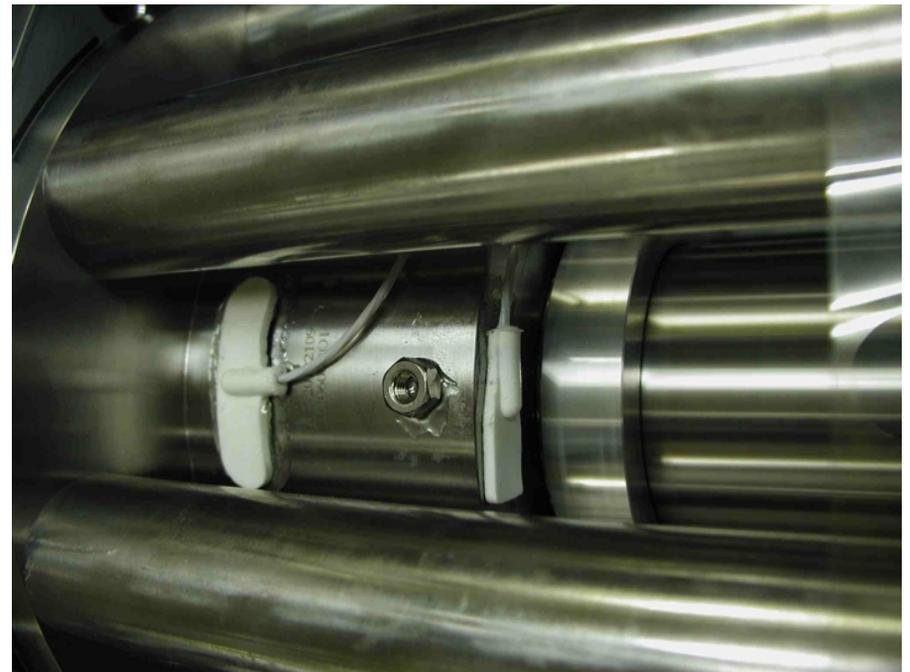
The Rigaku seal was not able to be run successfully at 2000 RPM

- Seemed OK when run unloaded on the vertical test stand
- Under load there was a large acoustic noise from the bearings
- Repeated pressure spikes
- High Temperatures on the case at 1000 RPM
 - 31 C on case
 - 46 C on the end

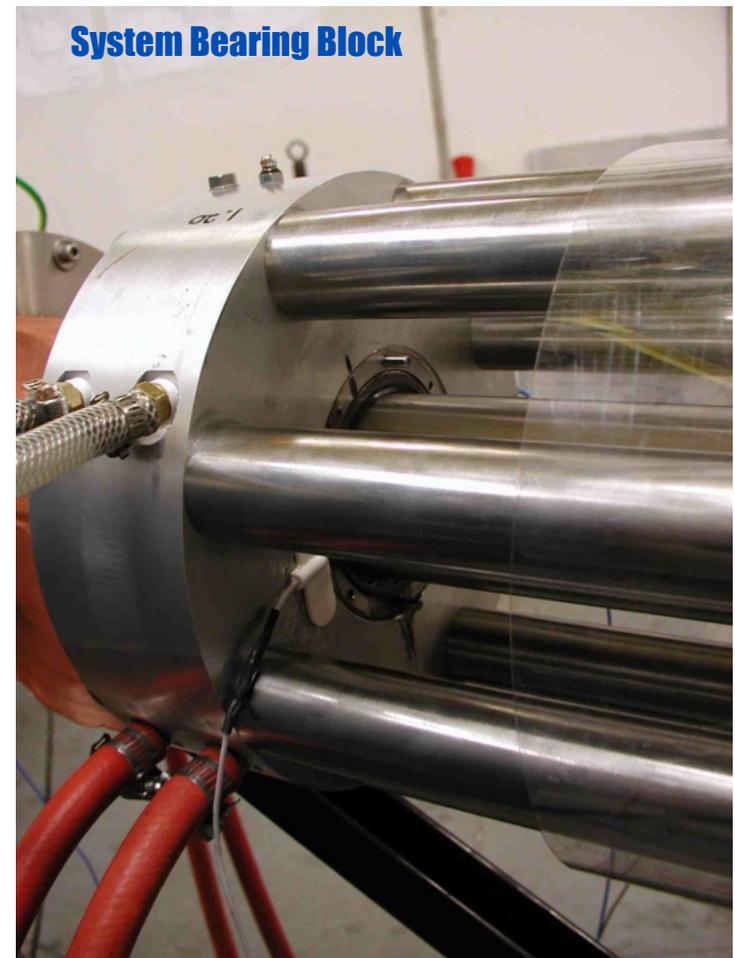
Rigaku seal was dismantled, FerroTec seal #3 was installed

- Installation completed August 30th
- Ran at 500 RPM over the weekend with no seal problems but developed a water leak in the central shaft at the bearing block
- Once the leak is fixed we will balance and run at 2000 RPM
- We will allow the system to run until it develops a problem

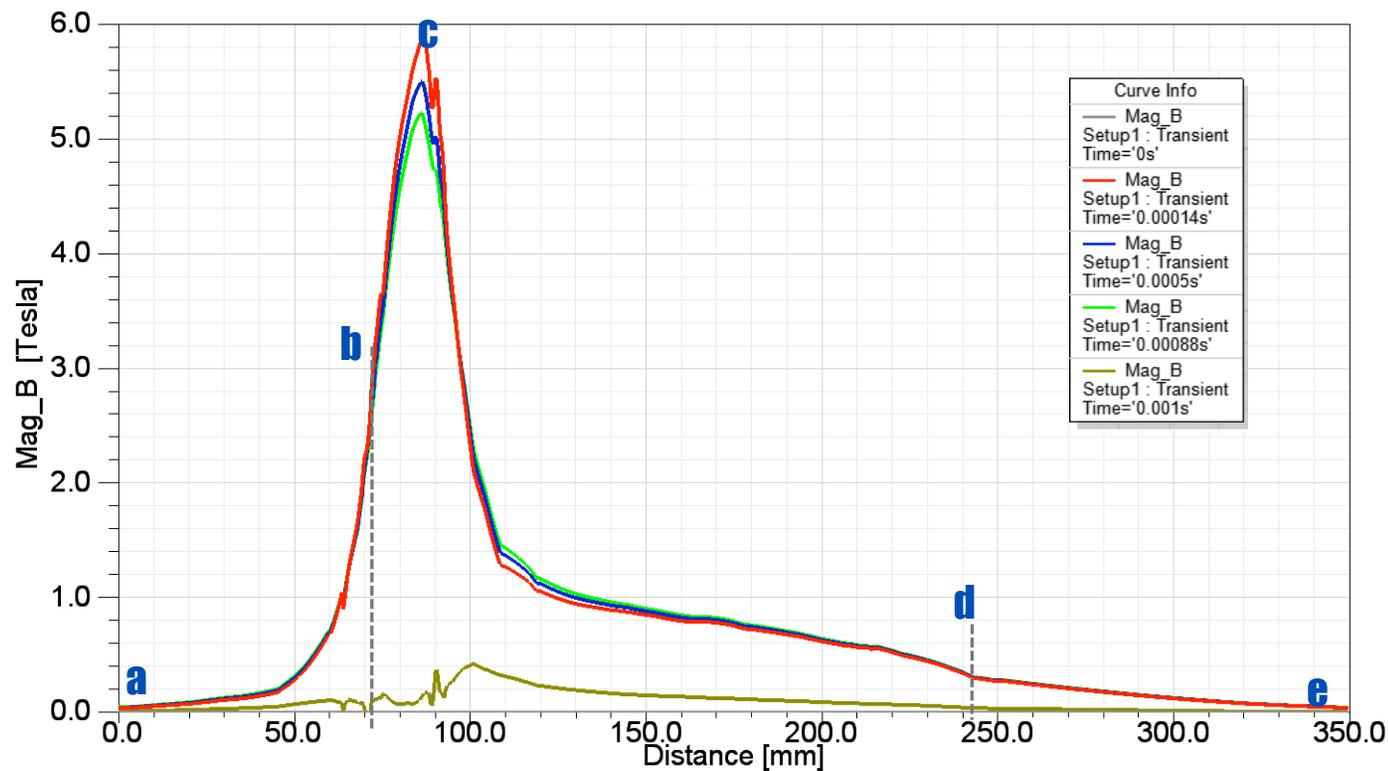
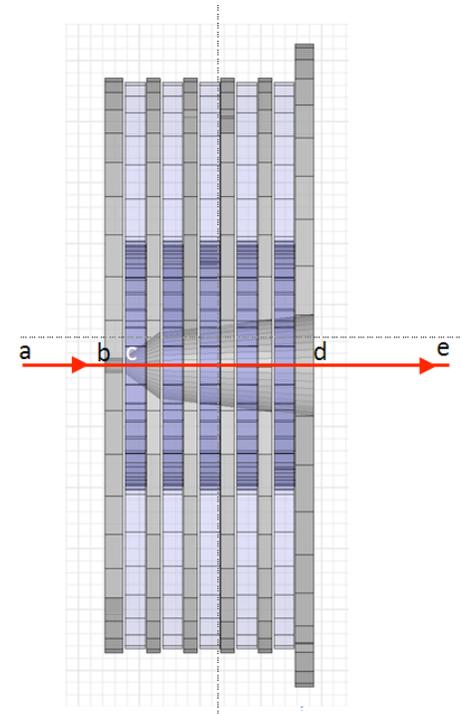
- Pulsed flux concentrators are a known technology that work well for short pulses
- We want a constant magnetic field profile over the 1 ms beam pulse
 - Induced currents in the concentrating plates will decay as stored energy is converted into ohmic heating

Pulsed Flux Concentrator to increase capture efficiency and reduce magnetic field at the target
