**Design and Prototyping of the ILC
Positron Target System**

Oct 22, 2012 - LCWS 2012

We are doing design and prototyping of the rotating shaft seal and the capture magnet

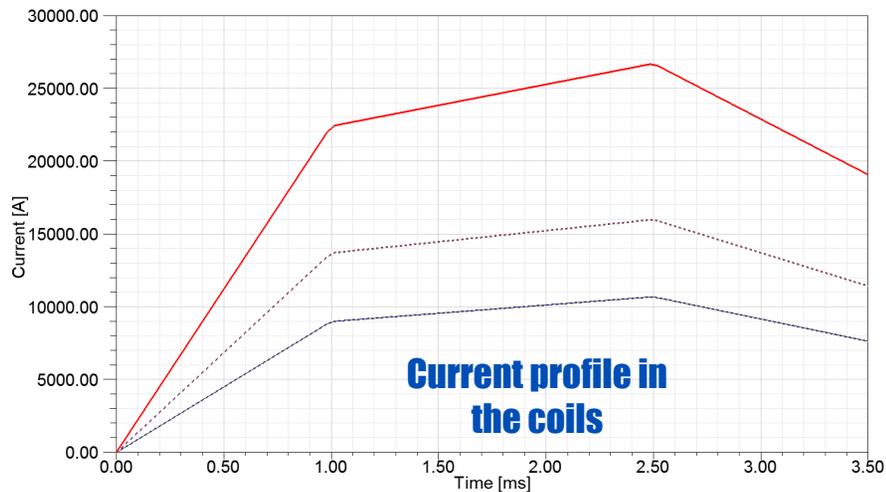
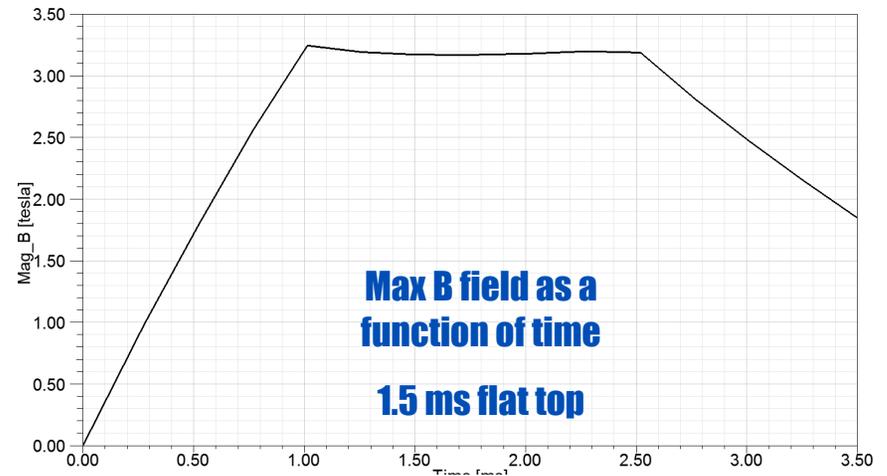
A 20% current ramp over 1.5 ms leads to a constant magnetic field during that period

- A current ramp from the pulse forming network can counteract the magnetic field droop - even at room temperature

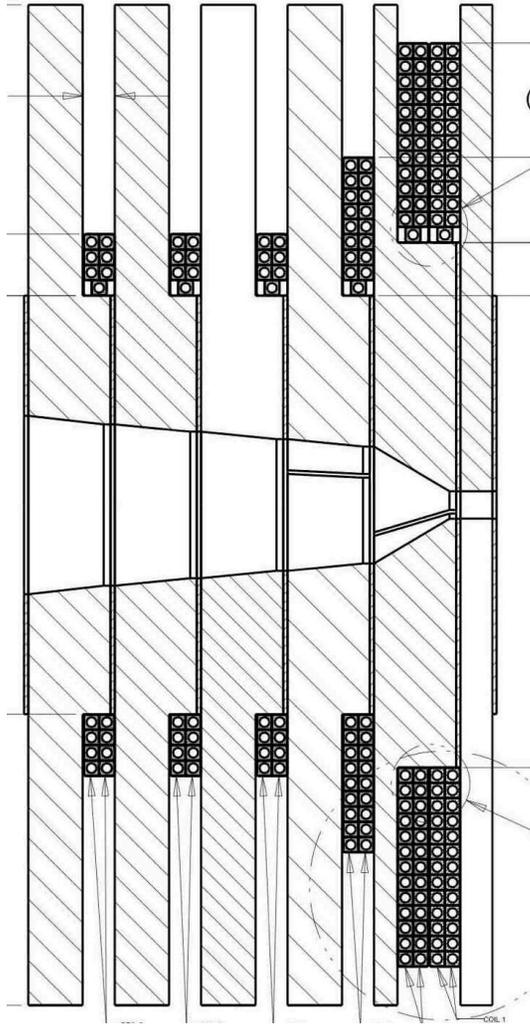
Water cooling and room temperature greatly simplifies the design

- Device sits in the vacuum
- All power and cooling connections move to the rim
 - Coils are kapton wound, hollow copper, water cooled
 - Plates are OFHC copper with water cooling pipes soldered in
 - Only metal in the high radiation areas
- Plates and coils stack and bolt together

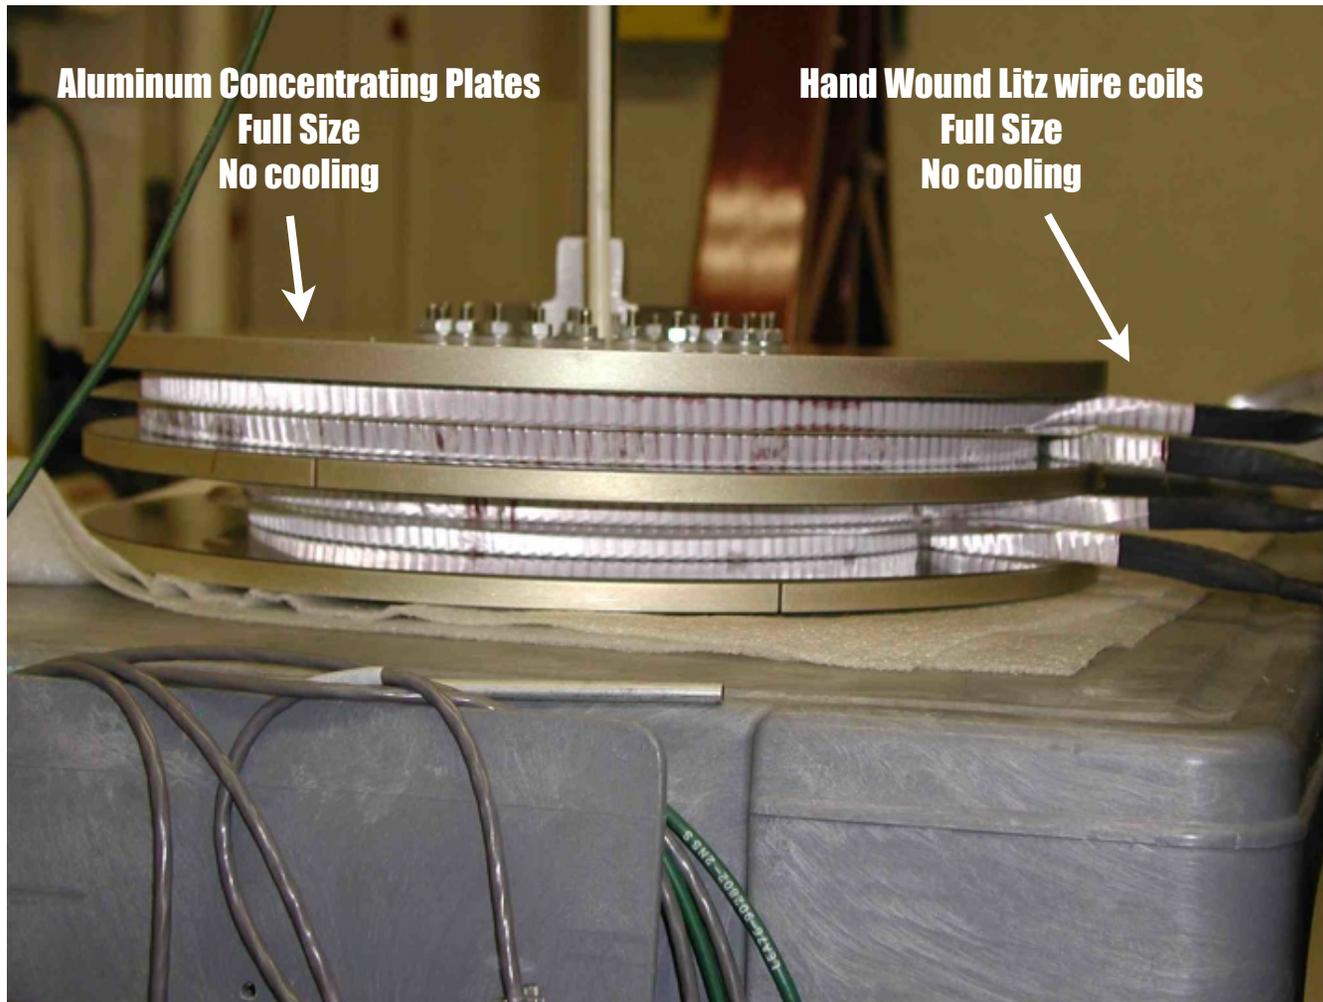
We built a test stack of 3 Aluminum concentrating plates and 2 Litz-wire coils

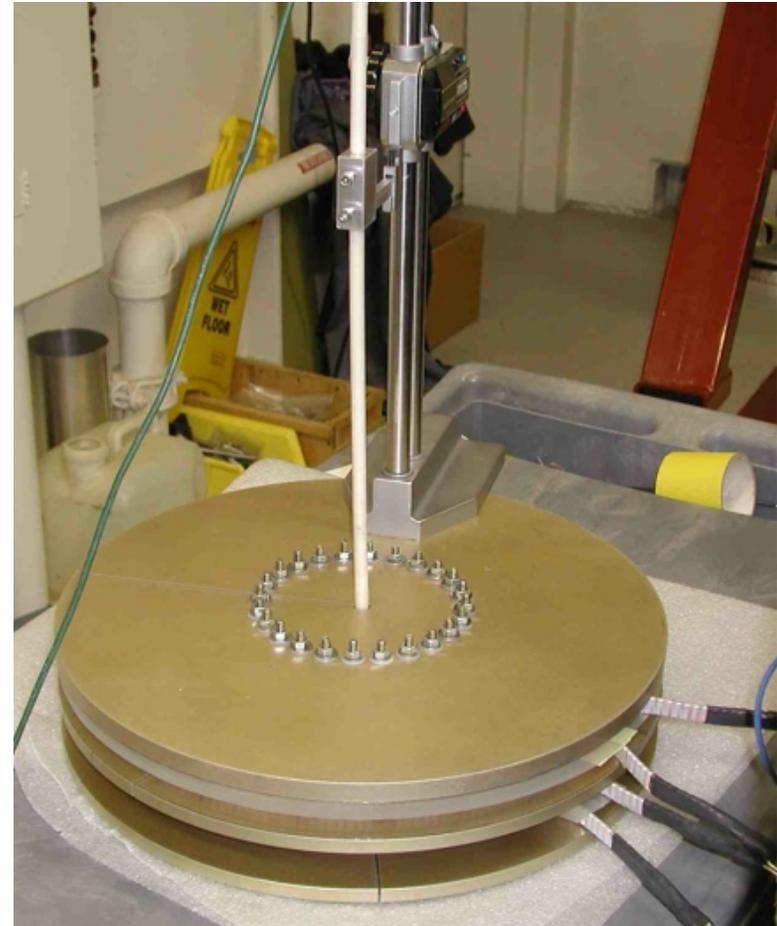
We use a wire loop to measure the time-dependent magnetic field in the bore

- Wire loop:
 - 5 turns
 - 3/8" diameter = $7.12 \times 10^{-5} \text{ m}^2$
 - $B(\text{T}) = 2809 \times \text{Volt-seconds}$

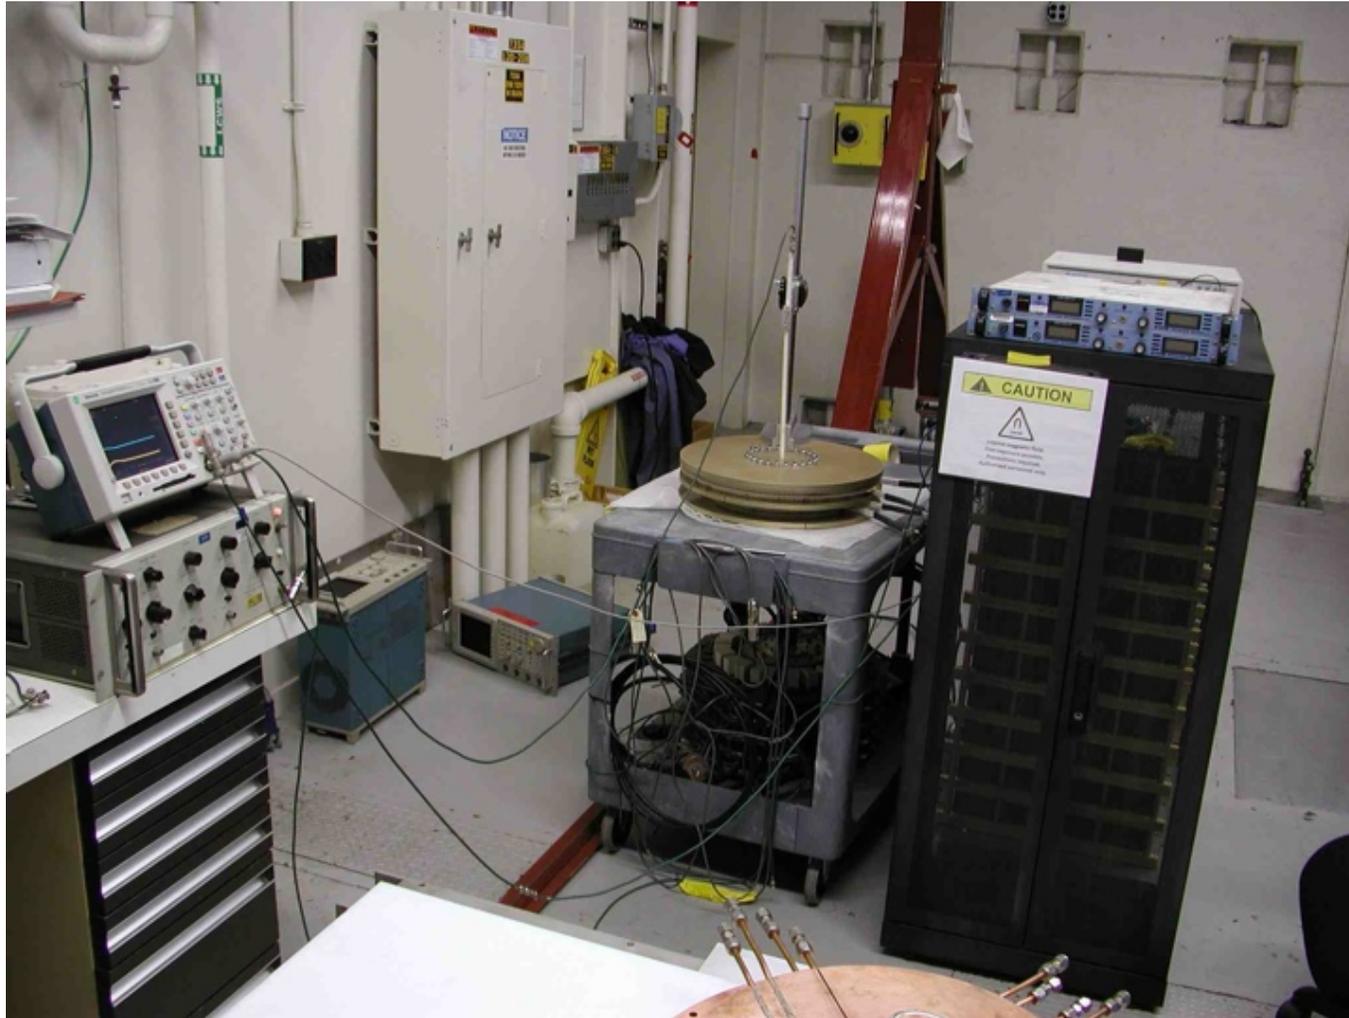
Capacitor stack configured for a single pulse

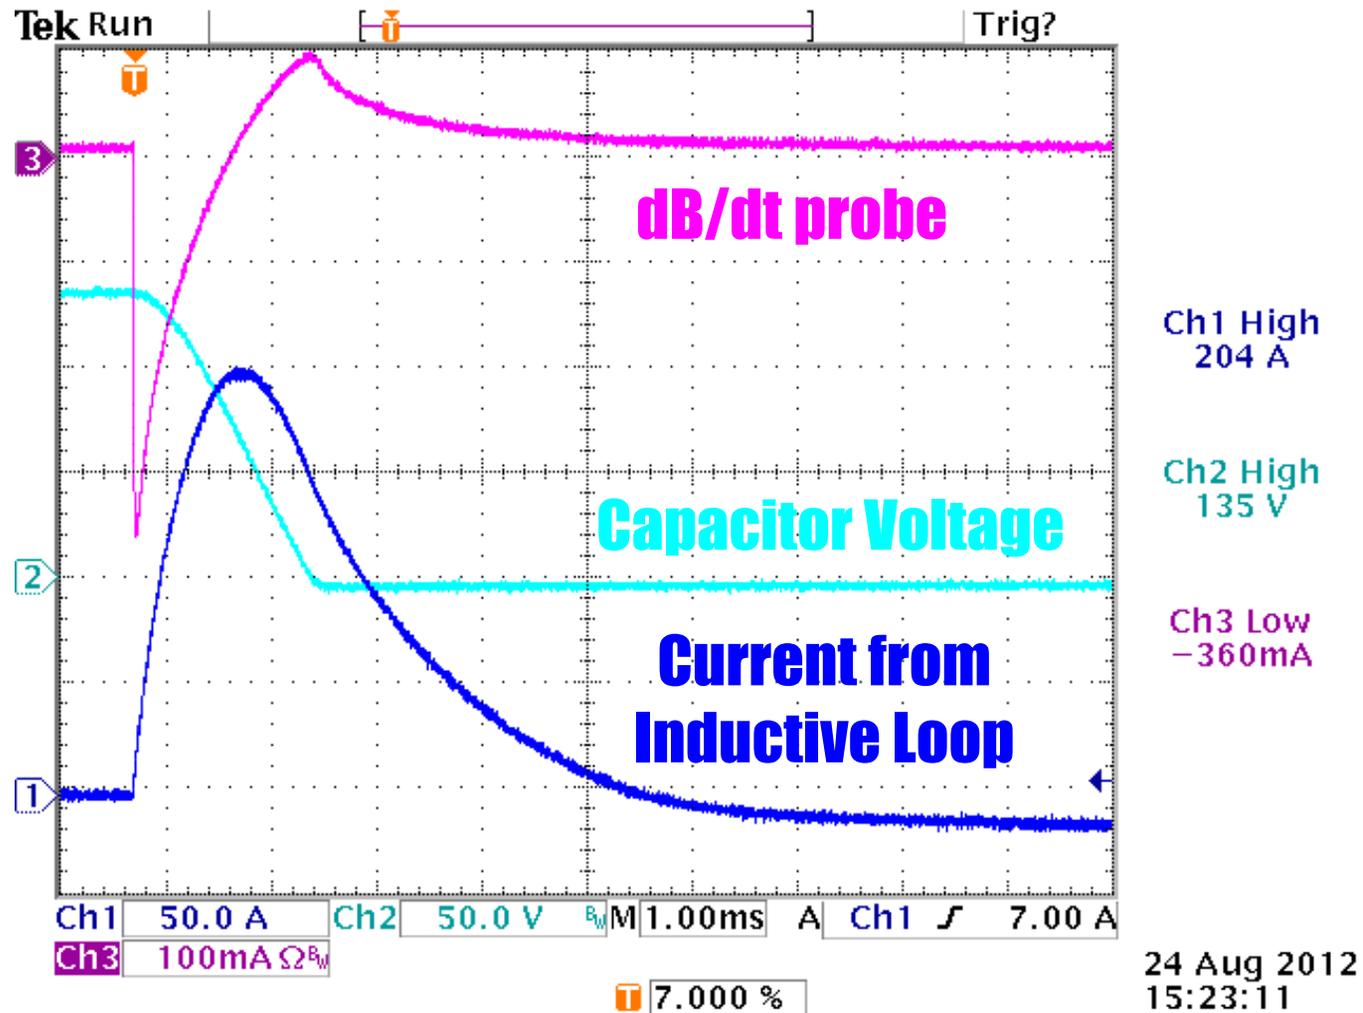
Example measurements from 200A peak pulse

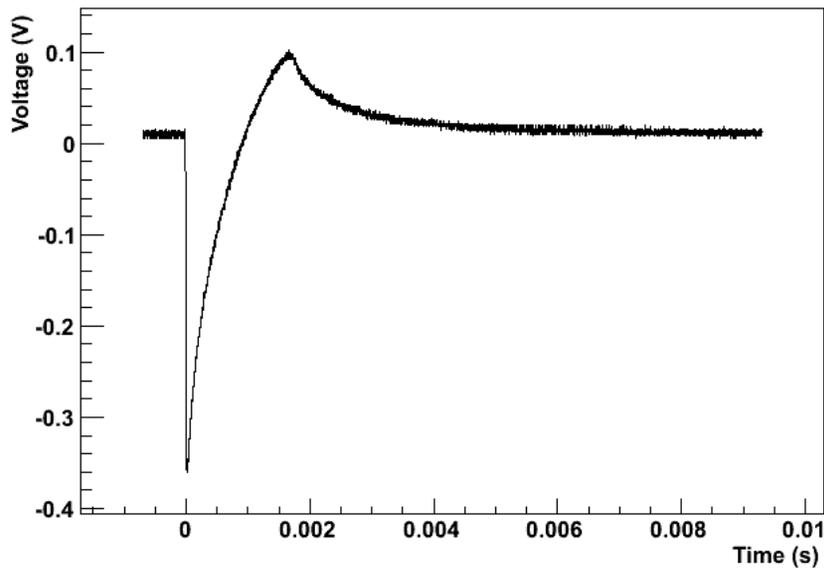
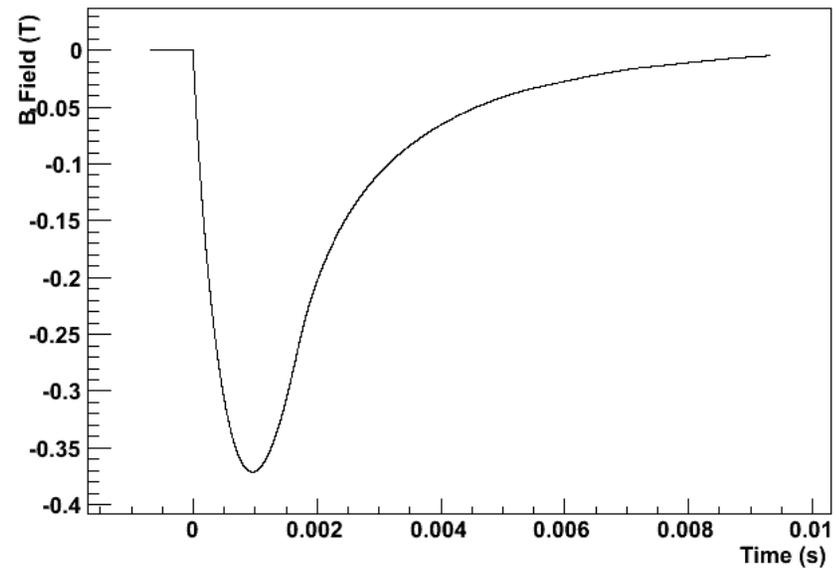
The voltage of the dB/dt probe is integrated over time to measure the time dependent B Field

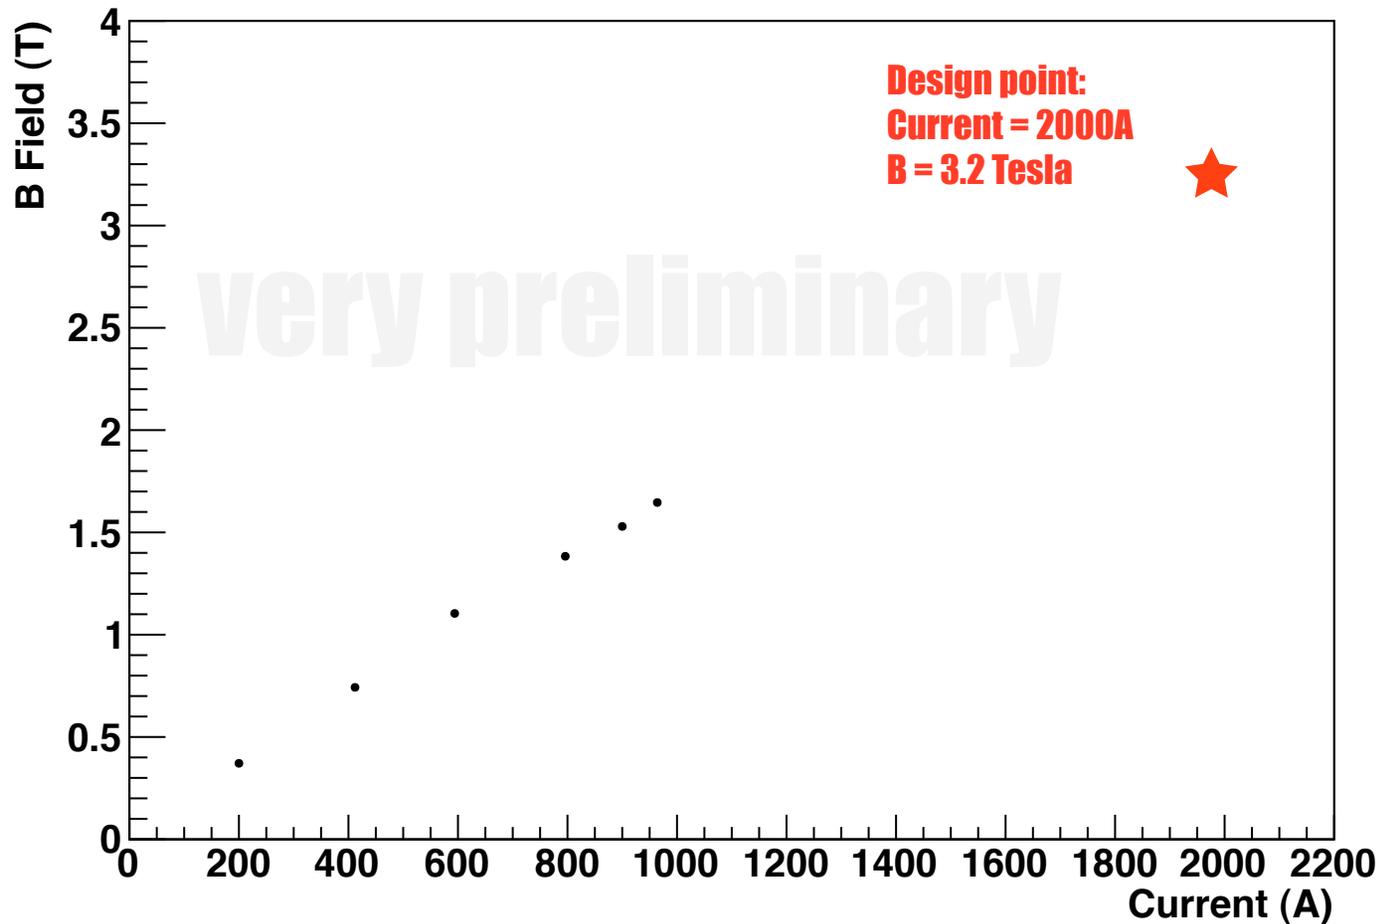
Measured peak axial magnetic field out to 1000A peak current

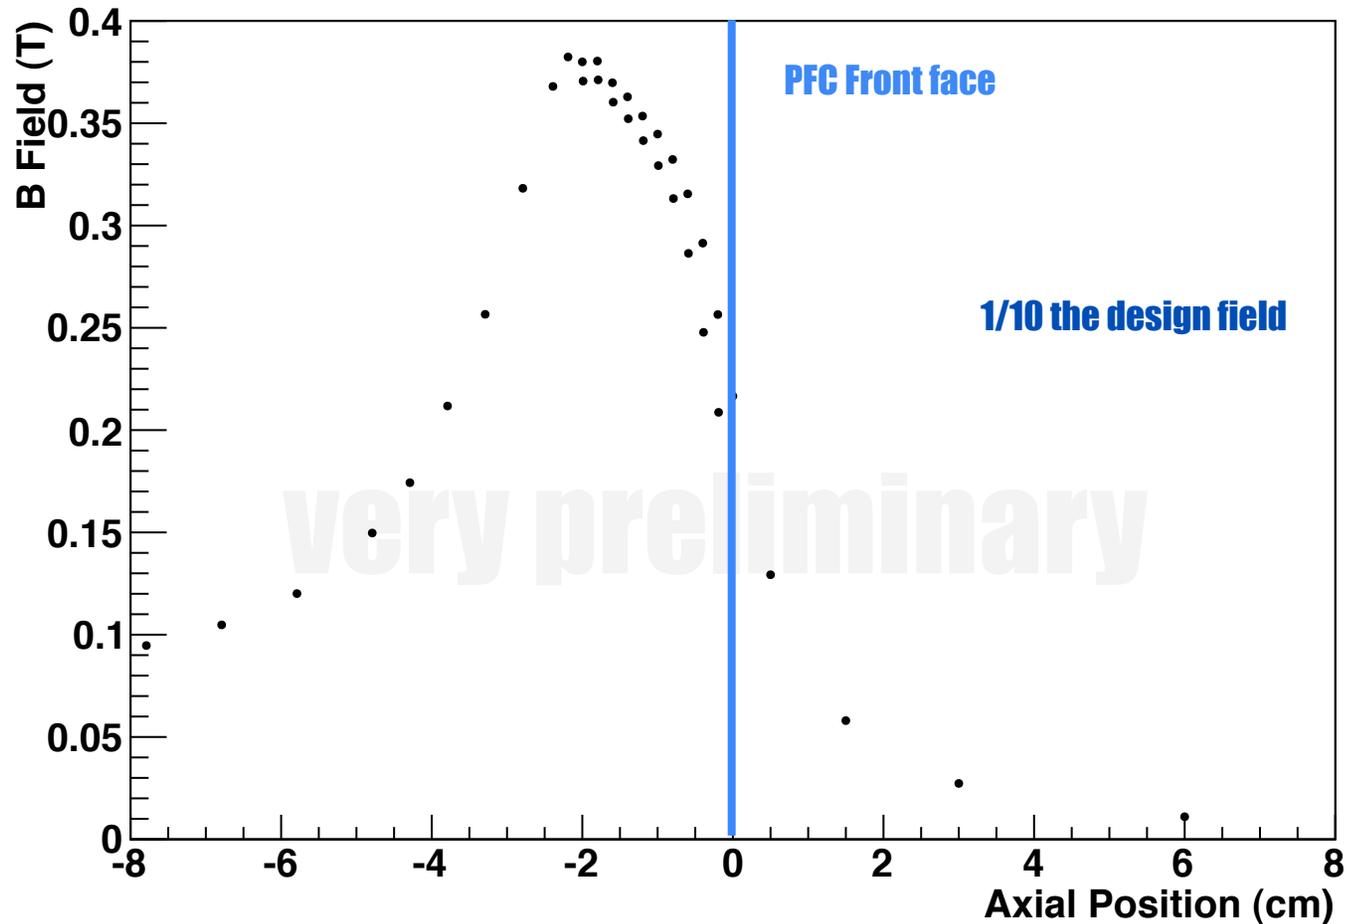
We mapped out the axial magnetic field in the bore as a function of position for a 200A pulse

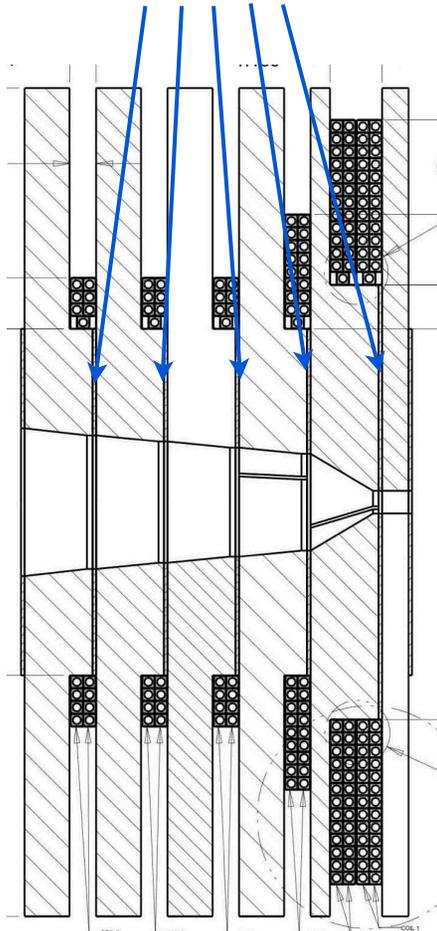
Separators

All measurements were done with Stainless Steel separators between the concentrating plates

- Insulating Zirconia Toughened Alumina insulators between the concentrating plates
 - Prevent current flows between the plates
 - Potential problem with fracturing under 5 Hz repetitive stress
- Stainless Steel is a poor electrical conductor.
 - More robust to repetitive stress and radiation
 - Allows current to flow between the plates

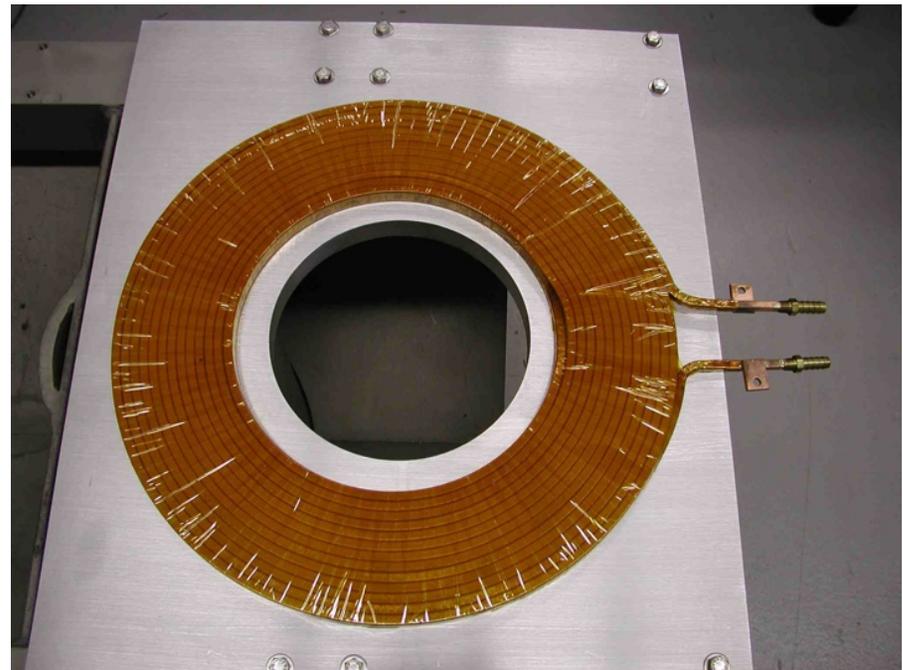
Coils are kapton wrapped, center cooled copper, up-set winds, cooling is not a problem

- Wire dimensions:
 - 7 mm x 7 mm square
 - 4.5 mm dia inner hole
 - resistivity $1.68e-8 \Omega\text{m}$
 - skin depth between 5-6.5 mm
- Largest 25 turn coil
 - 27.8 m long wire
 - will dissipate $\sim 800\text{W}$
 - 5 mL/s flow - 30 cm/s - 18 kPa
 - $50 \text{ K } \Delta T = 900 \text{ W}$

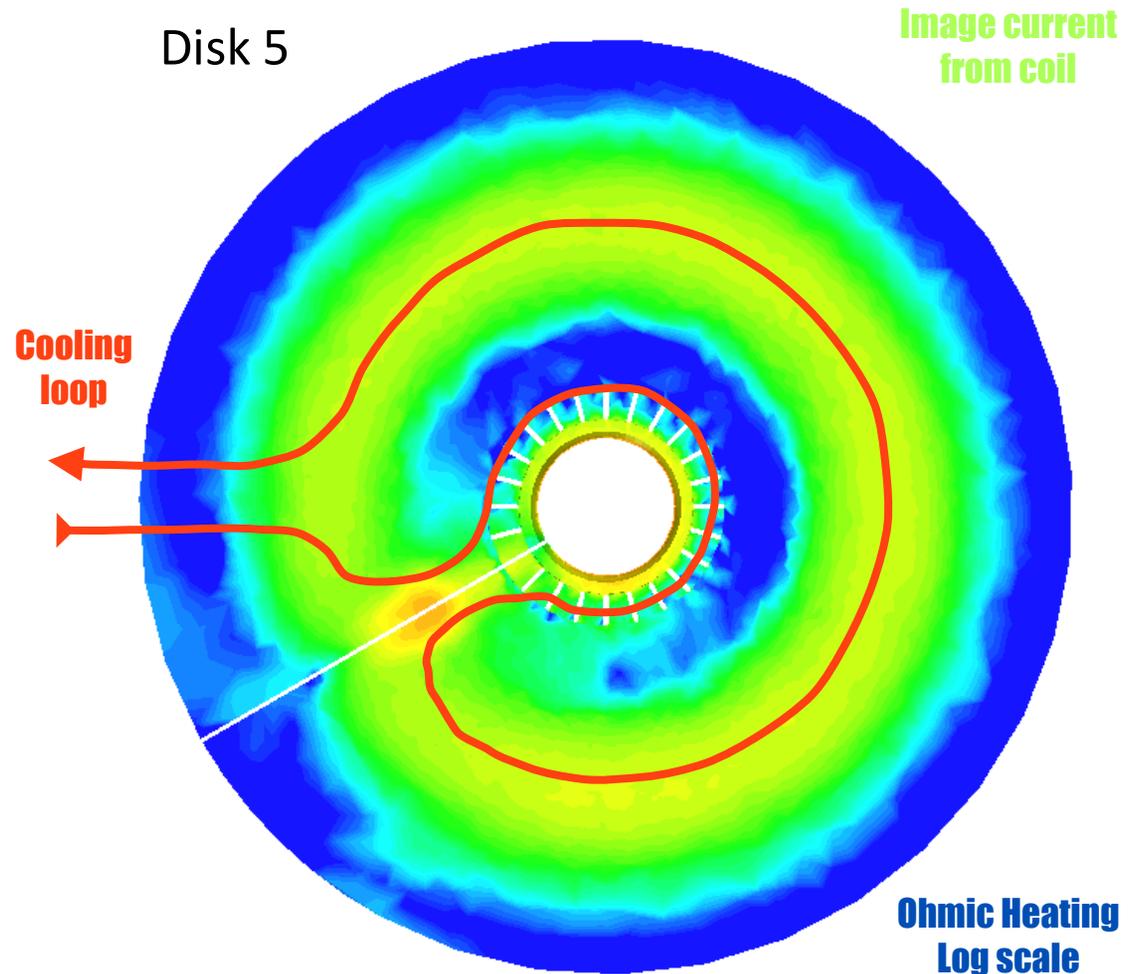
Cooling of the concentrating plate must remove the ohmic heating around the bore

- Cooling lines should go where the heat is.
- A loop should run around the region of the coil image current.
- Up and down the side of the slit
- Around the bore

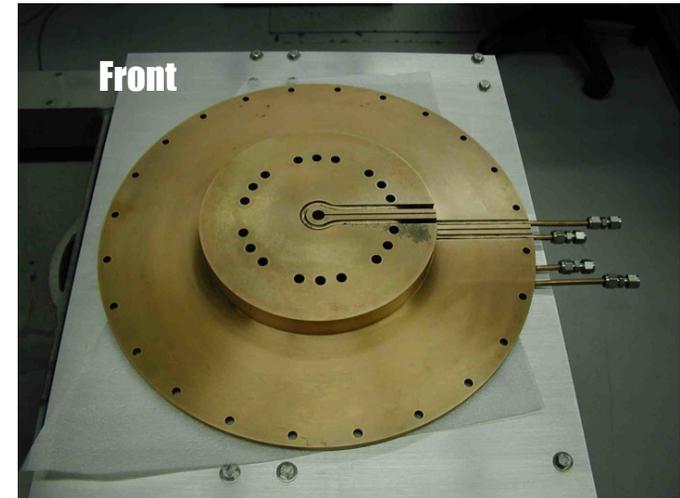
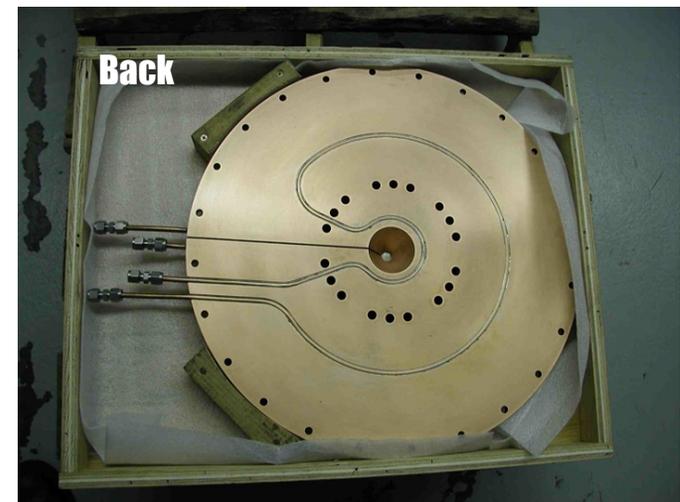
Plate 2 has two separate cooling loops

- Front loop:
 - Runs along slit and around the bore
- Back loop:
 - Runs around the bore and in the region of the coil image currents

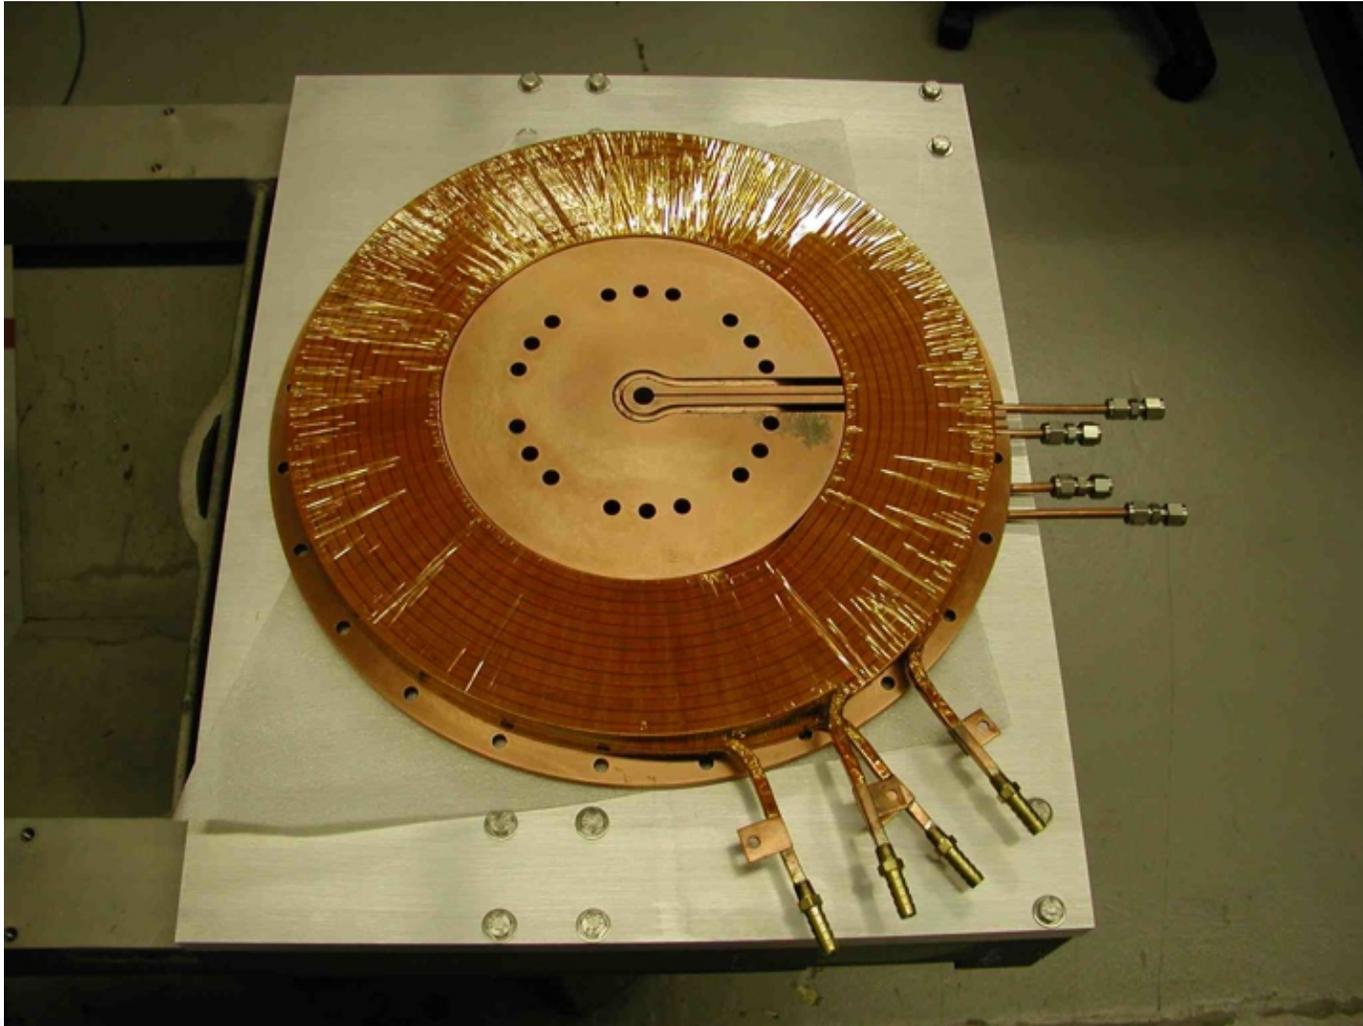
Plate 2 with 50 turn energizing coils in place

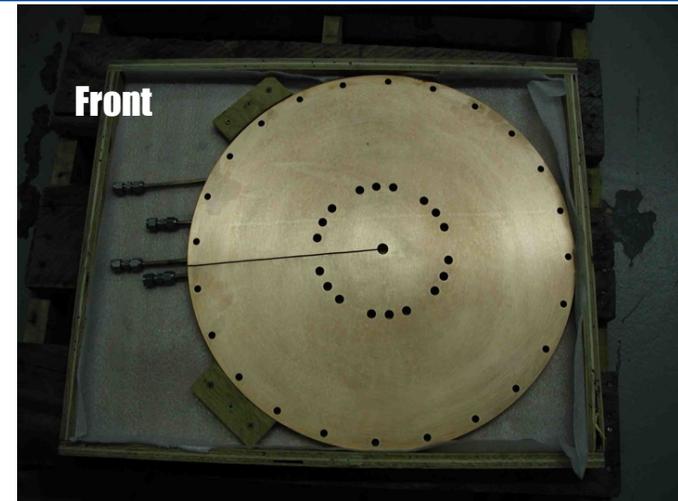
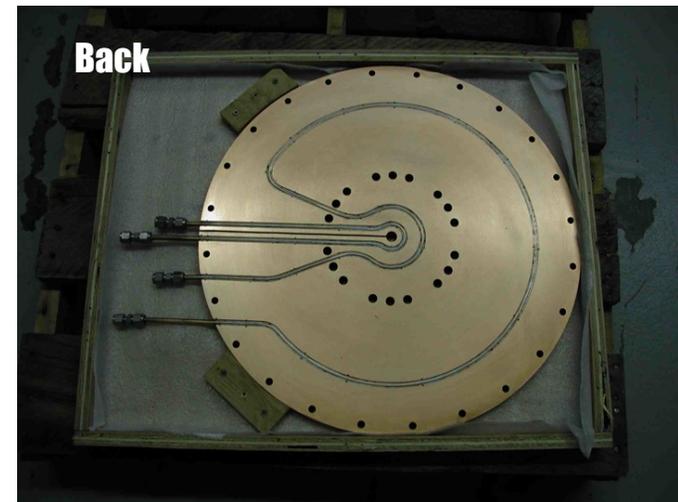
Plate 1 has both cooling loops on the back

- Front:
 - Bare metal to provide maximum shielding against beam particles
- Back:
 - One loop around bore and along slit
 - One loop around the bore and in the image current region

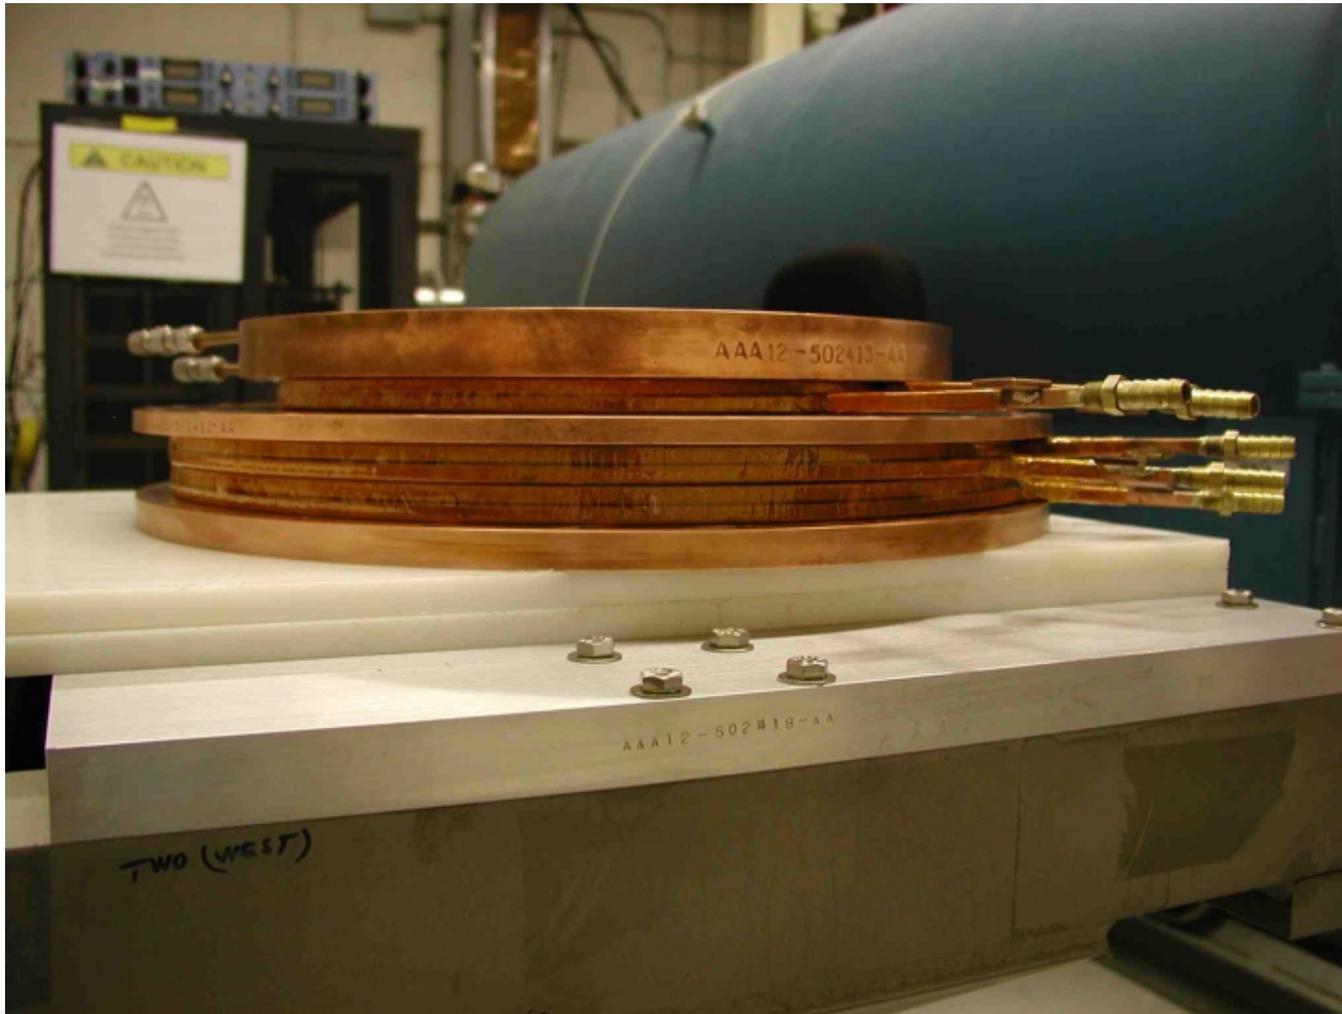
The 3 copper concentrating plate and 2 center cooled copper coil test stack

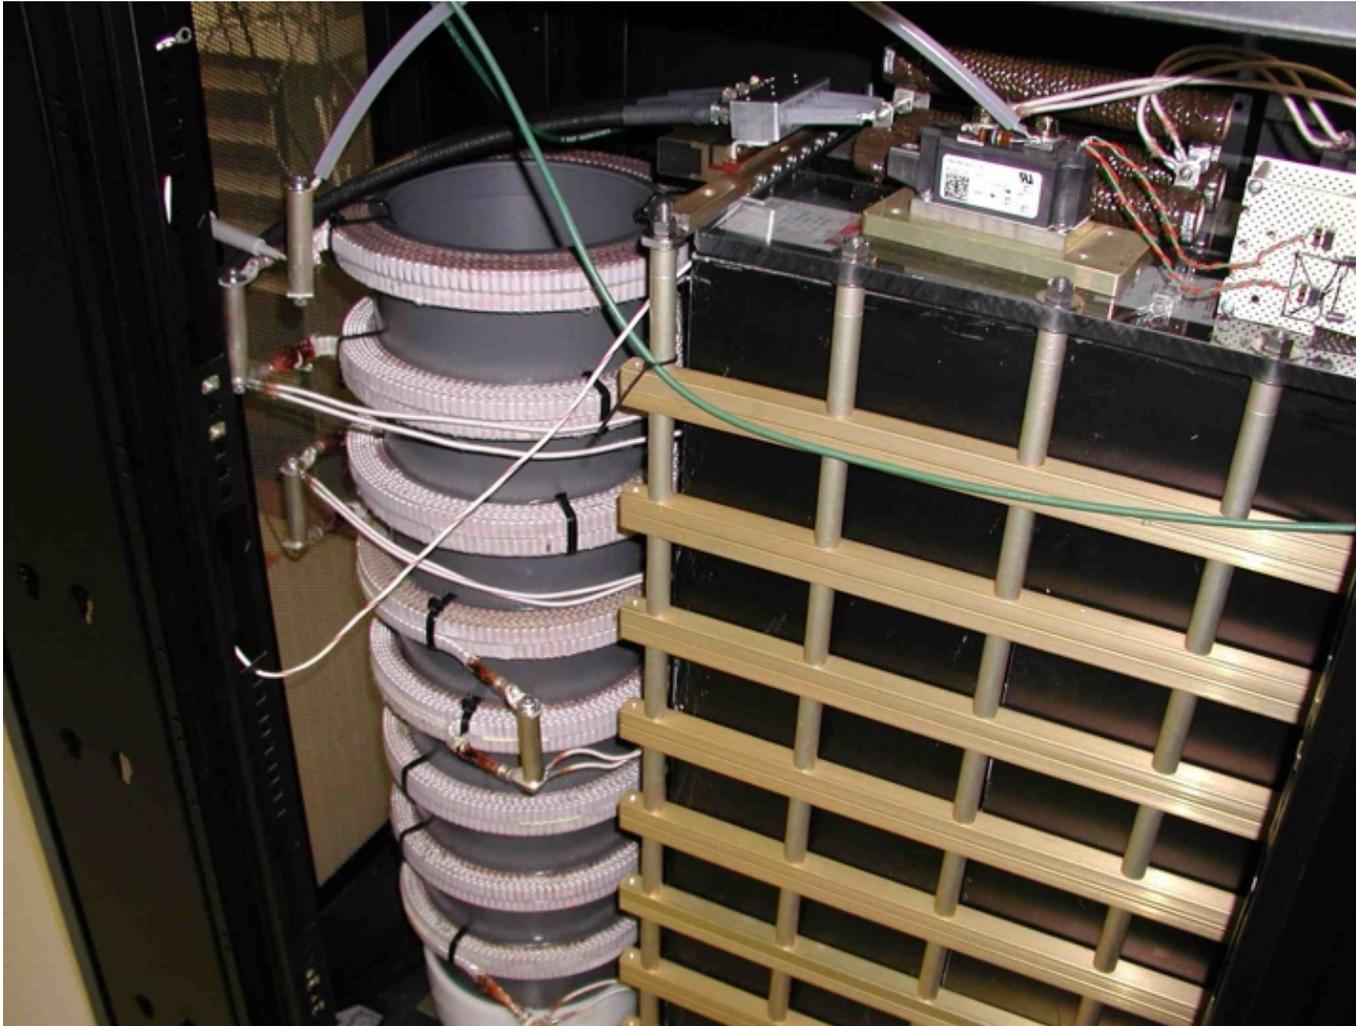
Pulser modified to form a ramped pulse forming network

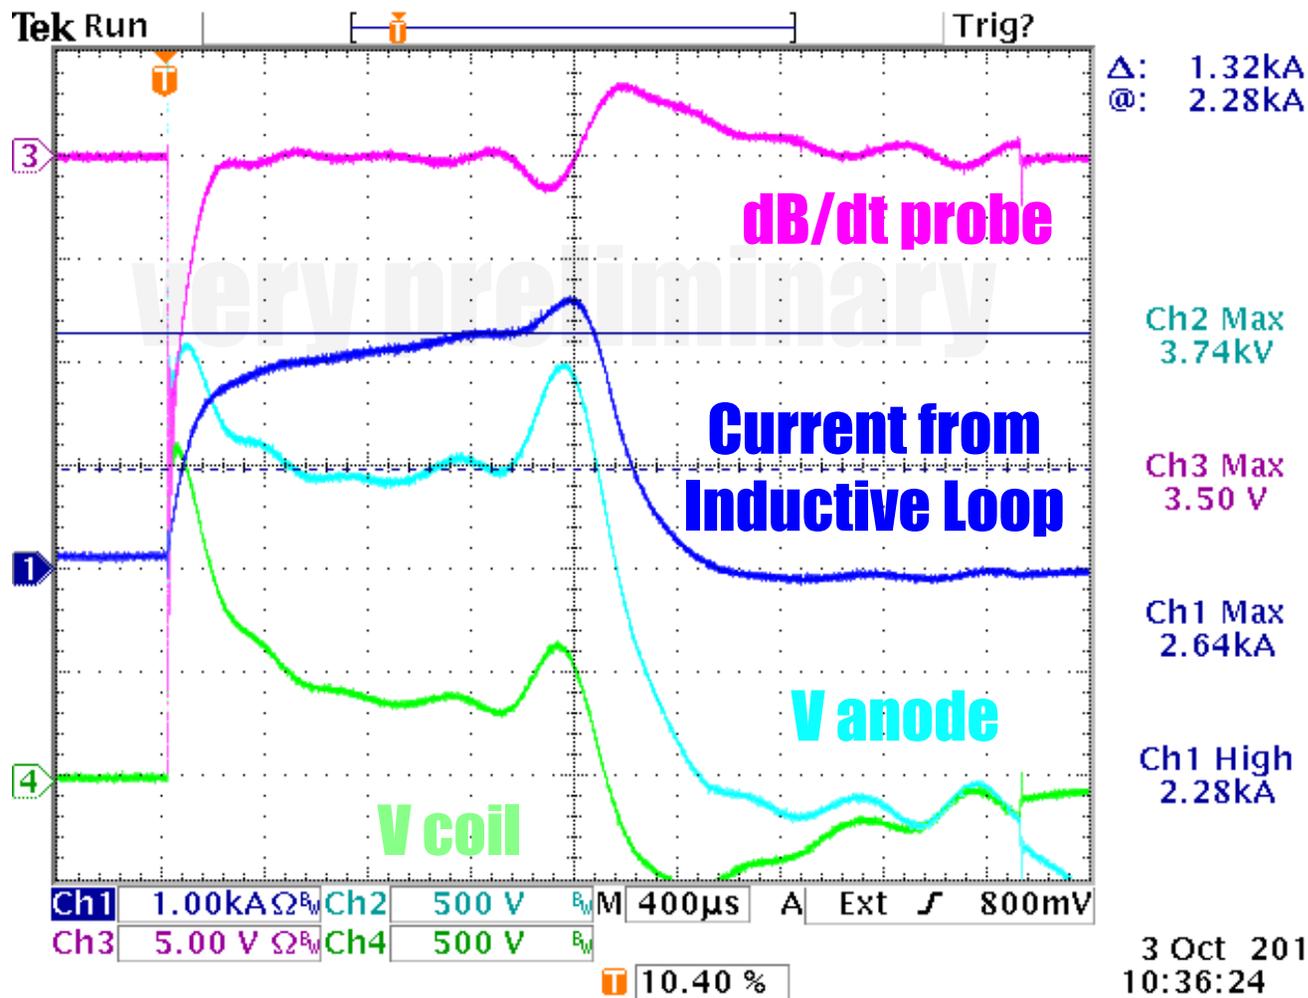
The device has a flat top when we use the insulating spacers

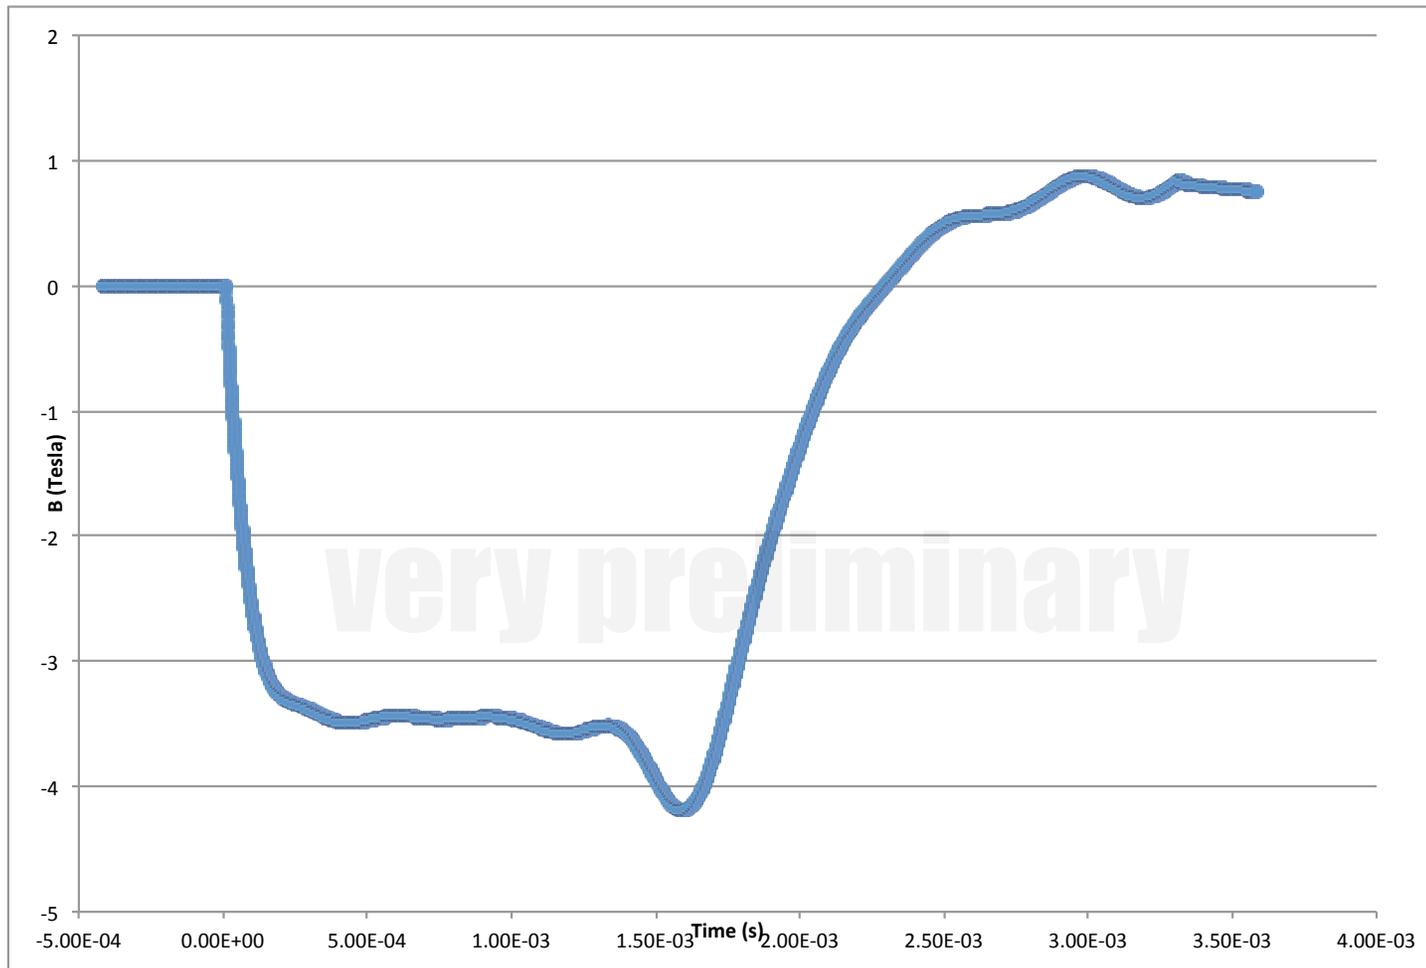
The magnetic field has a 1 ms flat top

very preliminary

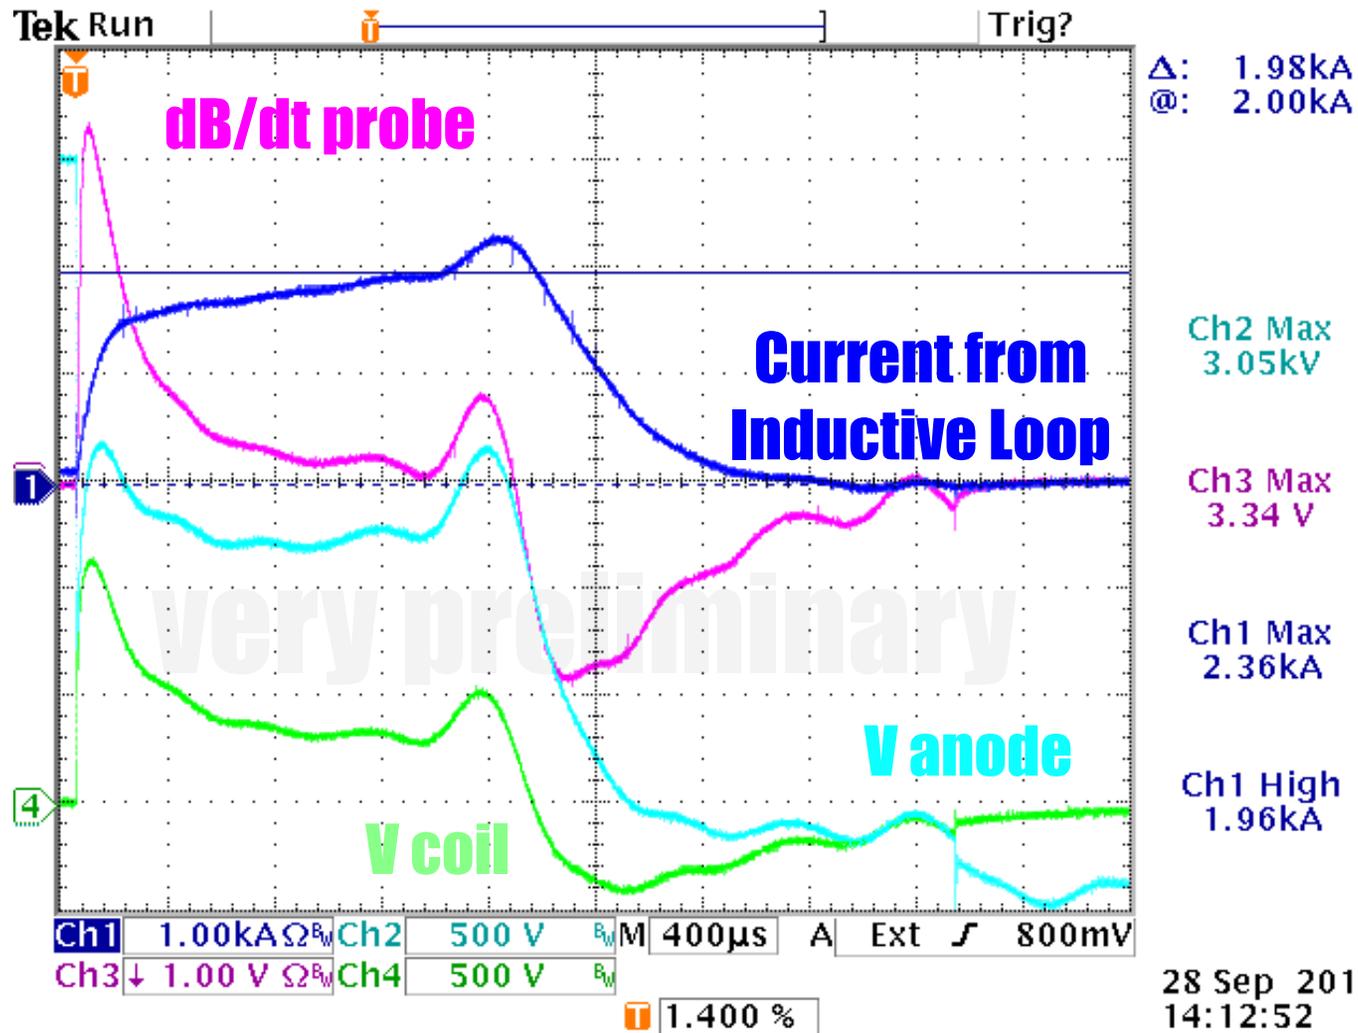
The conductive Stainless Steel spacing plates change the magnetic field behavior
