**Design and Prototyping of the ILC
Positron Target System**

Oct 22, 2012 - LCWS 2012

We are doing design and prototyping of the rotating shaft seal and the capture magnet

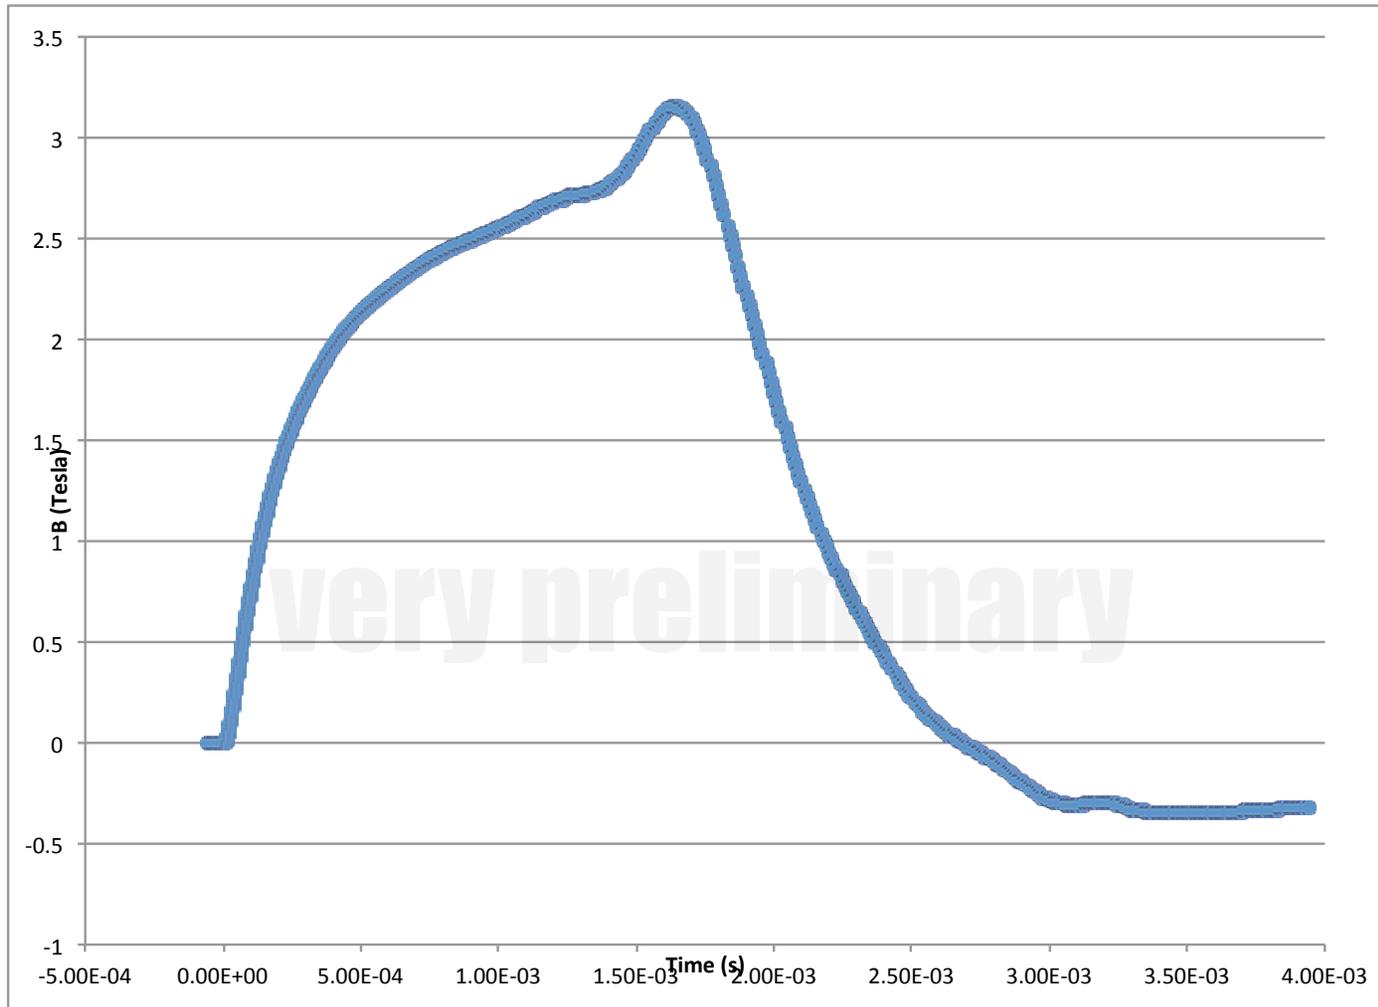
There is now an LR time constant in the concentrating plate

- We have built a ramped pulse forming network and have observed a flat top magnetic field in the device at full current
 - Insulating plates are necessary to achieve the flat top using the ramped PFN
 - Stainless steel separators introduce an LR time constant in the plates
- 5 Hz operation will not be possible
 - full test of the cooling will not happen in this program
