Surface study at KEK

sponge cleaning
 special single-cell cavity with de-toutchable Nb-samples

T. Saeki on behalf of Jlab-FNAL-KEK SO study collaboration LCWS08 at Chicago

17 Nov. 2008

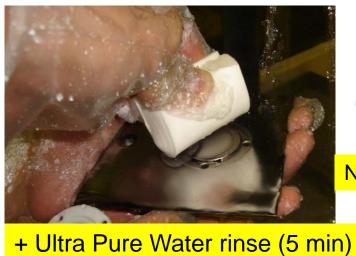
Wipe 10 times for each arrow = 40-times wipes in total

Nb-sample-2

Nb-sample-1

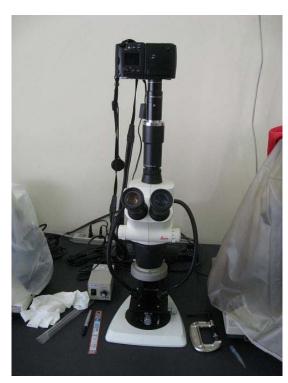
- Filtering drained UPW (10L) through the filter-paper of 0.20μm
 - → Condensation of filtered UPW (10L) to 70 ml.
 - → Ion Chromatography (IC) analysis for filtered /condensed UPW (70 ml).
- Residuals on the filter-paper → Optical Microscope → Component-analysis by X-ray fluorescence (XRF) analyzer

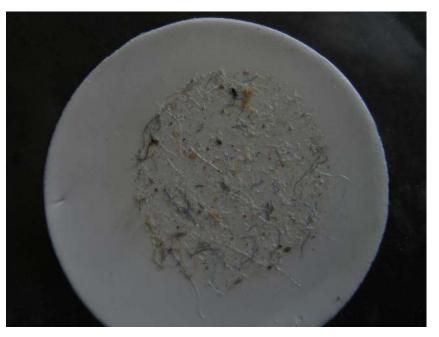
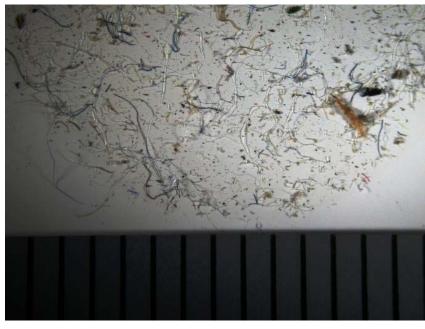
Residuals on the filter-paper

Residuals look like fibers/particles

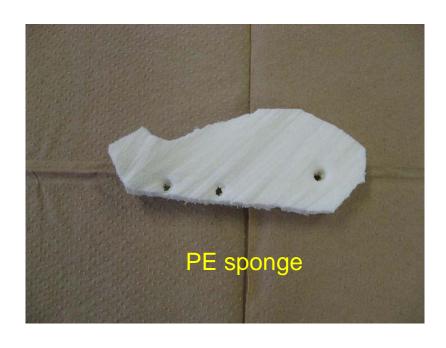
Residuals on filter-paper from beaker UPW

PE sponge rinse test in a beaker

- Pour 400 ml UPW into a 500ml-beaker.
- Wipe inside the beaker by PE sponge for 10 minutes.
- Filter the UPW in the beaker by filter-paper.
- Analyze residuals on the filter-paper.

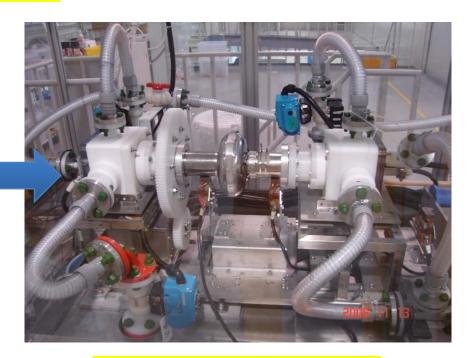
EP 20 um + UPW rinse (No ultrasonic-rinse)

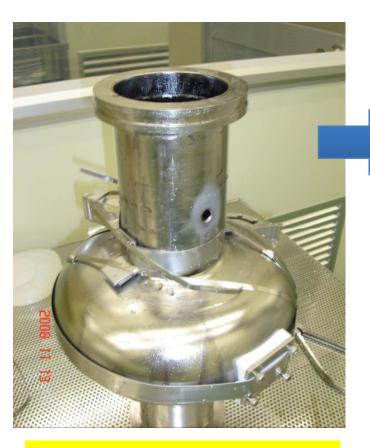
Disassembly in class-10 Clean-Room
