3.9 GHz Effort at Fermilab

E. Harms
2 August 2007

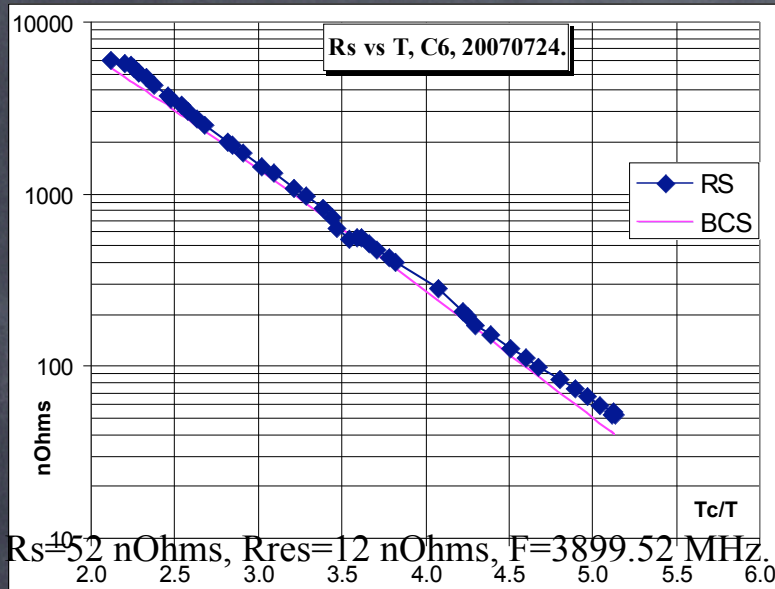
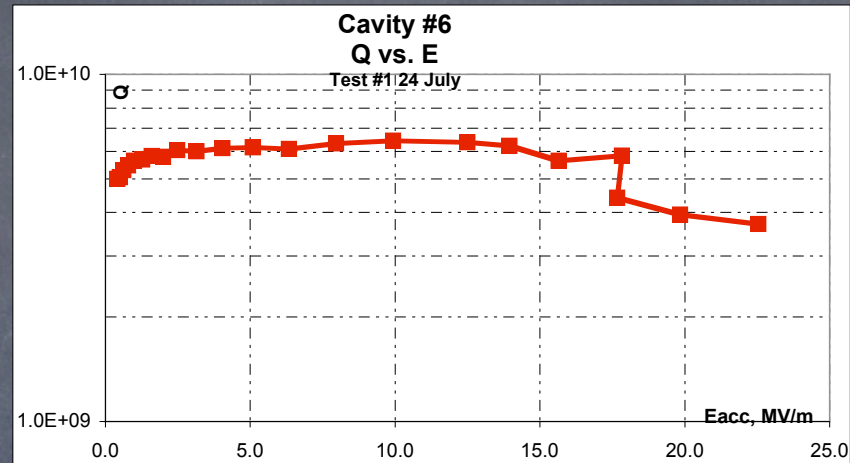
Cavity Performance - #6

- Cavity #5: First Vertical test on 22 June - 25 MV/m with no field emission or significant heating. Want to perform quench limit tests. Trimmed F-part HOM.
- Cavity #6: First Vertical test on 24 July - 22.5 MV/m. Field emission observed beginning at 9.5 MV/m. Bottom HOM quenching limited gradient. Trimmed F-part HOM.
- 4 Acceptable bare cavities in hand....

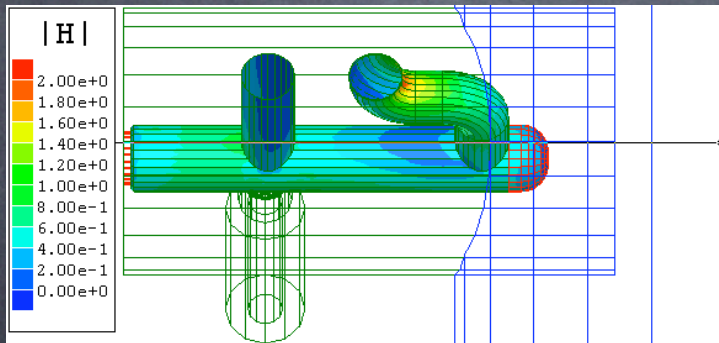
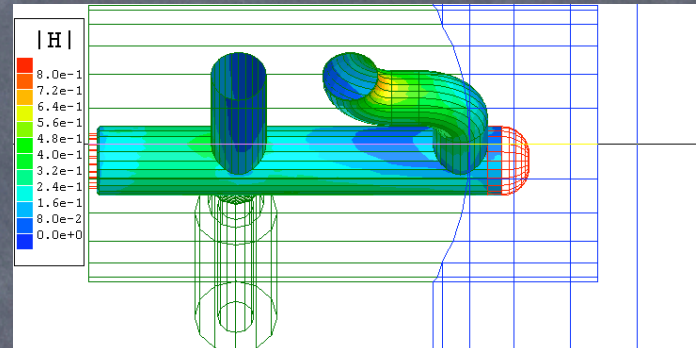
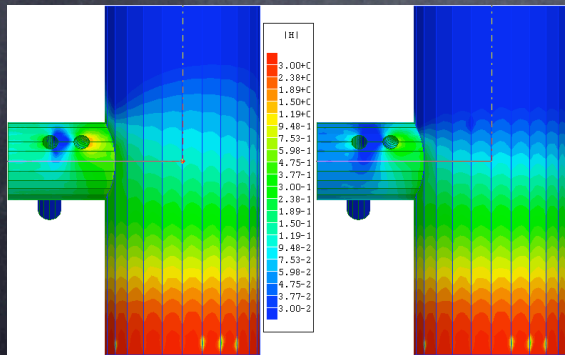
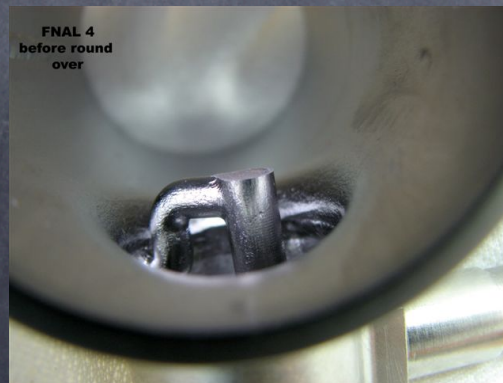
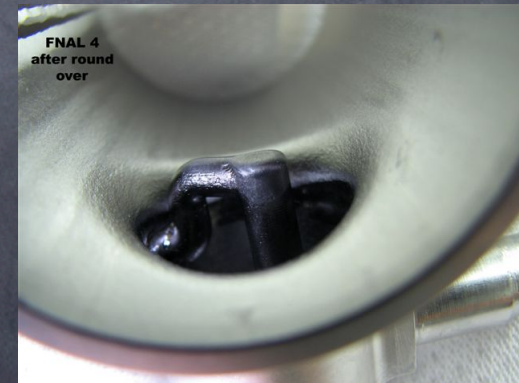
HOM Trimming

- 3mm trimmed from tip
- Peak Surface field reduced by factor of 2.5

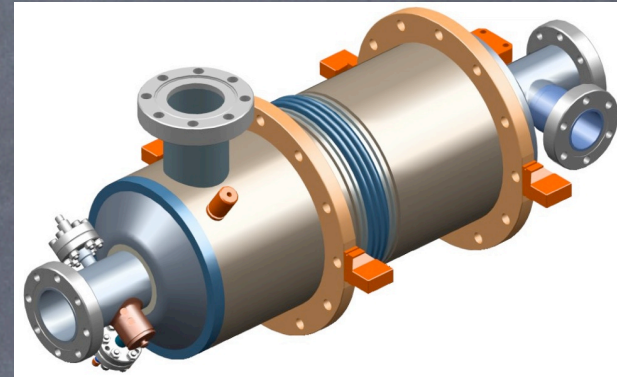
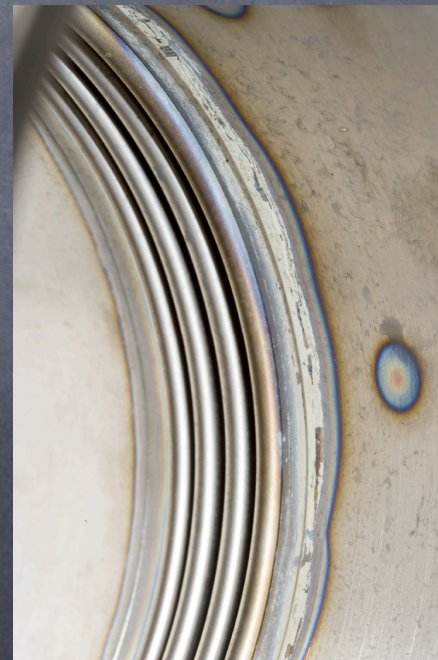
- Cavity 2 welded into Helium vessel - prototype
- Remaining Helium Vessels - Bellows (Titanium) welds found to be suspect, improper welding procedure
- New vessels being procured - 1 built at FNAL, remainder by outside vendor. All parts for #1 in hand except bellows assembly (mid-August).
