Optical Inspection update at KEK

Ken Watanabe (KEK)

ILWS08 in Chicago 17-Nov-08

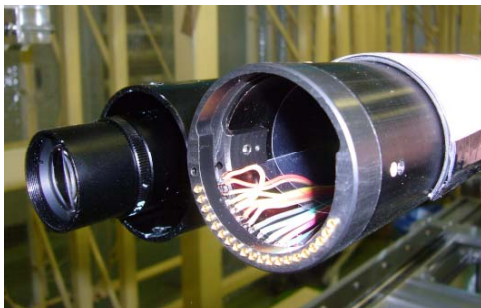
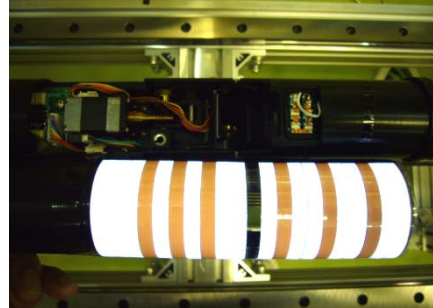
Schematic drawing of the wall gradient measurement

Characteristic of Kyoto camera system

- * The high resolution image can be taken.
- * The wall gradients of inner surface can be measured to use the Strip line EL illuminator. (Judgment of Pit or Bump is possible)
- * The heights or depths can be estimated by measured wall gradients for some well-conditioned defects.

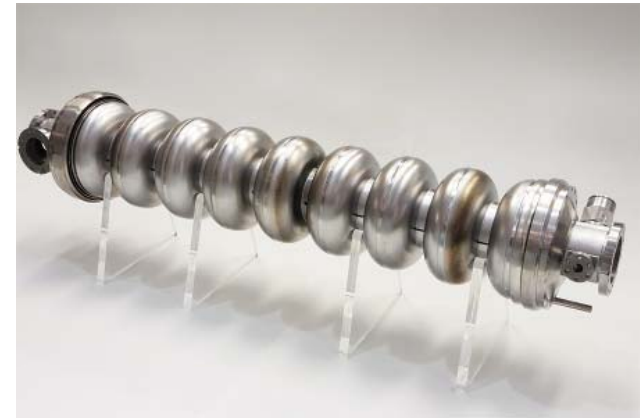
2) Result of inspection of the STF Baseline cavities (#5, #6) Spots type

Two type of spots were observed in the STF Baseline cavity #5, #6

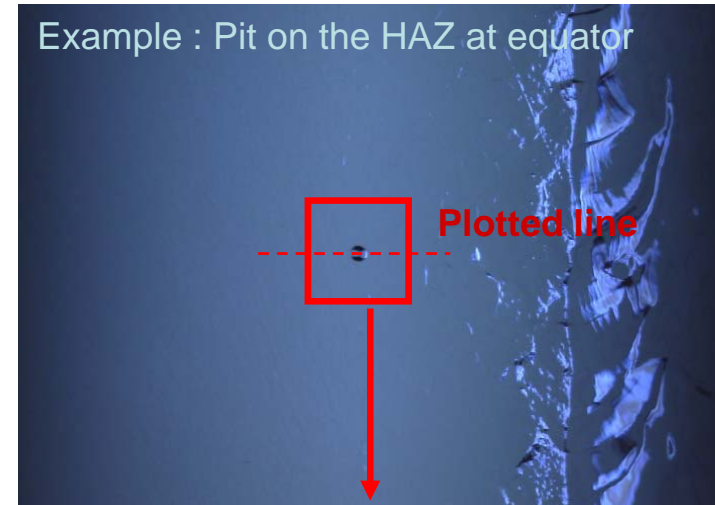
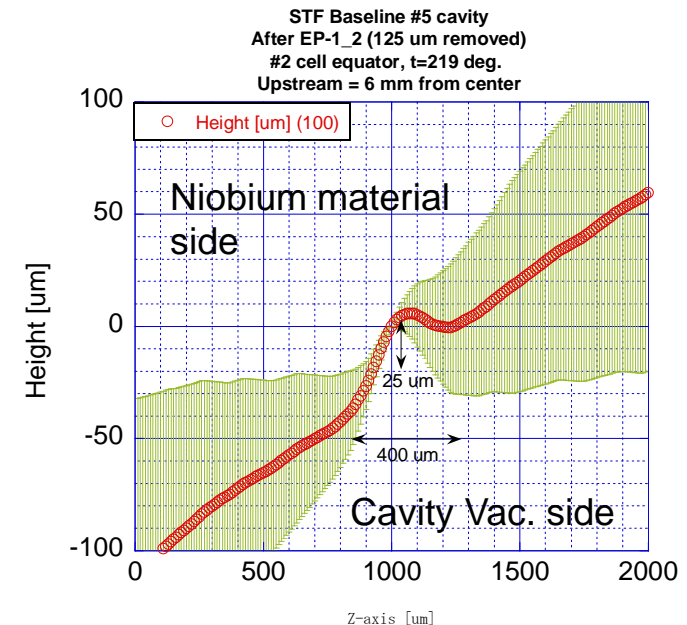
- 1) Bump on the HAZ at equator (diameter: > 300 μm)
- 2) Pit on the HAZ at equator (diameter: > 300 μm)

EBW seams were smooth. (No group and single of spots)

Result of spots of the STF Baseline cavities.

(The shape analysis were carried out after EP process 125 μm)

STF Baseline cavity #5 has,

One bump at the HAZ (#1 cell equator),

Fourteen pits at the HAZ (#1, #2, #3, #4, #5, #6, #7, #9).

STF Baseline cavity #6 has,

No Bump at the HAZ,

Fifteen pits at the HAZ (#2, #3, #4, #5, #6, #7, #8).

At vertical test, thermometer will equip on the these spots.

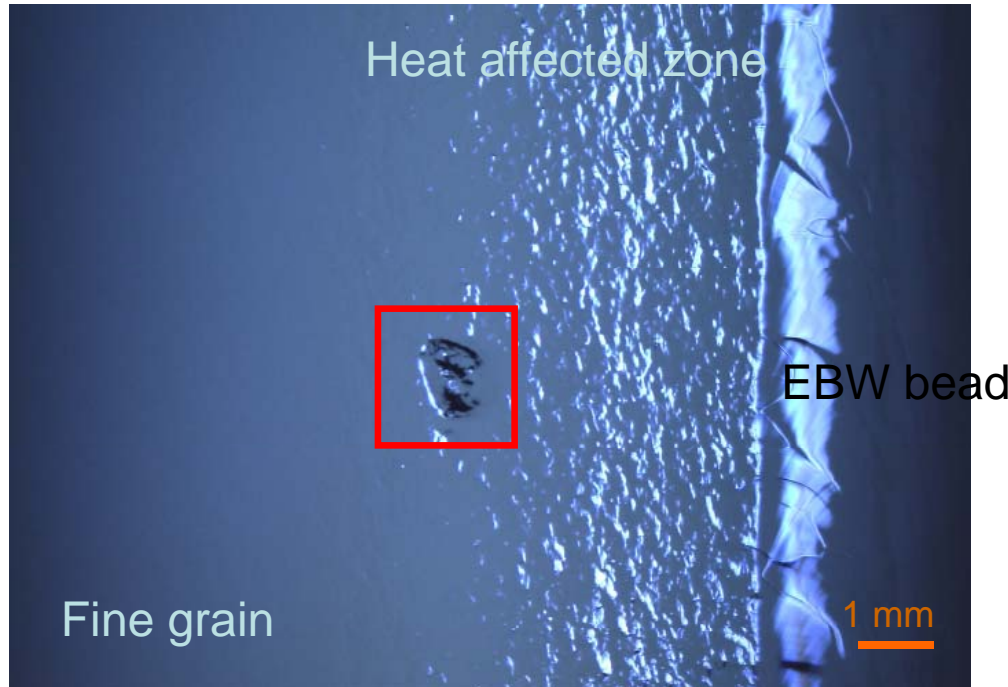
2) Bump on the HAZ at STF Baseline cavity #5

#1 cell equator end group side, t=200deg.

This spot is big bump.

Diameter = 800 μm ,

Height = about 60 μm

Vertical test of this cavity will be done in the first week of Dec 2008.

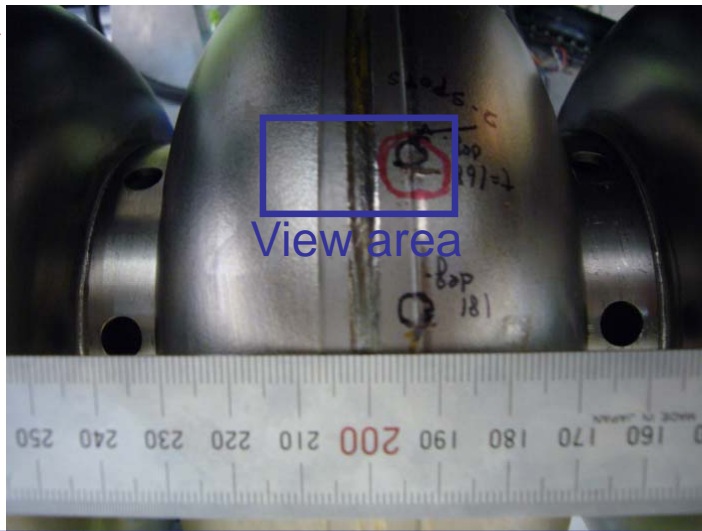
Twin spots were observed on the heat affected zone (HAZ). EBW seams were very smooth at all cell equators.

Other spots position : #3 cell equator, t = 181 deg on the HAZ.
(Bump, diameter = 400, height = 42 um)

#7 cell equator, t = 325 deg on the HAZ.
(Pit, diameter = 500 um, depth = 28 um)
Max Eacc = 16 MV/m, But no heating.

After this inspection, EP 20um process and Vertical test was done.

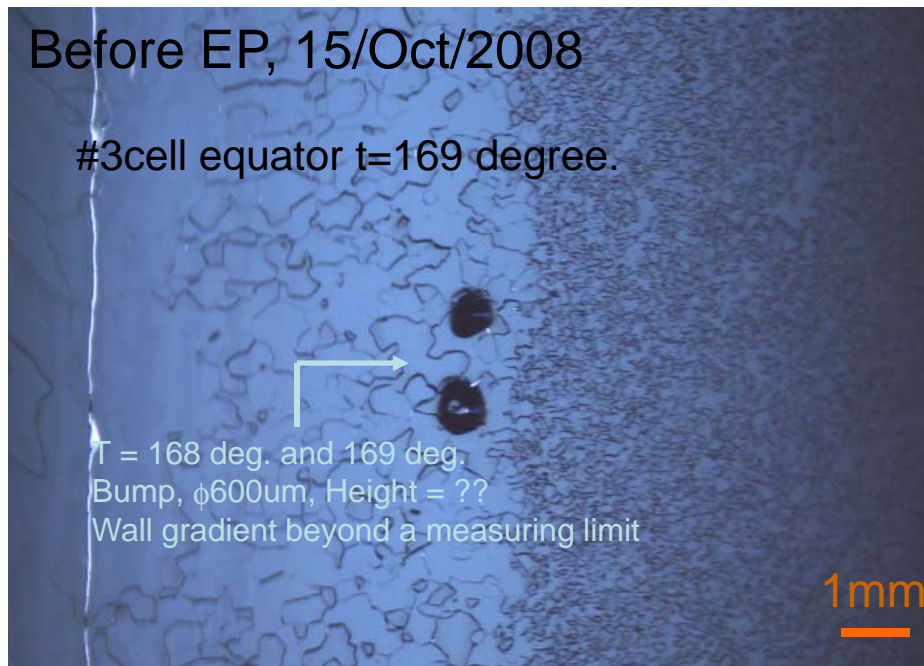
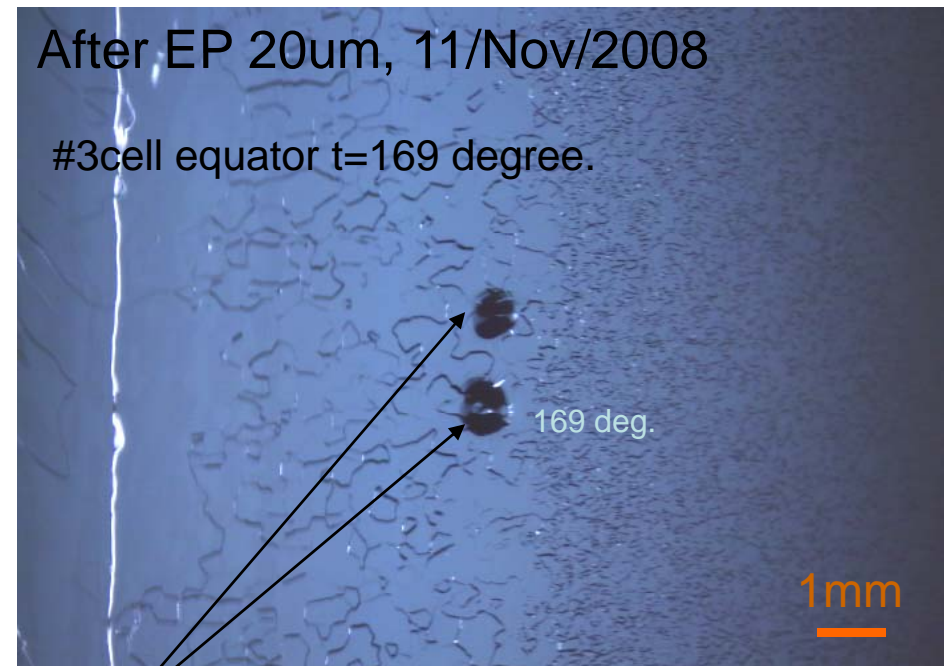
Heating at 22 MV/m on the #3cell equator t=169 degree.

Eacc was improvement from 15.8 MV/m to 22.1 MV/m (however HOT spot was same location.)

After EP 20um, the edge of the spots became bright. It shows that it become gentle wall gradient due to EP process (Maybe). The spot of 169 deg is possible to measure a wall gradient.

Treatment : EP 20um, HOT rinse, HPR and Baking at STF.

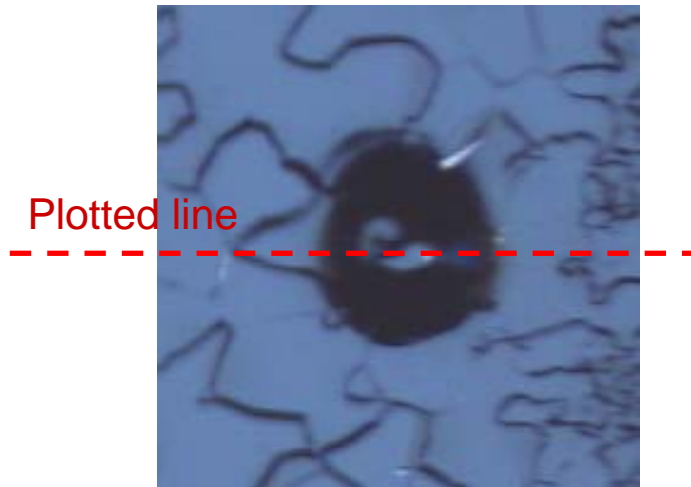
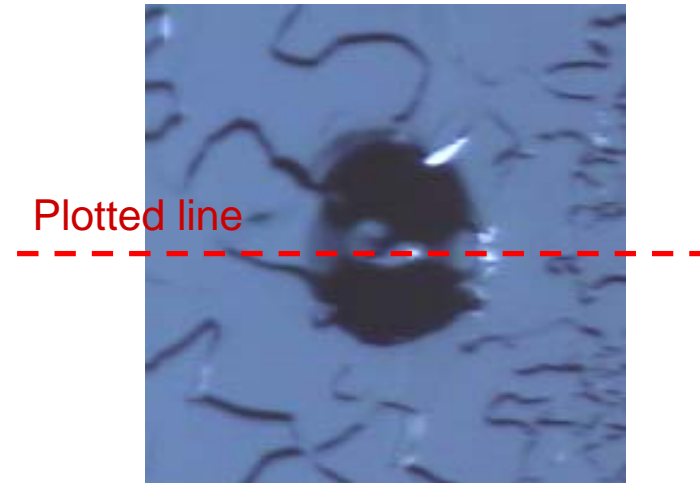
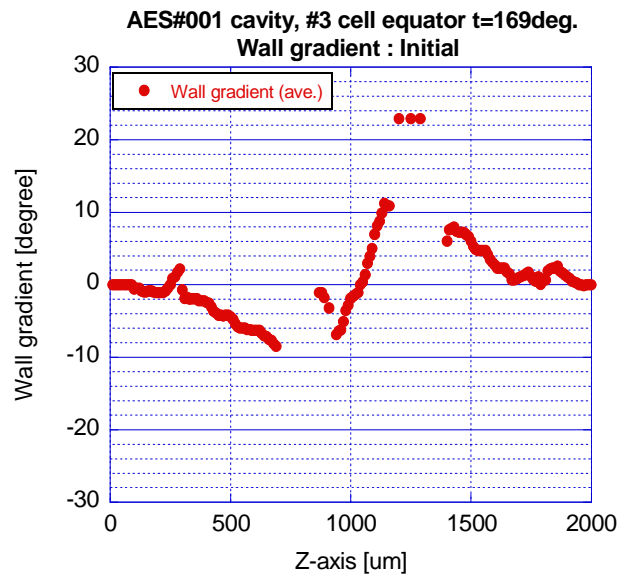
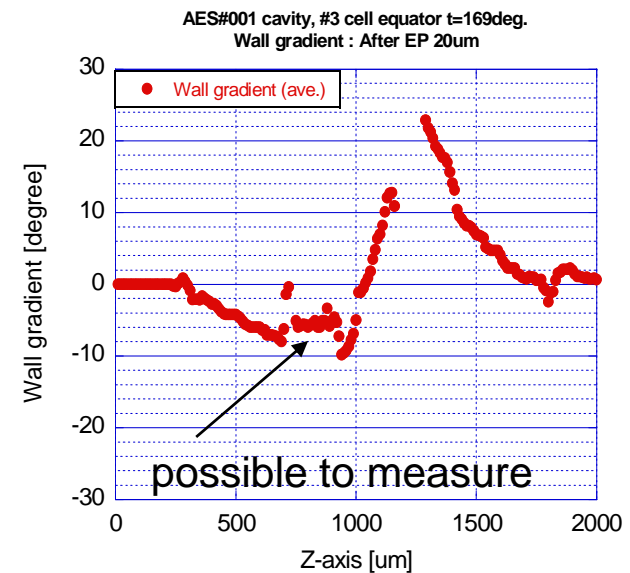
Comparison of wall gradients before and after EP

Before EP, #3cell T=169deg.

After EP 20um, #3cell T=169deg.

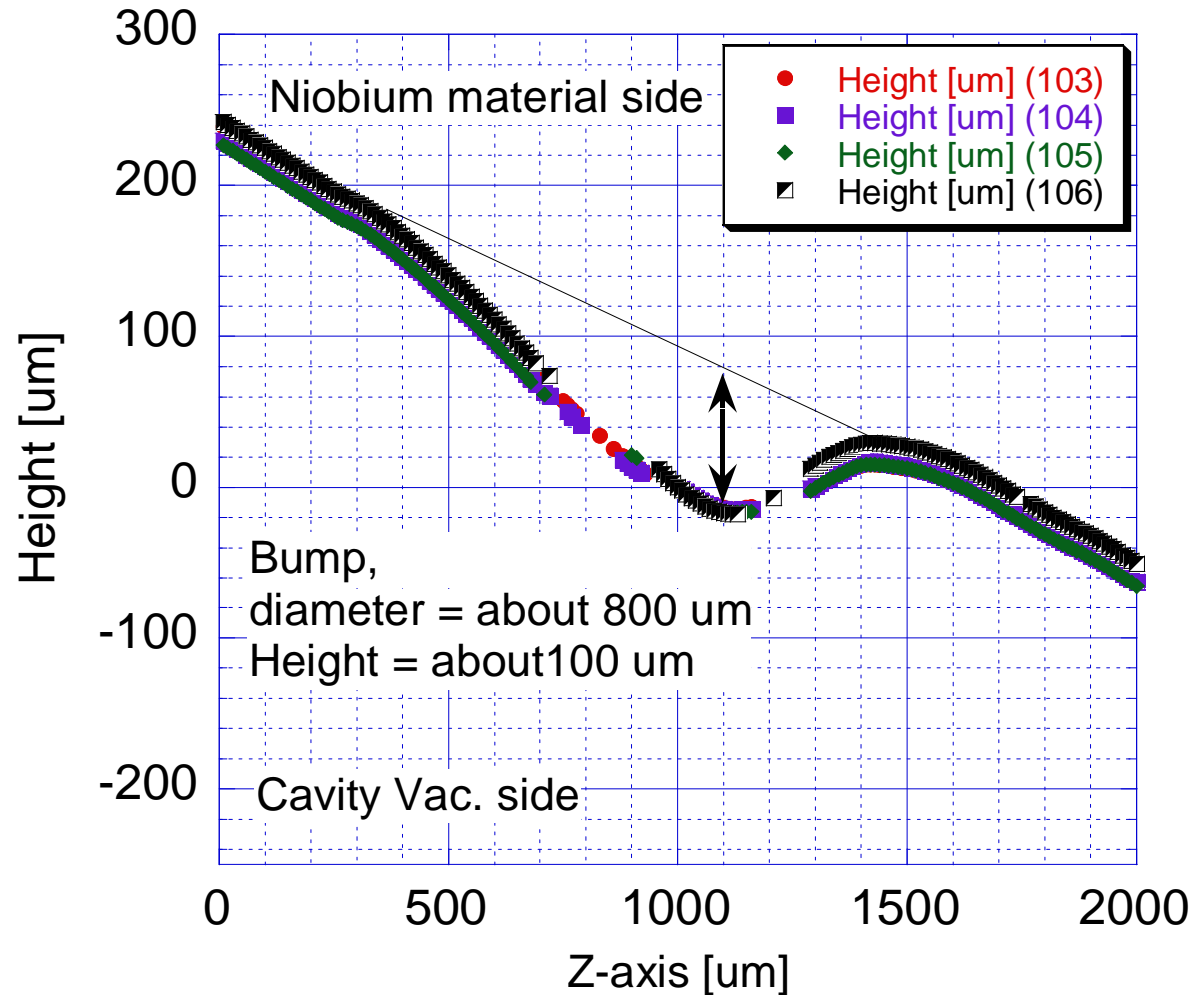
Estimated Bump shape at #3cell t=169deg.

AES#001 Cavity : #3 cell Equator, t=169deg.
After EP-2 (20um removed) and Vertical test
2008/11/7 at STF

Very big
Bump.

Quench field is
22.1 MV/m.

The Shape of HOT spot was estimated. The spot was Bump (Diameter = about 800 um, Height = about 100 um).
