undulator manufacture and measurement

James Rochford

Nov 2008

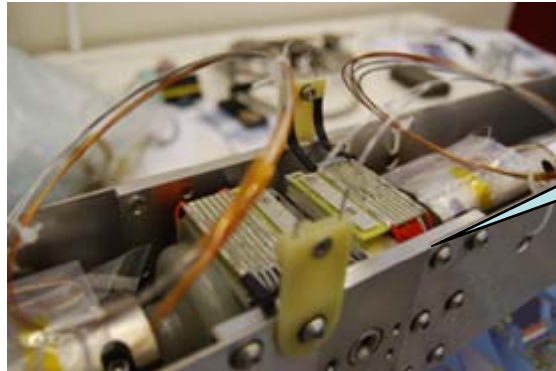
4 meter module assembly

Straightness
250um

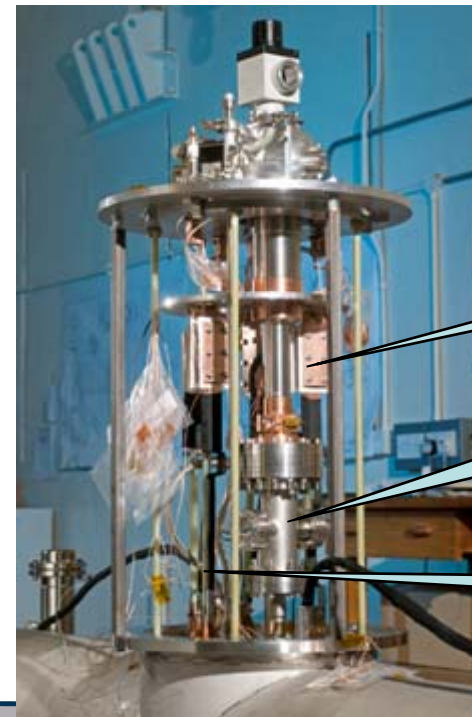
Current leads

Condensing pot

HTS leads

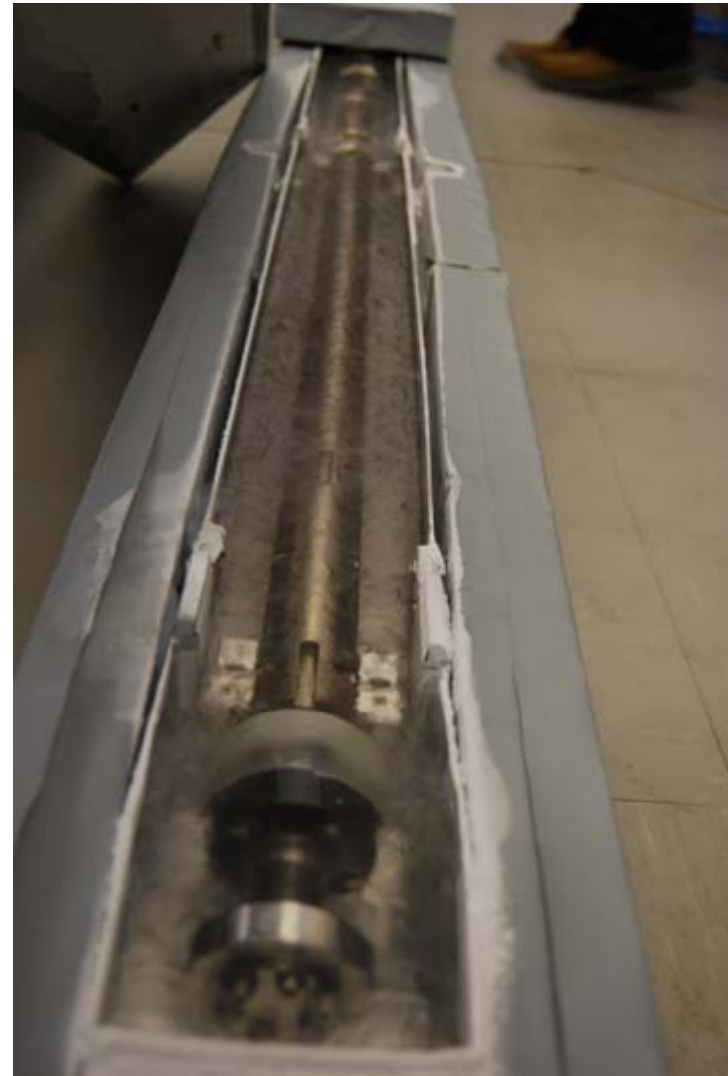
Cryogenic leak testing

Created a large open Liquid nitrogen bath

To immerse magnets whilst leak testing

Initially found a leak at the indium seal between magnets

Fixed this by modifying the clamp arrangement

Much more worryingly we seemed to have a leak through the magnet structure, on magnet 1 and magnet 2

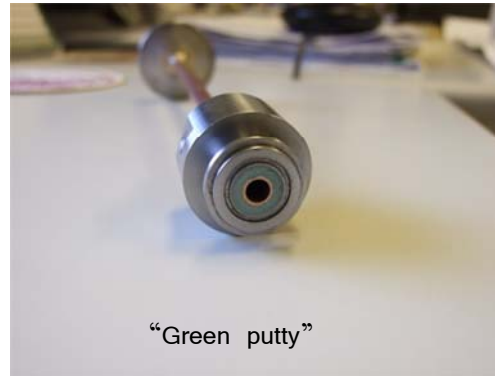
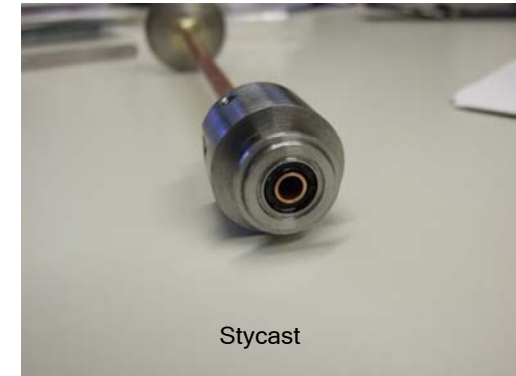
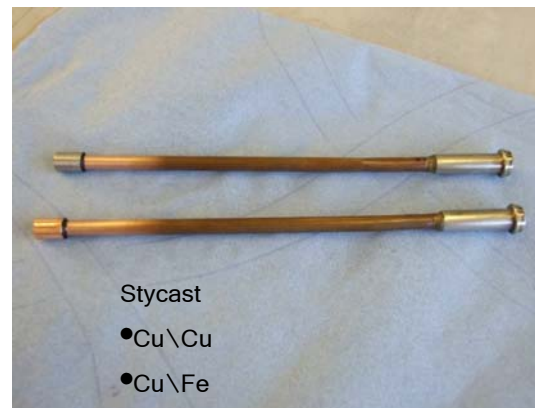
R&D Samples

Different epoxies
 All fail under repeated
 cycling for Cu|Fe combination
 Problem seems to be the
 differential contraction

Stycast with a Cu\Cu
 Joint works—implication need to
 machine away Steel flange

More samples to test using
 woods metal.
 Have some ideas to inset a
 Steel\Cu ring to act as a
 filler which can better match
 the conductivities
