# Initial Test Results for the Hamamatsu LumiCal Silicon Sensors

**Iftach Sadeh** on behalf of

Tel Aviv University

Oct 19<sup>th</sup> 2009  
sadeh@alzt.tau.ac.il

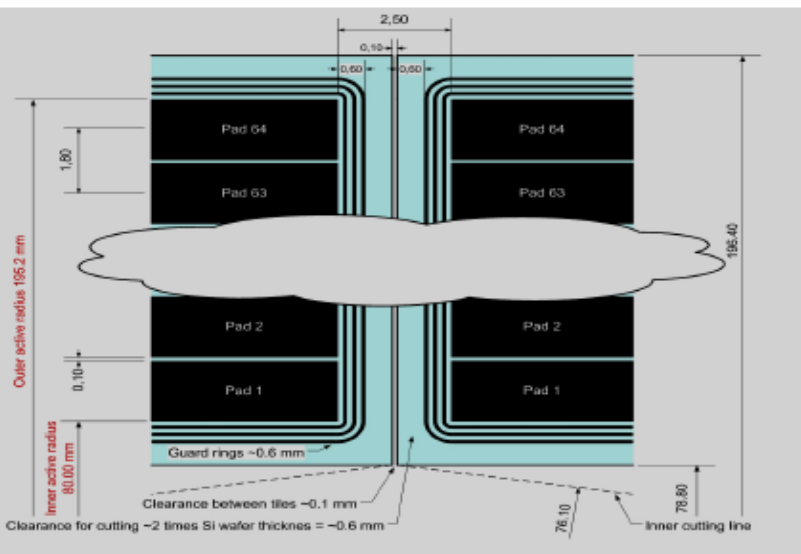
Details of the structure: gap between tiles and guard rings

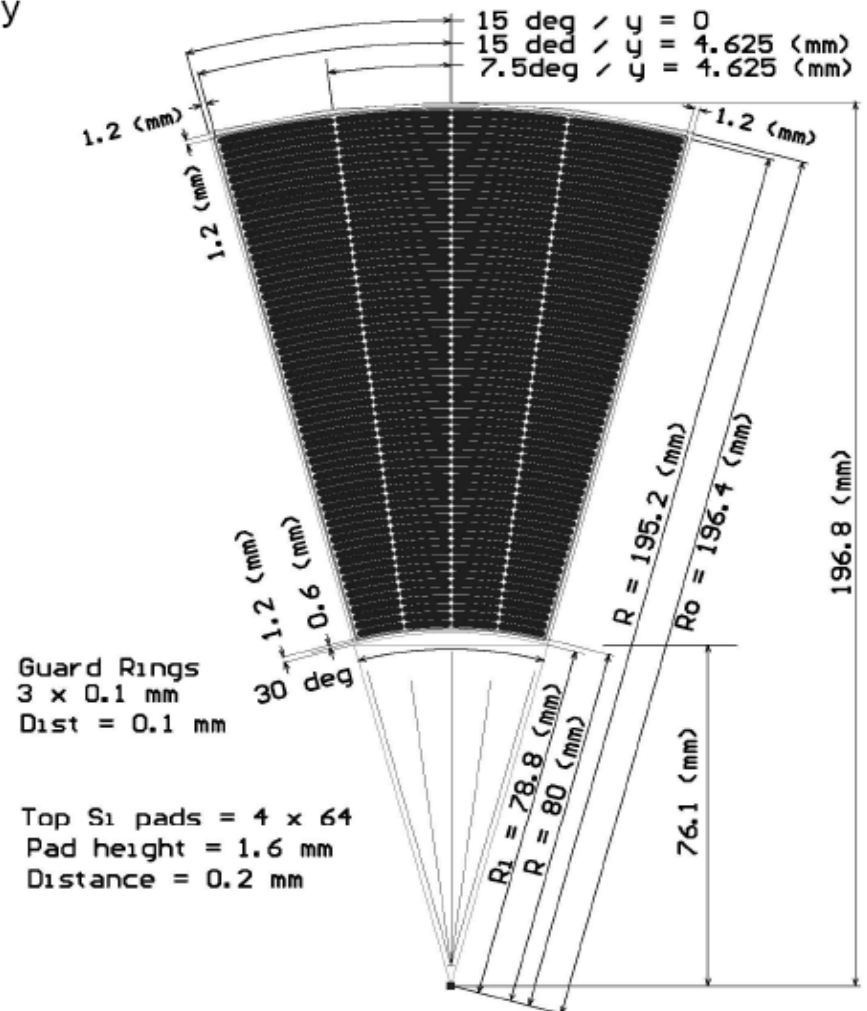
Top Layer & Dimensions

Segmentation of 4 sectors -  
they were produced by Hamamatsu

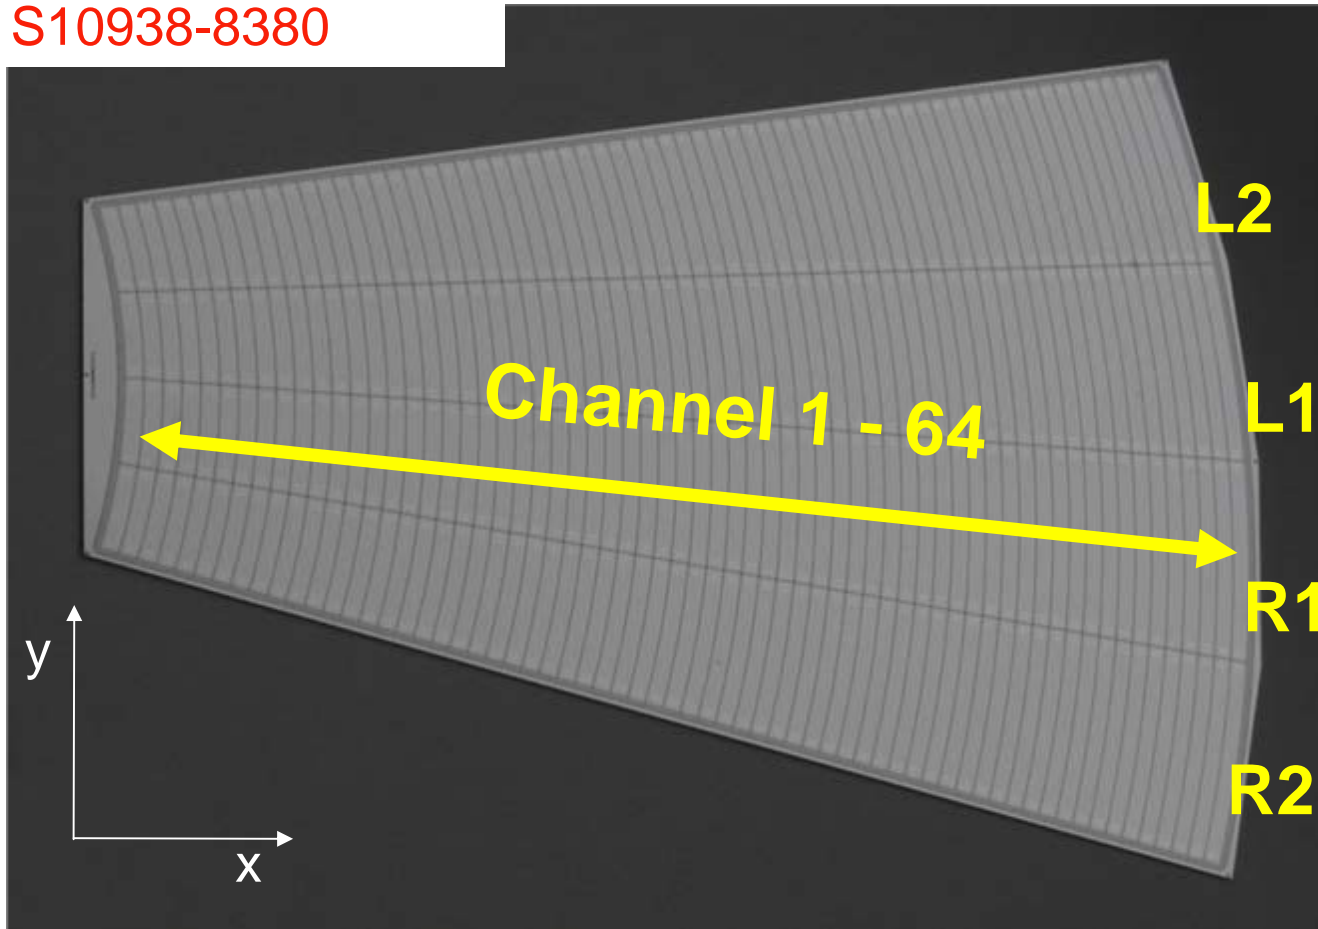
S10938-8380

“Cracow-Design”

- High resistivity n-type Si
- 1,7mm p+ - strips with an Al-metallization
- Backplane: n+ implant and an Al-metallization
- 3 Guard rings

x-Size = 10,8cm

y-Size = 4...12cm

(6 Inch Wafers)

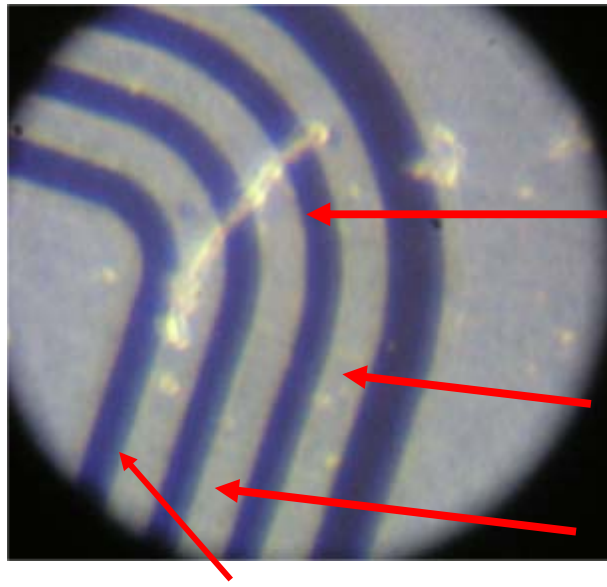
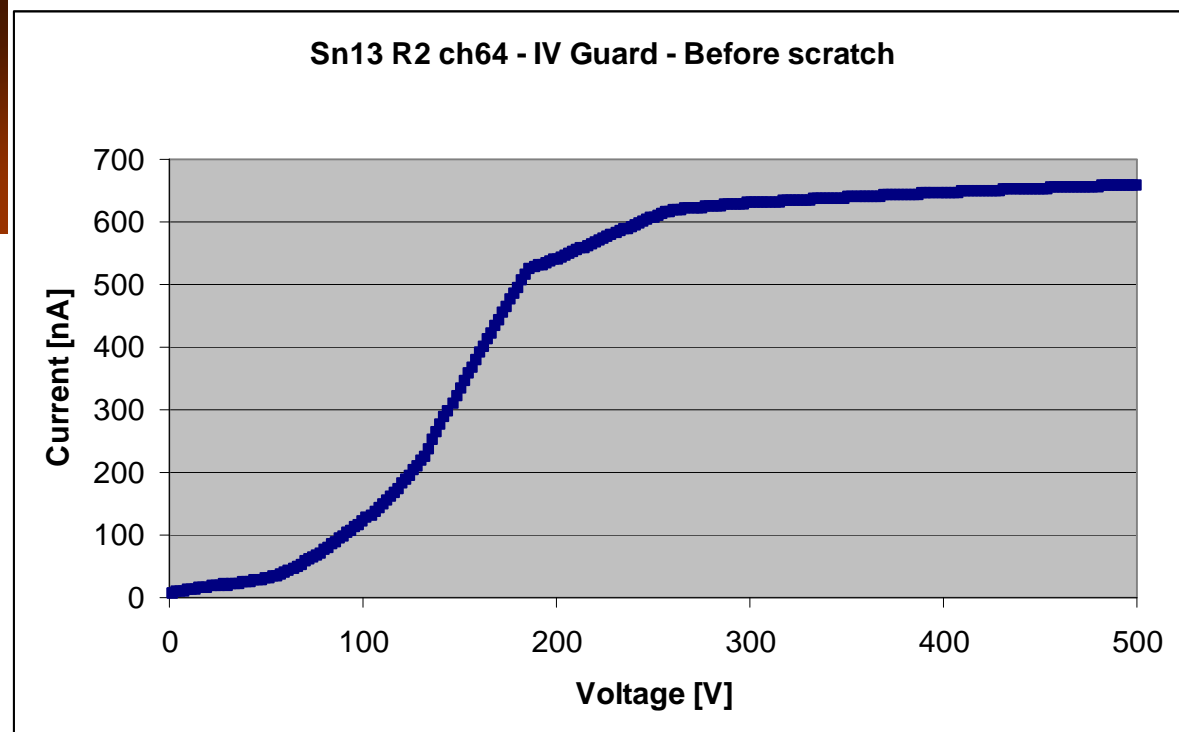
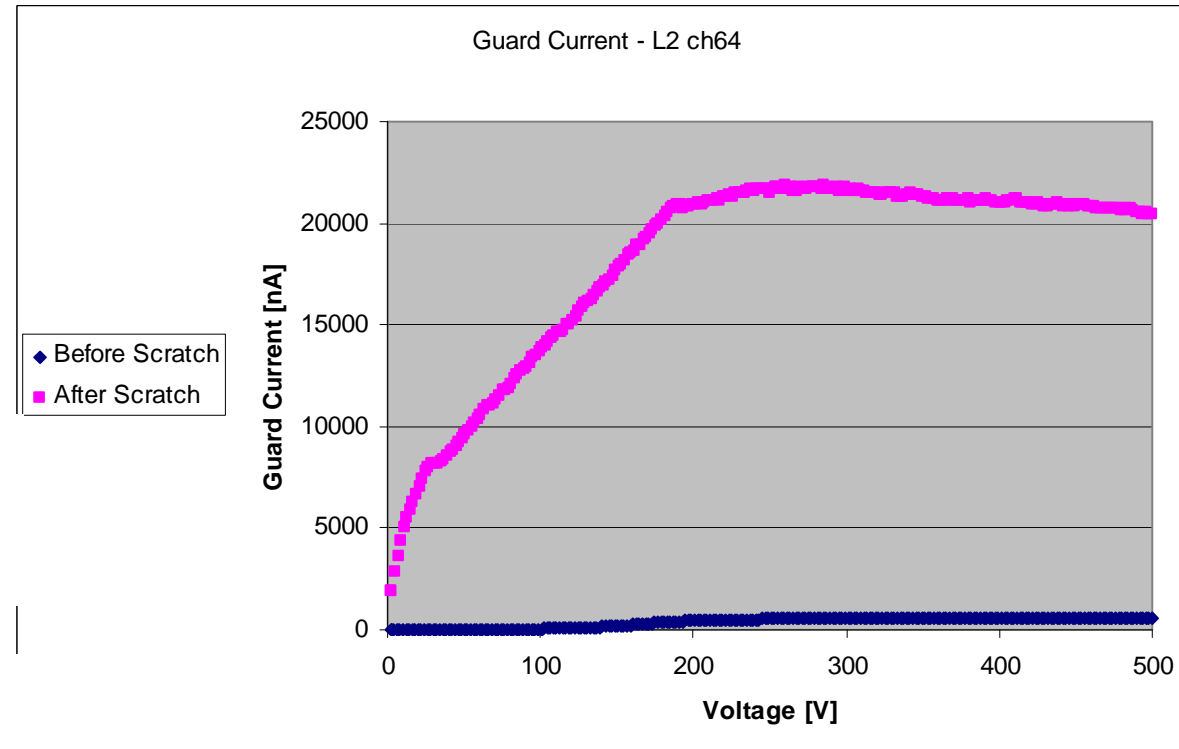
- One of the Sensors was damaged during the measurements. The scratch in the area of the guard ring had **no affect on the pad-current**, but the **guard-ring current spiked**.

inner guard ring

scratch

outer  
guard  
ring

middle  
guard ring

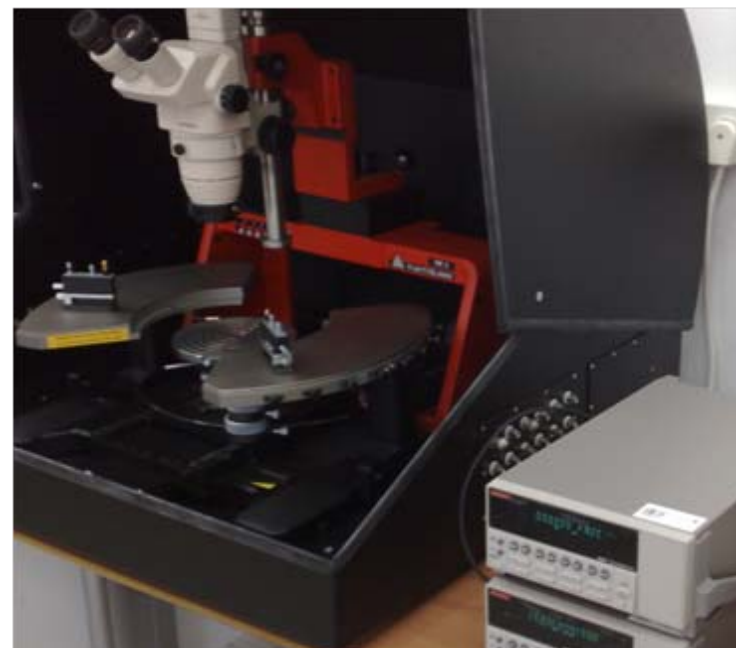
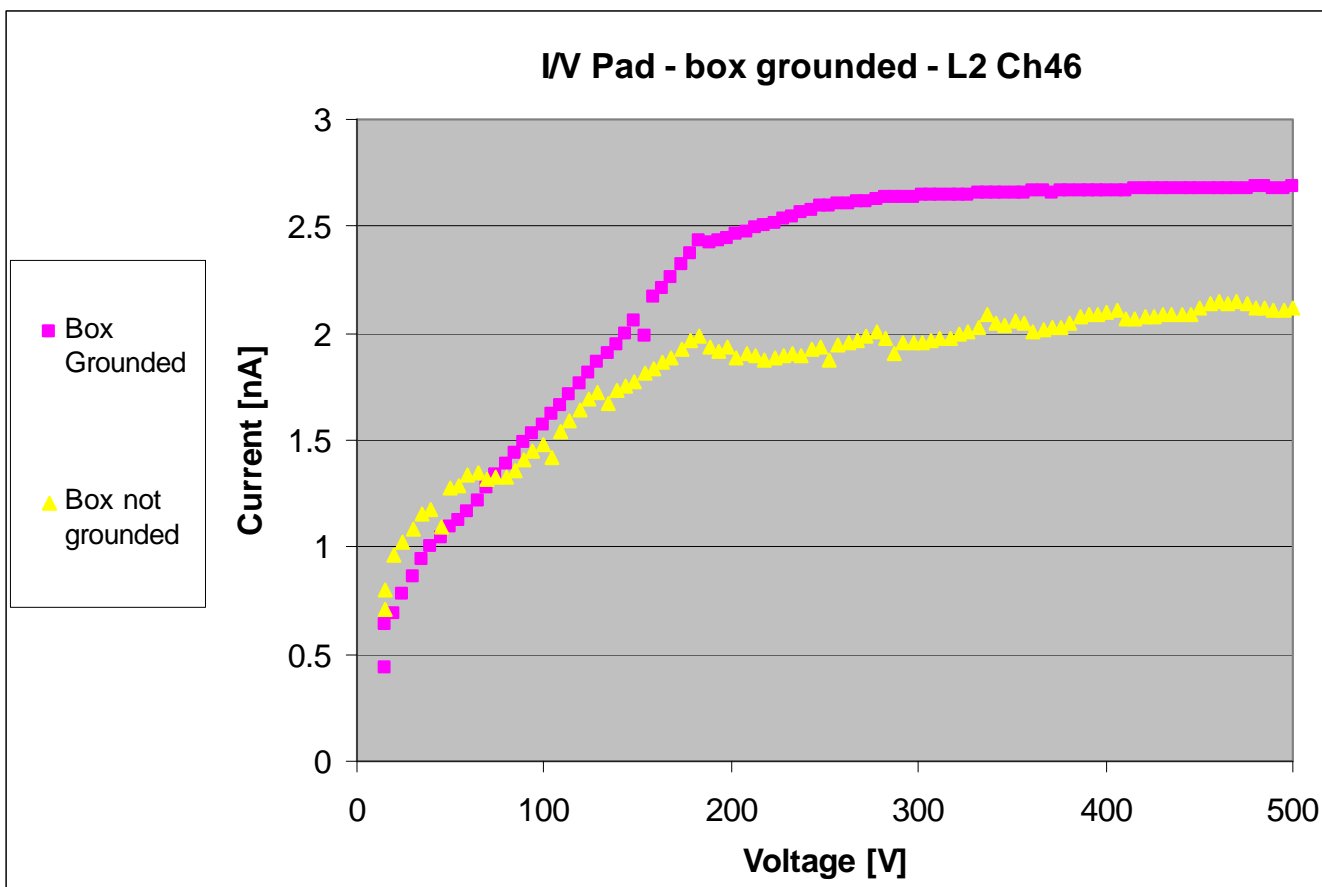
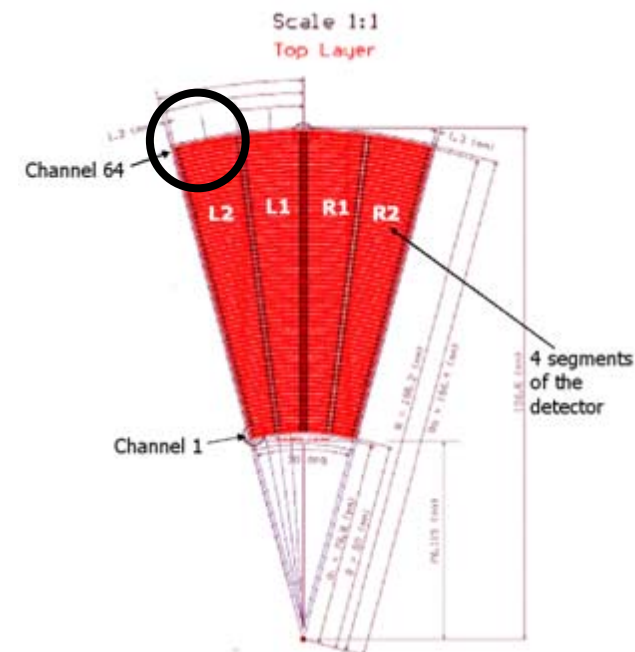
- The measurement setup is extremely sensitive to grounding.
- The plot shows an I/V measurement before and after grounding of the prob-station box

- The preliminary measurements produce similar results to the DESY-Zeuthen tests for the C/V measurement and for the I/V pad-current measurements.
- Grounding is a major issue; additional I/V measurements need to be performed with grounding of more neighboring pads.
- For the near future we plan:
  - A full set of tests on all pads in all sensor planes.
  - Comprehensive temperature and humidity dependant I/V curves.

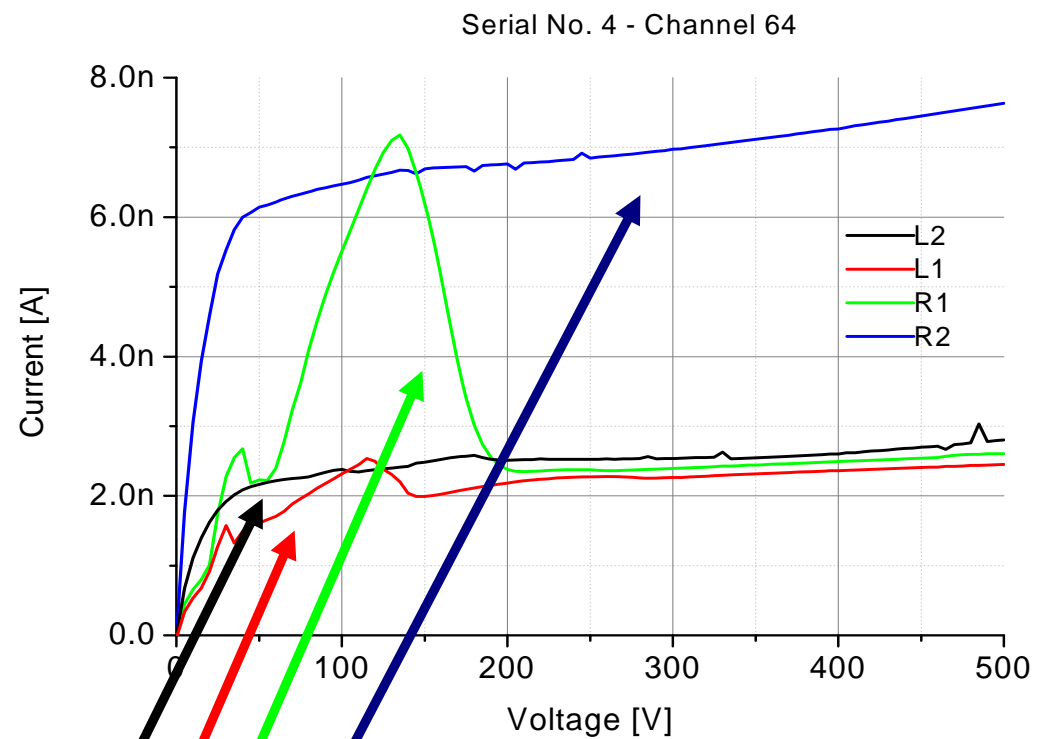
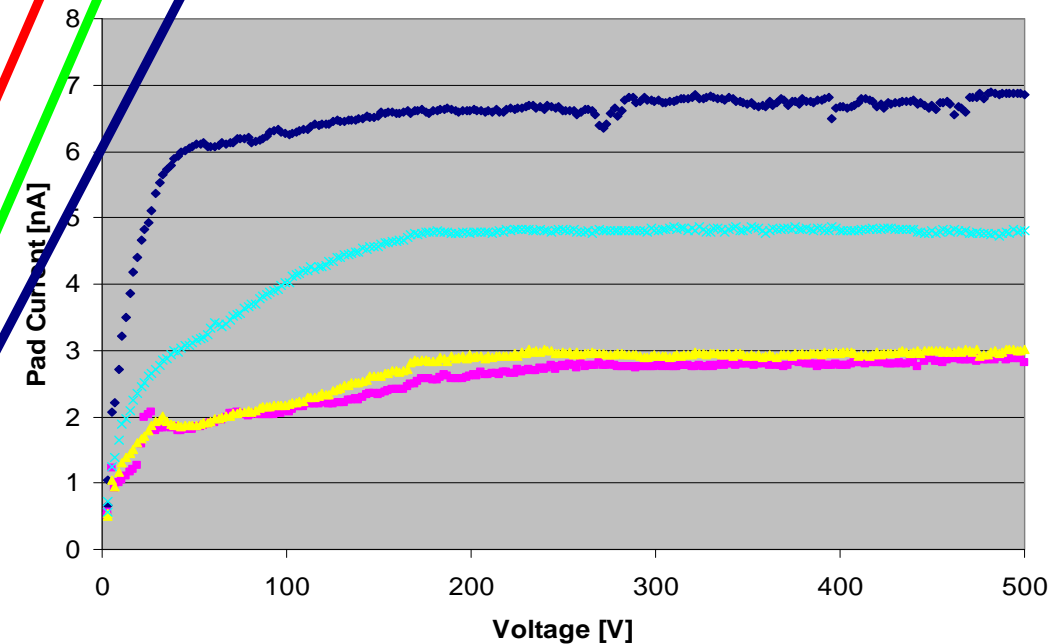
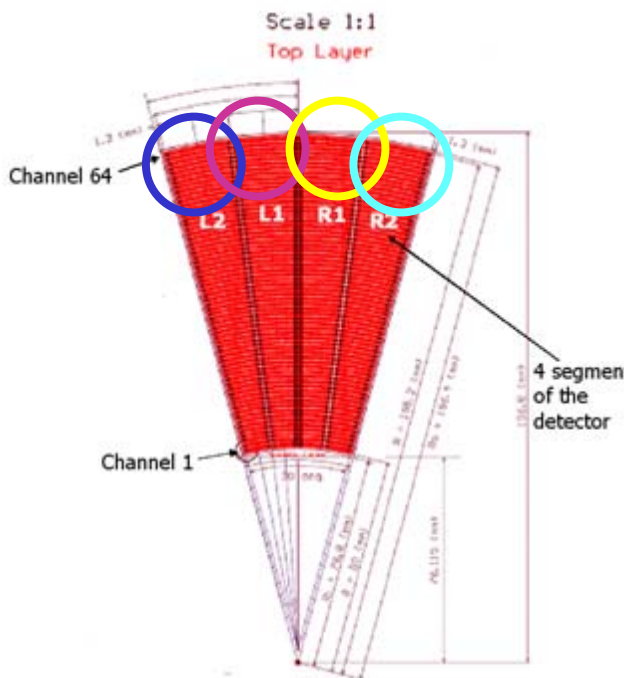
Serial No. 13 Channel 64

- Measurements were performed by our student both at DESY-Zeuthen (top right figure) and at Tel-Aviv (bottom figures) on different sensors, but on the same pads.

- ◆ L2 Ch64
- L1 Ch64
- ▲ R1 Ch64
- × R2 Ch64

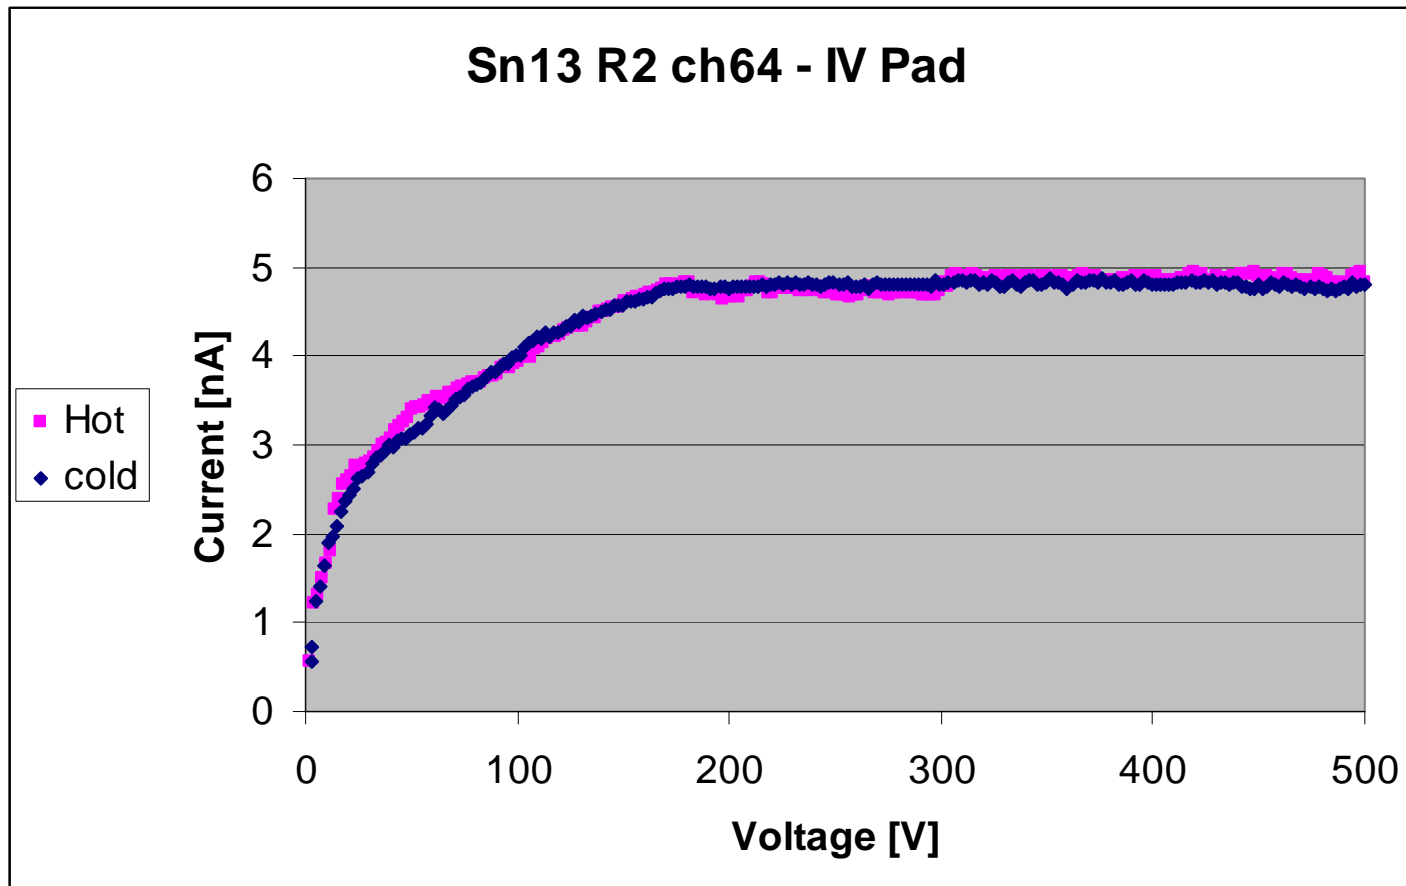
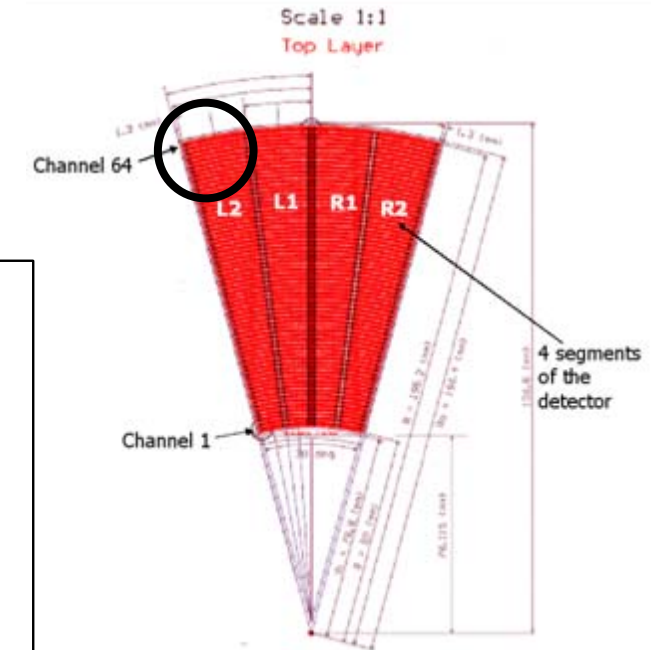
- Measurements were performed on the same pad with different external conditions, defined in the plot as:

Cold == ~45% humidity, ~19°C

Hot == ~60% humidity, ~24°C.

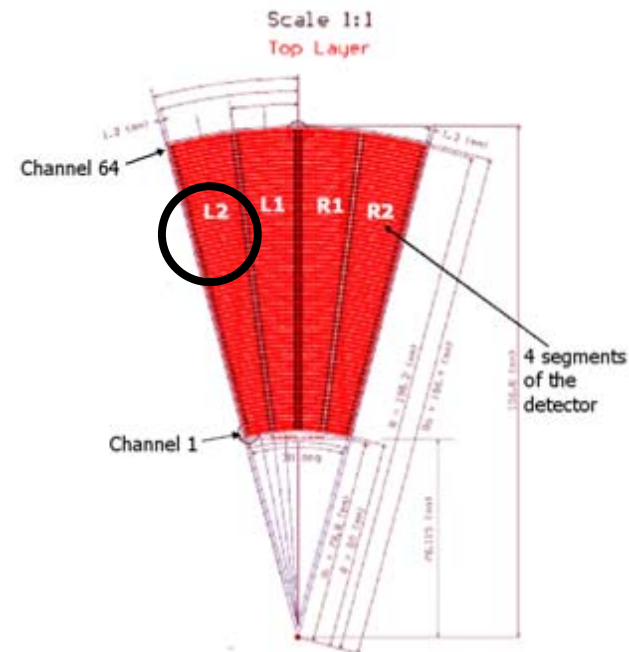
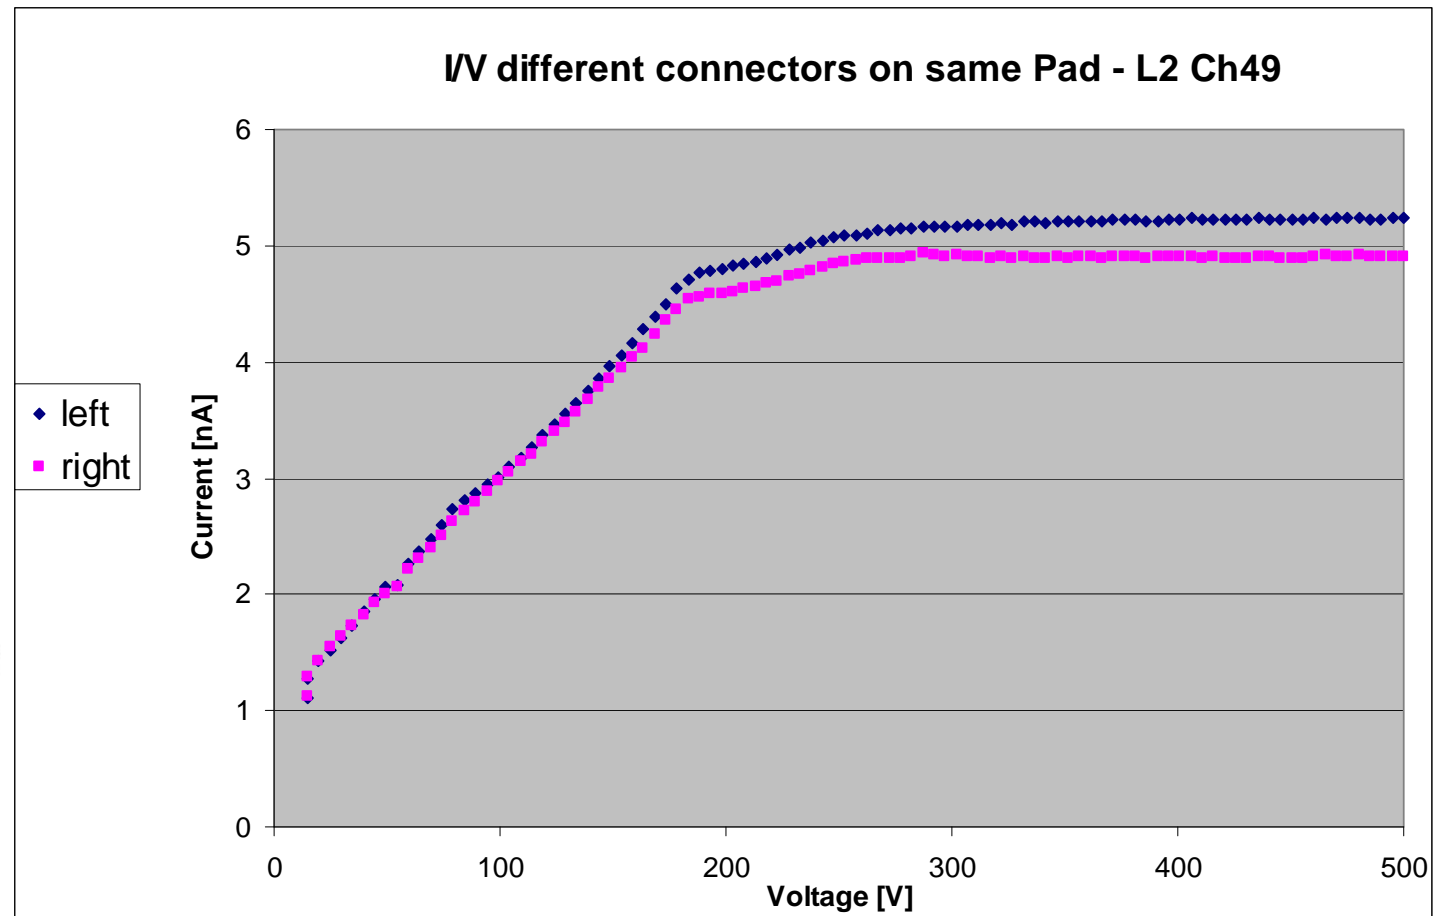
- Measurements were performed on the same pad on the two different connectors, showing slightly different results ( $\sim 0.3$  nA) between the **right** and **left** connectors.
- The difference may be due to the vicinity to the gourd ring.

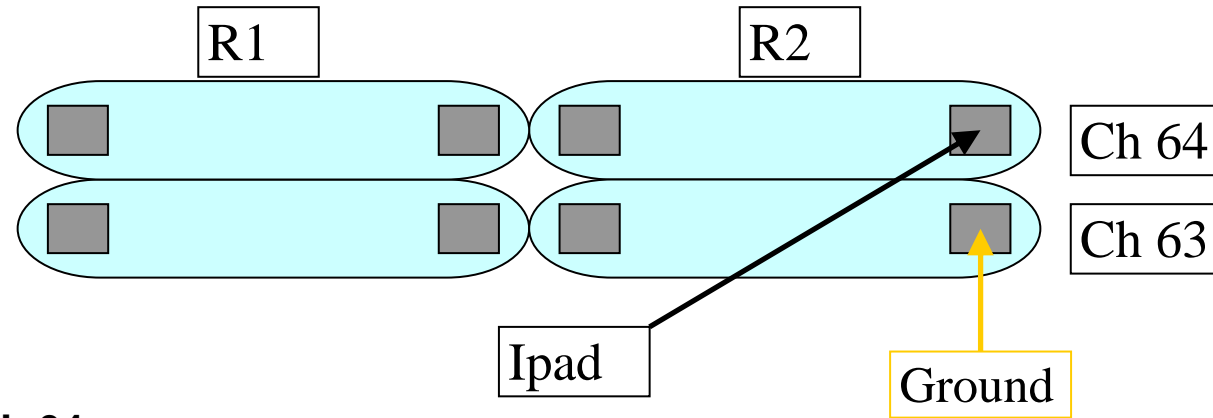
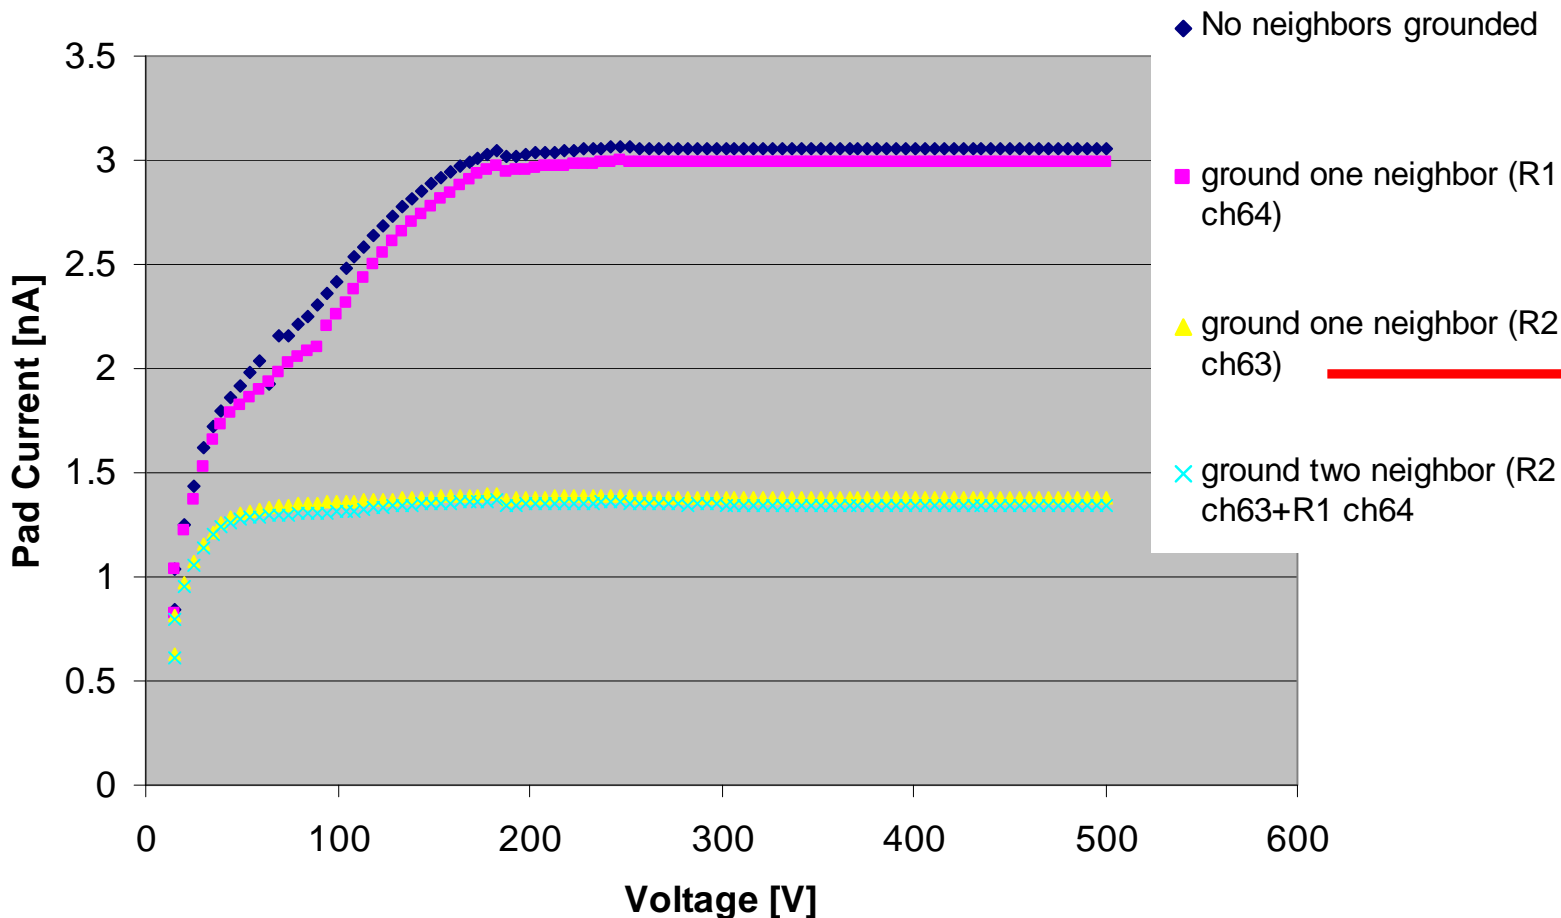
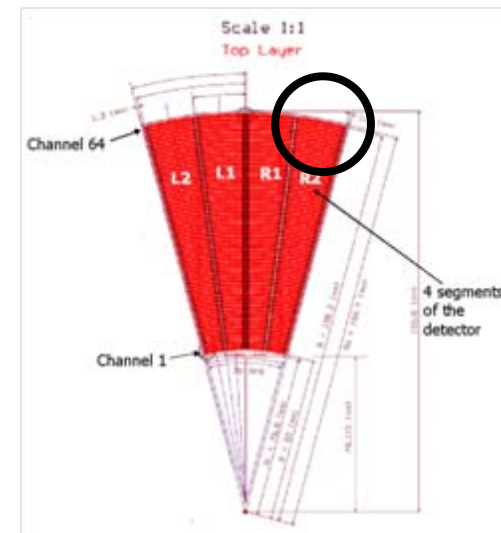
I/V Pad - Sn13 R2 ch 64

- Measurements were performed on pad R2 64 and one/two neighbors were grounded in different configurations.

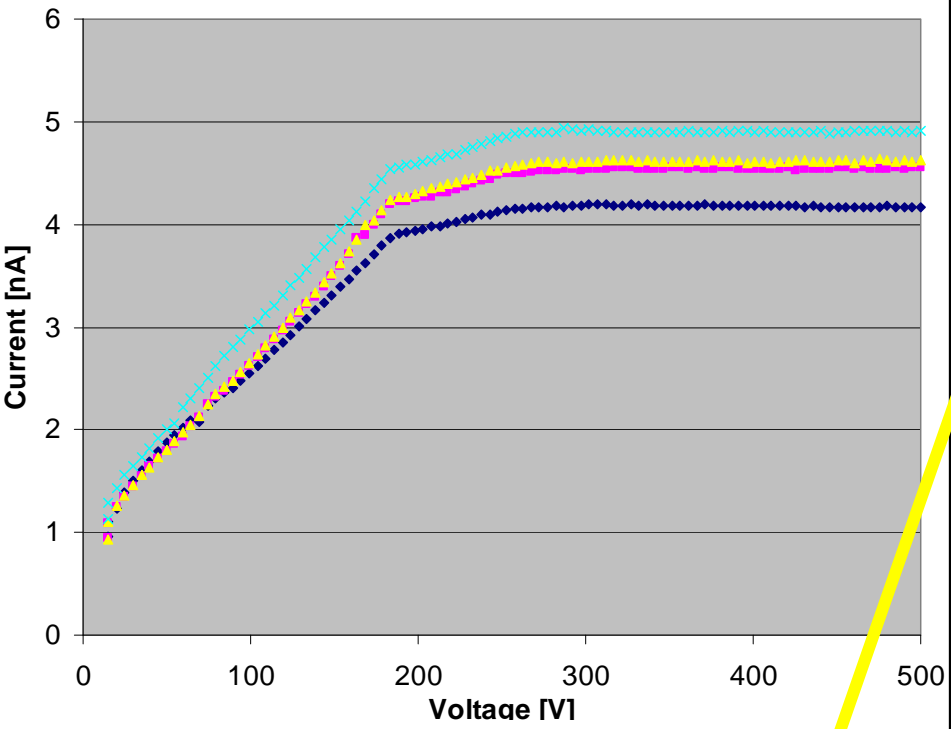
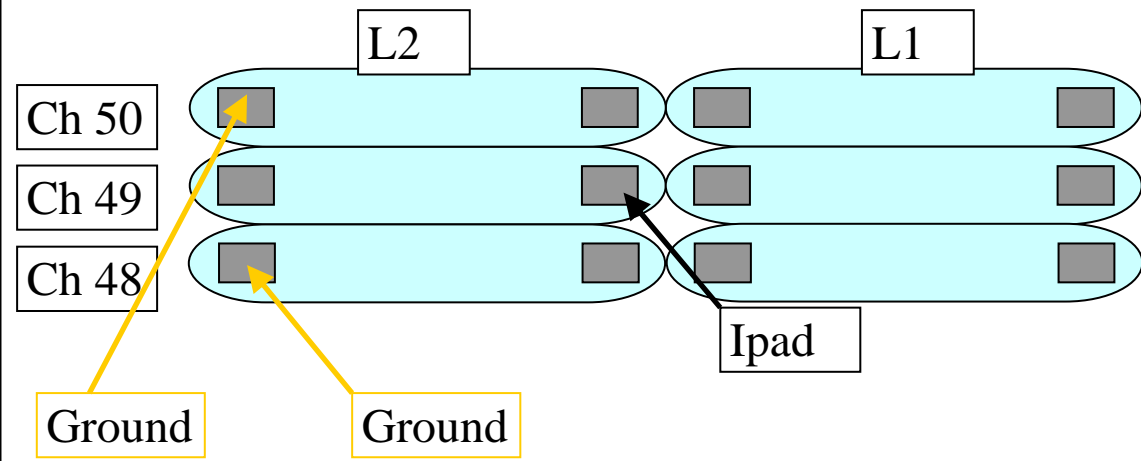
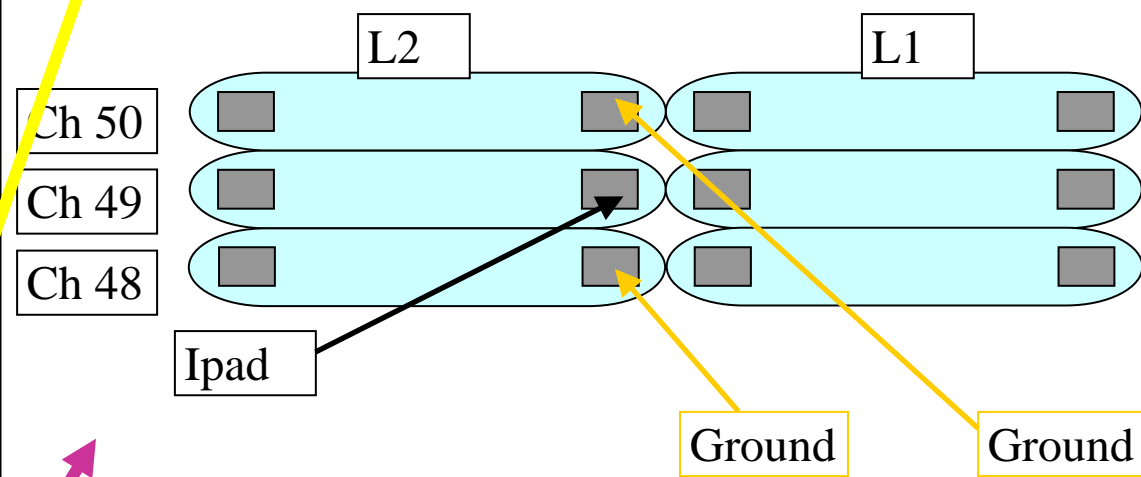
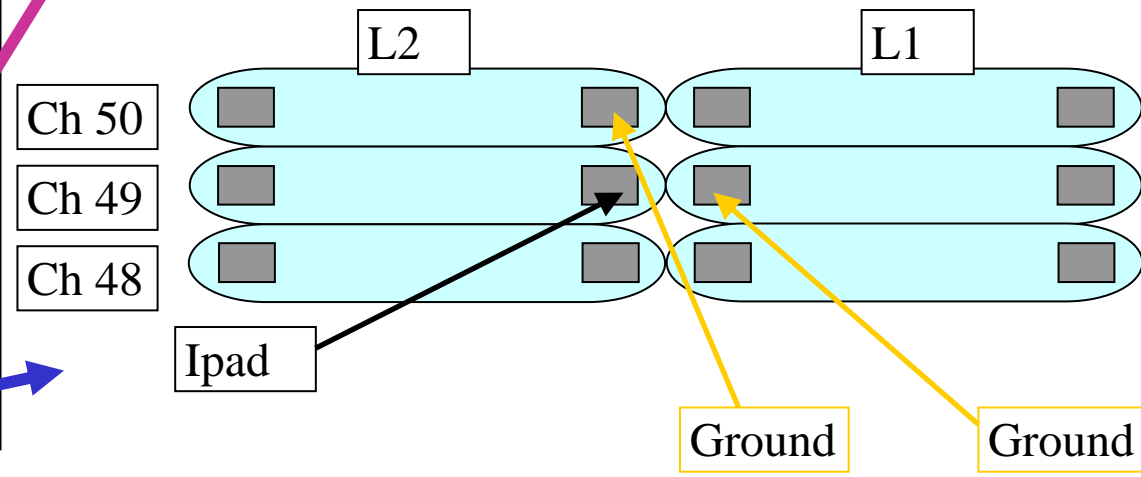
I/V grounding different neighbors  
SNo13 L2\_Ch49

No grounding  
Ground on top & bottom (left)  
Ground on top & bottom (right)  
Ground on right & top

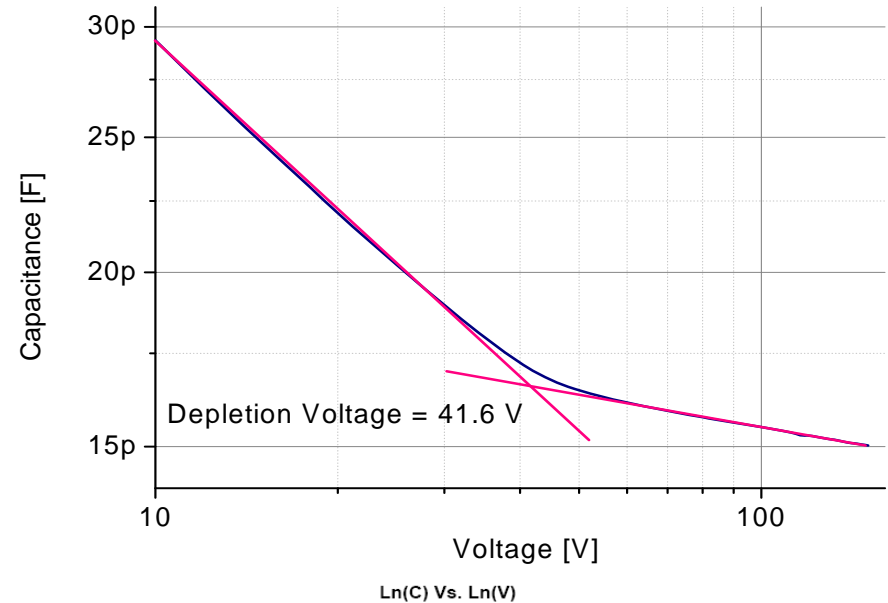
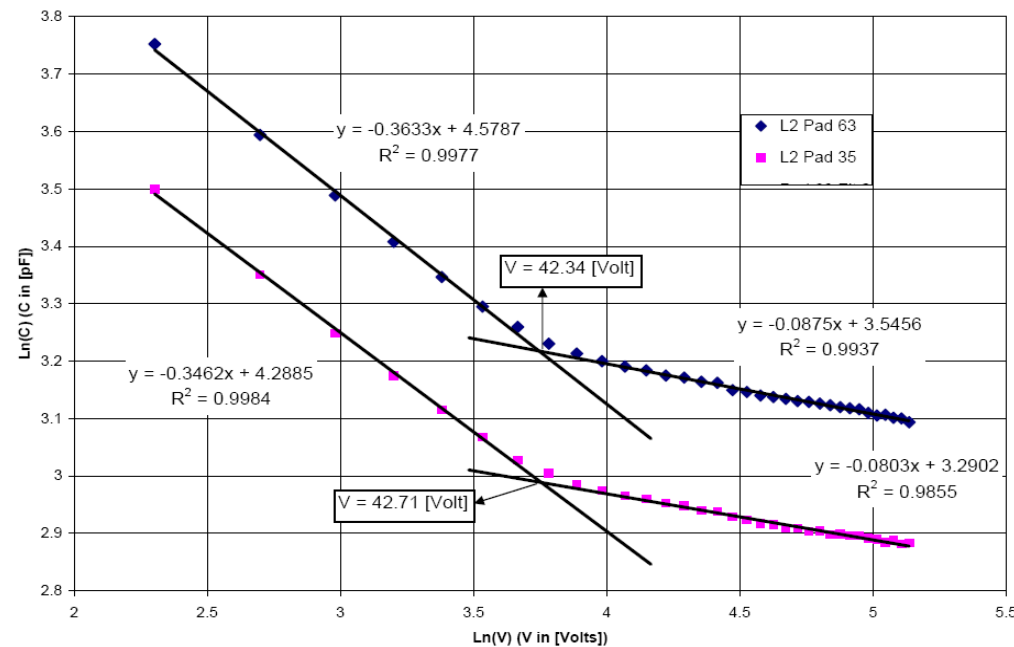
Serial No. 3 - L2 Channel 30

The full depletion voltage is determined by the voltage in which the capacitance saturates.

In these measurements the saturation is not full due to the fact that our sensor is not ideal. So the full depletion voltage is determined to be the cross point between two linear fits:

- one for the part of the curve where the capacitance decrease,
- the second for the “saturation” part of the curve.

Results in both labs give ~ 42 Volt as the depletion voltage

R. Schwartz at Desy-Zeuthen

At Tel-Aviv
