Recent 1.3 GHz 9-cell Cavity Results

J. Kerby, C. M. Ginsburg (Fermilab)

AES Site Visit

24 February 2010

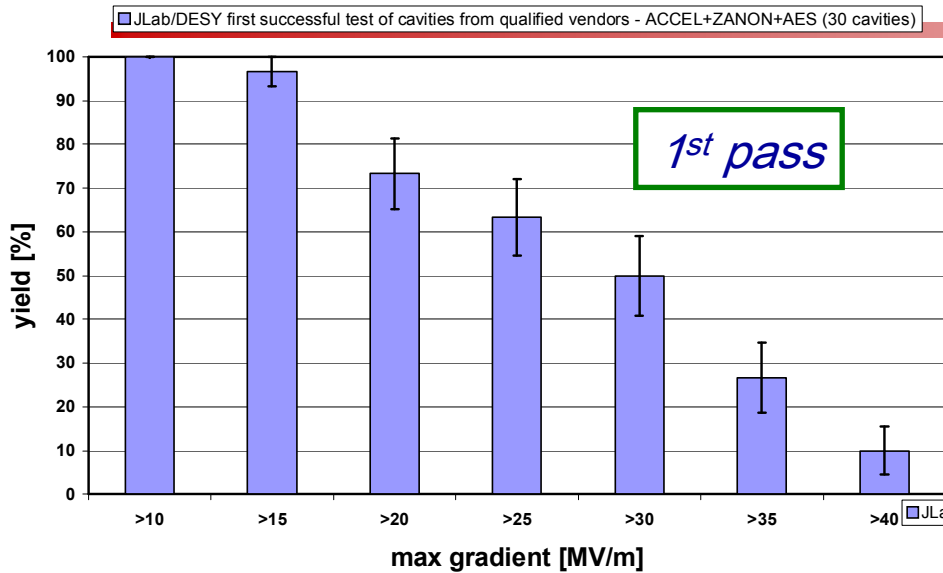
Electropolished 9-cell cavities

Performance typically improves after 2nd pass

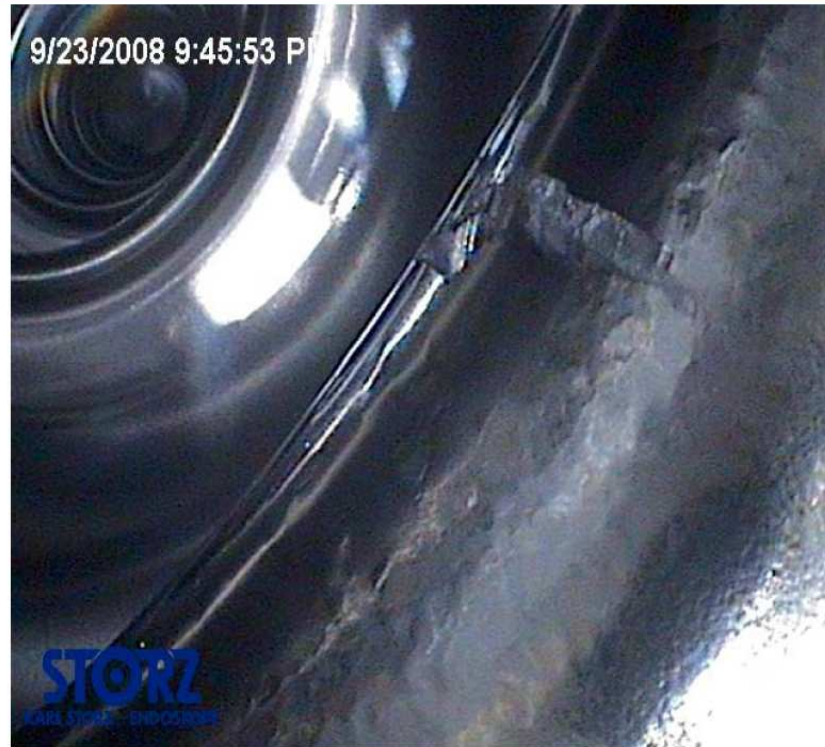
AES003 scratch

Cell 7 iris to cell 6, approx. 70°. This might have been caused by a screw head of the inspection system.

- JLab: 4 process/tests Jun.-Aug. 2007
 - Quench field repeatedly ~18 MV/m; no x-rays measured
 - Pass-band mode measurements implicate cell #4 and #6 ; confirmed with FNAL fast thermometry to be cell 4 (counting from input coupler)
 - mode measurements imply max gradient anywhere ~lower 20's MV/m; some field emission seen at higher gradients
- FNAL: 2 tests Jan.-Apr. 2008
 - hot(-test) spot found more precisely, mode measurements, first test of variable coupler
- LANL:
 - test stand commissioning and instrumentation development
 - bunch of spots found correlated with thermometry
 - Has been scratched on the iris (see picture next slide)

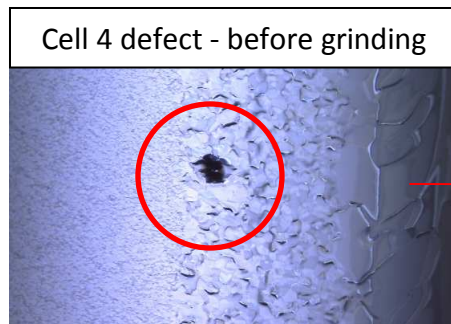
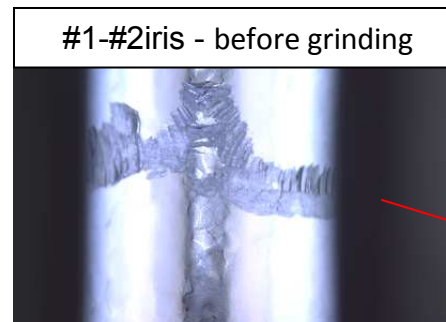
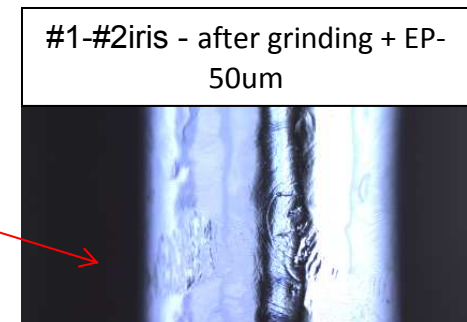
AES003 Repair

- Sent to KEK for optical inspection (Kyoto/KEK system) , local grinding of equator and iris defects, and EP

- FNAL/ANL first test after partial HPR 30 MV/m; field-emission limited; no heating at previous quench site
- FNAL/ANL full HPR cycle, cavity performance improved to 34 MV/m; currently field-emission limited; additional improvement anticipated

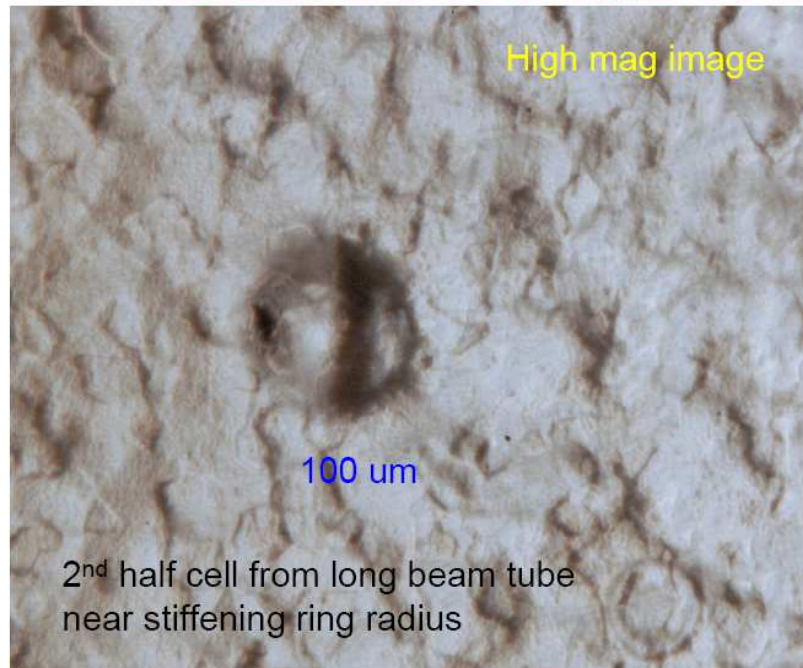
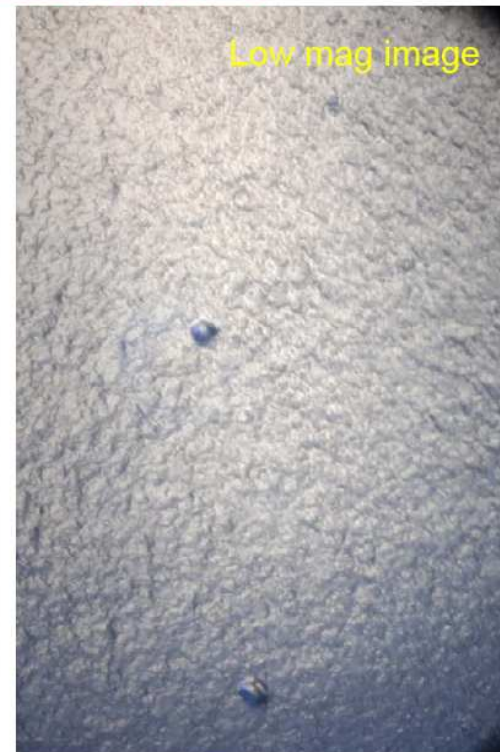
AES004 defect

AES4 High E Field Region

Cavity FE limited even after repeated EP
pass-band measurements suggest field emitters in end cells

- All surface processing work was done at JLab
- Always field-emission limited
 - 28.0, 25.5, 19.5, 21.5, 27.0 MV/m
 - Iris defect found with optical inspection (see next slide)
- Used for HPR commissioning at FNAL/ANL facility
- 2nd dressed cavity at FNAL
- Horizontally tested (first cold RF test at HTS) at FNAL
 - Maximum gradient 25-31 MV/m (calibration needed work), quench limitation, field emission observed
- Currently at KEK for S1-Global cryomodule

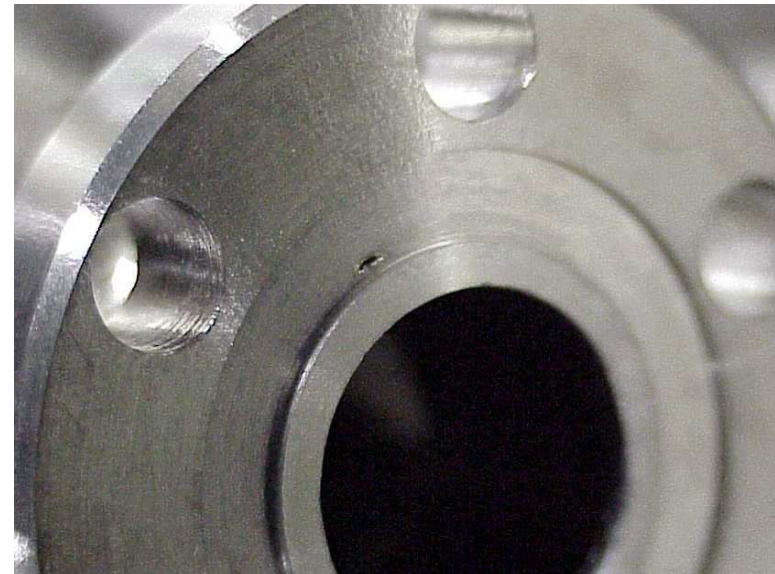
TB9AES007

-
- FNAL incoming inspection showed void in HOM weld (see photo)
 - No remediation – wait and see
 - To get final surface process this week at JLab and cold vertical test soon thereafter

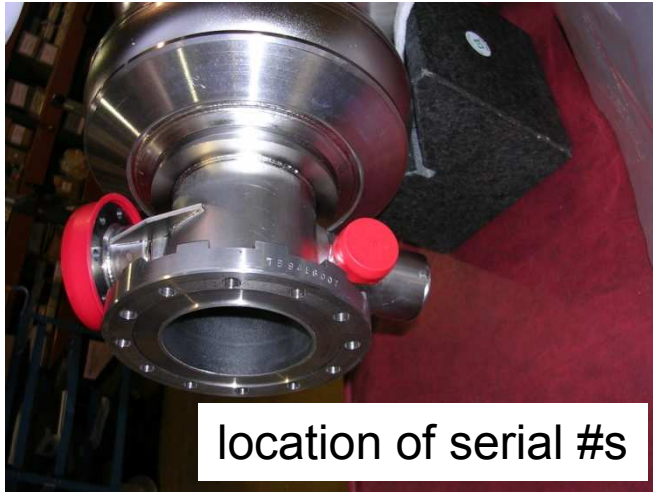
location of serial #s

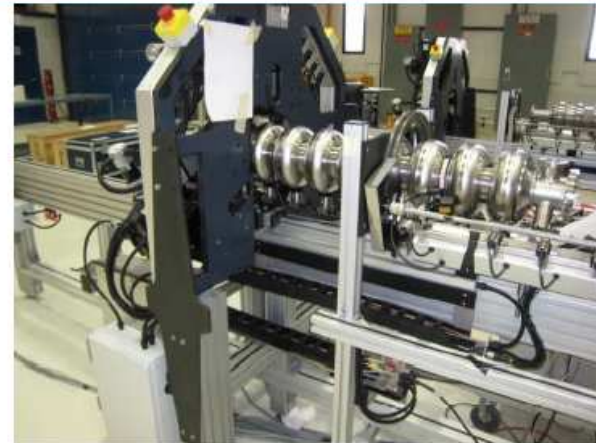
RF tuning machine
