DESY status

ALCPG 2011

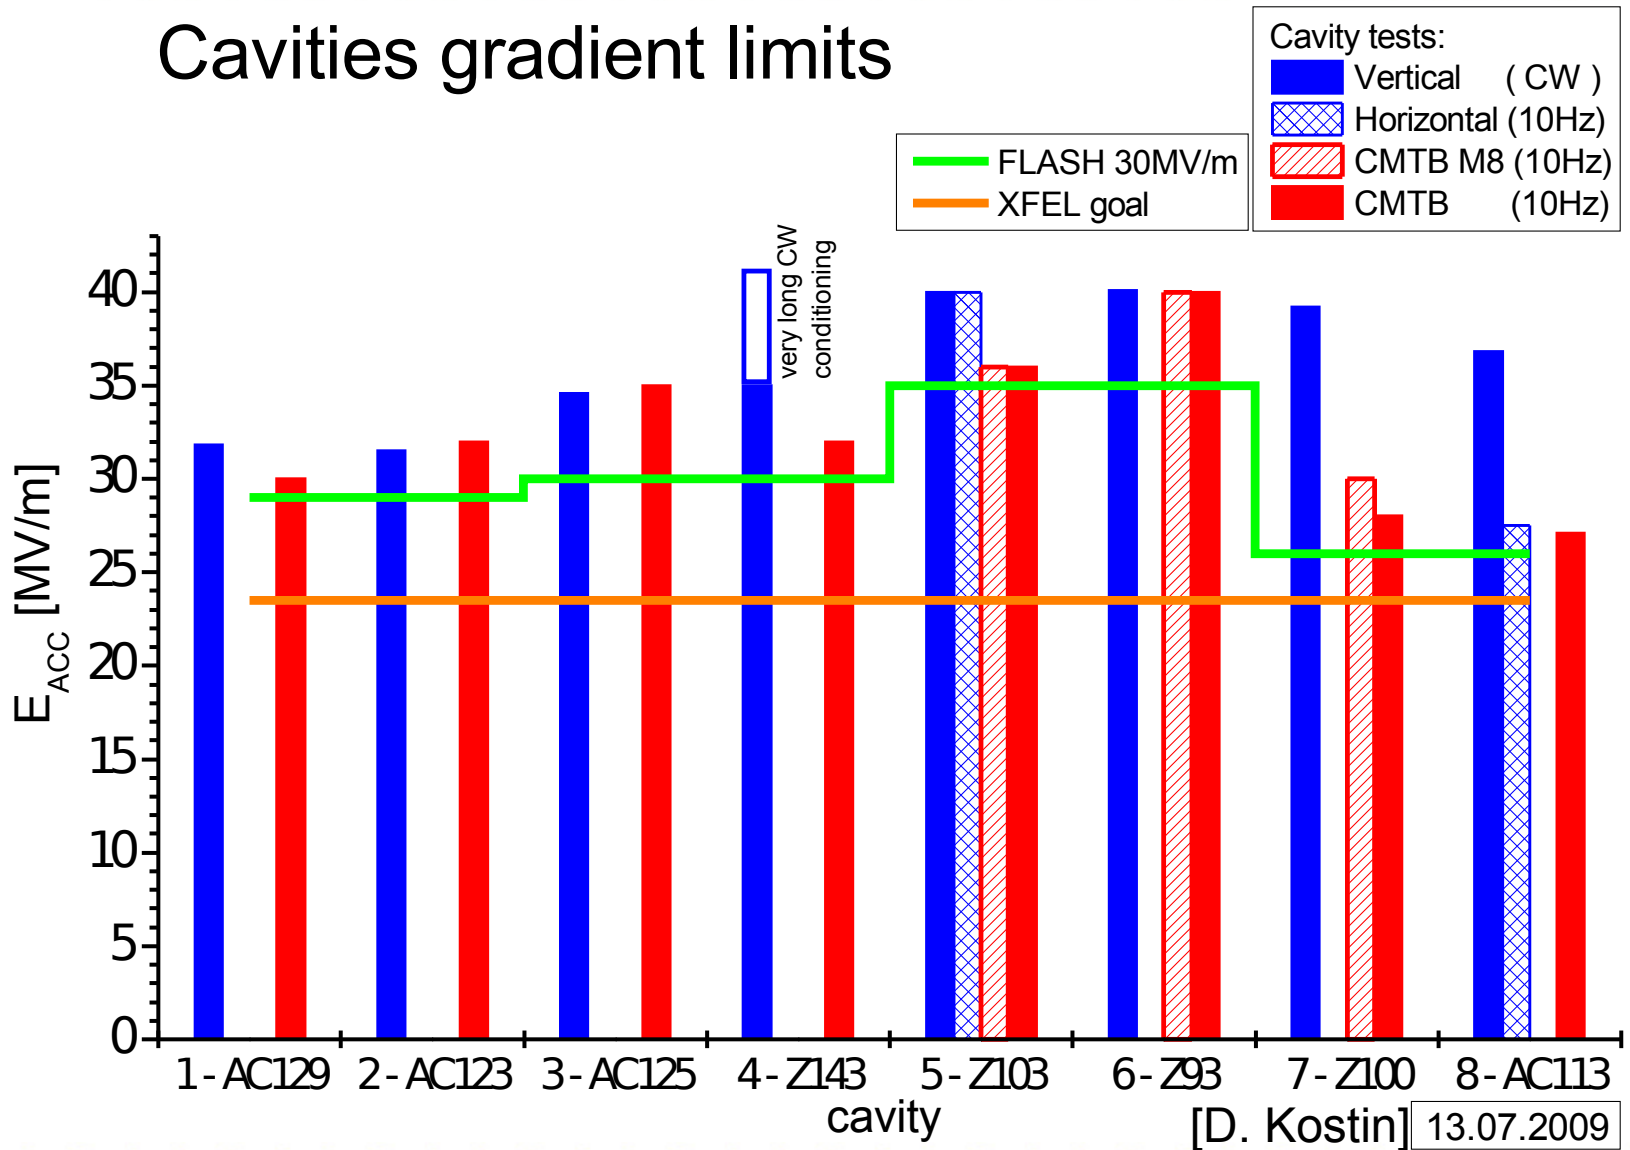
Cavities gradient limits

[D. Kostin] 13.07.2009

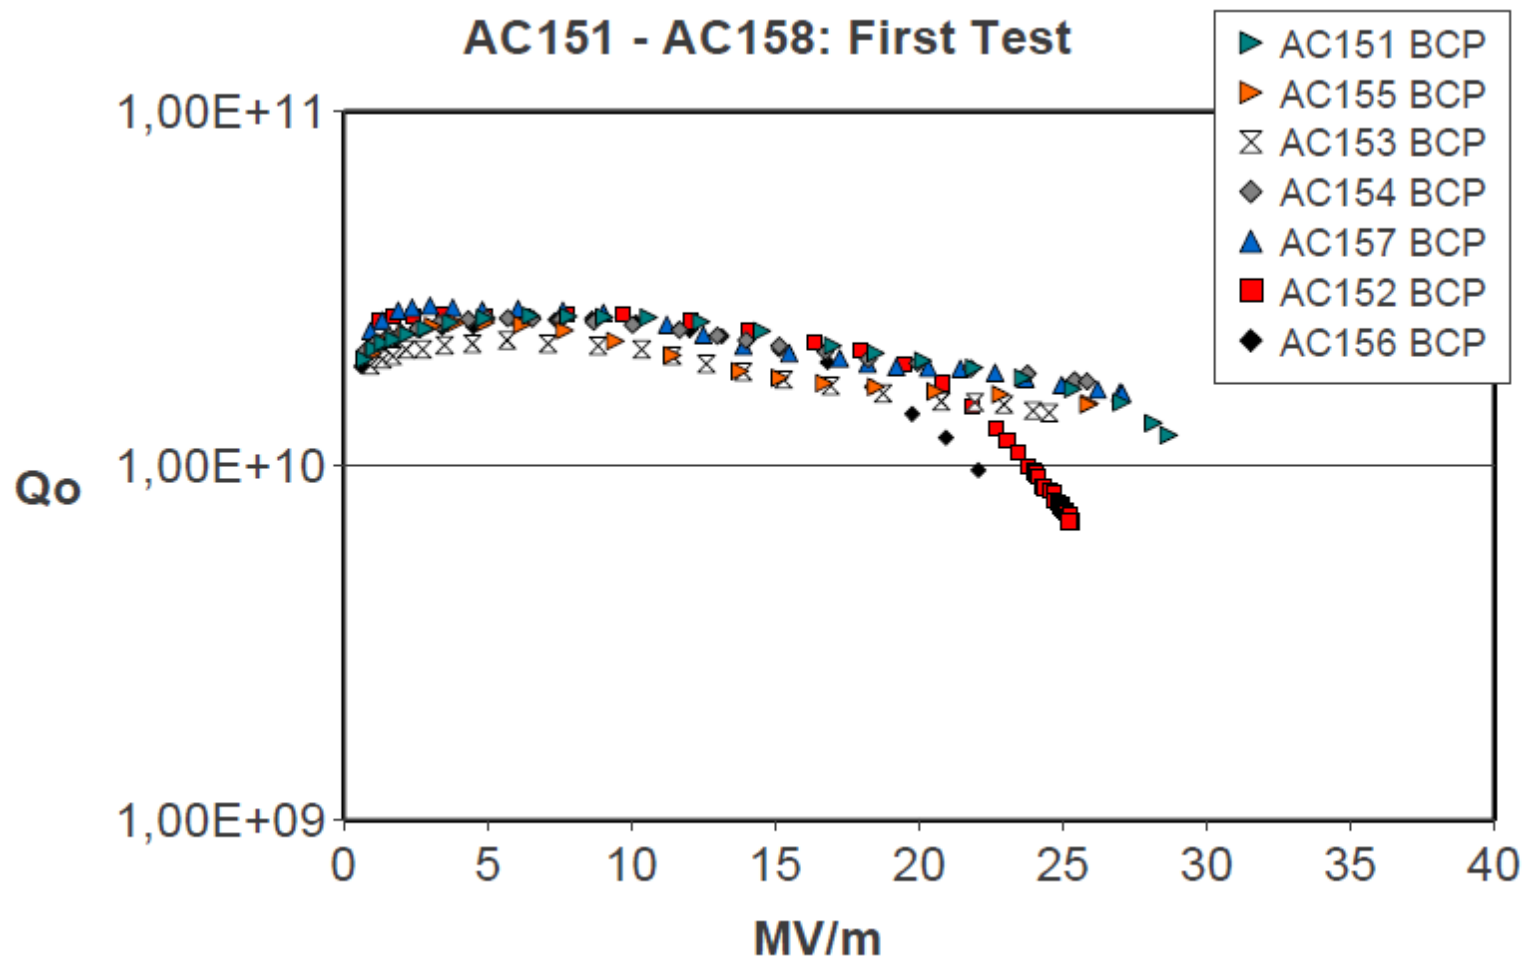
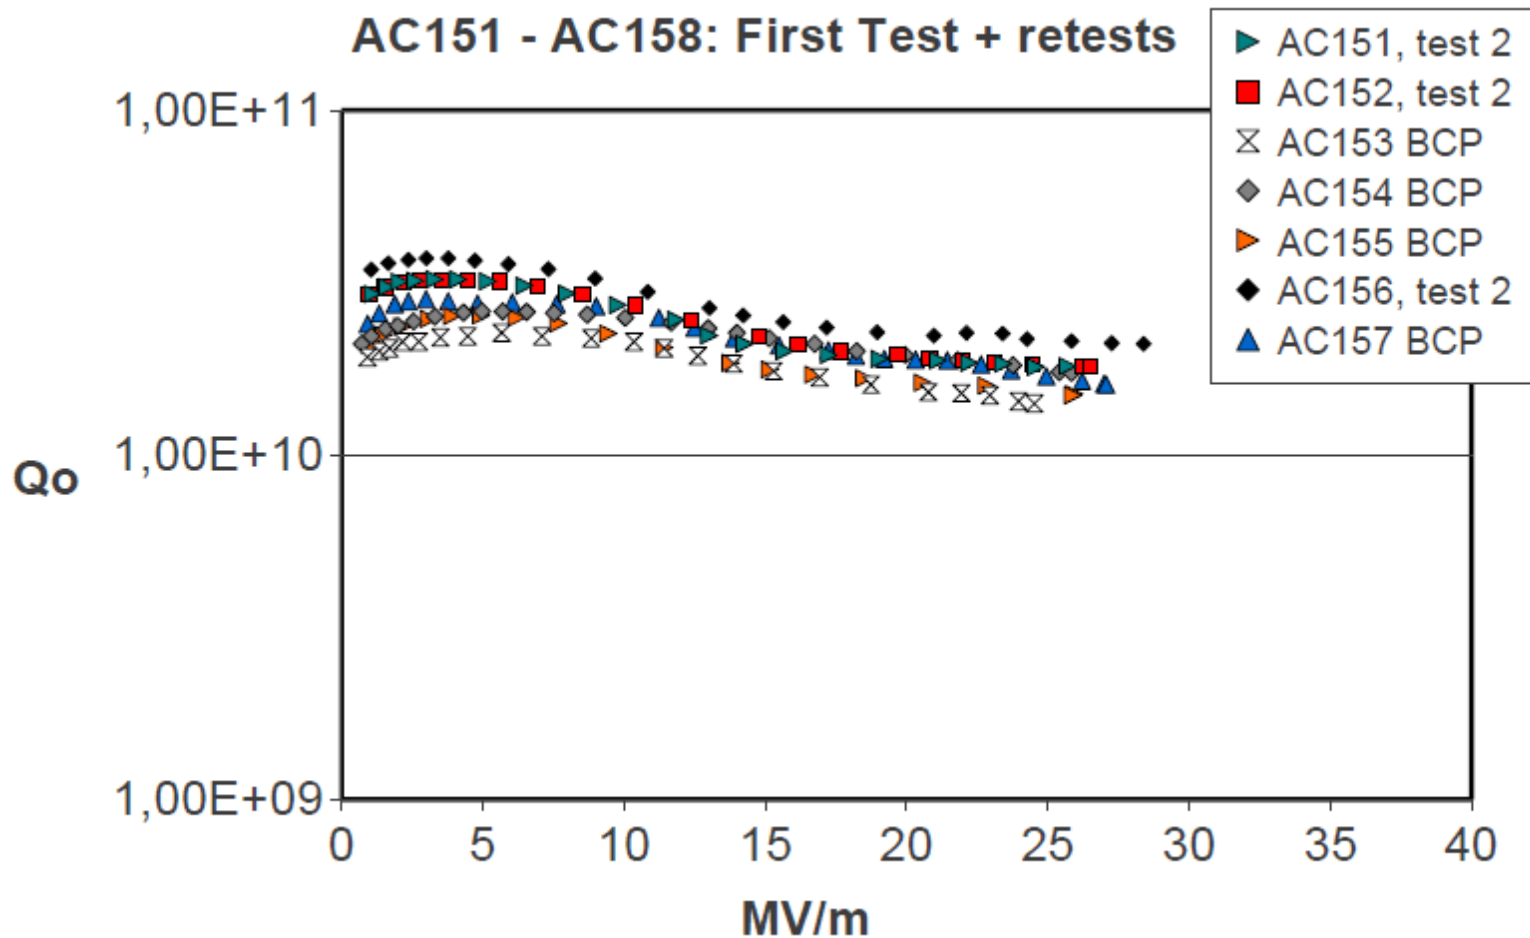
LG first test

- 8 LG-cavities built from Heraeus material by RI
 - first test after BCP removal of 120-130 μm , HPR and bake at 120C for 48h
 - three cavities with considerable FE in first test
 - additional HPR and 2nd test
 - now 7 out of 8 are limited by BD at 25-28 MV/m with no or very low FE
 - Quench location found by 2nd sound for two cavities: optical inspection done → no obvious defect
 - one cavity (AC158) with leaks and FE (~ 28 MV/m) in two tests, third test ongoing
- next: EP of all eight cavities
