Cavity status; recent KEK activities

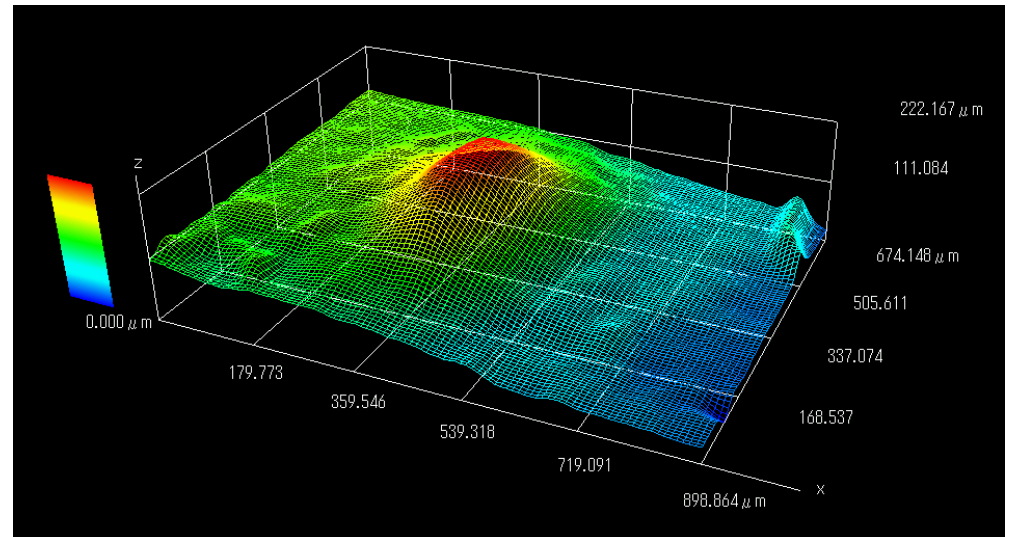
AES#001 3-cell Equator, t=169-1 deg.

- (2) **KEK-FNAL collaboration; on molding**
Bumps replica of AES001 taken at FNAL during TTC were analyzed
by using profiler micro-scope. (bumps are heating spot at 22MV/m)

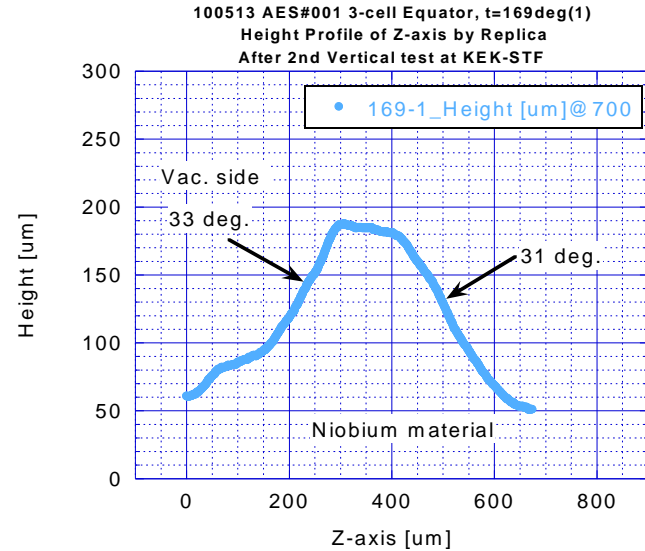
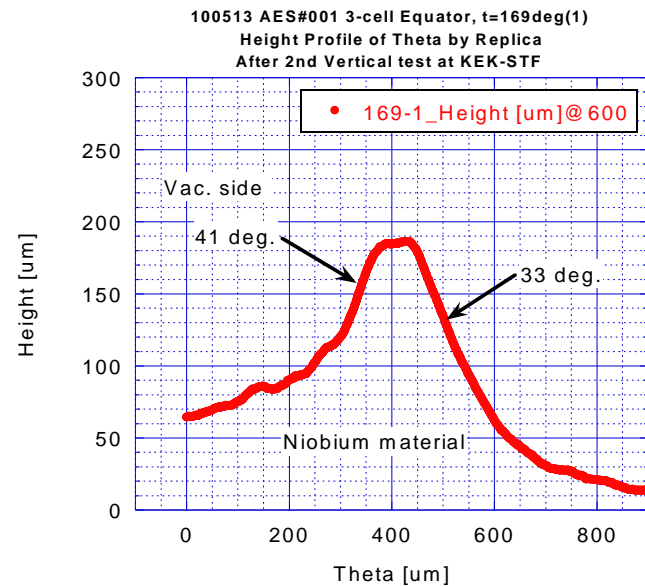
AES#001 3-cell Equator, t=169-1 deg. : Profile

Surface gradient : 41 degree. and 33 degree

Kyoto-camera could only measure surface gradient less than 22degree. So it could not measure.

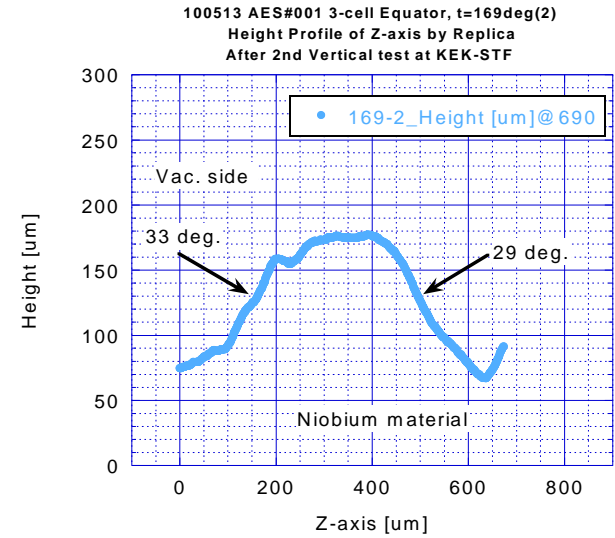
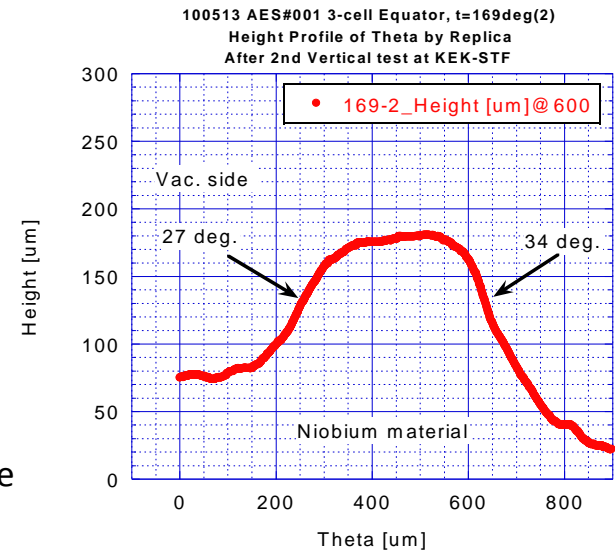
AES#001 3-cell Equator, t=169-2 deg. : Profile

H-field of TM010

Surface gradient : 27 degree. and 34 degree
