Recent 9-Cell Cavity Test Results

Joe Ozelis
Fermilab/TD/T&I

SRF Integration Meeting
May 24th, 2010

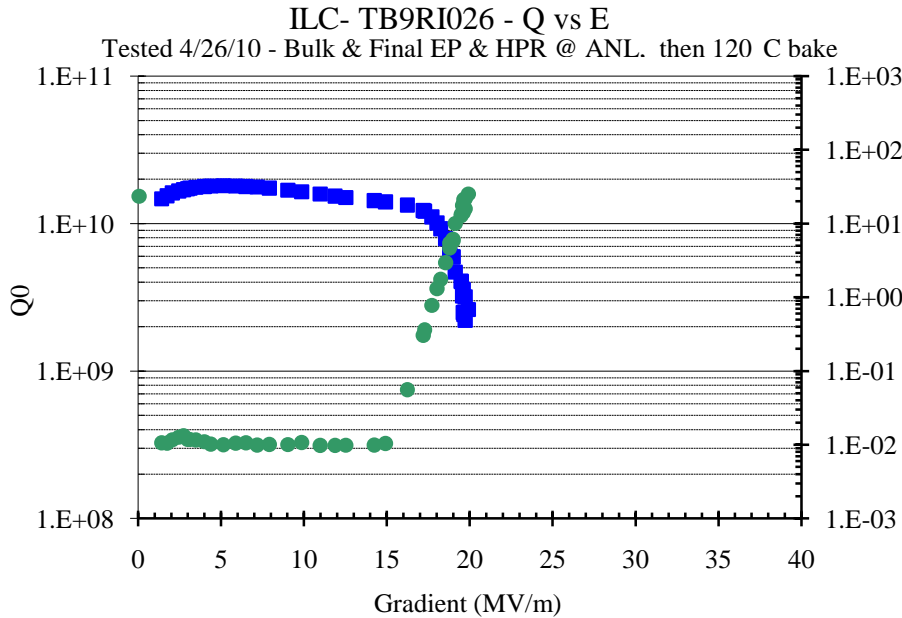
After mode measurements where FE processing was observed, cavity now reached 19.6MV/m in the π -mode (up from 14MV/m, but well below initial run to 29MV/m).

Limited by strong FE/Q-drop.

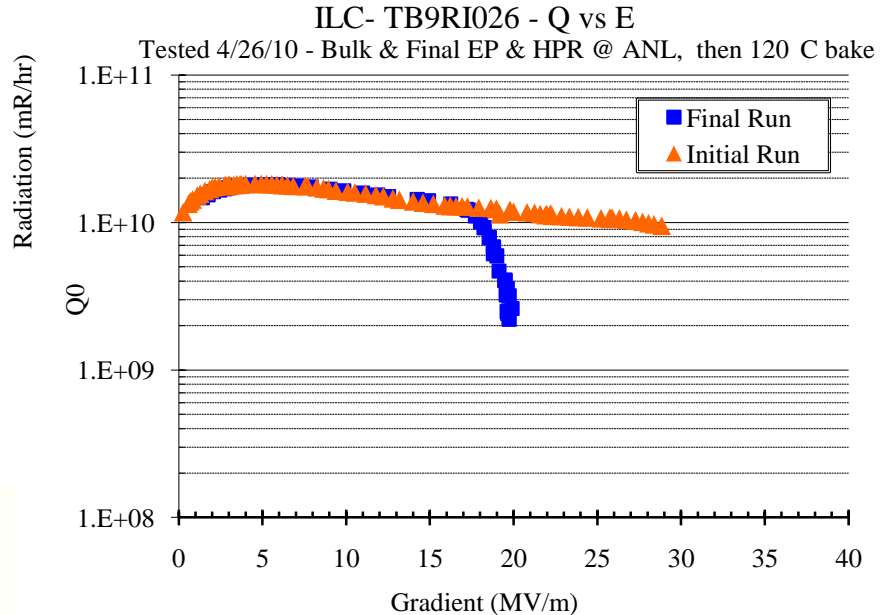
Comparison of initial (pre strong emitter turn-on) and final (post mode meas.) Q_0 vs E curves. Low-field Q_0 behavior is unchanged, but Q_0 drops sharply at 16MV/m due to strong FE (FE onset 15 MV/m).

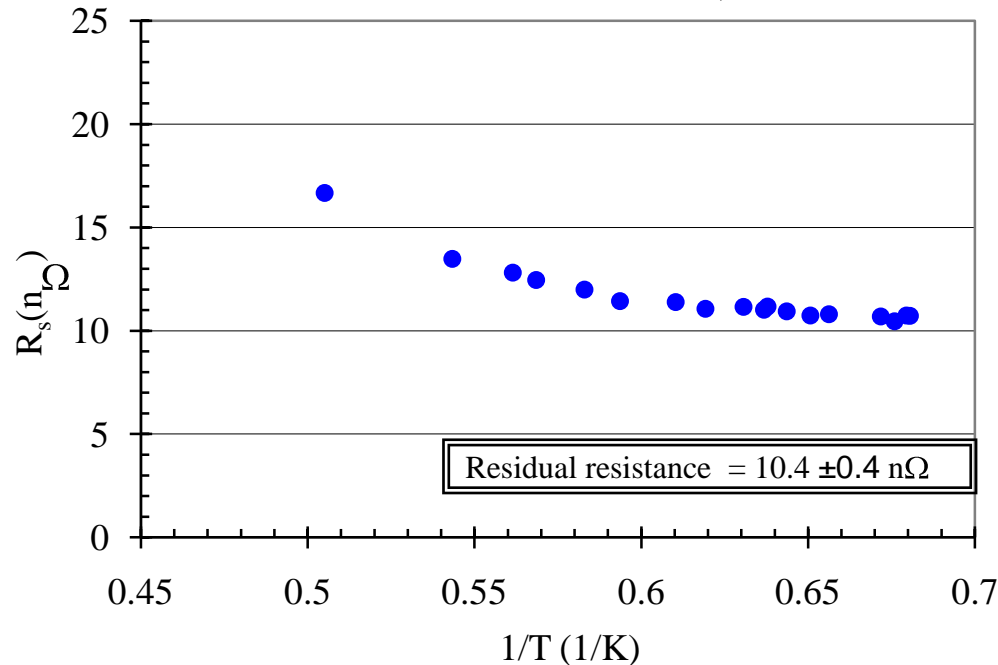
ILC-TB9RI026 - R_s vs T

Residual surface resistance = 10.4n Ω – a rather high value compared to typical (good) EP'd 9-cell cavities (4.5 – 6.0 n Ω). Is the degradation due to the activation of a strong emitter, which subsequently globally affects the cavity surface? Q_0 vs T measurements are performed at low fields (3-4 MV/m) where FE is not active, so it does not affect the Q_0 vs T measurement.

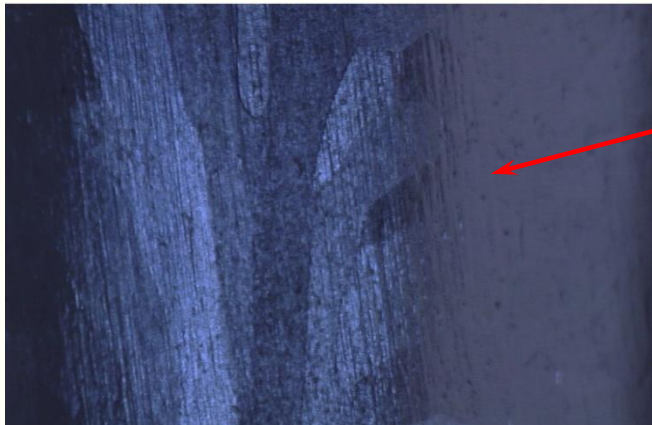
As received

Optical inspections (D. Sergatskov) revealed the evolution (growth) of a feature on the iris between cells 8 & 9 :

Was the feature on the iris between cells 8 & 9 the source? Did it “turn on” after reaching some threshold, then “process” or evolve into a bad (worse) emitter? Optical inspection to follow vertical test.

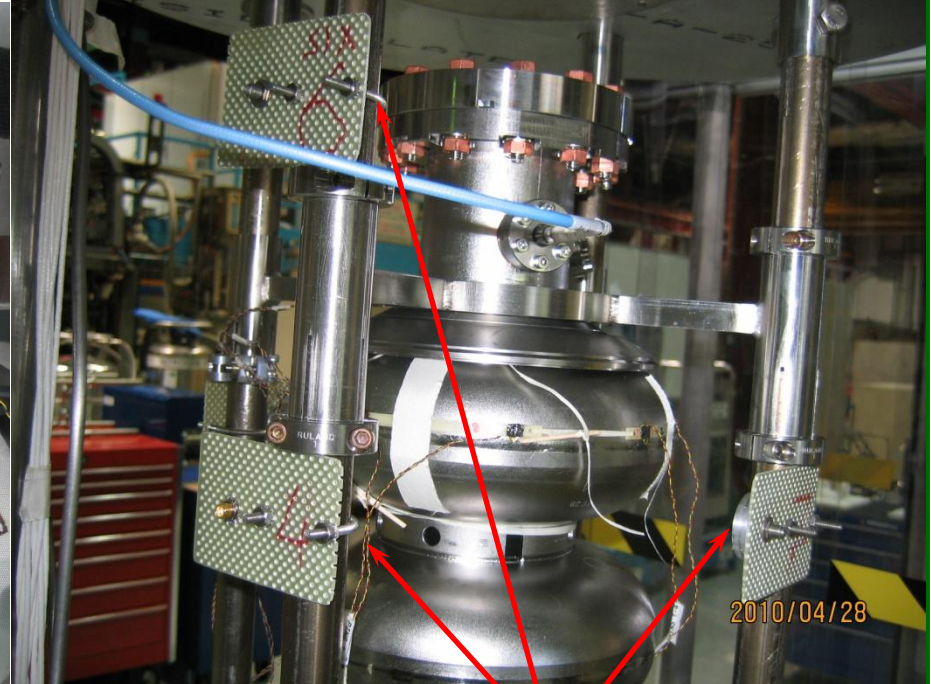
Second sound sensors

RTD's (Cernox)

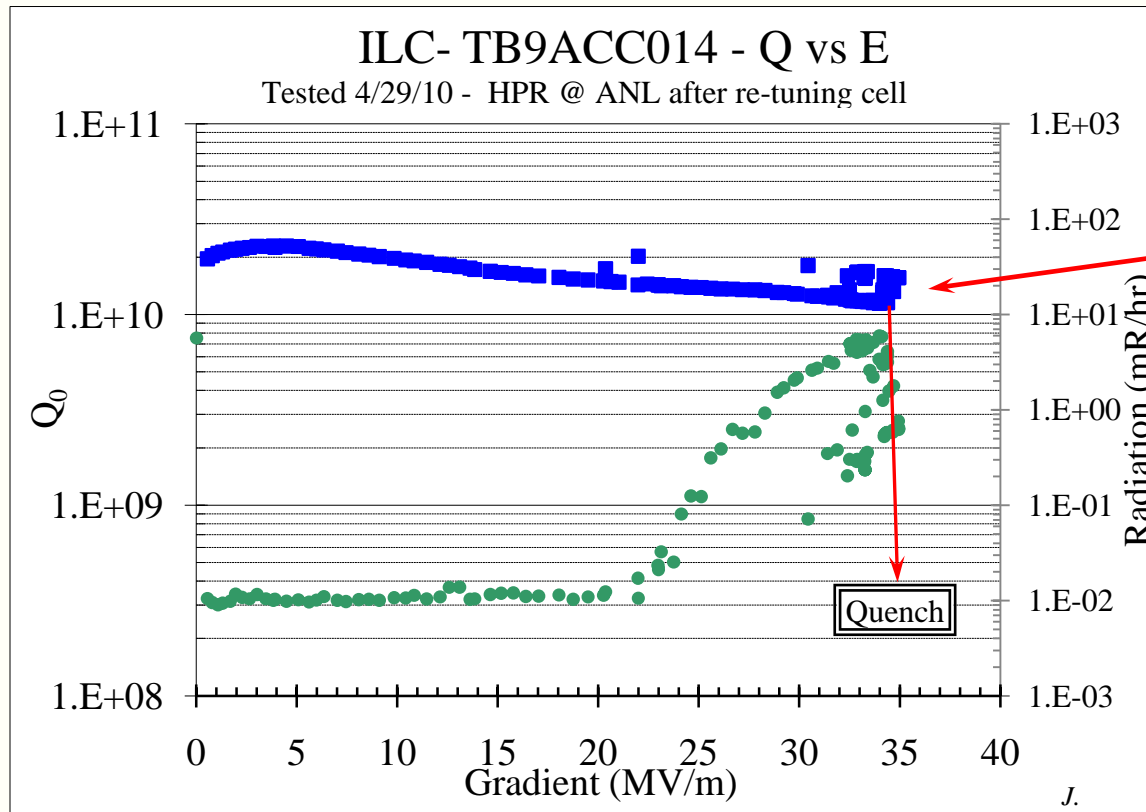
Low field Q_0
 2.3×10^{10}

Some FE processing occurred while performing scans of SS sensors while quenching at $T < 2K$

Quench at 34.4 MV/m, Q_0 at quench = 1.2×10^{10}
 FE onset at 22 MV/m, radiation levels moderate (~6mR/hr).
 In π -mode the SS sensors indicate quench at cell #1.

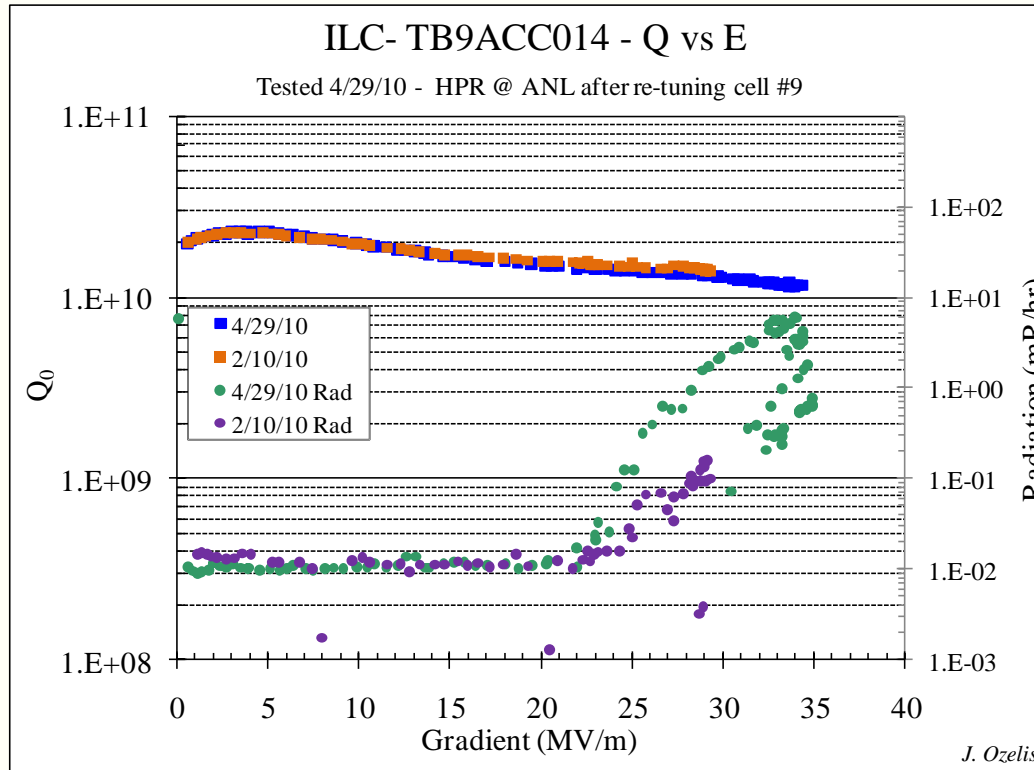
Q_0 vs E curves are nearly identical (low field Q_0 “hump” and Q-slope) - would not be expected if there were a calibration error (P_{loss} would be wrong).

Cavity showed a 20% improvement in maximum gradient during this latest test.
 Field probe calibration differed by ~8% → ~4% change (increase) in gradient.
 Improvement in gradient to 34.4MV/m from 29MV/m is real - result of cumulative FE processing during the two test cycles ?
 Initial FE during this test was actually higher than the initial FE during the last test!

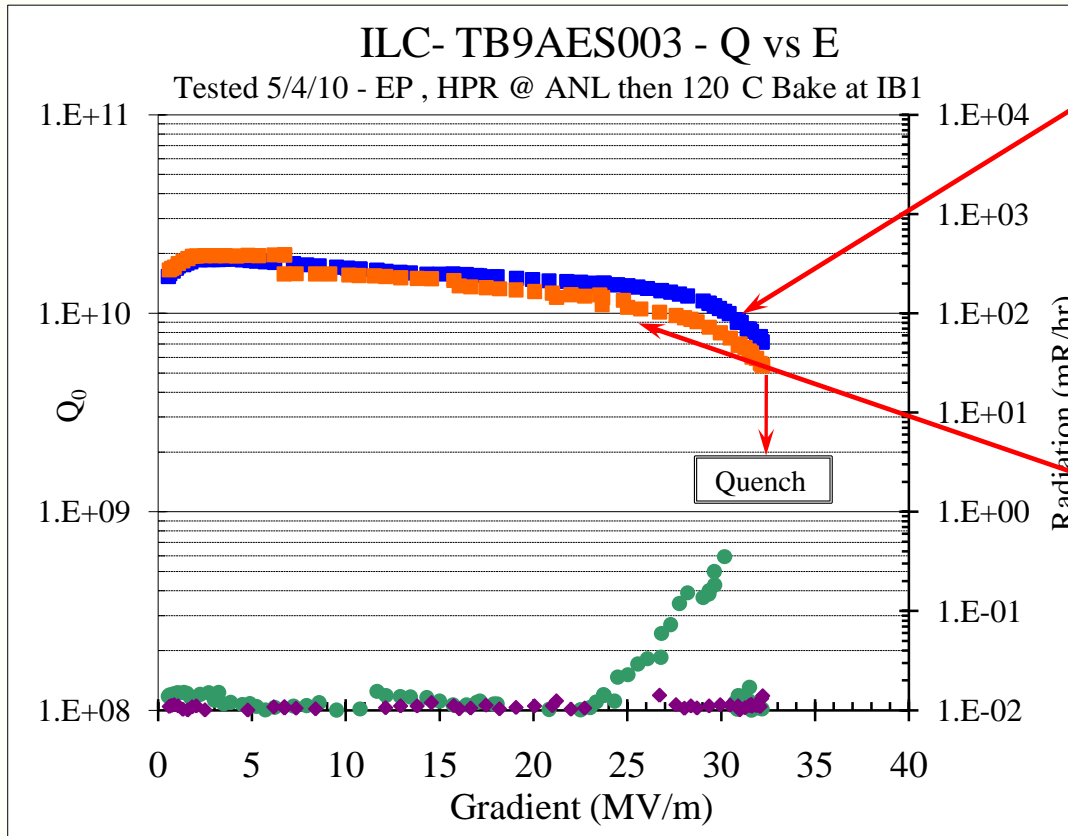
During initial power rise, note error in P_{ref} measurement. Suspect cable/connector heating (later verified – vent holes in connector improperly drilled).

Periodic re-cal of cable when lowering power fixes this.

No error on E (P_{tran} used only). Q_0 error up to 25% if not corrected.

Low field $Q_0 = 1.9 \times 10^{10}$, quench at 32.2 MV/m, Q_0 at quench = 5.6×10^9 . FE onset at 23 MV/m, radiation increasing, then processed away. Still see Q-drop at ~27-28 MV/m even w/o FE loading, with 120°C bake. Mode measurements suggest cells 4/6 lowest performers.

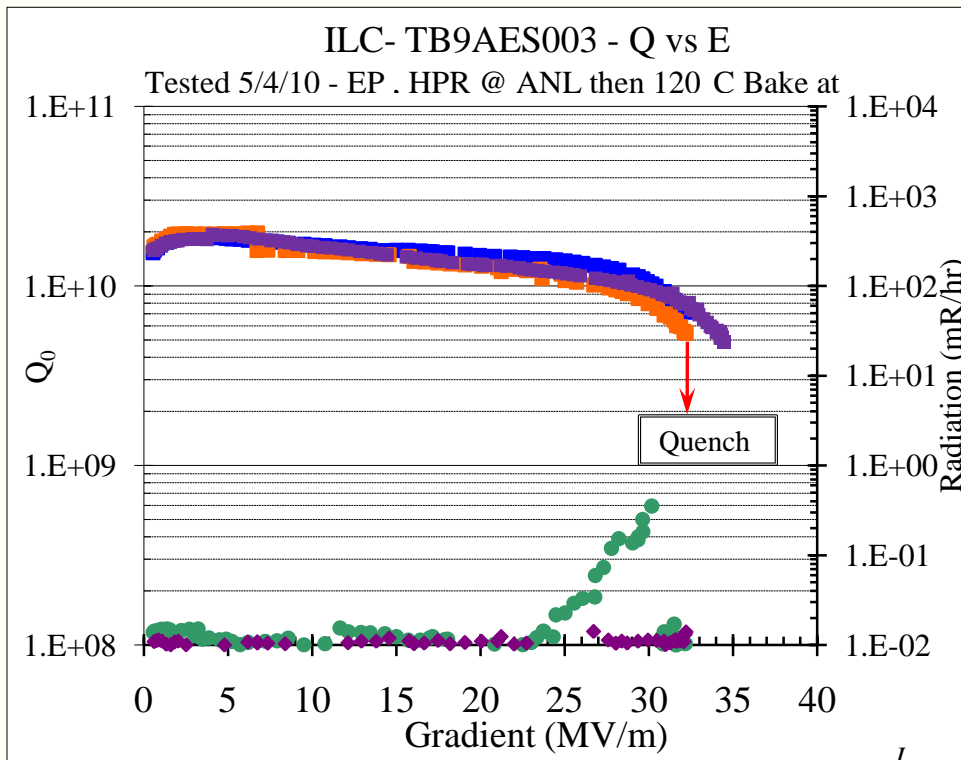
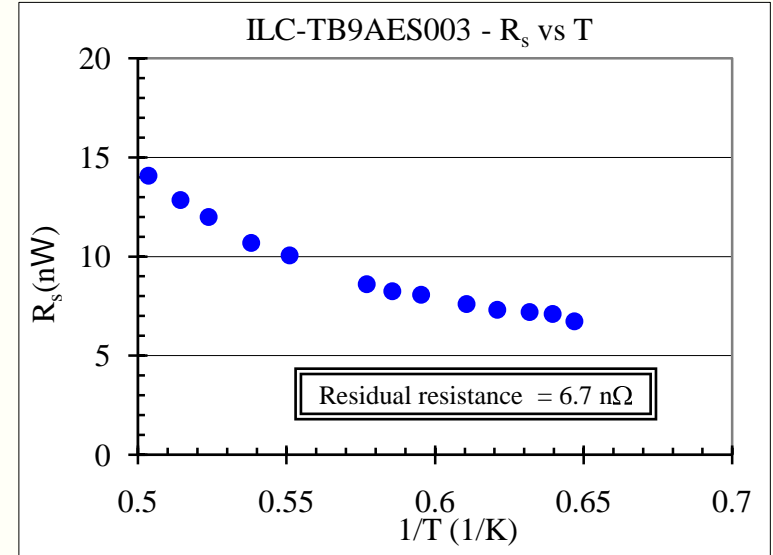
Residual surface resistance = 6.7nΩ; last time was 6.0nΩ .

Essentially no change/improvement, consistent with other good cavities.

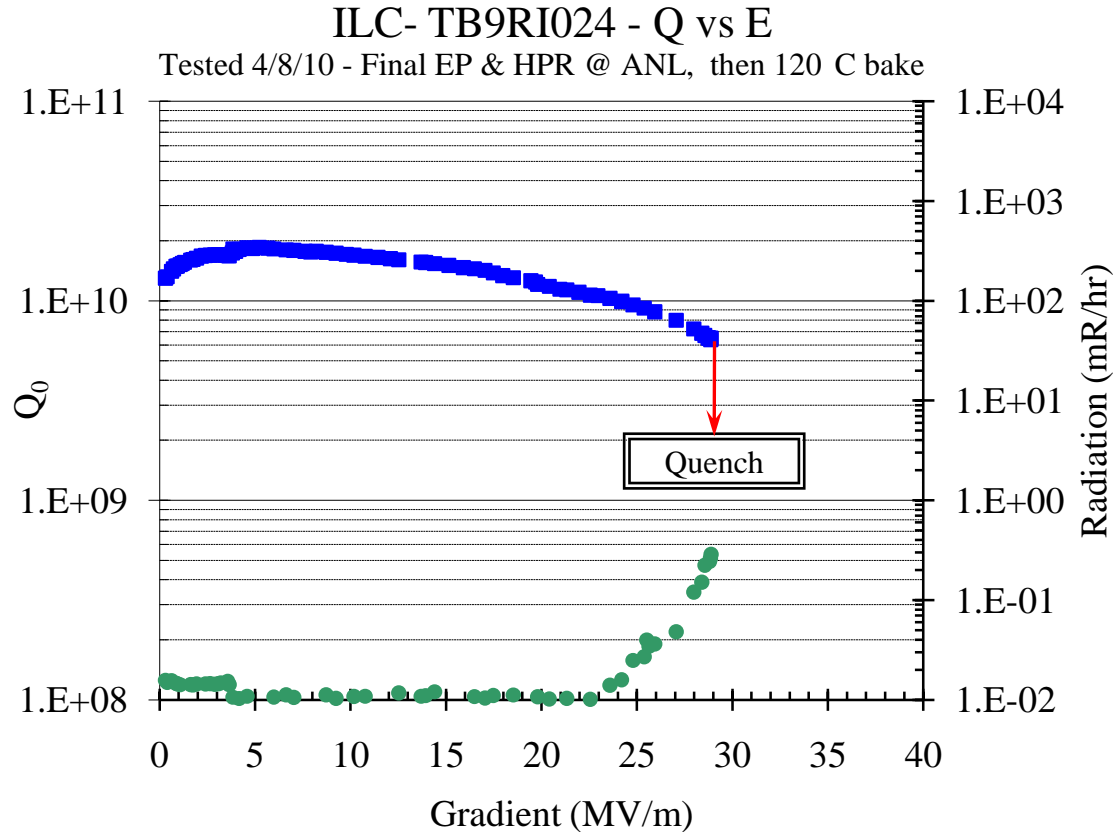
Low field $Q_0 = 10^{10}$

Quench at MV/m, Q_0 at quench =
 FE onset at MV/m, radiation levels moderate. Fairly strong Q-slope
 beginning at ~ MV/m, even without presence of FE.
