## Progress work and the result of vertical test : HIT-01

Ken Watanabe (KEK), STF cavity Group

2010/July/20 webex meeting

2010/May/07 : Cavity fabricated by Hitachi. Cavity Type: TESLA-like without HOM couplers.

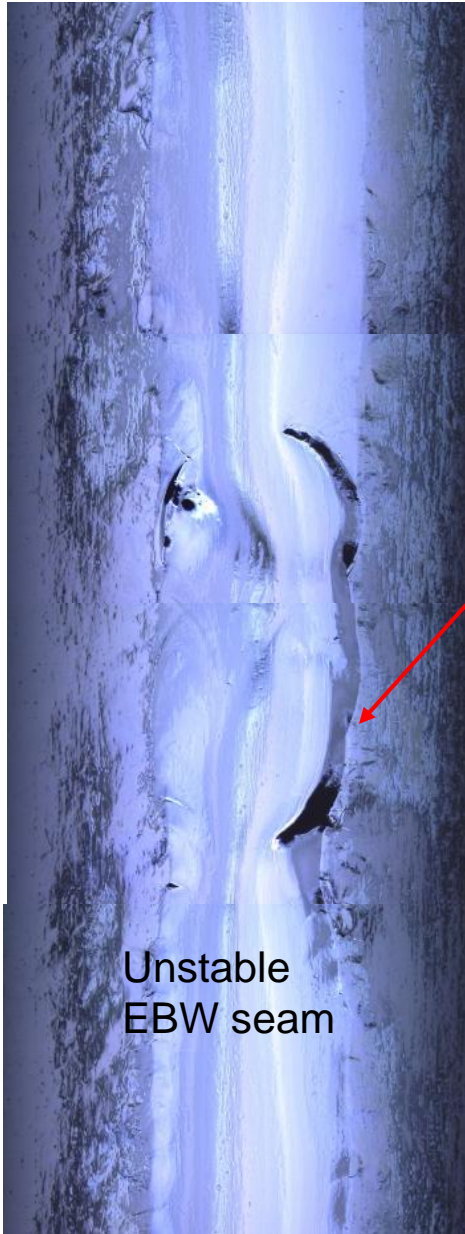
1-cell equator,  $t=200$  deg.

Cell 1&9[MV/m]	Cell 2&8[MV/m]	Cell 3&7[MV/m]	Cell 4&6[MV/m]	Cell 5[MV/m]	Comment
$\pi$ Initial	>35.1	>35.1	>35.1	>35.1	>35.1	Quench : Heat@1cell 210deg. Equator down Qo=5.93E9, Po=219W, X-ray 16.9 mSv/h
Final	35.2	35.2	35.2	35.2	35.2	Quench: Heat@1cell 210deg. Equator down Qo=6.50E9, Po=201W X-ray 14.6 mSv/h
8 $\pi$ /9	37.1	33.1	24.5	13.7	0	Quench: Heat@1cell 210deg. Equator down Qo=6.76E9, Po=104W X-ray 307 $\mu$ Sv/h
7 $\pi$ /9						
6 $\pi$ /9						
5 $\pi$ /9	29.9	20.4	35.3	6.0	38.0	Quench: Heat@5cell 120,150deg. Equator Qo=7.00E9, Po=105W X-ray 2.8 $\mu$ Sv/h
4 $\pi$ /9	29.0	38.0	16.5	42.1	0	Power Limit Qo=3.89E9, Po=246W X-ray 3.5 $\mu$ Sv/h
3 $\pi$ /9	19.6	39.2	19.6	19.6	39.2	Quench: Heat@5cell 150deg. Equator Qo=7.92E9, Po=92W X-ray 0.5 $\mu$ Sv/h
Eacc,max	37.1	39.2	35.3	42.1	39.2	ave. 38.5MV/m

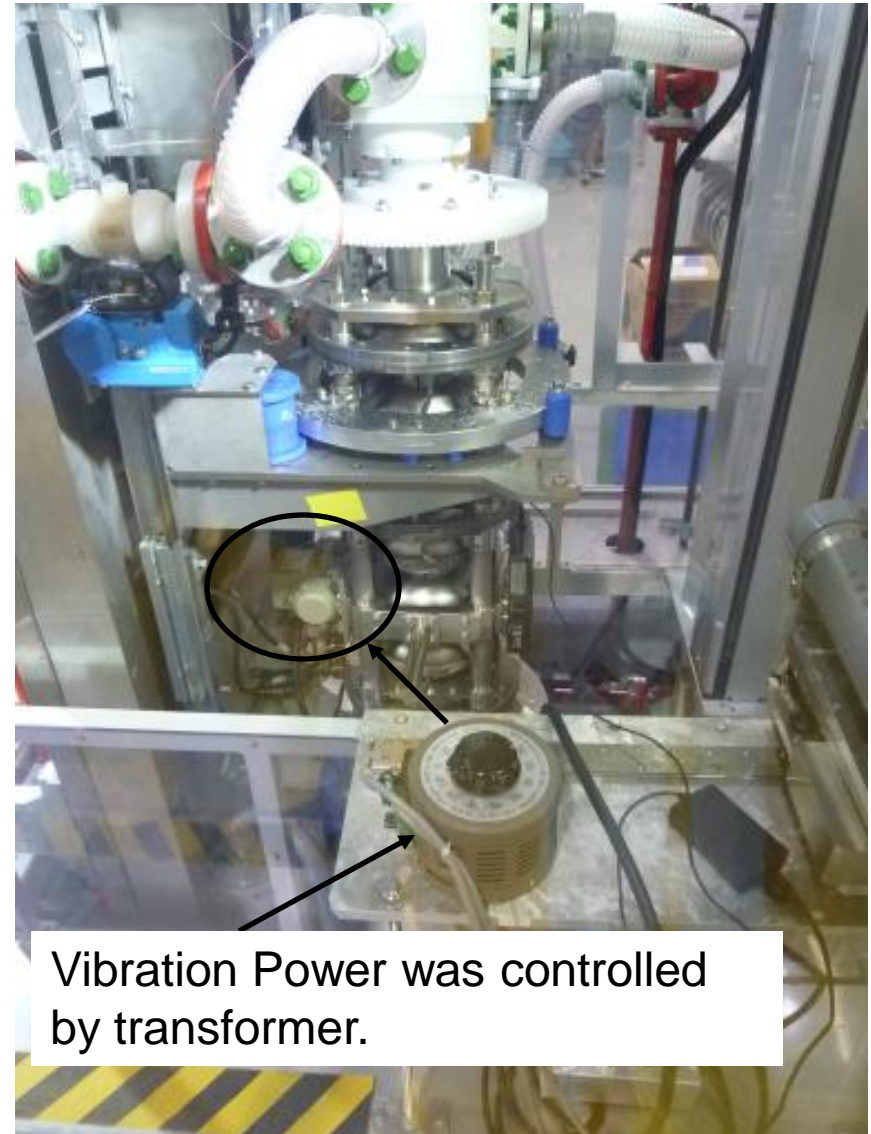
# 1st water rinsing with vibration motor (1<sup>st</sup> try)

Total time : 90 min

Sequence : sealing by water during 1<sup>st</sup> water rinsing.

- (1) Water in 10min -> water out 1 sec.  
after overflow, motor was turn on.
- (2) Water in 3 min -> water out 1 sec.  
-> Repeat (2) until 90 min.

Target : for Stain problem, for improvement 1<sup>st</sup> water rinsing etc..

\*The vibration motor used during 1<sup>st</sup> water rinsing for the stain problem and the field emission etc...

It was 1<sup>st</sup> try at STF EP system.

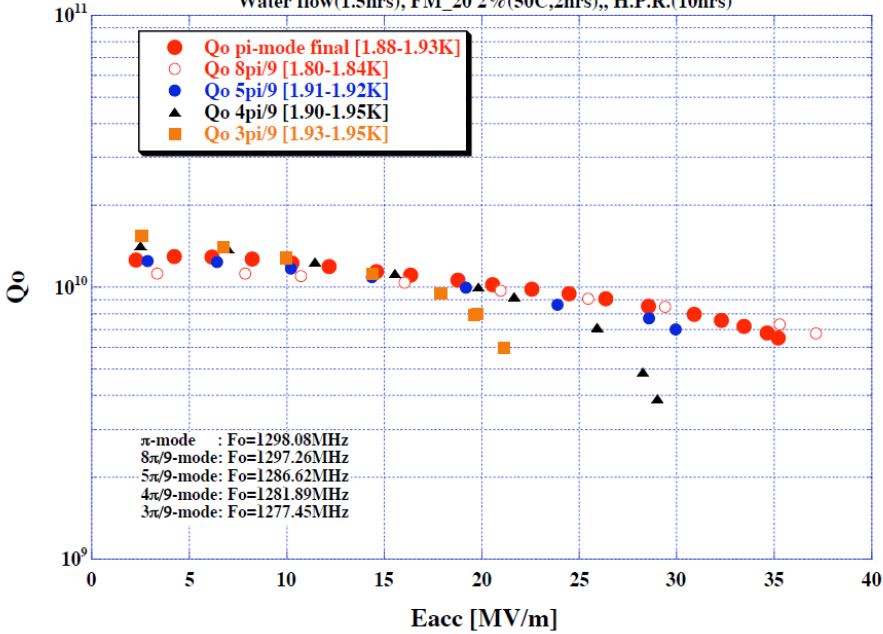
# Result of 1<sup>st</sup> vertical test (2) : Passband measurement

HITACHI 9cell Cavity HIT\_001 [Without HOM Couplers]  
 1st. Vertical Test 06/24/2010  
 Low Current Density EP-II(20 $\mu$ m) with N2 gas,  
 Water flow(1.5hrs), FM\_20 2%(50C,2hrs), H.P.R.(10hrs)

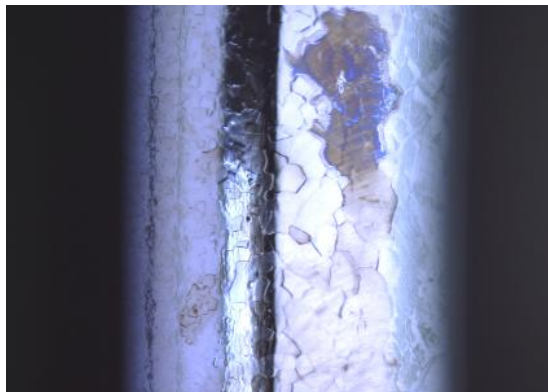
#9-BP : 135 deg.

Image of stains after EP-2 and vertical test.
